Toulmins Spring Branch Watershed Stormwater Management

DATE: 11/20/2014

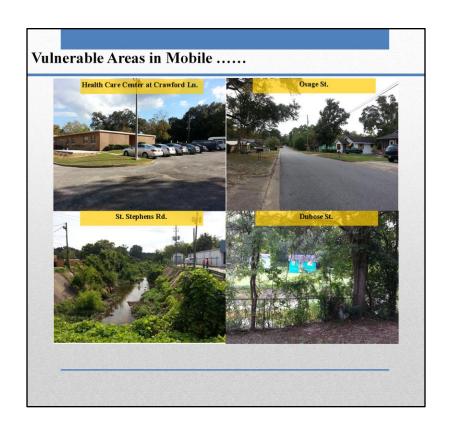
Notes: In Mobile, we found some areas where houses get flooded every year, 2 to 3 times, after heavy rain events. The creek where it crosses the St. Stephens Rd. was found with dense vegetation. People who work and live there were complaining that this section of the creek does not get much attention in terms of maintenance. This is where Mobile and Prichard is connected.

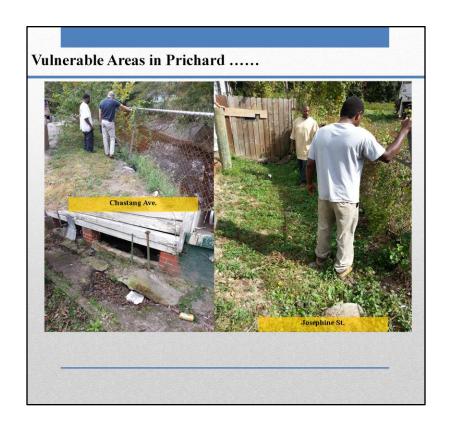
Notes: In Prichard, we found some places where houses get flooded every year; here you can see houses on Chastang ave, and Josephine St. In Chastang ave, we interviewed this guy, on the left of the screen. He said that water gets up to the plinth level of his house and causes damage to his properties. On our right on the screen, it shows a house on the Josephine st that gets flood from the creek. He also complained that a drainage pipe ends right in front of his house. So stormwater from other areas is discharged into his property area, and it causes damage and inconvenience for him every year.

Low elevation of lands along with dense vegetation in the creek [Josephine St, Chastang Ave (Prichard)]

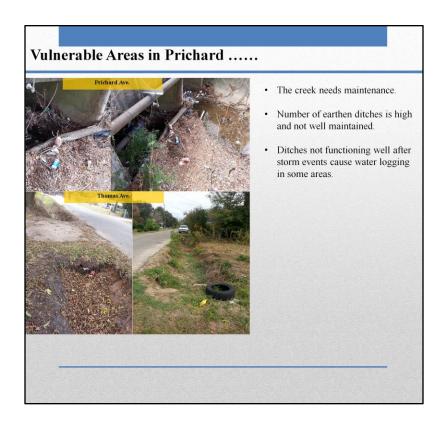
Notes: The pictures here show that the creek needs maintenance. Number of earthen ditches was found high in Prichard area, and not so well maintained. It was reported by some respondents that these earthen ditches not functioning well after storm events cause water logging in some areas.

Inadequate storm water drainage facilities, earthen ditches getting filled up, no ditches for drainage of water, vegetation in the ditches [Neely Ave, Thomas St and surrounding areas (Prichard)]

- · Reducing storm water runoff/promote infiltration upstream from problem areas
- · Clean and maintain ditches and tributaries

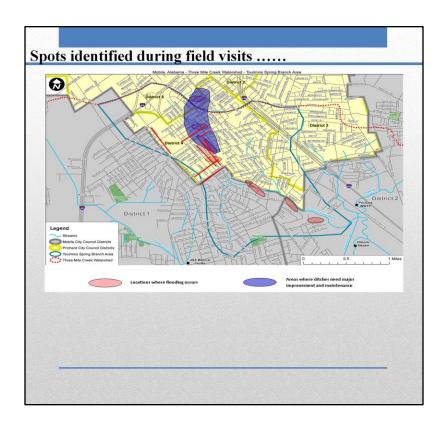
Notes: In this map, we have tried to summarize our findings from the field visits. The pink spots show areas that are suffering from flooding every year after heavy storm events. And the areas colored by blue are the areas where there have been incidents of water logging, and the drainage system needs to be improved.

Also you can see some red lines on the map. These are the streets where ADEM has recorded Sanitary Sewer Overflows. You can see that the red lines coincide with the areas affected by flooding. This might be indicative of the fact that flooding in those areas are causing these sanitary sewers to overflow, and eventually affecting the water quality downstream.
