Erosion Activity Assessment of the D'Olive Creek Watershed

Erosion Activity Assessment of the D'Olive Creek Watershed. Daphne, Alabama.

Tetra Tech, Inc.
2110 Powers Ferry Rd.,
Suite 202
Atlanta, GA 30339

Thompson Engineering, Inc.
2970 Cottage Hill Road, Suite 190
Mobile, AL 36606

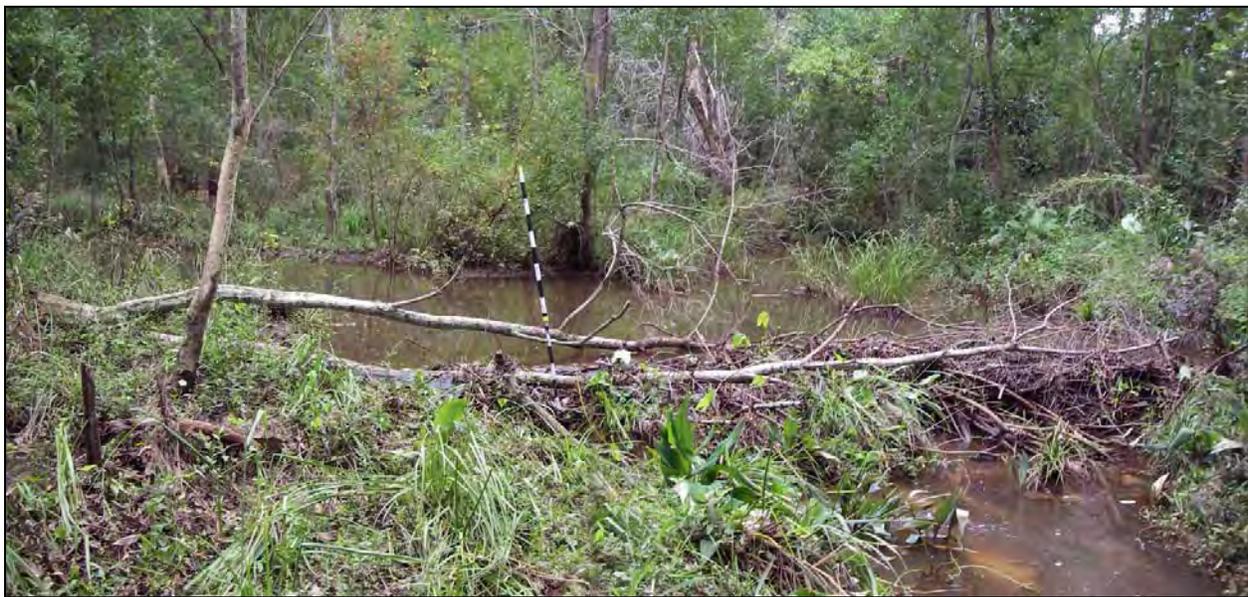
Beaver activity was documented at three locations, two in the upper portions of the Tiawasee Creek Sub-Watershed (WMUs 8 and 9) and a third in WMU 2. A 0.5 meter high beaver dam was observed at site T32 which marks the transition between the non-incised channels of the upper Tiawasee and the incised channels of the lower Tiawasee (Figure 4-2). Beaver activity, such as gnawings on trees, was observed near sites DB4, DB5, and DB6. Beaver dams do not appear to be contributing to stream channel erosion through bank scour around the dams. In general, beaver dams appear to be promoting the deposition of sediment on the narrow floodplains of Tiawasee Creek and tributary TC.

Figure 4-2. Beaver Dam on Tiawasee Creek. Site T32.

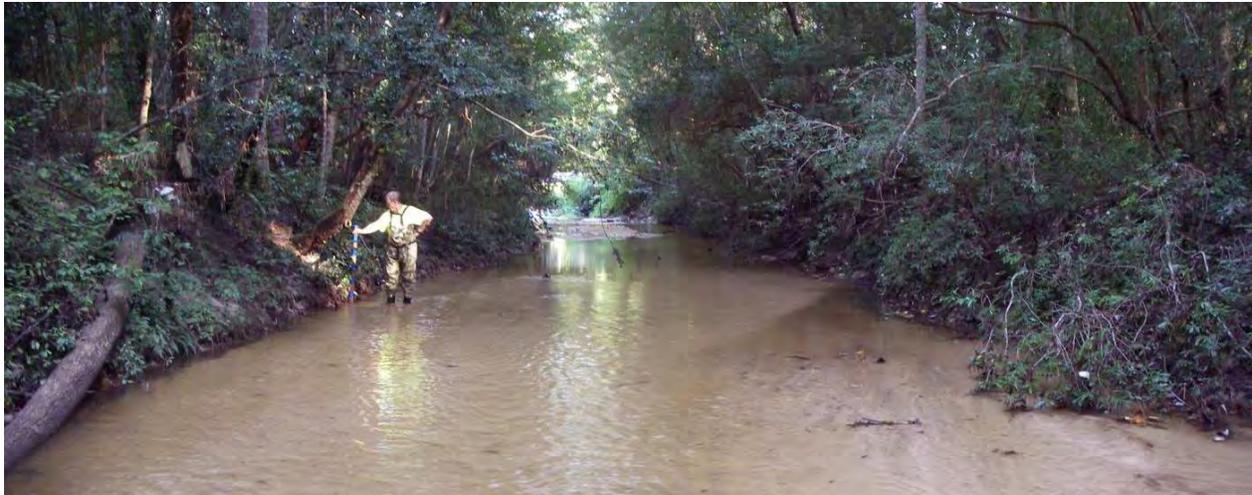
Figure 4-4. Exceptionally straight reach of Tiawasee Creek choked with sediment. Site T7.

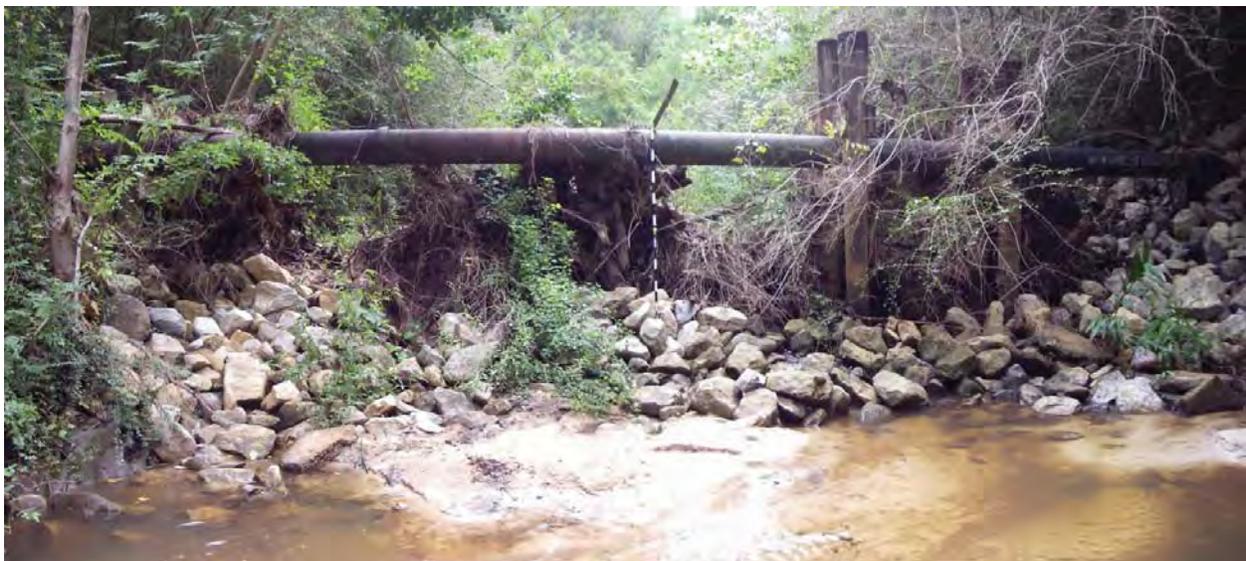
Sewage pipeline crossings have a fairly high potential for woody debris jams forming around the support structures or on the pipelines themselves. During high flows, these jams promote scour of the streambanks and around the support structures as well as create a higher load on the pipeline. Tiawasee Creek has the greatest potential for sewage line crossing impacts with seven locations noted between sites T14 to T29 (Figure 4-6). All the sewage pipelines along Tiawasee Creek had additional rip-rap protection against bank and bed scour.

Figure 4-6. Woody debris jam formed on sewage pipeline crossing. Site T18.

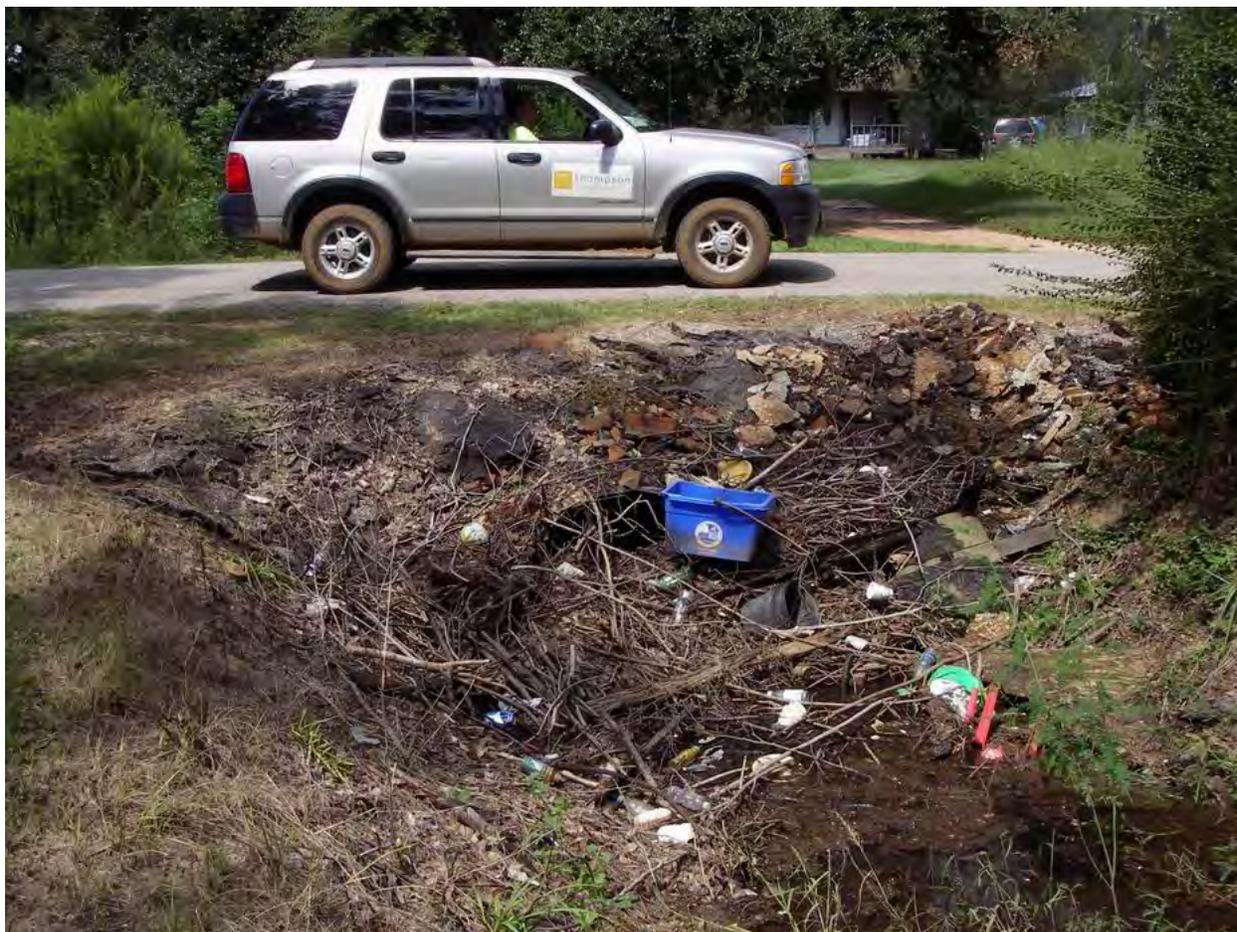
Figure 4-7. Culvert blocked by debris. Site TCC1.

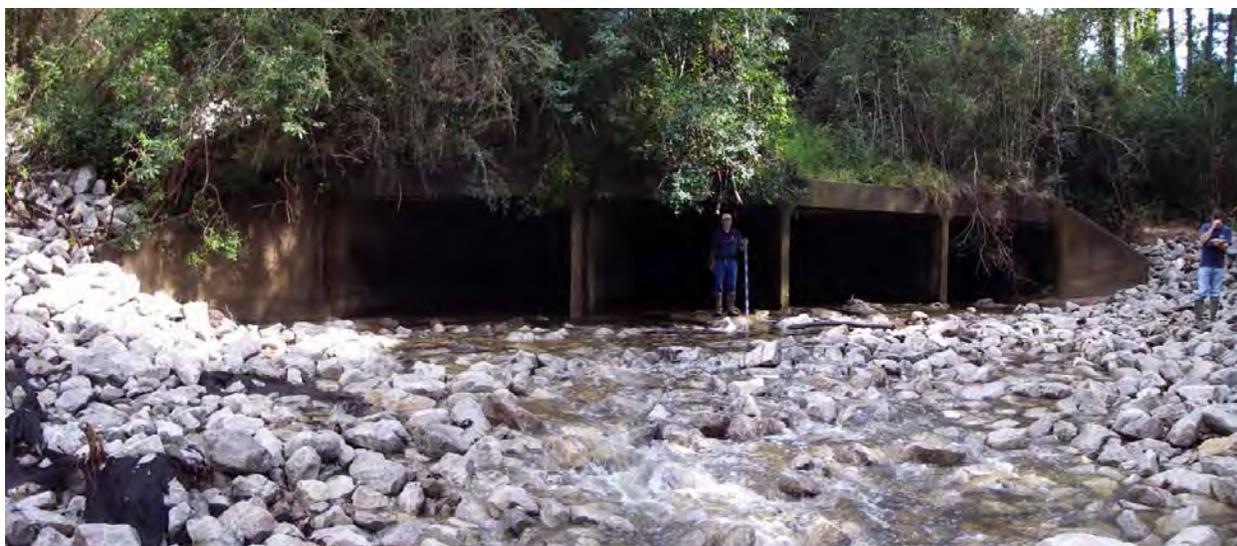
Figure 4-8. Scour repair below I-10 crossing of D'Olive Creek. Site D7.

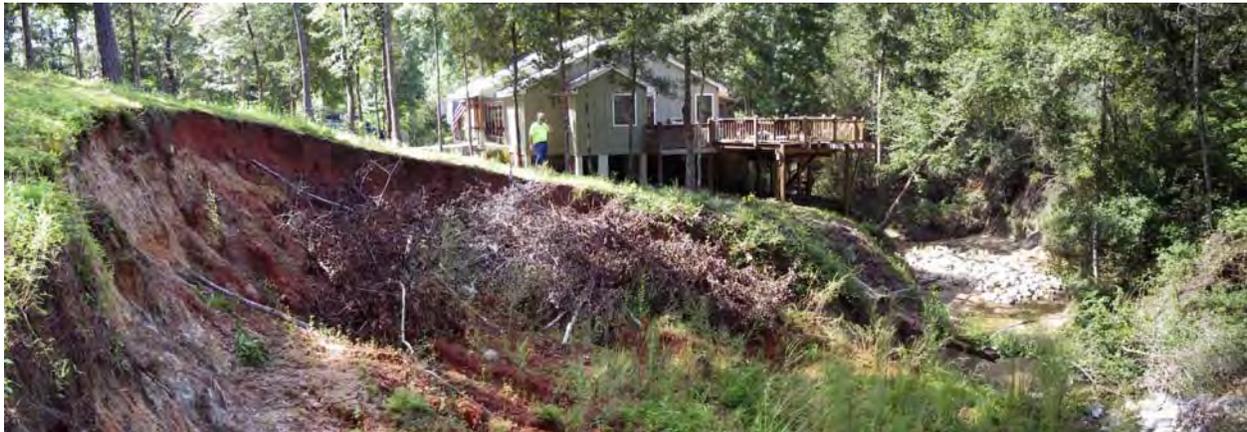
Figure 4-9. Recent mass wasting of streambank in Lake Forest. Site DA23a.

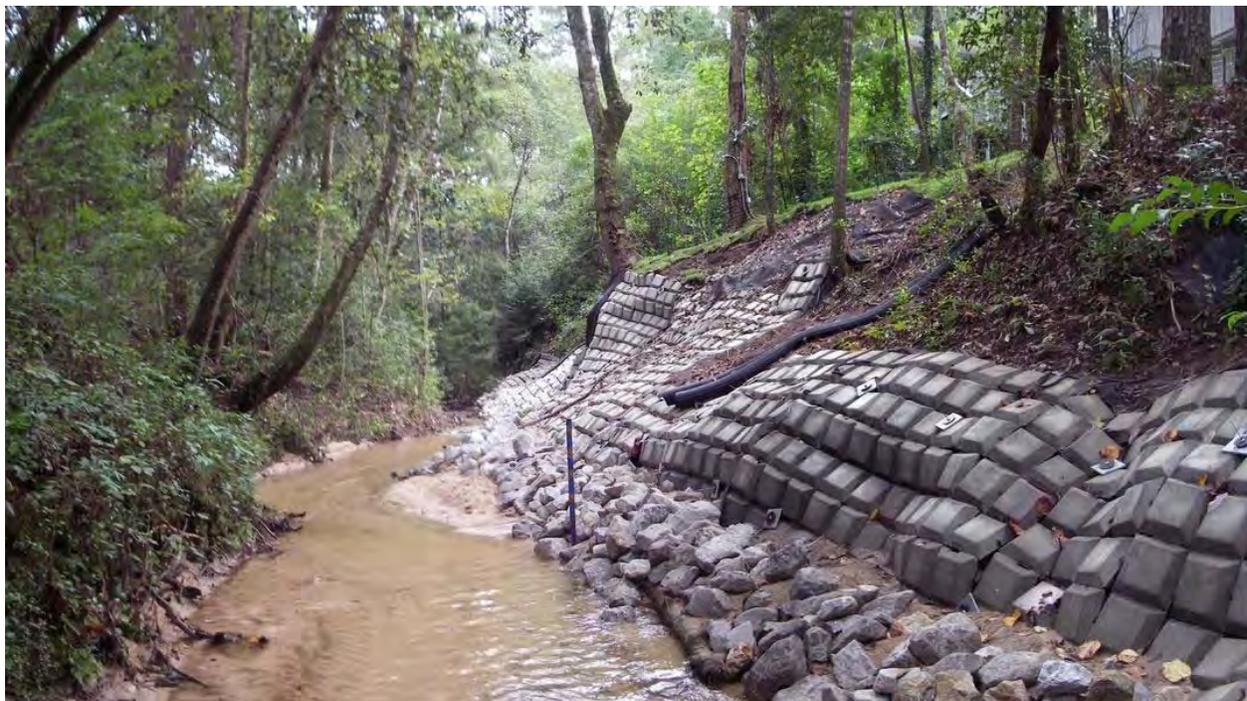
Figure 4-10. Bank protection along an incised reach of trib DA. Site DA9.

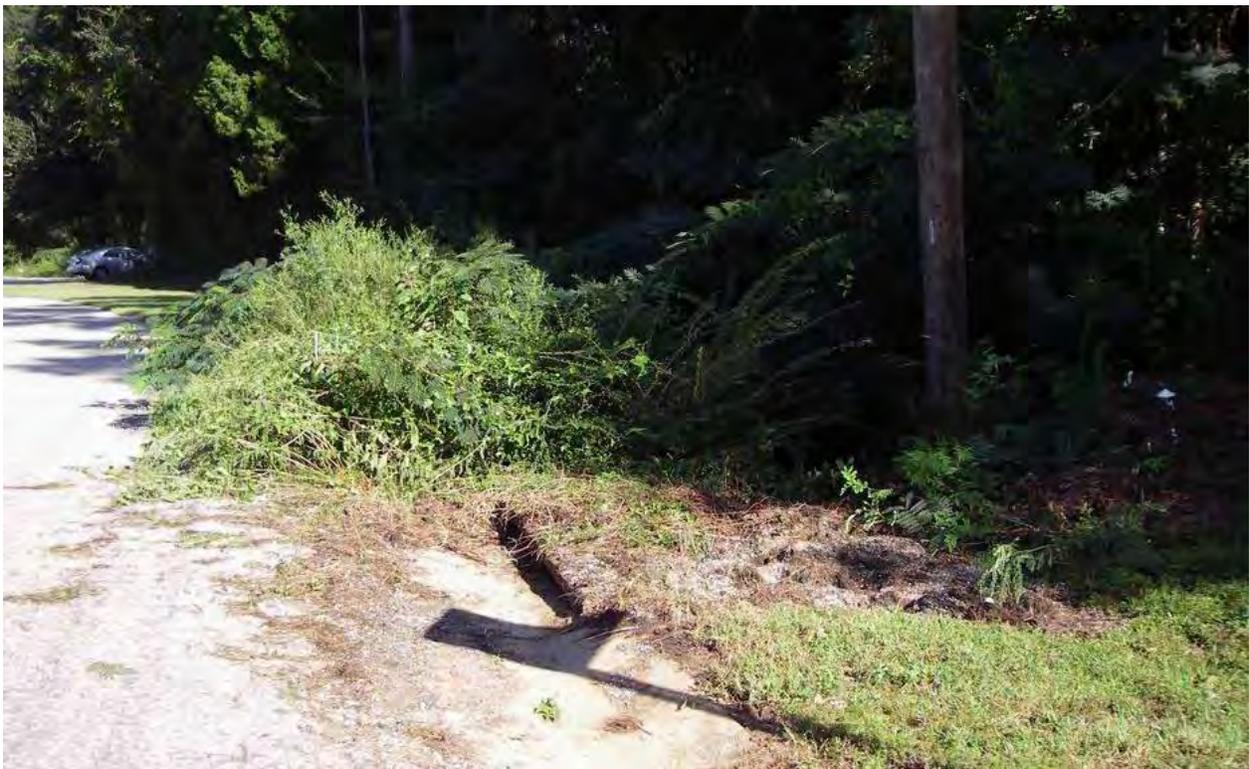
Figure 4-11. Four meter deep gully within 5 meters of road is totally obscured by vegetation. Site U37.

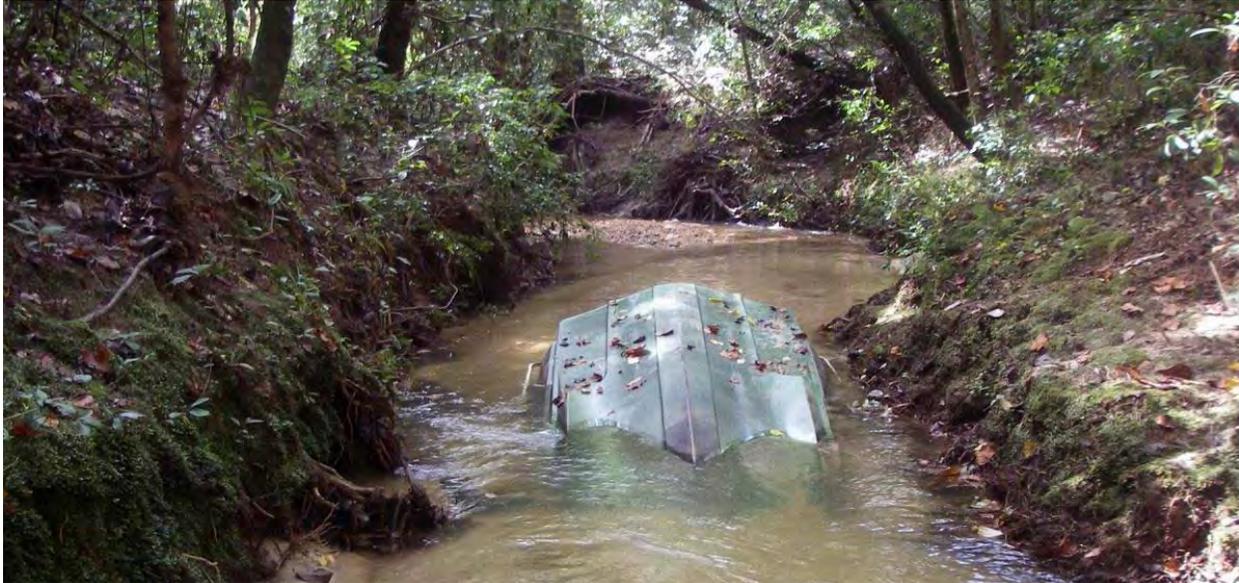
Figure 4-13. Boat in tributary DA. Site DA2.

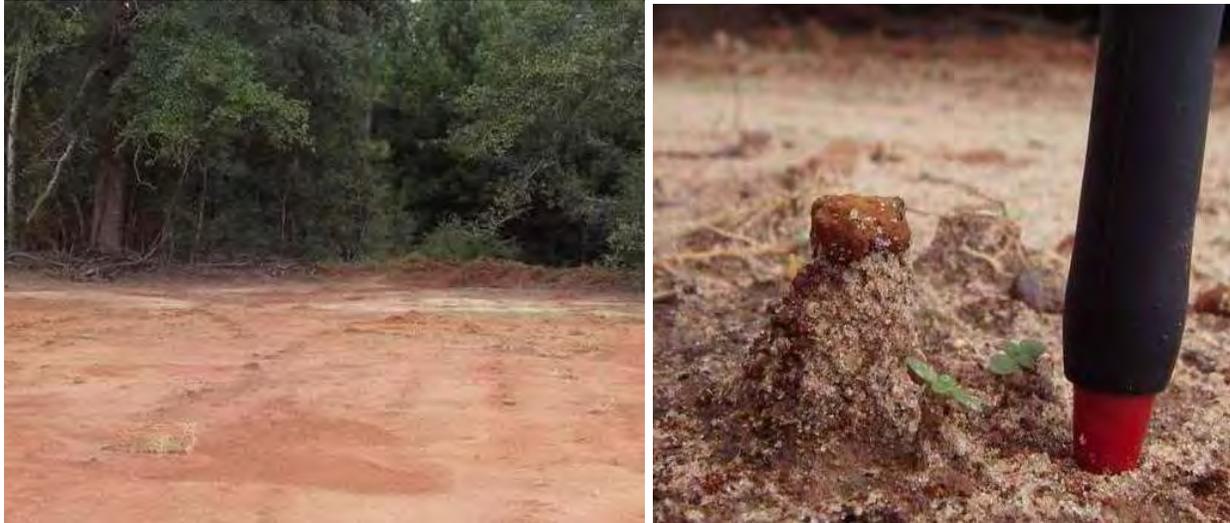
Figure 4-15. Construction site. Note 1/2 inch of soil loss marked by pedistalled pebble. Site U13.

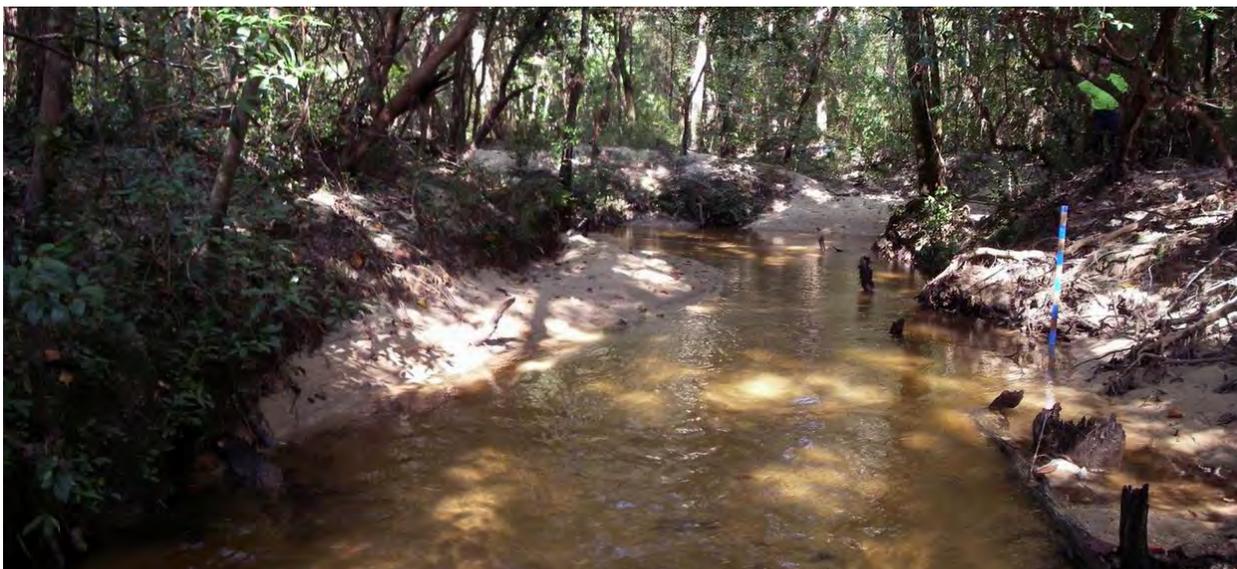
The main stem of D'Olive Creek from site D1 to site D2f is a depositional reach with heavy sand deposits on the bed. Tree stumps along the channel margin indicate that the stream has been migrating laterally at a relatively fast rate. Bank erosion by scour is common, but mass wasting is uncommon (Figure 5-1). Residential property along this reach does not appear to be impacted by the channel migration/scour erosion. However, flooding at Gordon Circle and Lakeview Loop may have been exacerbated by heavy sediment deposits on the stream bed.

Figure 5-1. Laterally migrating reach of D'Olive Creek with heavy sand deposits. Site D2.

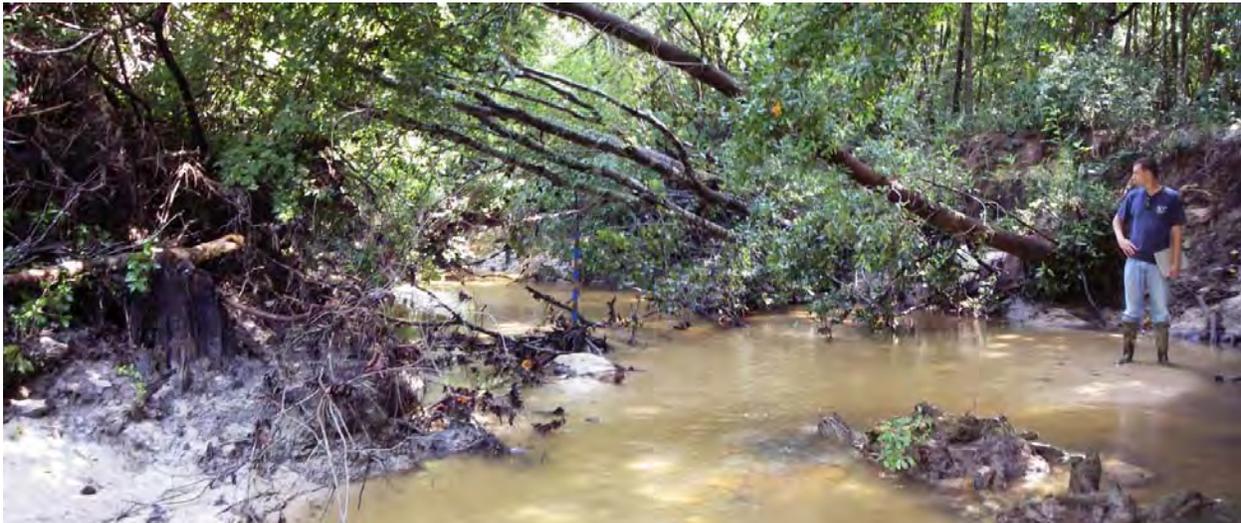
From D3 to D5 D'Olive Creek flows in an incised channel between banks approximately 3.5 meters high. Channel incision provides a significant sediment source. Mass wasting of the banks is prevalent and many trees growing near the bank top margin are recruited to the channel through mass wasting (Figure 5-2). These trees become the foundations for forming LWD jams which severely exacerbate channel erosion by forcing high flows to scour around the ends of and underneath the jams. Other jams along this reach, that had blocked the entire channel, were partially removed during the stream restabilization effort performed in the summer of 2009 between sites D6 to D7. Historically the reach from US 90 to I-10 was approximately 4 feet deep and 12 feet wide during the 1980's (Carlton, 2009).

Figure 5-2. Trees recruited to channel by bank mass wasting. Site D5.

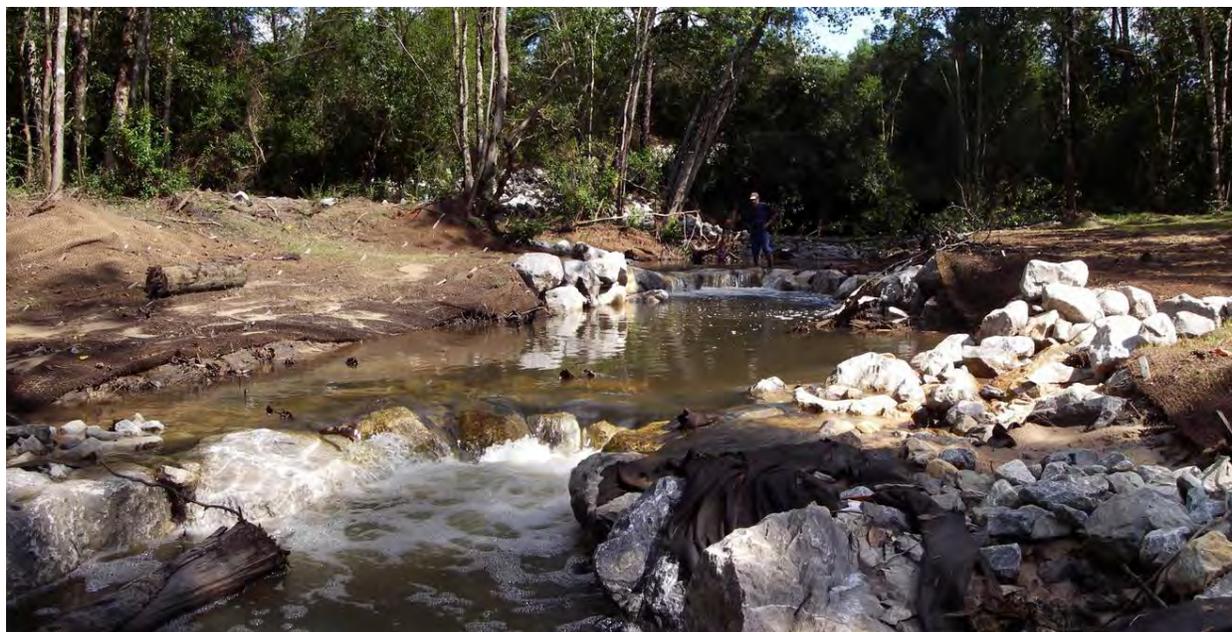
High flows in 2008 caused by Tropical Storm Fay and Hurricane Gustav caused severe scour and undercutting of the box culvert under I-10 that threatened the integrity of the interstate over D'Olive Creek (Campbell, 2009). It appears that a headcut had been rapidly migrating up the channel, creating a deeply incised stream with many trees falling into the channel from the unstable banks. During the summer of 2009, the undercut culvert was repaired and the first 500 feet below the culvert from D7 to D6 were restabilized. Banks were laid back to a low angle, riprap was placed at key areas, and crossvanes were placed in the channel to create grade control structures (Figure 5-3). In the restored state, this reach does not appear to be a significant sediment source.

Figure 5-3. Restabilized reach below I-10. Site D6.

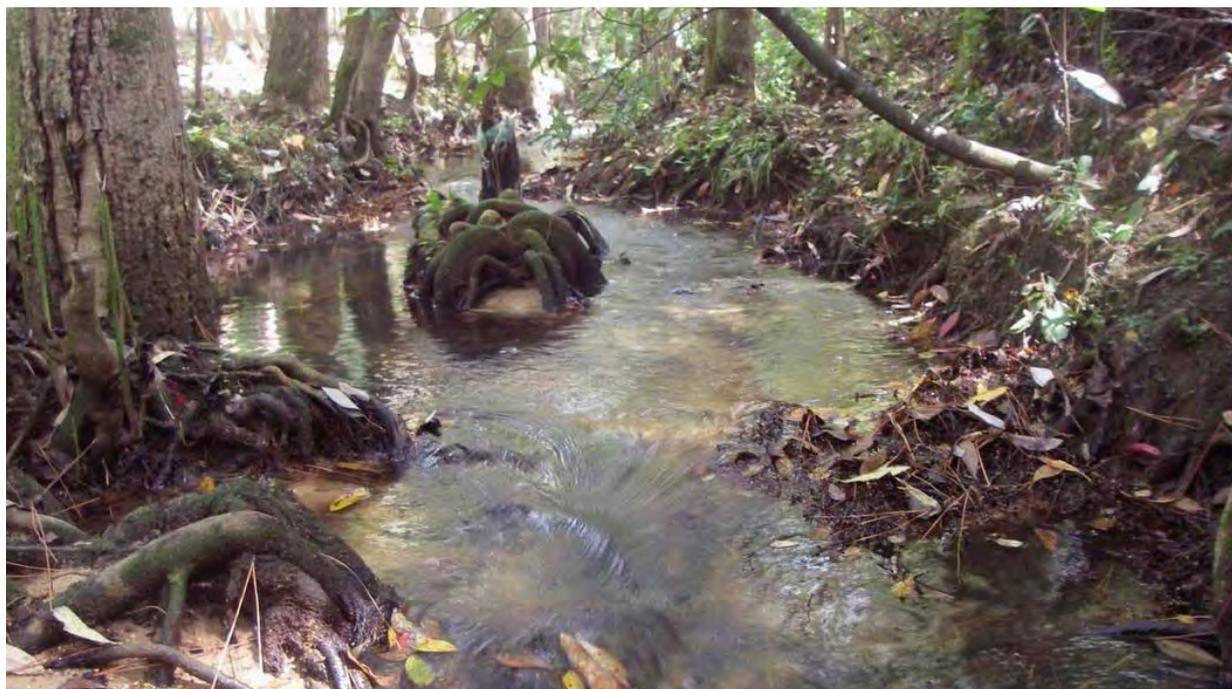
Within the Timber Creek subdivision, D'Olive Creek is a stable channel that appears to be transporting its sediment load and is not a sediment source. The stream is flowing through a bottom type valley with broad wooded riparian zones on both banks. Banks heights are low and bank faces are well protected by dense roots. Fresh sand was noted on floodplain (Figure 5-4).

Figure 5-4. Stable reach in Timber Creek subdivision. Site D11.

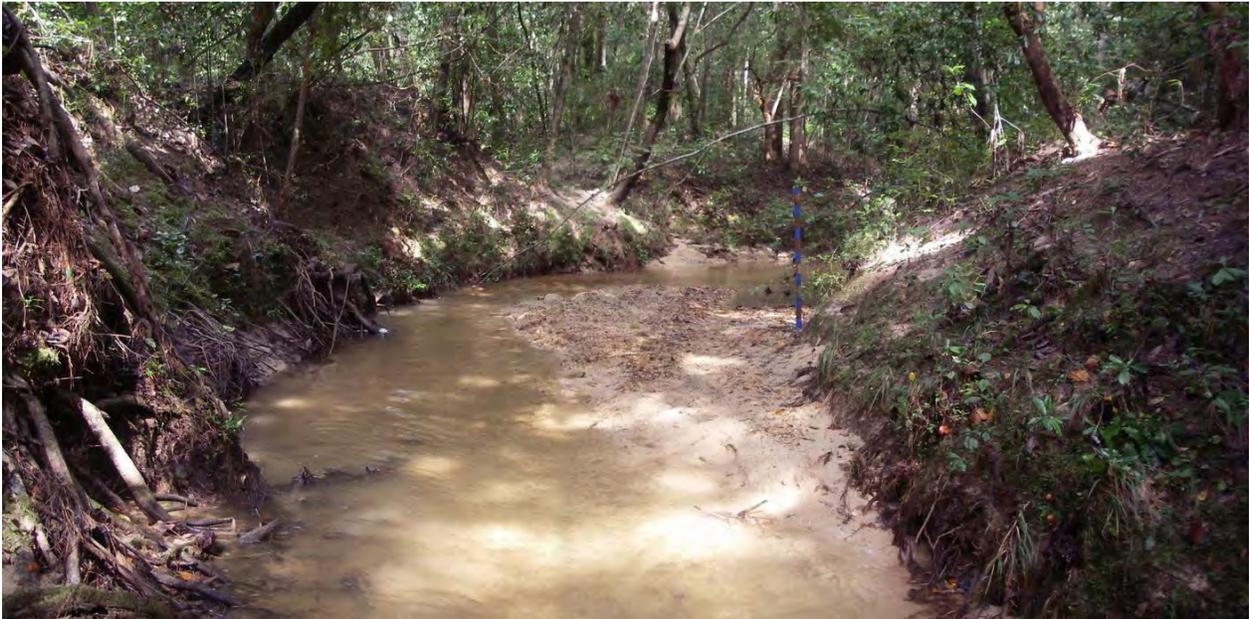
Figure 5-5. Reach impacted by both bank erosion and bed sedimentation. Site DA2.

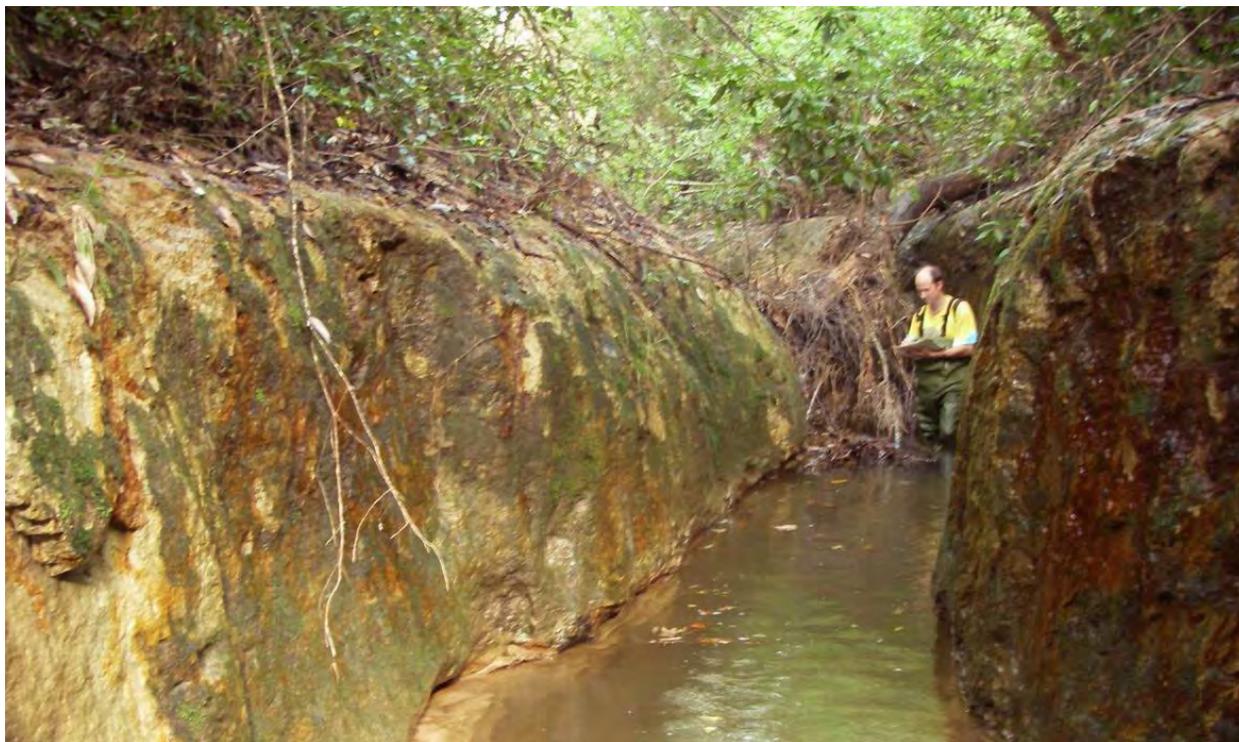
Figure 5-6. Slot canyon channel in hard clay. Site DA32

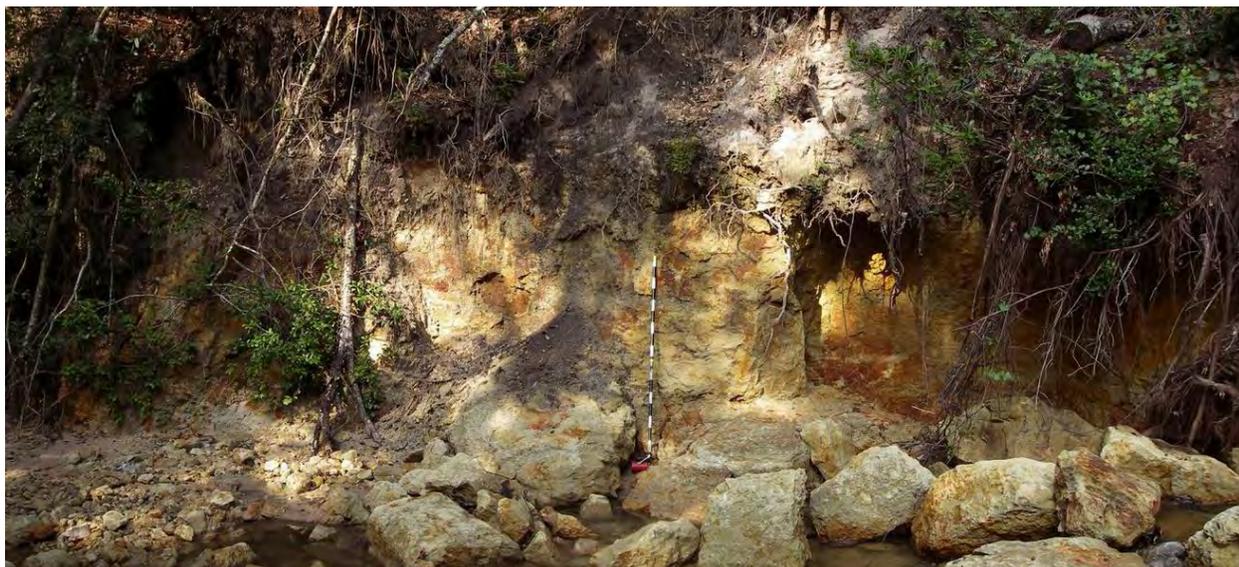
Figure 5-7. Erosion by block failure observed at DA22 and DA34. Site DA22

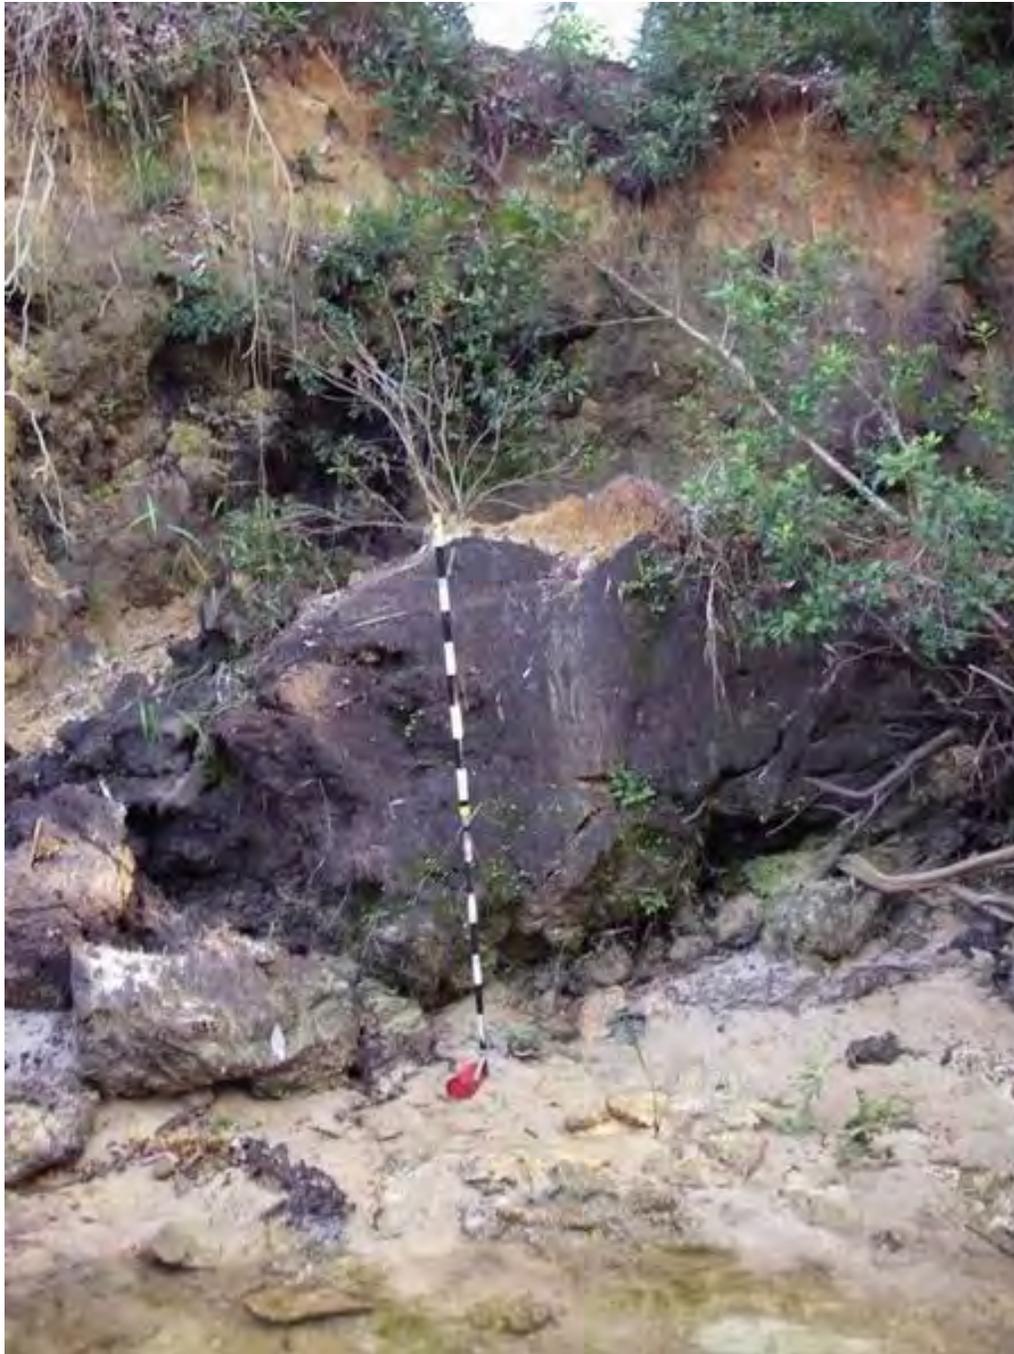
Figure 5-8. Mass wasting of streambank beneath power line crossing. Site DA36

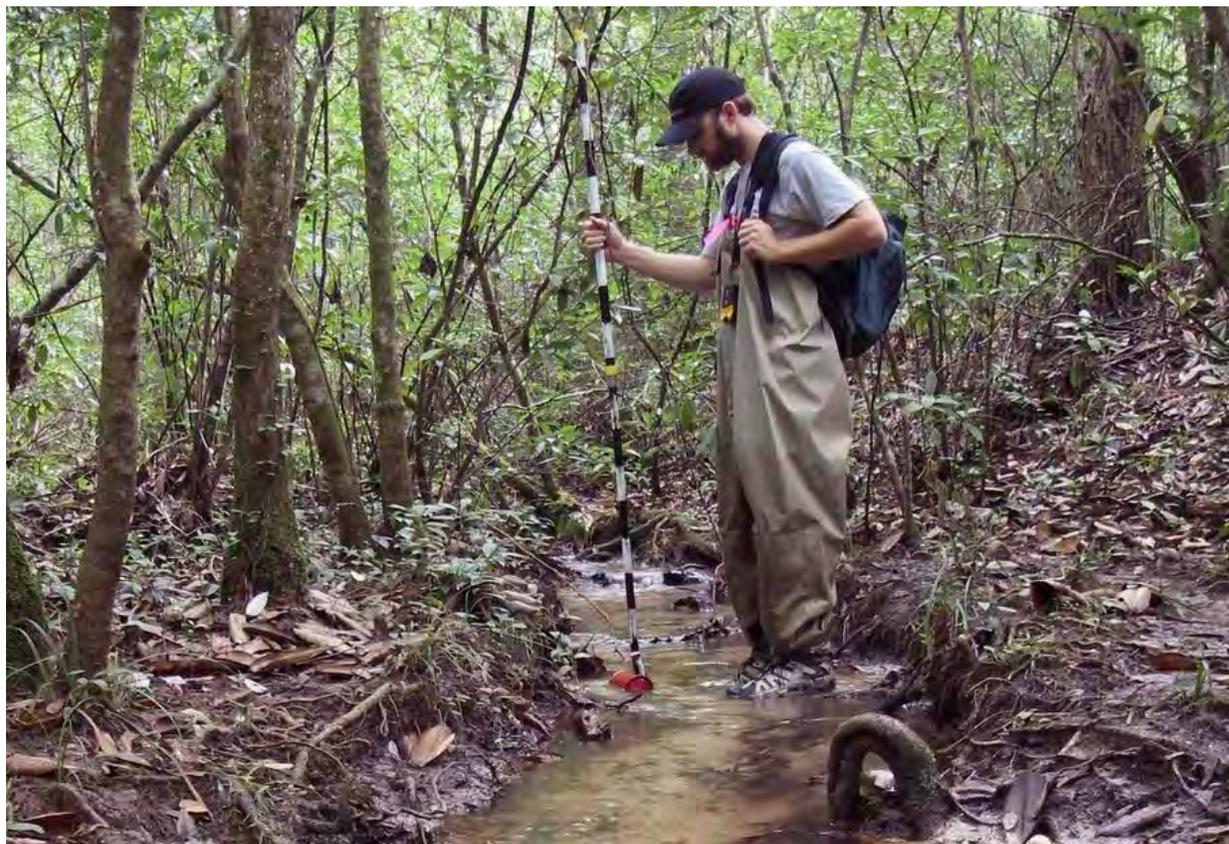
Figure 5-9. Typical channel form below US 90 on trib DA. Site DA46

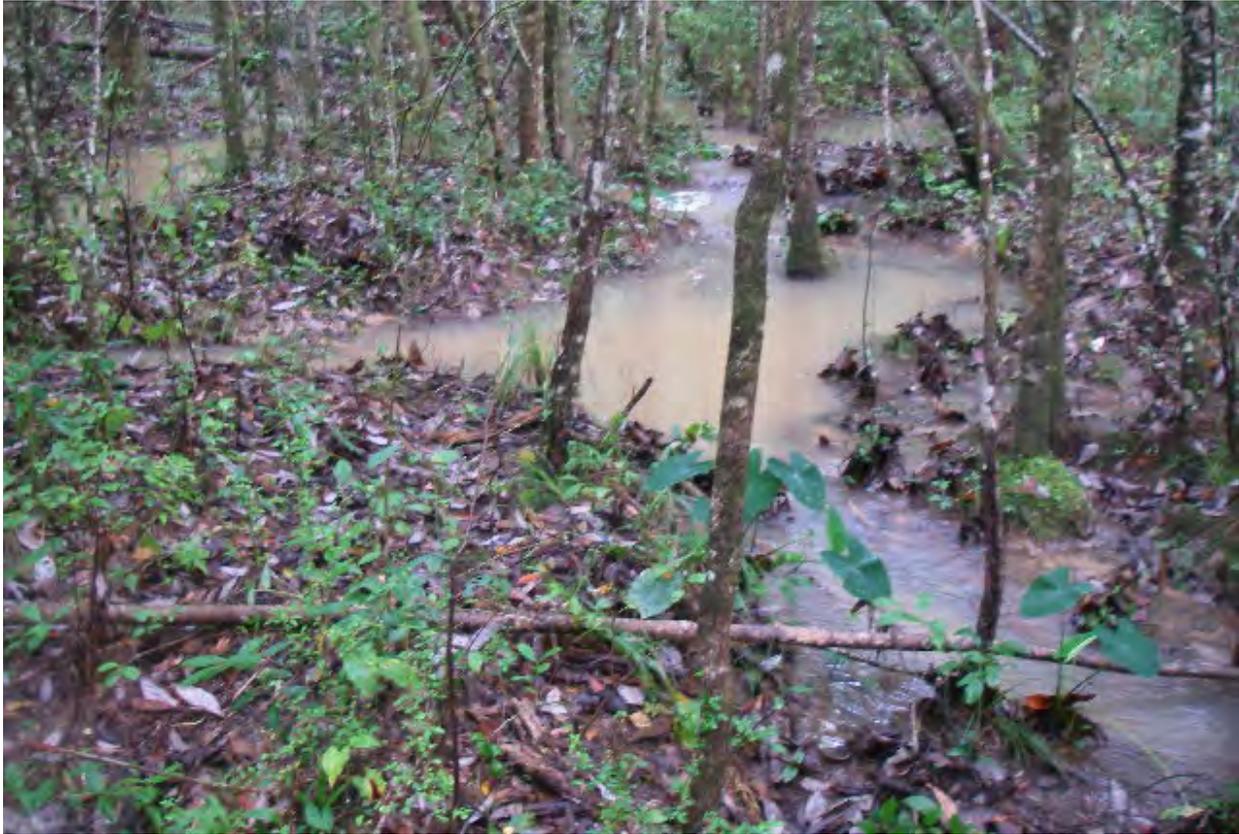
Tributary DB is a stable stream flowing across a bottom type valley and does not appear to be a sediment source (Figure 5-10). It appears to be transporting its sediment load. Sediment entering from upstream is transported through the reach without excessive deposition taking place within the channel. Sediment deposits were noted on the floodplains. DB is impacted by beaver dams near sites DB4, 5, and 6. The headwaters near highway 31 are impacted by

Figure 5-10. Typical stable reach of tributary DB. Site DB8.

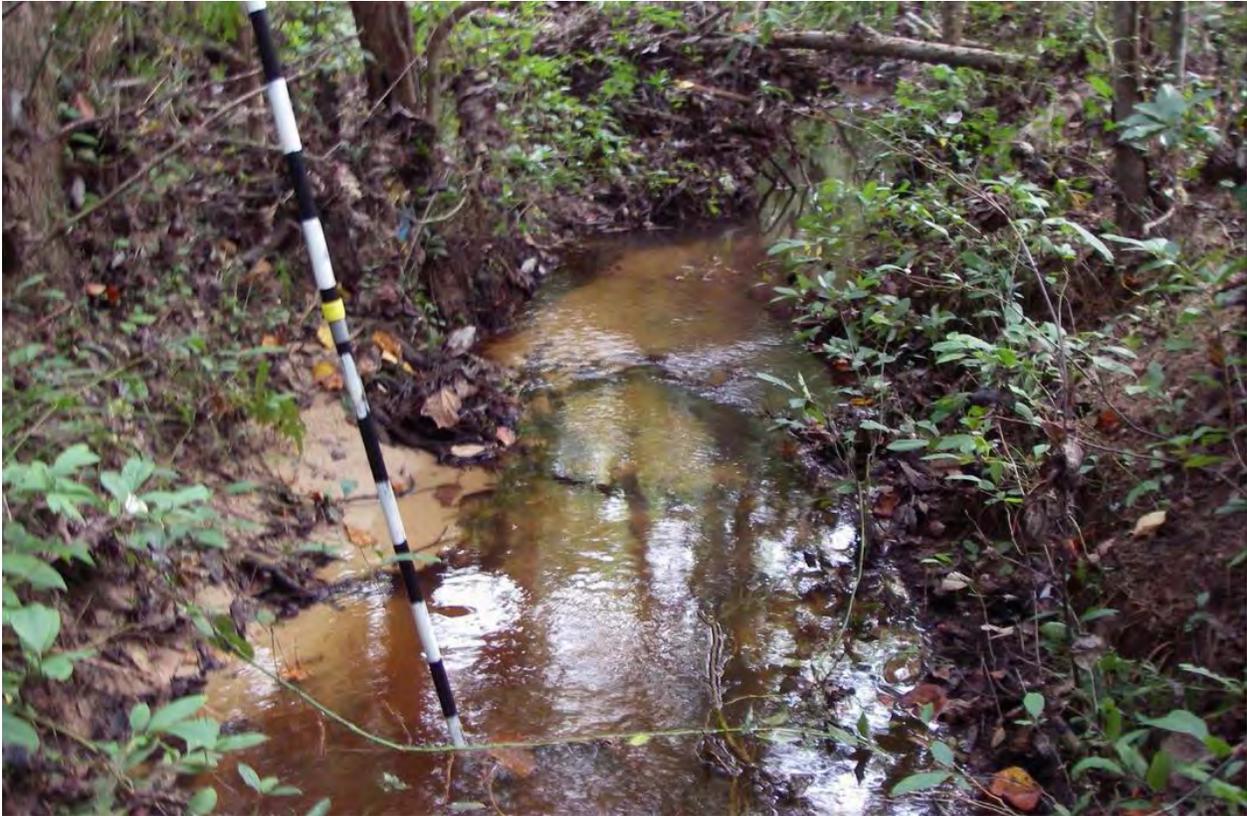
Tributary DC is a stable stream flowing across a bottom type valley with low banks that are well protected by roots and subjected to minimal erosion (Figure 5-11). This reach does not appear to be a sediment source and appears to be transporting its sediment load. Sediment deposits were noted on the floodplains. At sites DC12 and DC13 the stream encroaches on the western valley wall causing both erosion and potentially threatening property. The landowner at 139 Sara Street has placed concrete and other debris on the valley slope face in an attempt to slow erosion. This encroachment occurs naturally when a stream, in a meandering pattern across its floodplain, contacts the valley wall. Exceptionally heavy and recent sediment deposits were noted on the east floodplain near DC4 and near DC18 (Figure 5-12). The sediment source was not located with certainty, but is likely related to nearby construction activities at home sites immediately upslope from DC4 and DC18 within the Timber Creek subdivision.

Figure 5-11. Stable reach DC. Site DC7.

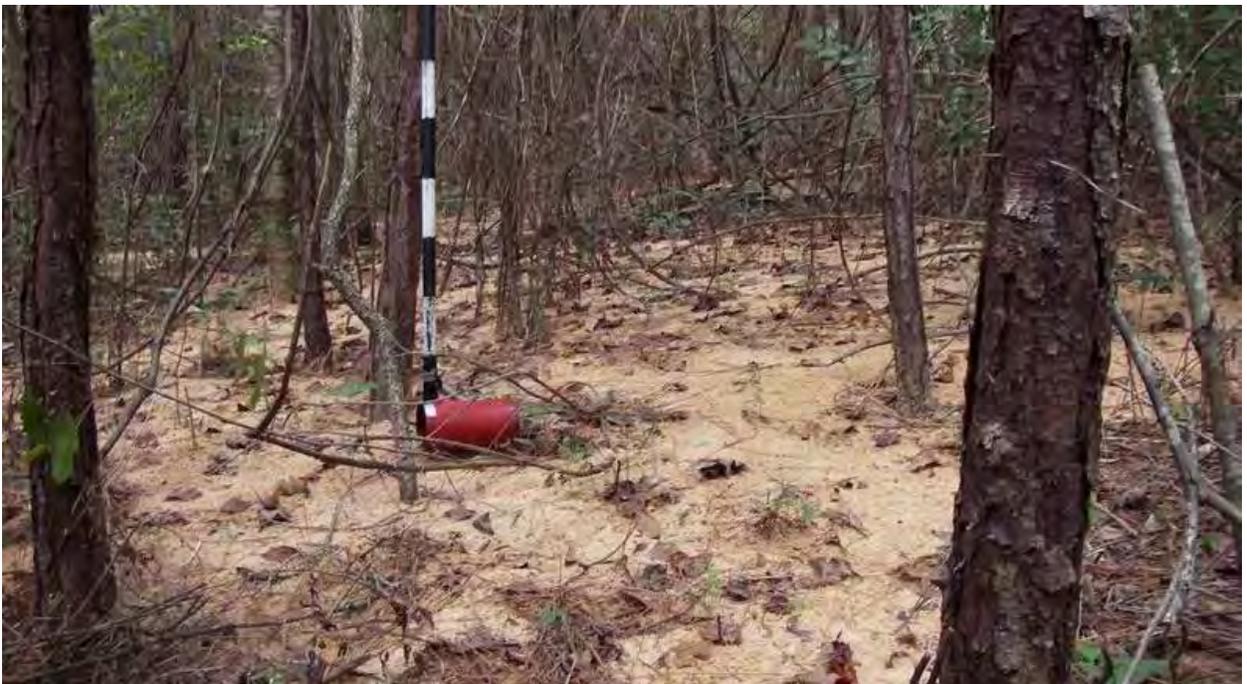
Figure 5-12. Fresh heavy floodplain sediment deposit. Site DC4.

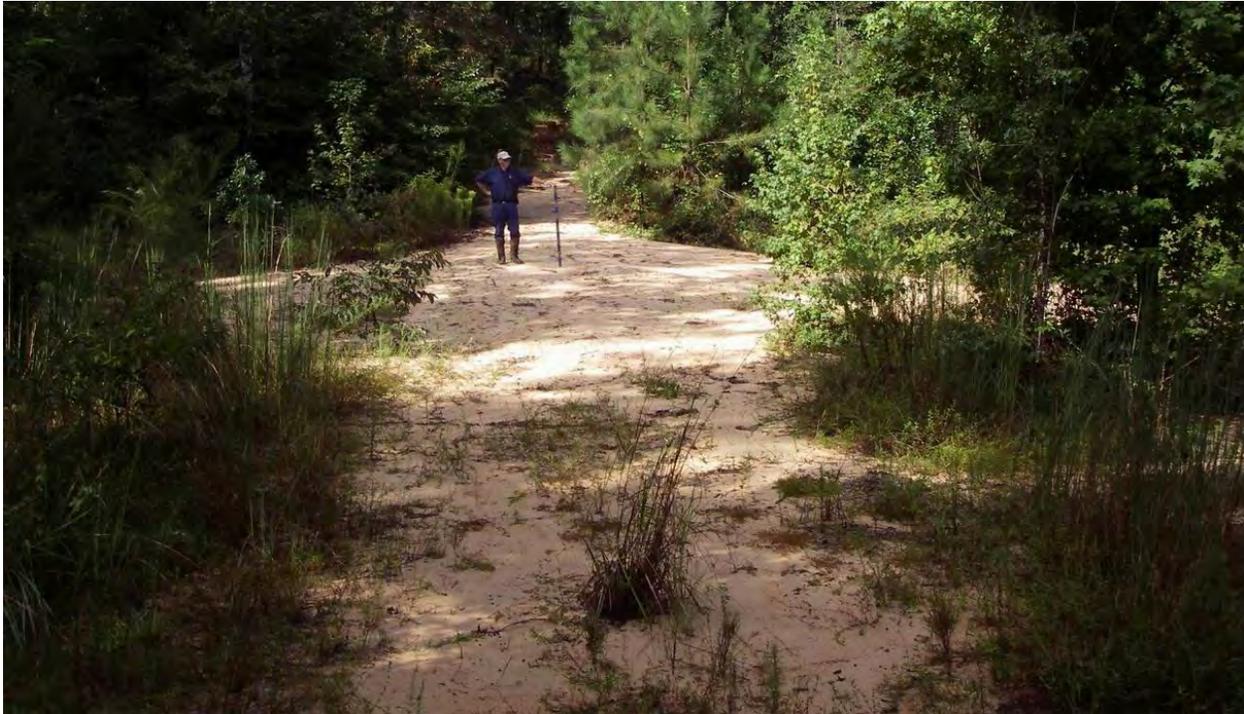
Figure 5-13. Alluvial fan from dirt road erosion. Site DD1.

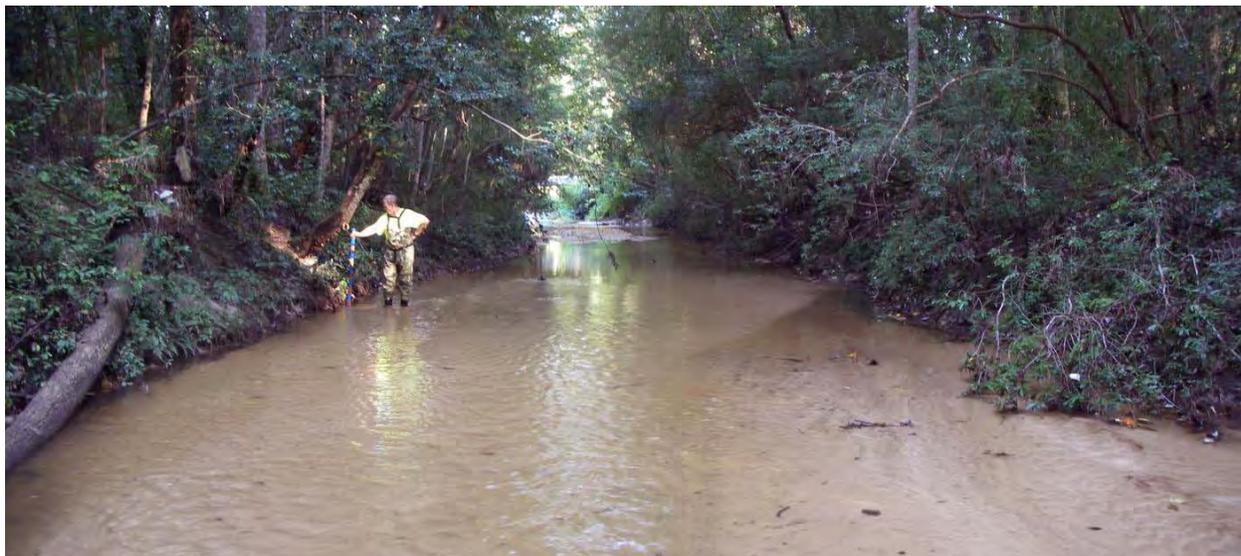
Tiawasee Creek is a depositional reach between sites T1 and T8 (Figure 5-14). A rod can easily be pushed 0.5 meters into the streambed. Flows have eroded around the north end of the riprap grade control structure at T5, resulting in excessive bank erosion. Some locations of bank scour were observed, but overall the reach is not a sediment source. The stream reach is responding to a high sediment load by aggrading, probably because the stream is within the backwater effect of Lake Forest Lake. Flows approaching the lake begin to slow down along this reach and the sediment drops out. This thick sediment layer is not permanently deposited but is transported downstream at a roughly estimated rate of 100 to 500 meters per year depending on how many high flow events occur. Ultimately, the sediment will be deposited in Lake Forest Lake. A riprap grade control at T8 protects any headcuts from potentially migrating up to the Bay View Drive Bridge.

Figure 5-14. Heavy sand deposits on Tiawasee Creek below Bay View Drive. Site T7.
