Erosion Activity Assessment of the D'Olive Creek Watershed

Erosion Activity Assessment of the D'Olive Creek Watershed. Daphne, Alabama.

Tetra Tech, Inc.
2110 Powers Ferry Rd.,
Suite 202
Atlanta, GA 30339

Thompson Engineering, Inc.
2970 Cottage Hill Road, Suite 190
Mobile, AL 36606

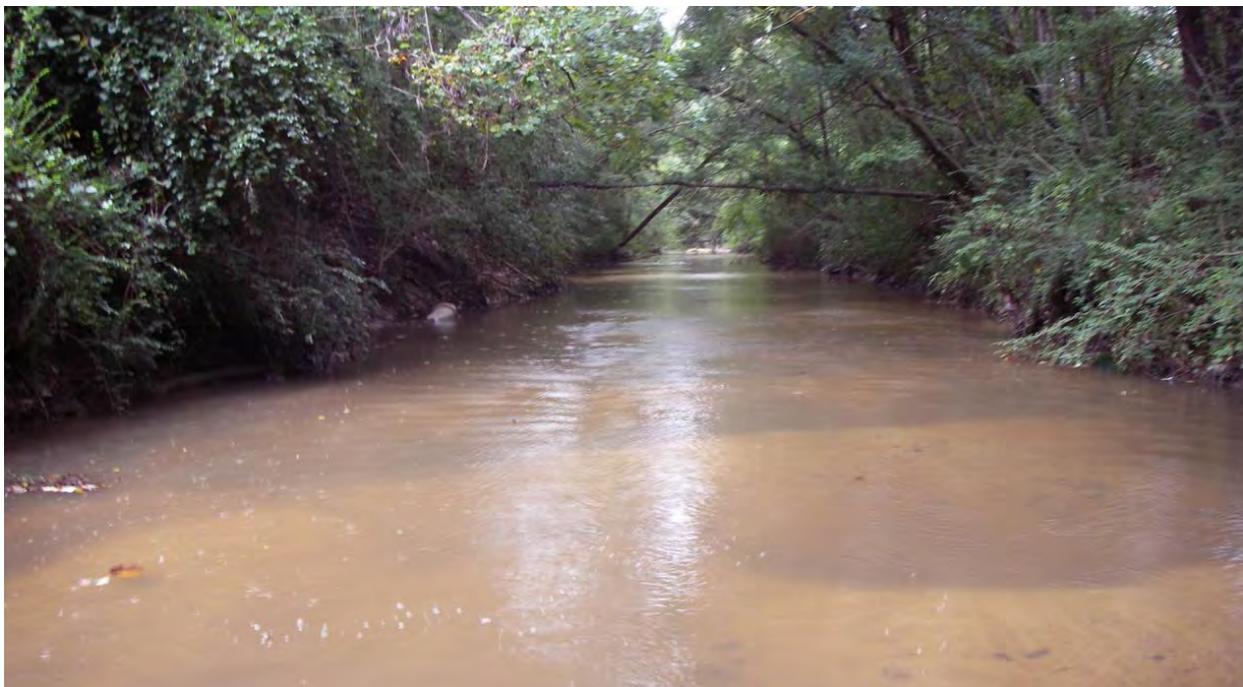
The reach from Bay View Drive to Ridgewood Drive was assessed at three locations; downstream (T9 and T10), middle (T11), and upstream (T12). The downstream and middle locations appeared to be impacted by heavy sediment deposits (Figure 5-15). A concrete grade control structure at T9 functions to reduce bank and bed erosion by preventing headcuts from migrating upstream, thus promoting upstream sedimentation. Both conditions help to keep upstream banks below their critical height above which they may fail by mass wasting. The upstream reach is characterized by high slopes adjacent to the channel for approximately 300 meters below Ridgewood Drive (Map 7). Although not directly assessed, these high slopes are indicators of a high potential for bank instability. Bank failure would create a high sediment source reach. At Ridgewood Drive, there is a 1 meter high grade control structure 20 meters downstream of the box culvert under the road.

Figure 5-15. Heavy sand load in the form of dunes on the bed of Tiawasee Creek. Site T11.

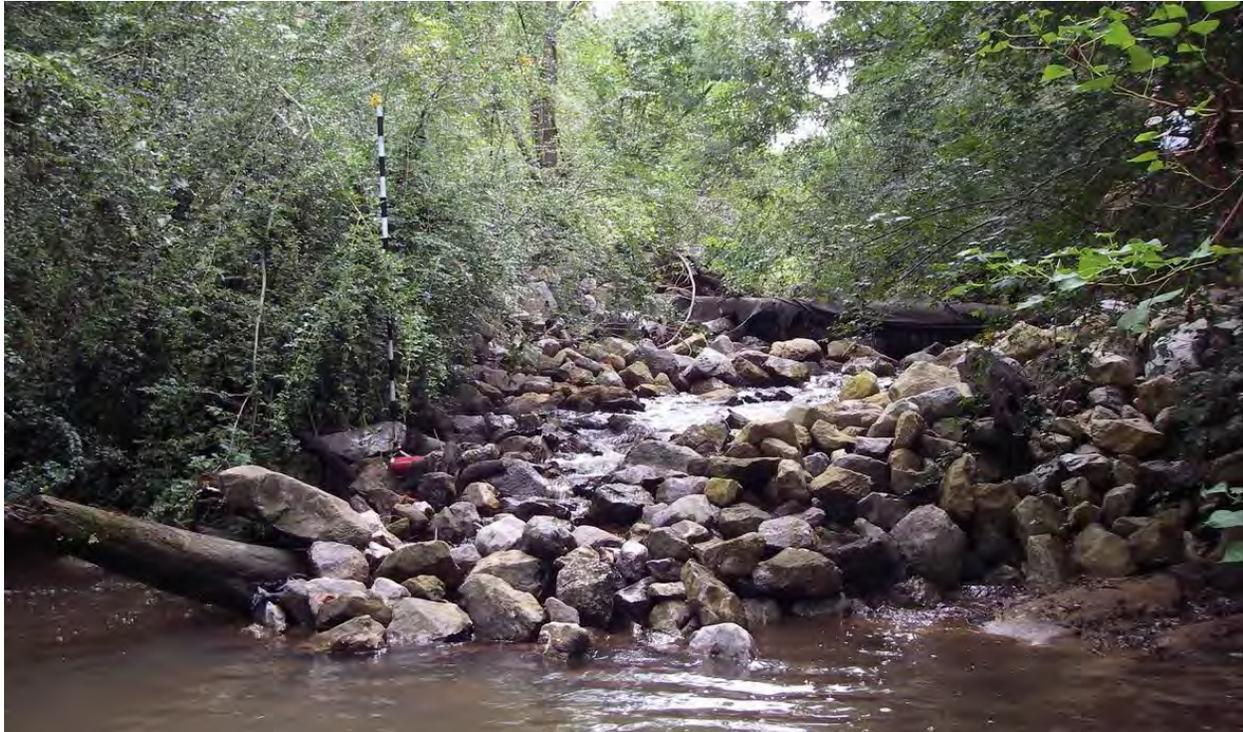
Figure 5-16. Typical riprap grade control protecting sewage pipeline on Tiawasee Creek. Site T23.

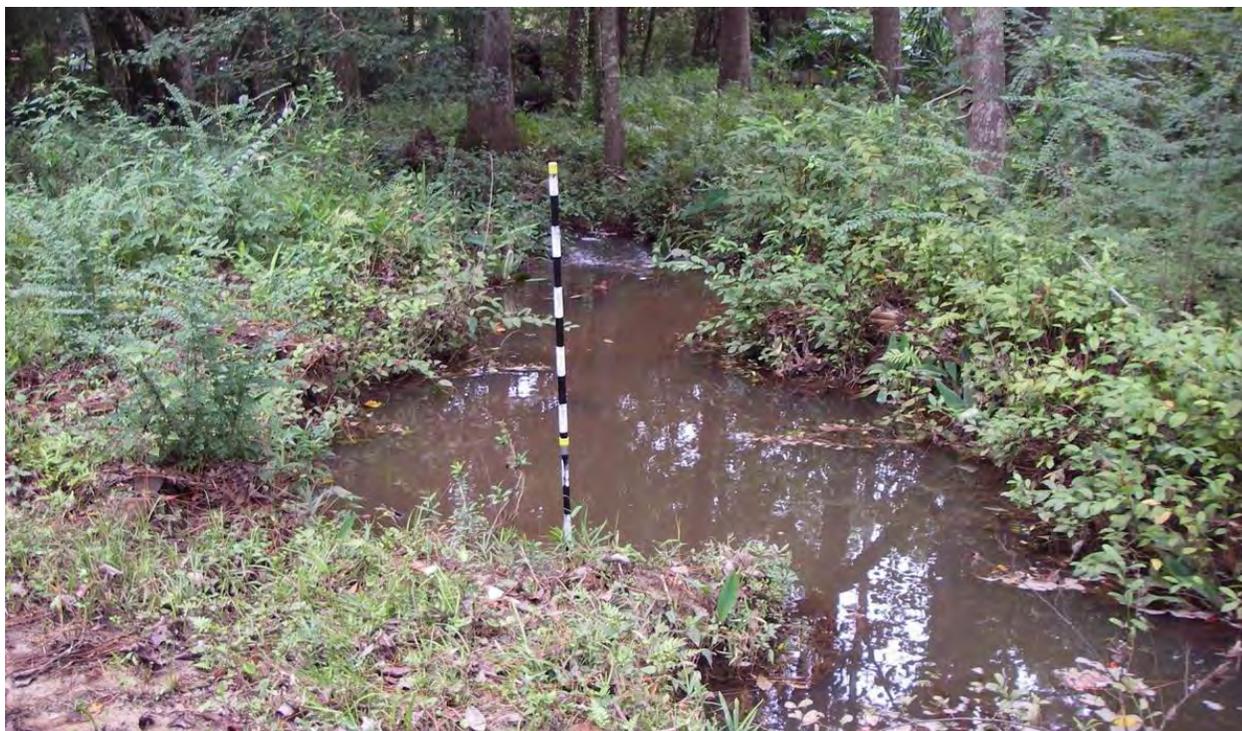
Figure 5-17. Stable channel characteristic of the upper reaches of Tiawasee Creek. Site T31.

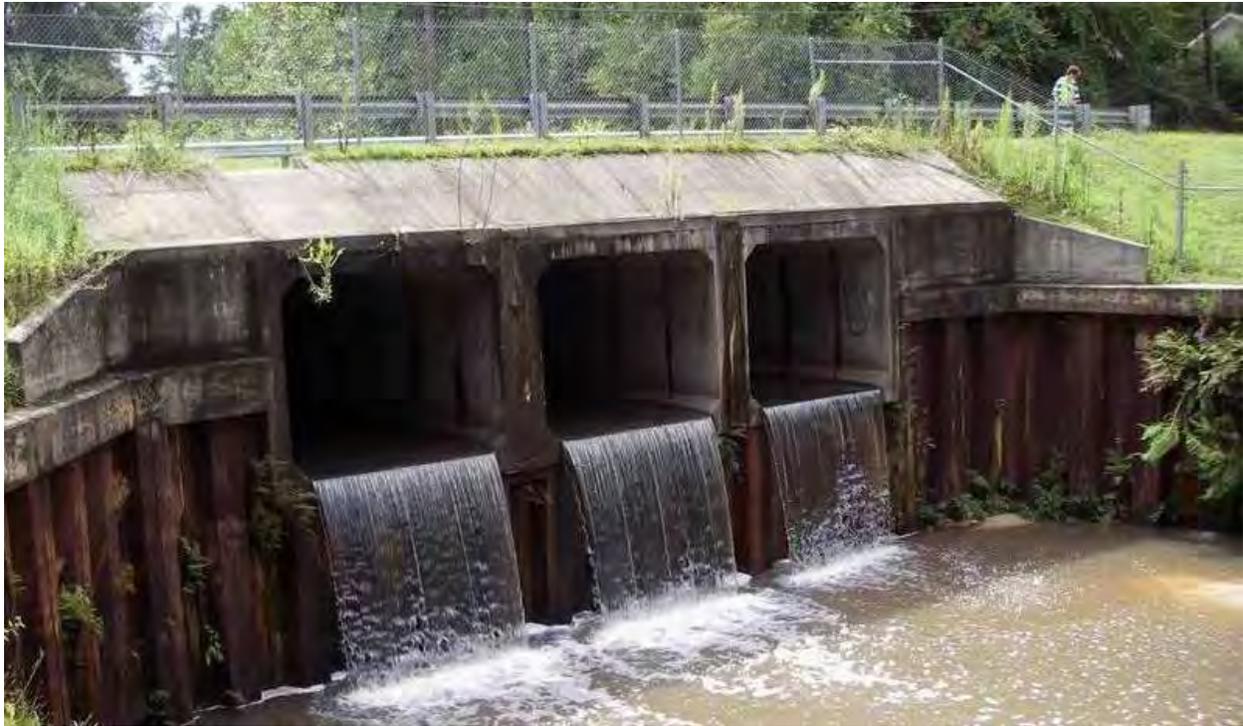
Figure 5-18. Concrete drop structure creates grade control below Greenwood Drive. Site TC1.

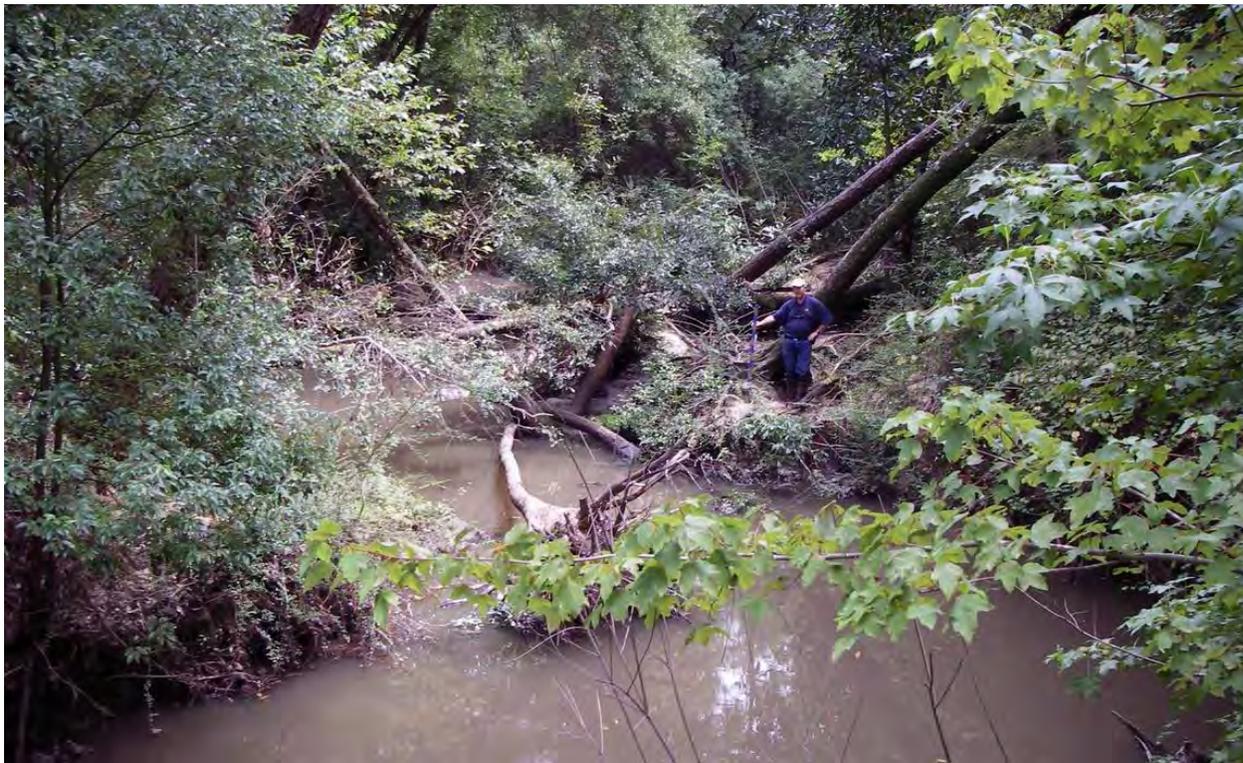
Figure 5-19. Person standing on rotational failure of high streambank with trees. Site TC2.

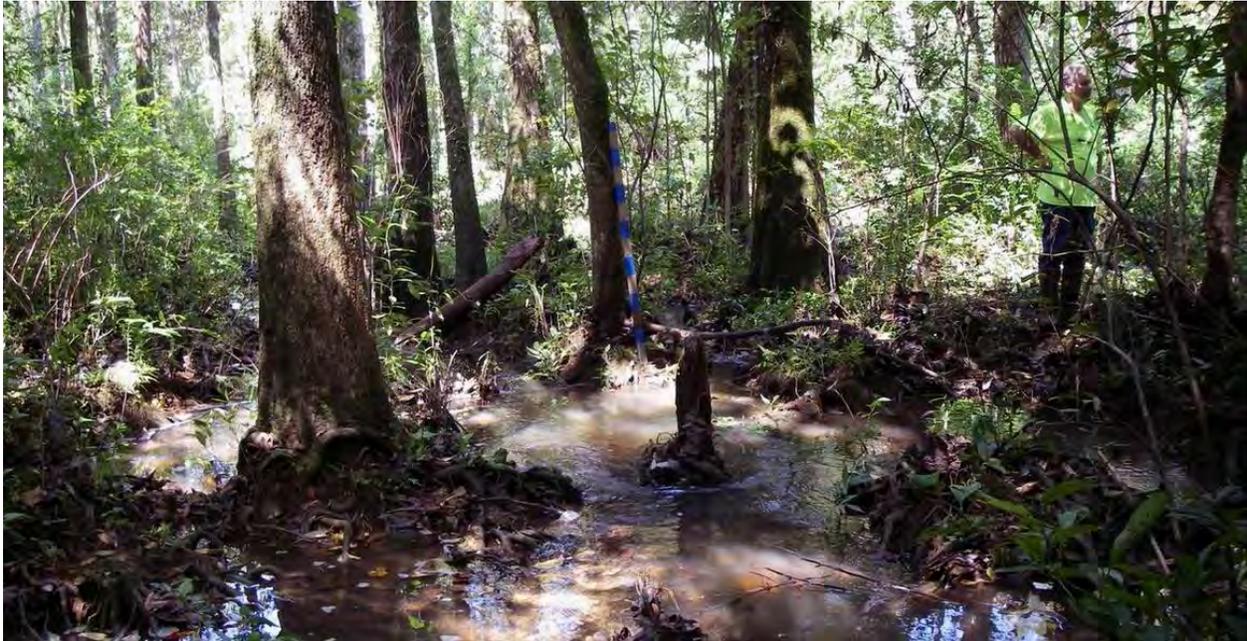
Figure 5-20. Multi-threaded low sediment load valley bottom type channel. Site TC7.

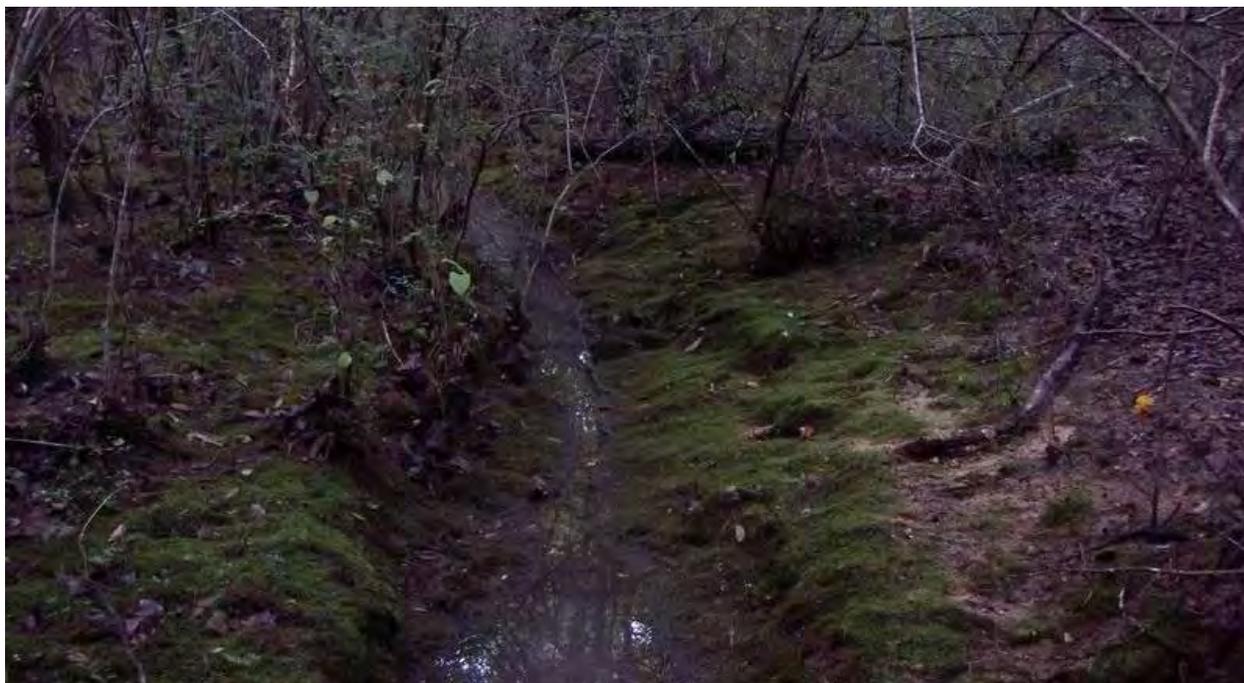
Figure 5-21. Stable valley bottom reach. Site TCA4.

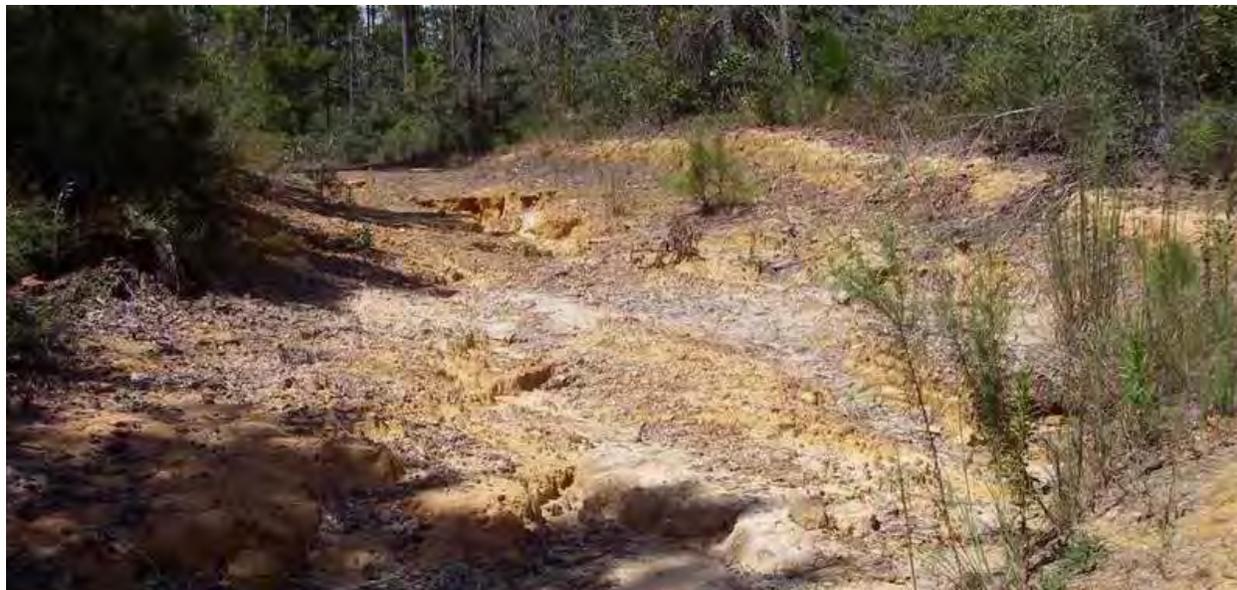
Figure 5-22. Eroding unpaved road north of tributary TCB. Site U46.

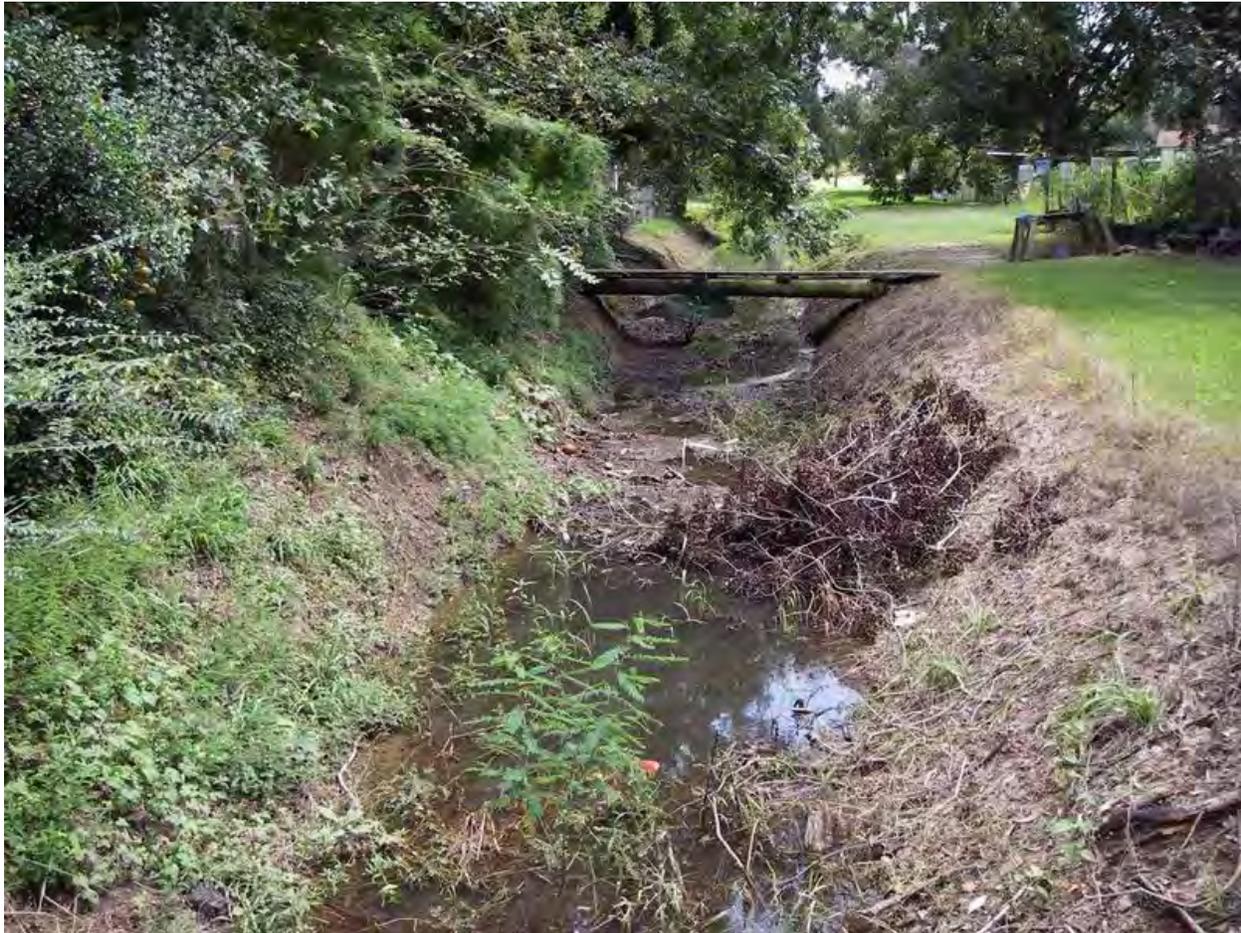
Figure 5-23. Straightened reach of TCC above Jackson Lane. Site TCC1.

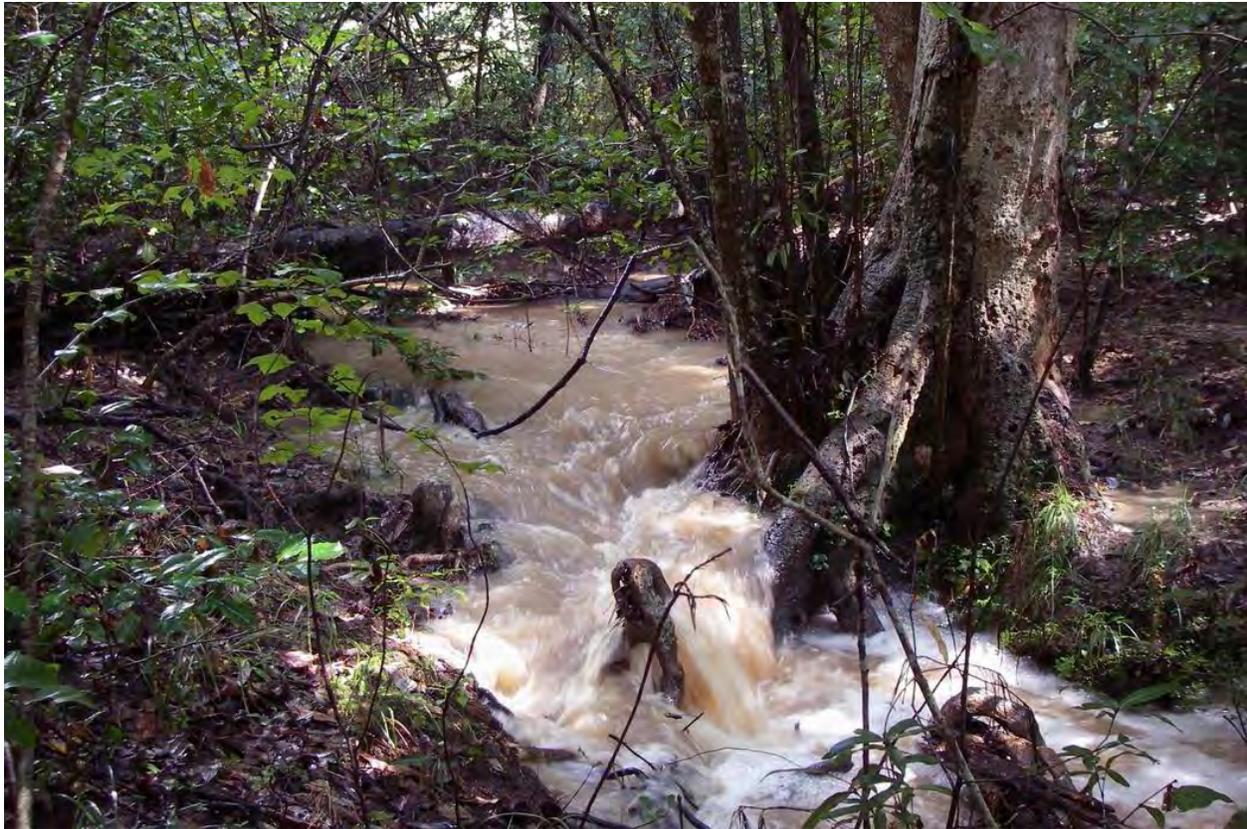
Figure 5-24. Stable reach of Joe's Branch during bankfull flow. Site J2.

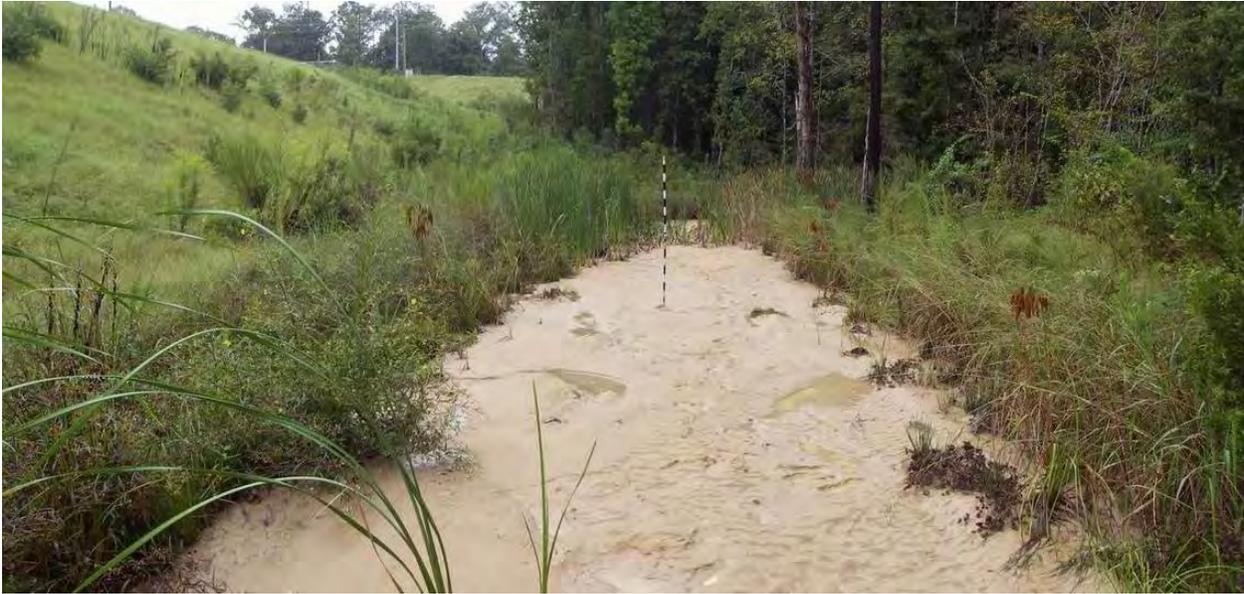
Figure 5-25. Essentially 100% of flow is beneath this sand blanked channel. Site JA1.

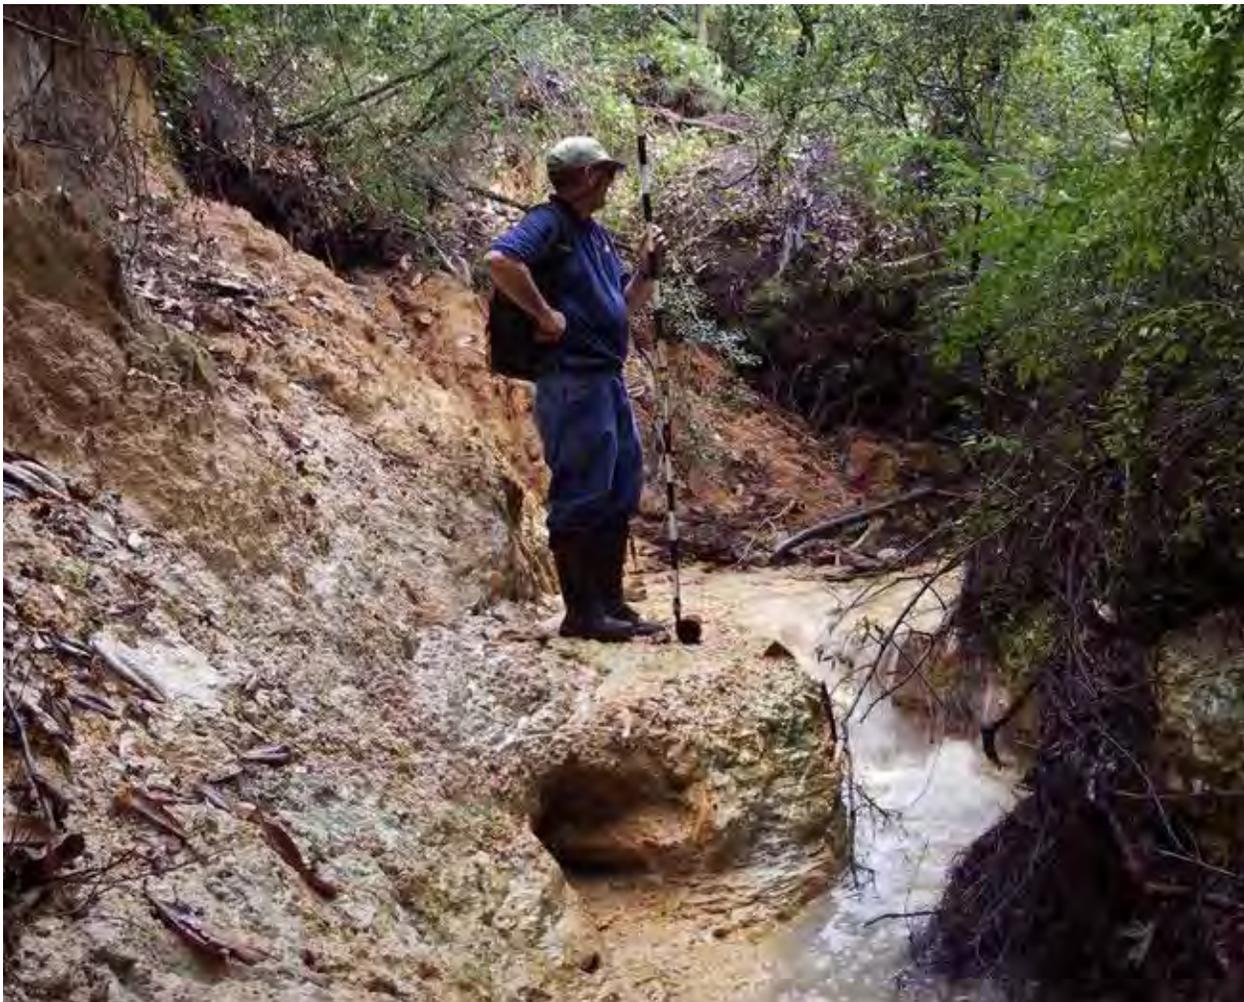
Figure 5-26. Severely eroding upper reach of tributary JA. Site JA4.

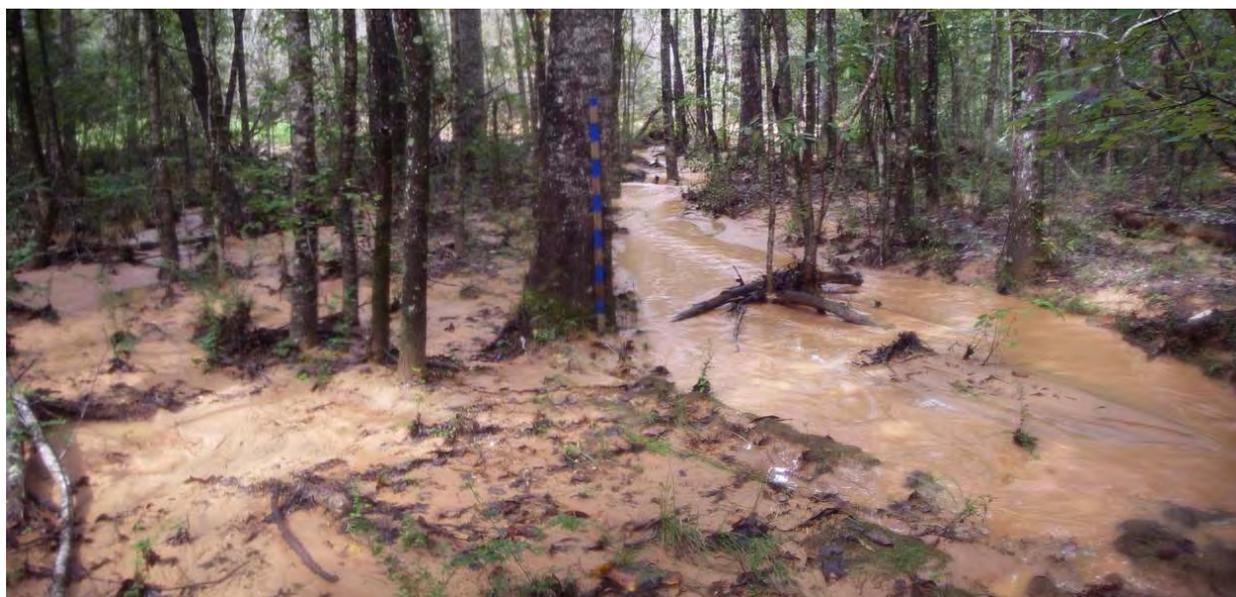
Figure 5-27. Reach of tributary JB choked with sediment. Site JB3.

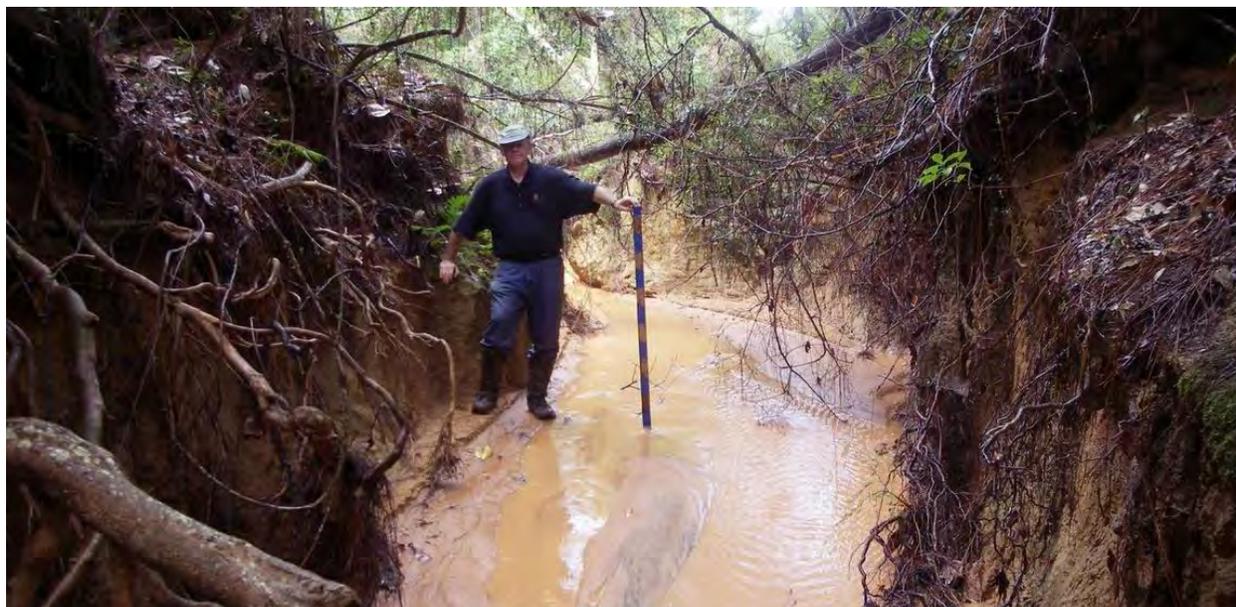
Figure 5-28. Incised reach of tributary JB undergoing bank mass wasting. Site JB6.

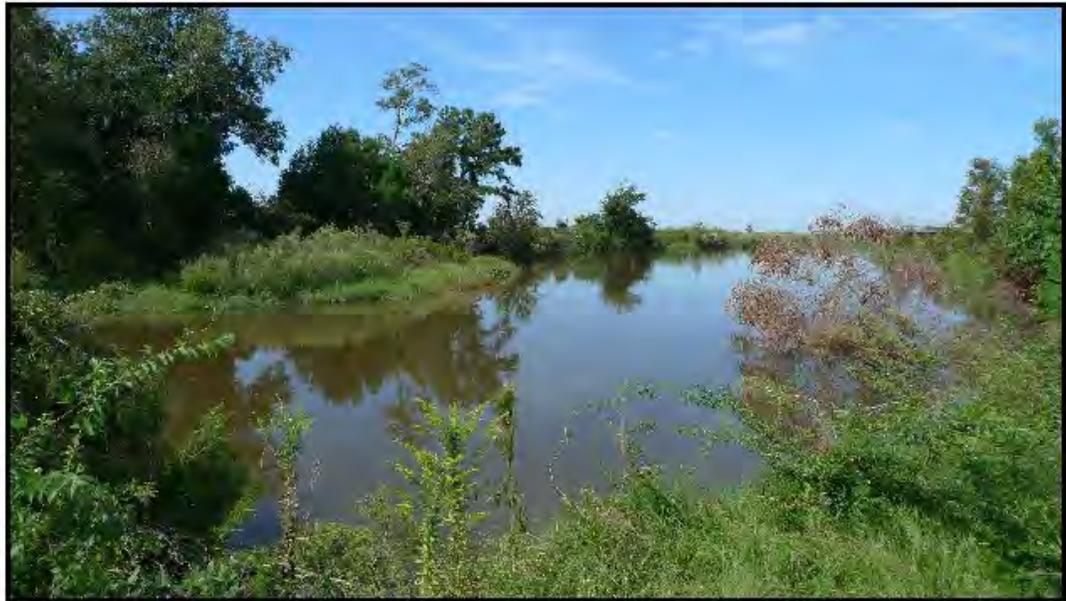
PHOTO 1: View of Site D1W looking southwest across D'Olive Creek. Note the exotic vegetative cover in the riparian area and lack of natural canopy.

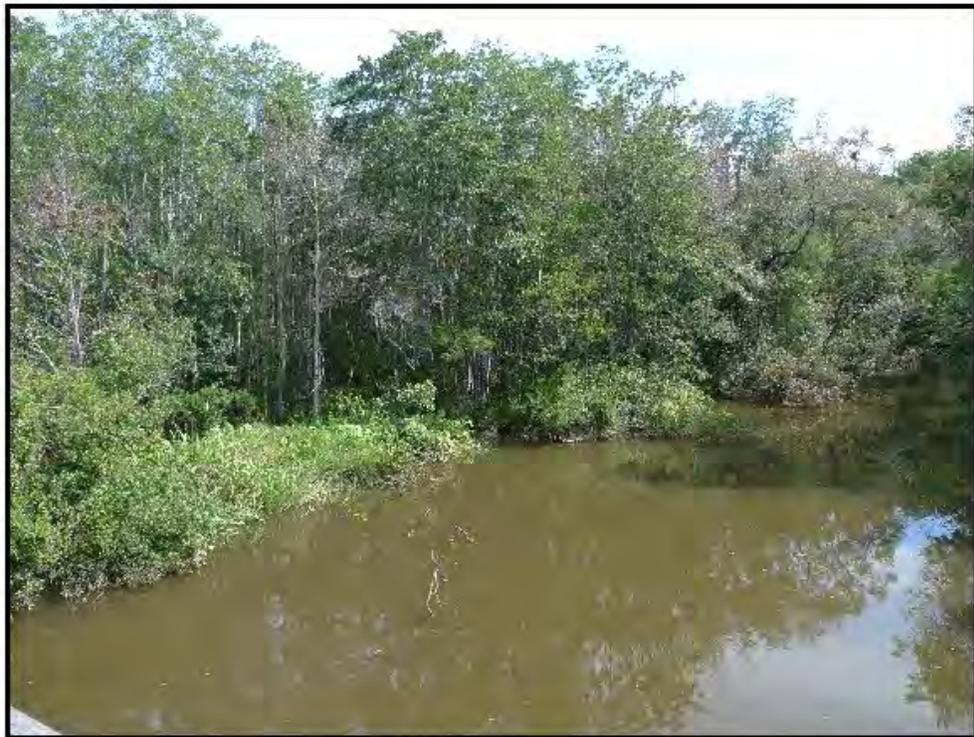
PHOTO 2: View of Site D2W looking northeast across D'Olive Creek. Note the natural vegetative cover in the riparian area and healthy native canopy.

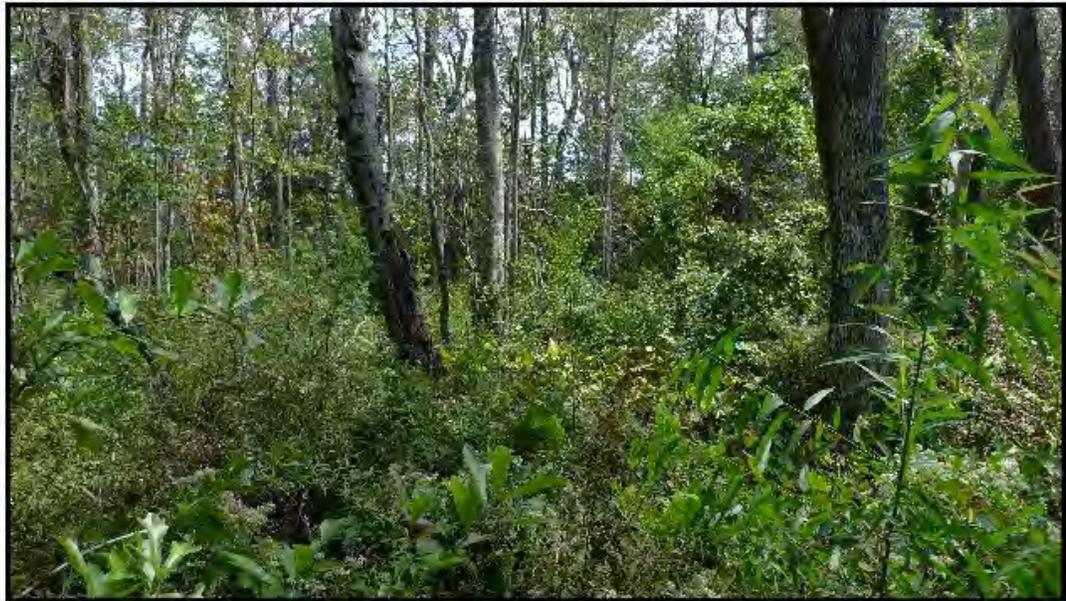
PHOTO 3: Site J1W understory (Joe's Branch). Note the heavy cover of exotic species and light penetration due to the stressed/open canopy.

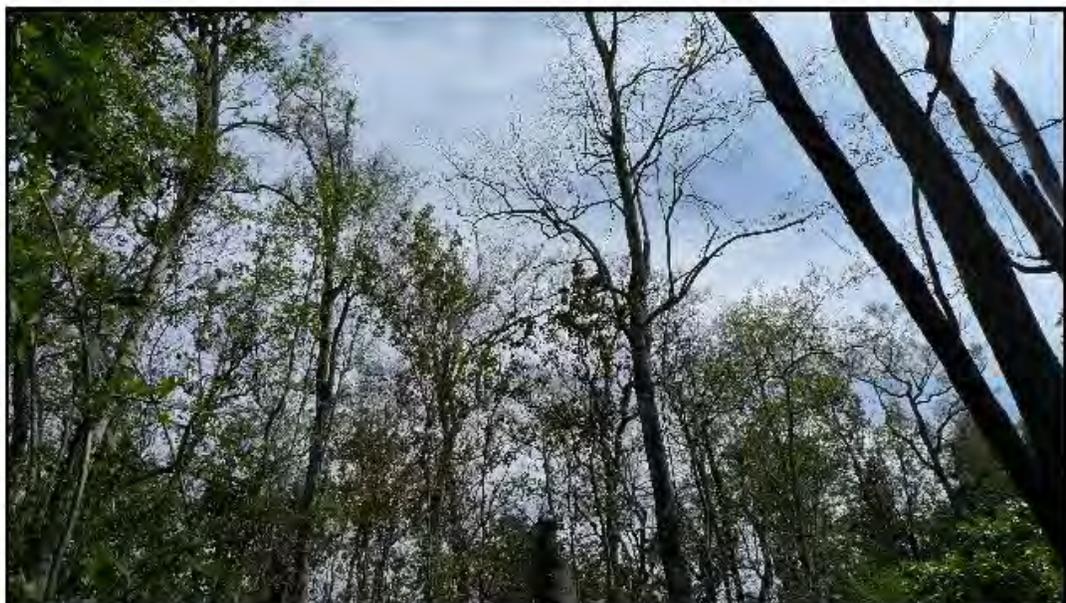
PHOTO 4: Taken from the same location as Photo 3, this angle shows the large openings in the canopy caused by tree death and/or defoliation.

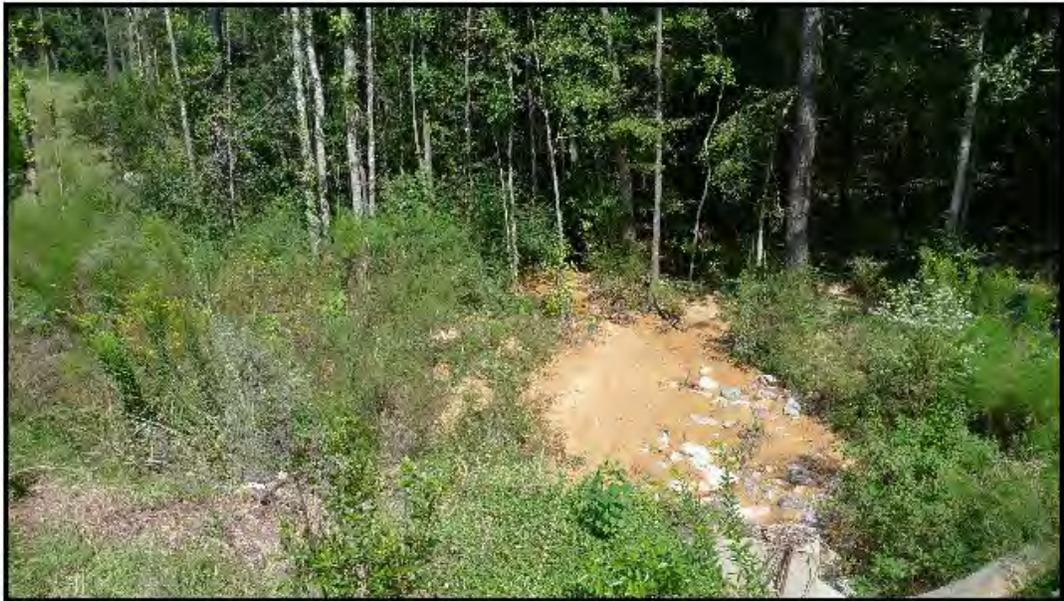
PHOTO 5: Site JB 1W looking north. Most significant impact to this area was the heavy sediment deposit and resulting stress in some canopy trees.

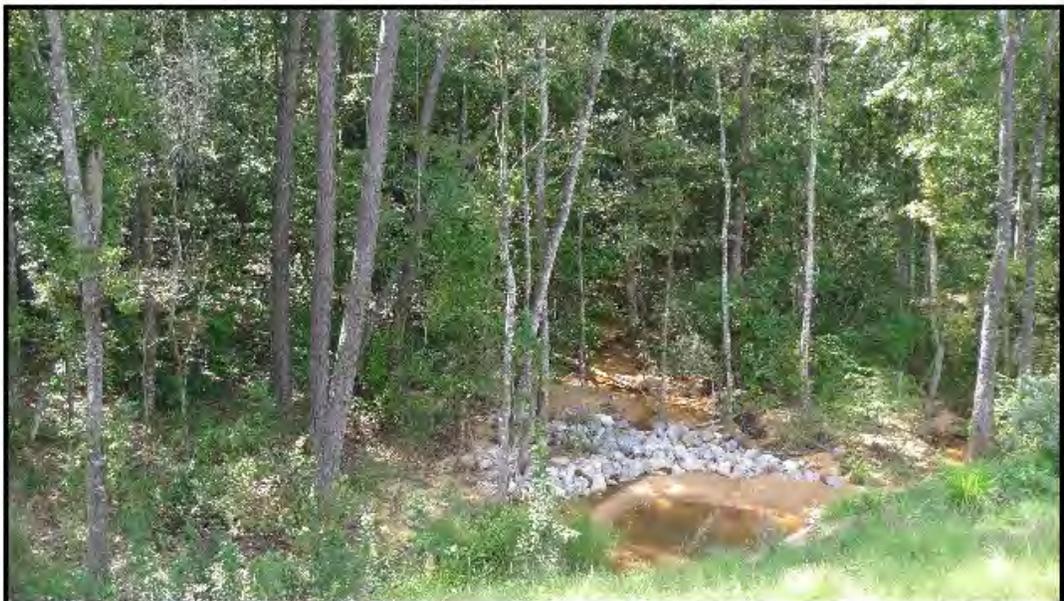
PHOTO 6: Site JB 1W looking south. Same situation as seen in Photo 5. Sediment deposits had altered the understory vegetative composition, but were not old/deep enough to kill the canopy trees.

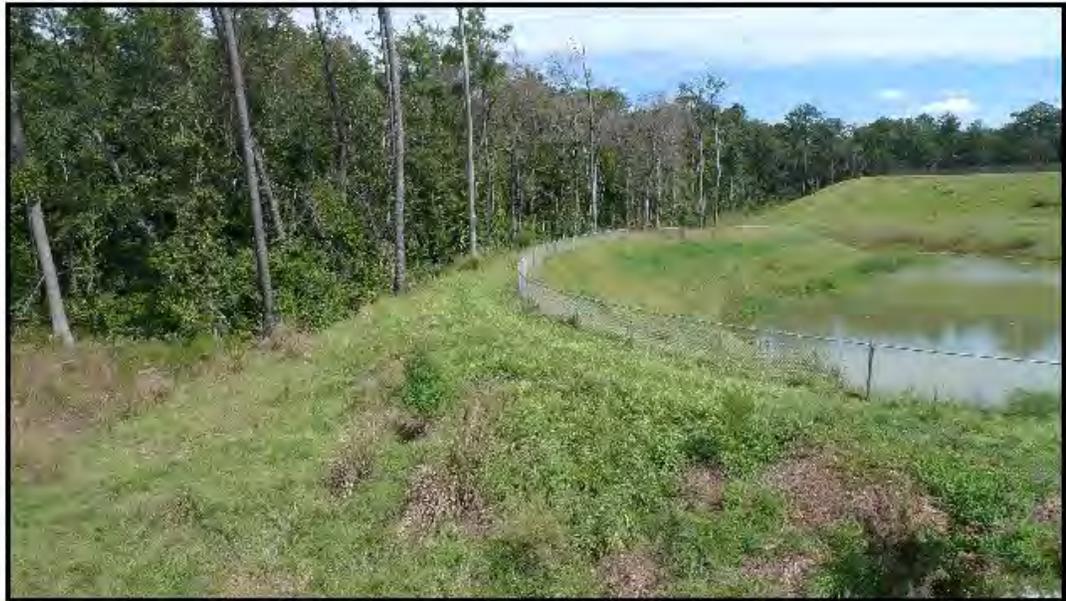
PHOTO 7: Site J2W looking north. Note the re-contouring of the upland buffer to the edge of the wetland line.

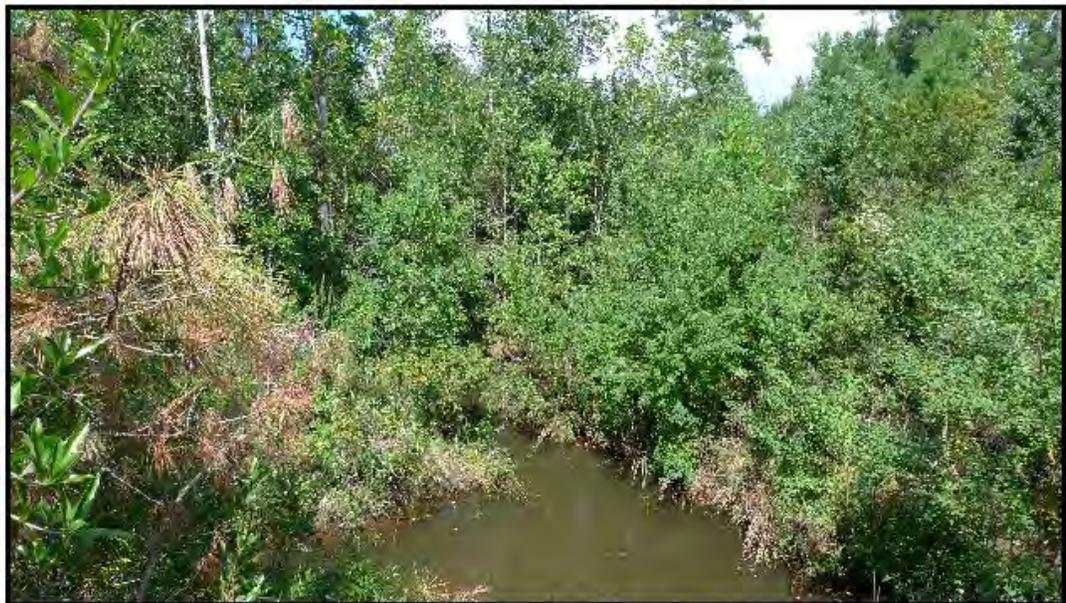
PHOTO 8: Site DC1W looking south. Note the extremely dense Chinese tallowtree (*Triadica sebifera*) in the mid and understories. The canopy had also been cleared of mature trees.

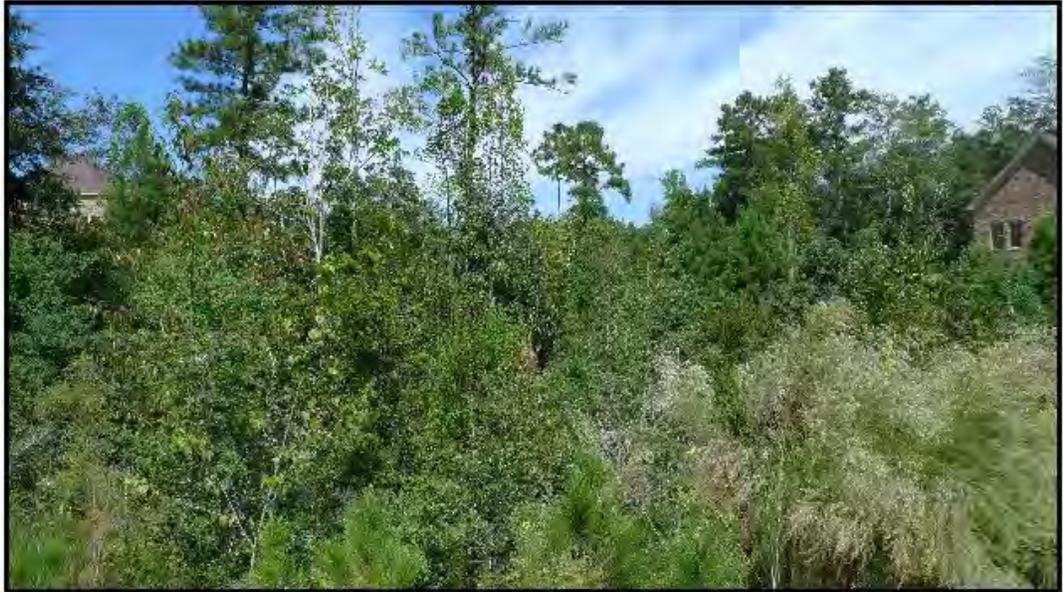
PHOTO 9: Site DC1W looking north. This view shows more clearly the damage done to the canopy of this wetland. The houses in the photo are located in the Timber Creek subdivision.

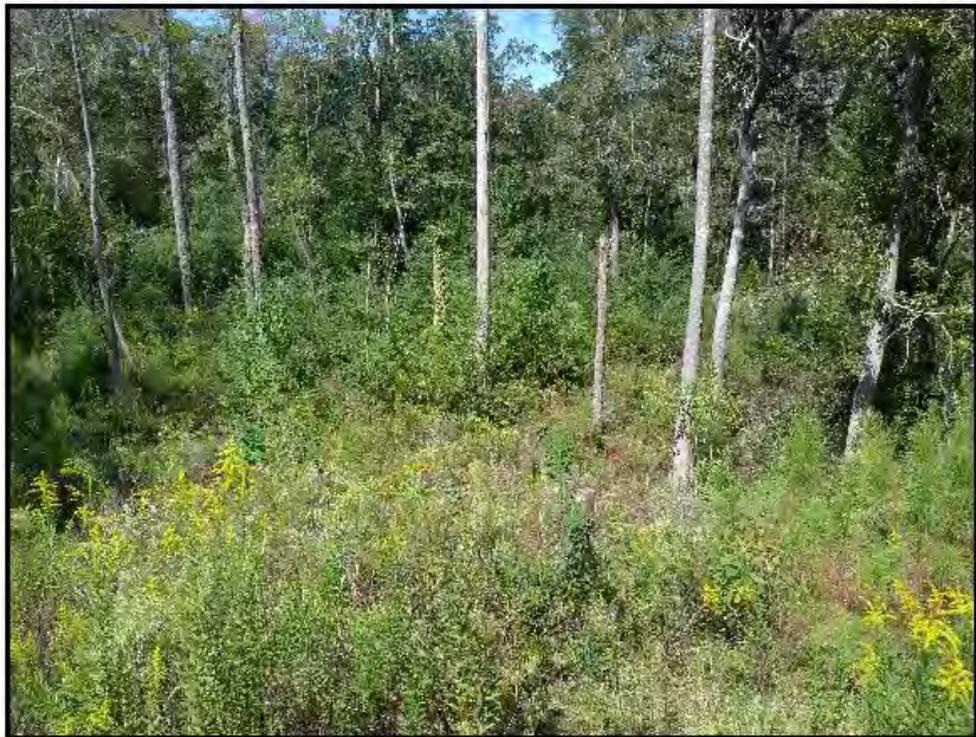
PHOTO 10: Site D6W looking north. A gain, sedimentation has severely stressed the canopy and eliminated much of the native understory vegetation in this section of D'Olive Creek.

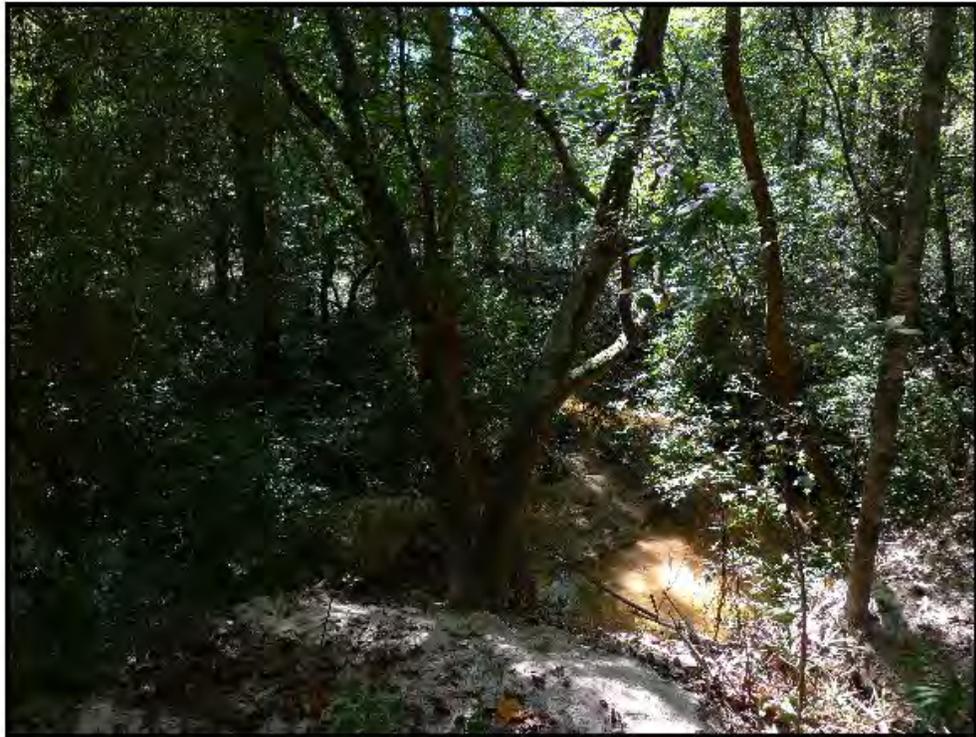
PHOTO 11: Site D4W was the only location that received a score of 5 on our grade scale. Note the native canopy, mid and understories. Exotic species are extremely sparse in this area of D'Olive Creek.

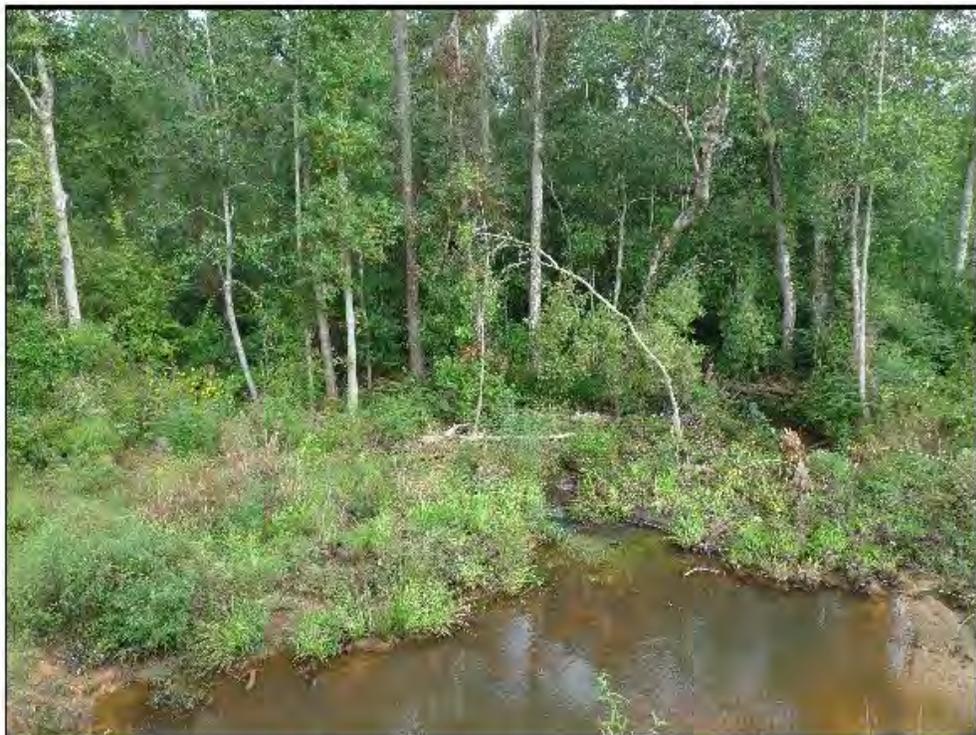
PHOTO 12: Site T2W was located on Tiawasee Creek in the Tiawasa Subdivision. Primary impacts to this section of Tiawasee Creek are associated with the establishment of exotic species in the understory.

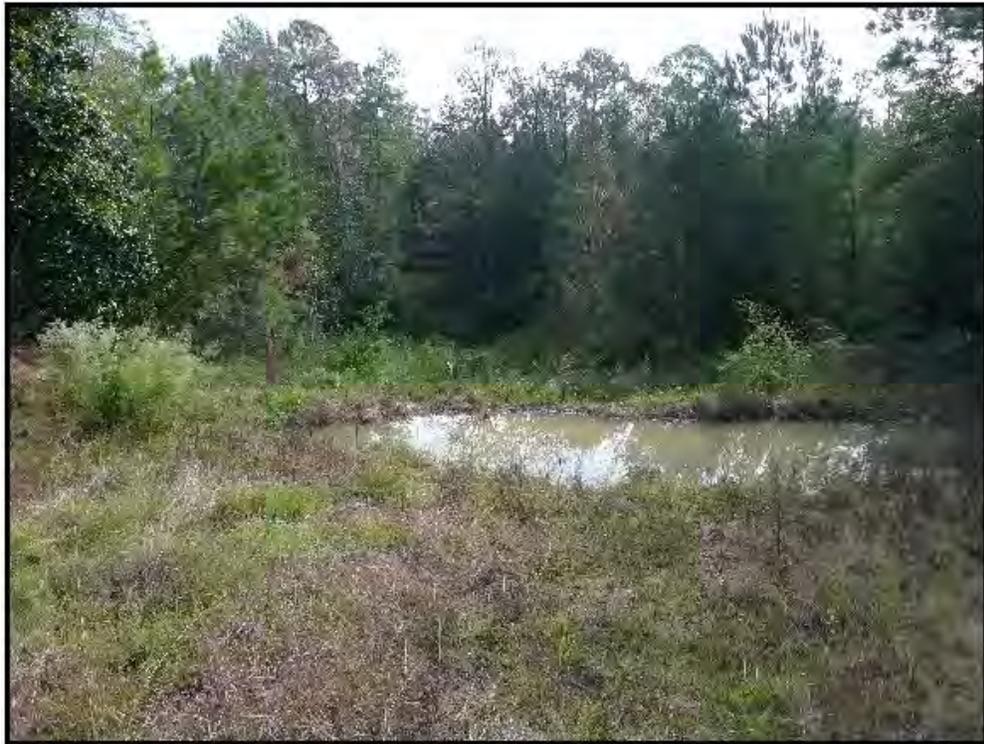
PHOTO 13: This photo was taken from the upland buffer just west of the Site TC1W wetland (visible as the bottom of the hill). Though the canopy trees at Site TC1W were relatively healthy, the understory was dominated by the exotic shrub Chinese privet (*Ligustrum sinense*).
