Erosion Activity Assessment of the D'Olive Creek Watershed

Erosion Activity Assessment of the D'Olive Creek Watershed. Daphne, Alabama.

Tetra Tech, Inc.
2110 Powers Ferry Rd.,
Suite 202
Atlanta, GA 30339

Thompson Engineering, Inc.
2970 Cottage Hill Road, Suite 190
Mobile, AL 36606

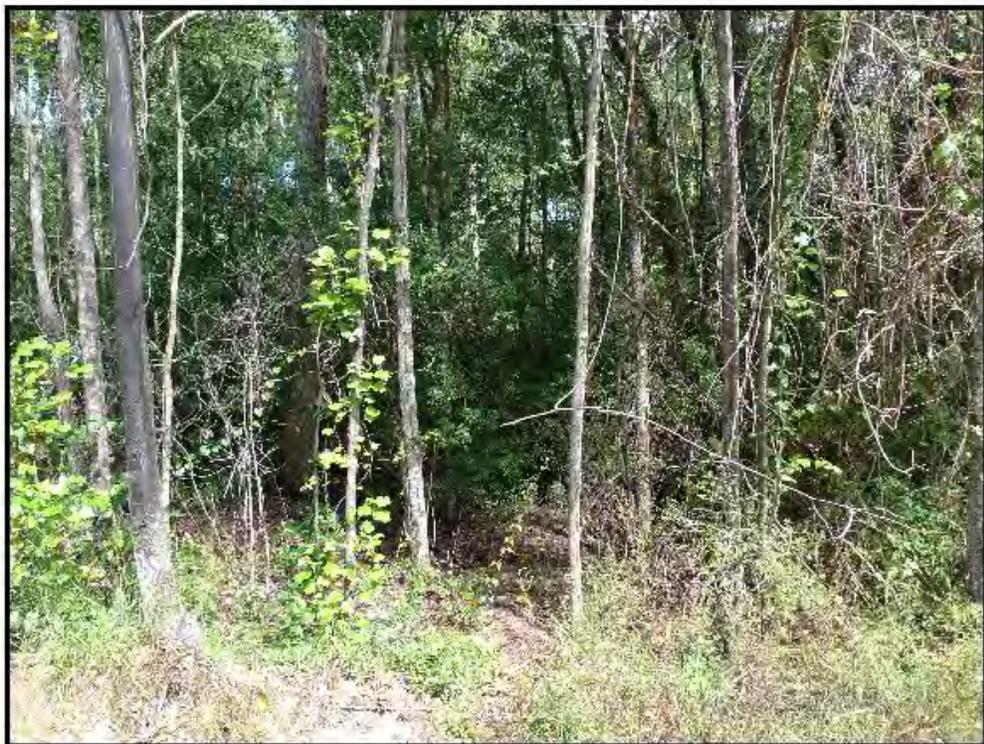
PHOTO 14: Site TA1W was located on a seepage slope near stream TA. Though the area had deep sediment deposits, the native vegetation in all strata had adapted and were relatively healthy.

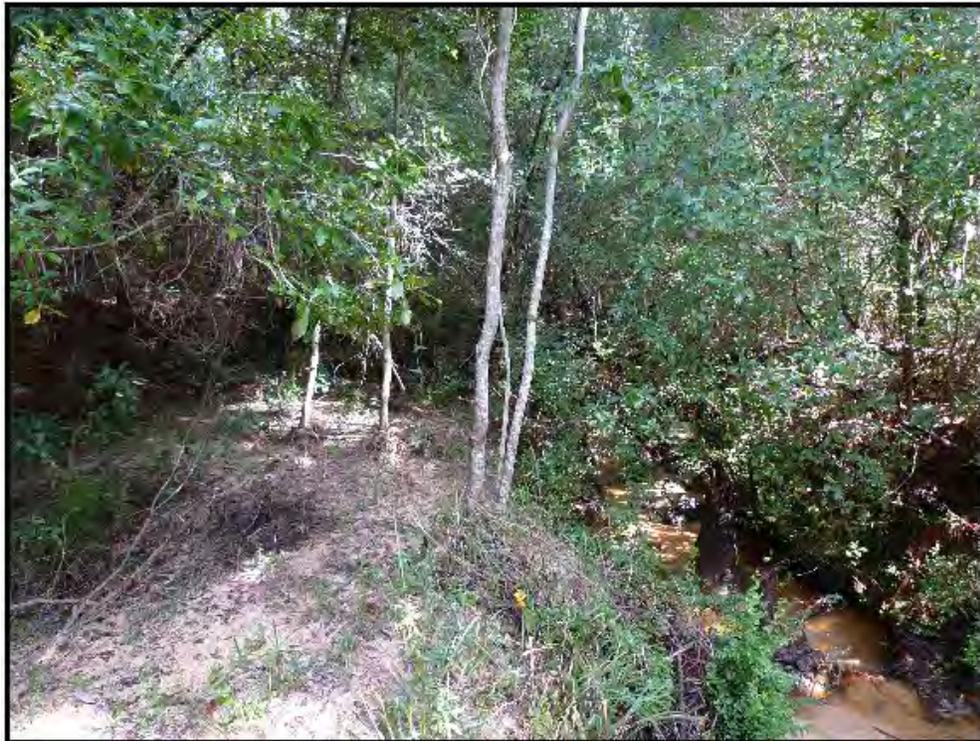
PHOTO 15: Wetlands at Site T1W were heavily impacted in several ways. In this photo, you can see exotic cogongrass (*Imperata cylindrica*) and Chinese privet (*Ligustrum sinense*) growing at the waters edge. Also, the nature hardwood canopy had been cleared and loblolly pine (*Pinus taeda*) planted in the riparian area.

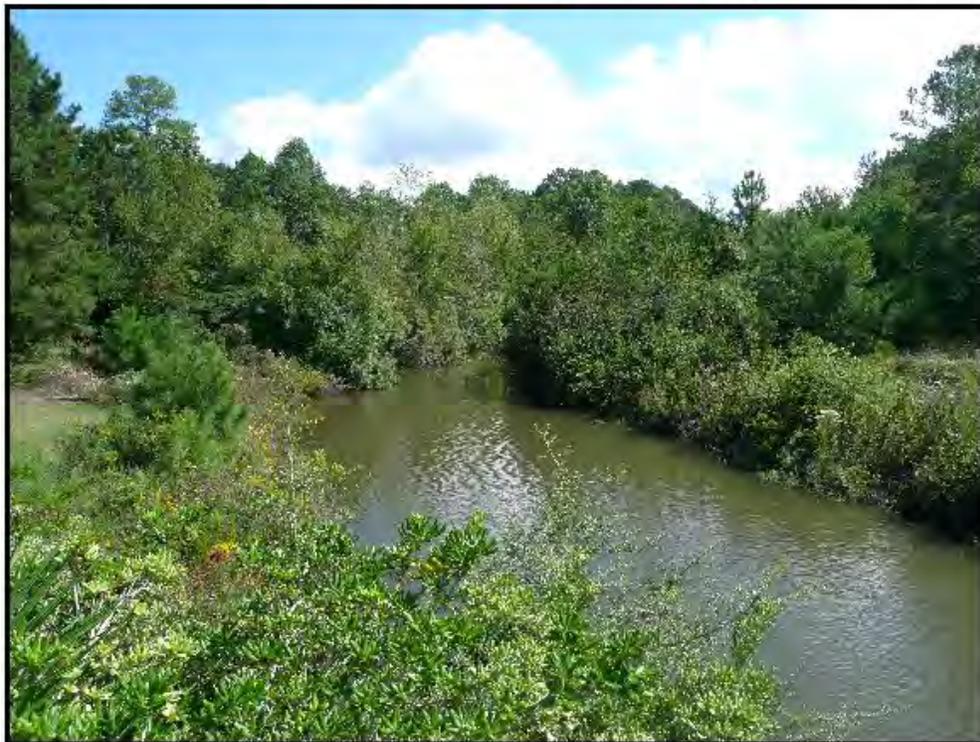
PHOTO 16: Site D3W was located just east of the Lake Forest pond and was dominated by exotic species in all strata. The water level in the wetland also appeared to have been artificially raised due the impoundment of the pond water.
