**WETLAND CONDITION EVALUATION:
D'OLIVE CREEK, TIAWASEE CREEK, AND JOE'S
BRANCH WATERSHEDS
(BALDWIN COUNTY, ALABAMA)**

**THOMPSON ENGINEERING
2970 COTTAGE HILL ROAD, STE. 190
MOBILE, ALABAMA 36606**

**BARRY A. VITTOR & ASSOCIATES, INC.
8060 COTTAGE HILL ROAD
MOBILE, ALABAMA 36695**

February, 2010

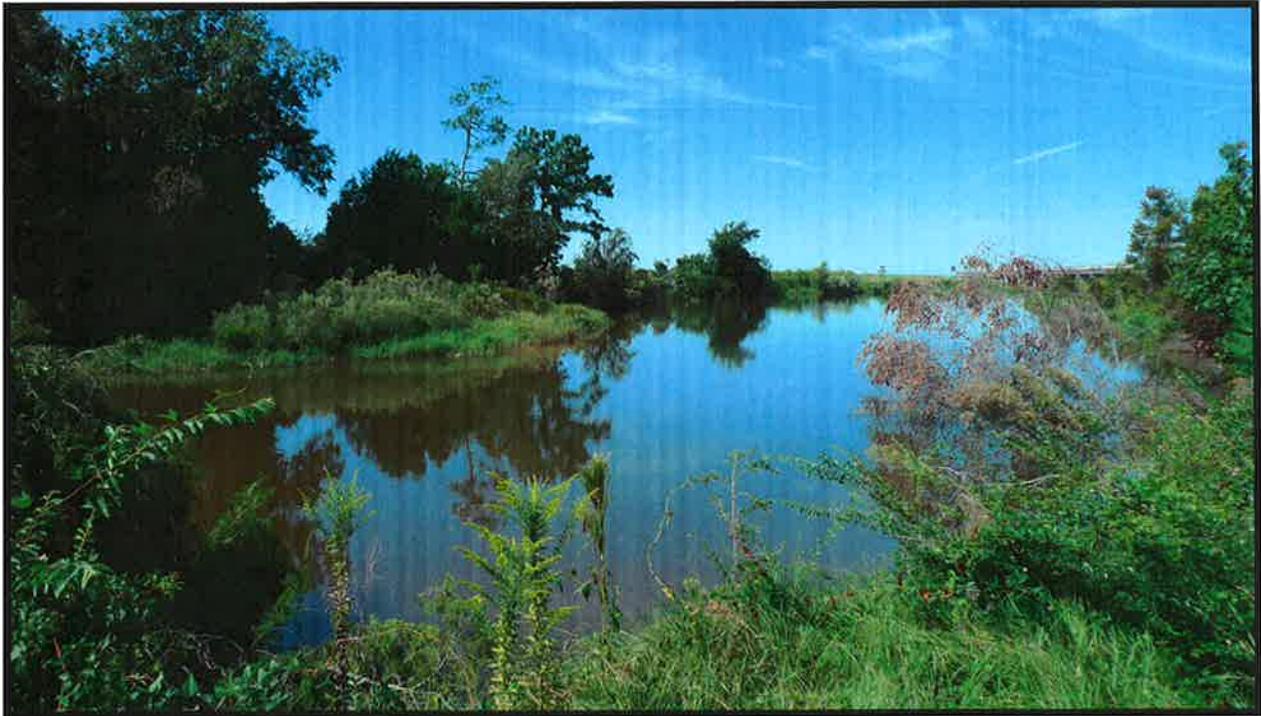
Site D1W was located just southwest of the Interstate 10 and Highway 98 interchange. Nearly all of the wetlands associated with D'Olive Creek in this area have been severely altered or filled, and Site D1W scored a 1 on our grade scale as a result. The narrow wetland fringe that remains on either side of the creek is dominated by young exotic species such as Chinese tallowtree (*Triadica sebifera*) and the native tree species, black willow (*Salix nigra*).

PHOTO 1: View of Site D1W looking southwest across D'Olive Creek. Note the exotic vegetative cover in the riparian area and lack of natural canopy.

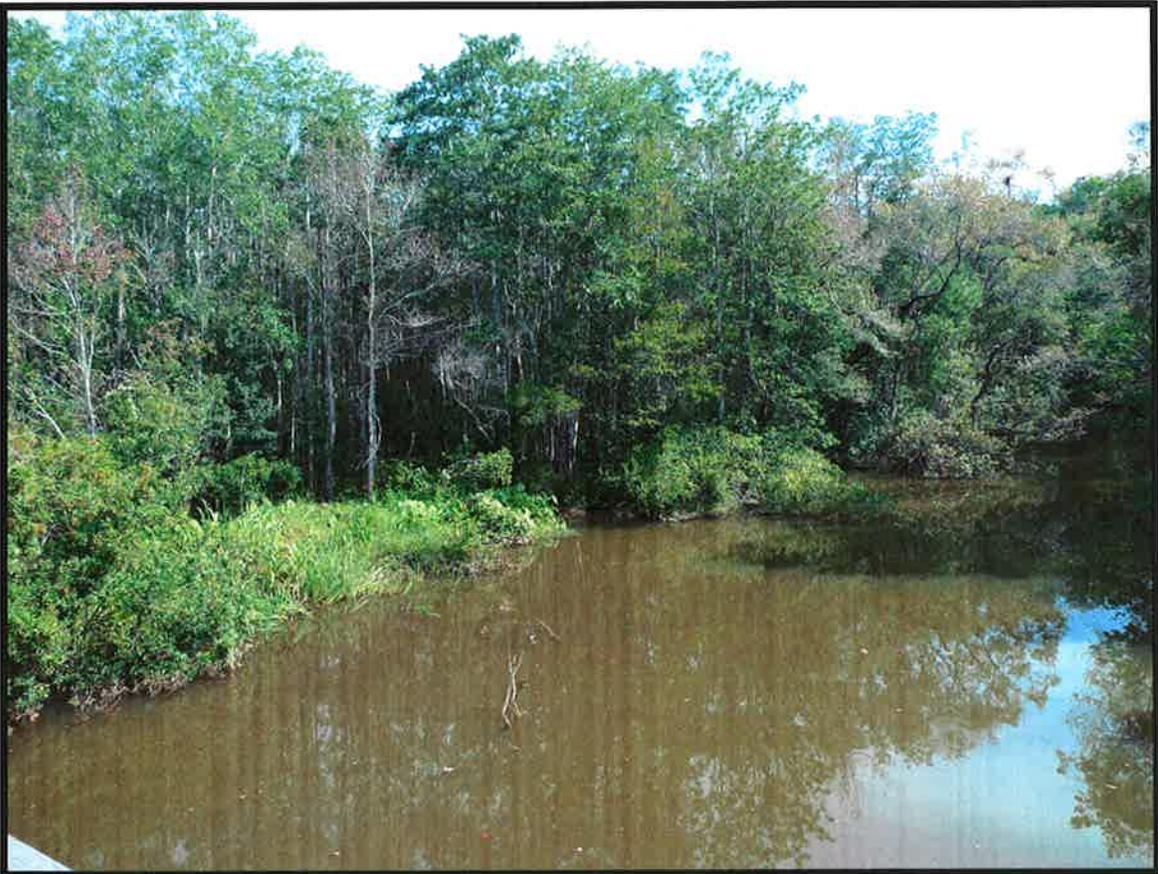
Site D2W was located east of Highway 98 approximately 1200 feet upstream (east) of Site D1W. The Mature forested canopy of Site D2W was healthy, mature, and contained primarily native trees such as Sweetbay (*Magnolia virginiana*), swamp tupelo gum (*Nyssa biflora*), bald cypress (*Taxodium distichum*), and red maple (*Acer rubrum*). Young exotics such as Chinese tallowtree (*Triadica sebifera*) and Chinese privet (*Ligustrum sinense*) were present in the under and mid-stories, but had not become dominant in those strata. Site D2W scored a 4 on the grade scale, and only lost a point due to the presence of scattered exotic species.

PHOTO 2: View of Site D2W looking northeast across D'Olive Creek. Note the natural vegetative cover in the riparian area and healthy native canopy.

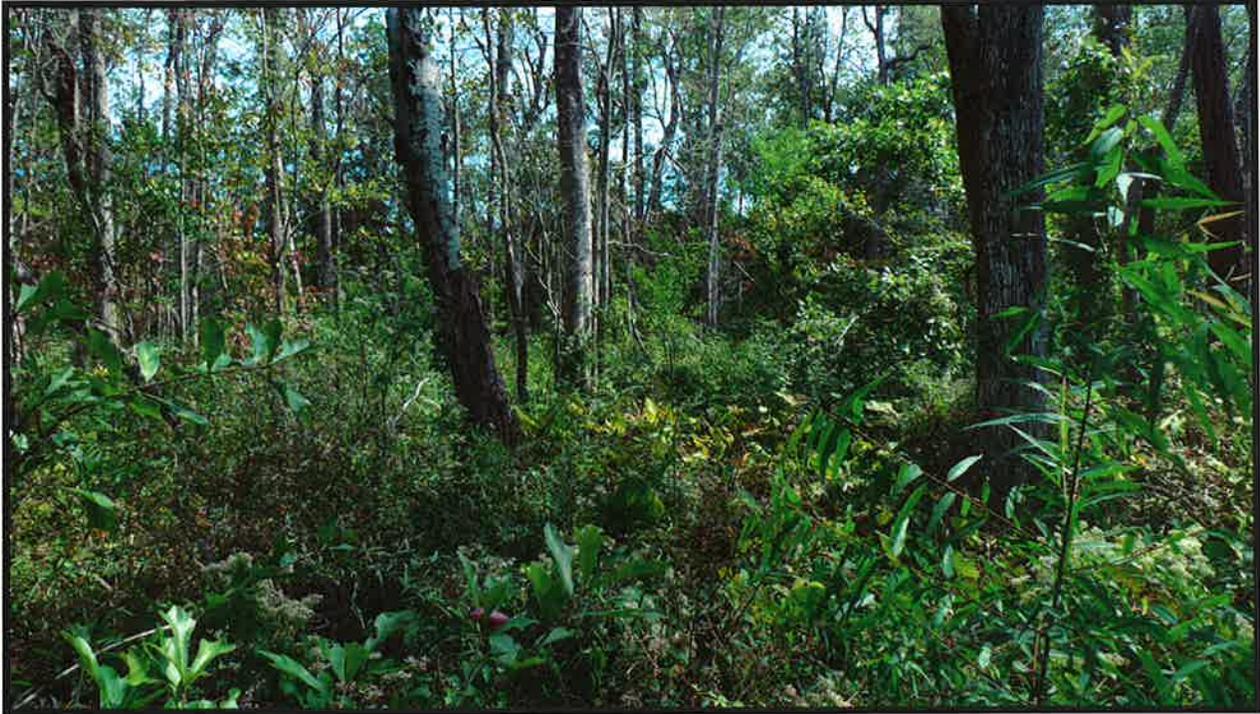
Site J1W (J=Joe's Branch, W=Wetland) was located adjacent to the new Spanish Fort Town Center, in between its southern entrance road (Bass Pro Drive) and the northern entrance road (Town Center Avenue). This section of Joe's Branch has been severely impacted by sedimentation. Approximately 50% of the mature, native canopy trees are dead or dying, the understory is dominated by exotic species. The sediment deposits are over 12 inches deep across much of the wetland, and the upland buffer has been cleared. Site J1W scored a 1 (highest impacts) on our wetland grading scale. While the recently constructed shopping plaza cannot be discounted as a possible source for some of the sediment in this reach of Joe's Branch, it appears that the most significant sources of the sediment have originated from upstream of the site. Tetra Tech's erosion activity assessment has documented actively advancing headcuts, resulting in channel incision and bank erosion, in both tributaries JA and JB. However, it should be noted that it was beyond the scope of this study to comprehensively quantify the relative contributions of sediment sources.

PHOTO 3: Site J1 W understory (Joe's Branch). Note the heavy cover of exotic species and light penetration due to the stressed/open canopy.

There are opportunities to enhance or restore segments of wetlands surrounding Joe's Branch, especially the section just north of Bass Pro Drive. Restoration activities could include mechanical removal of the sediment deposits, and supplemental planting of desirable native trees and shrubs. To increase the chance that the restoration activities would be successful, it would be necessary to control stream erosion upstream of the Spanish Fort Town Center. Stream bank and bottom erosion provide the major source of sediment impacting the wetlands. While reducing the sediment bed load transported into the wetlands from stream erosion is considered a priority, it would also be important to better stabilize and maintain the steep upland slopes surrounding the wetlands to protect the wetland from sediments generated by on-site erosion of steep slopes.

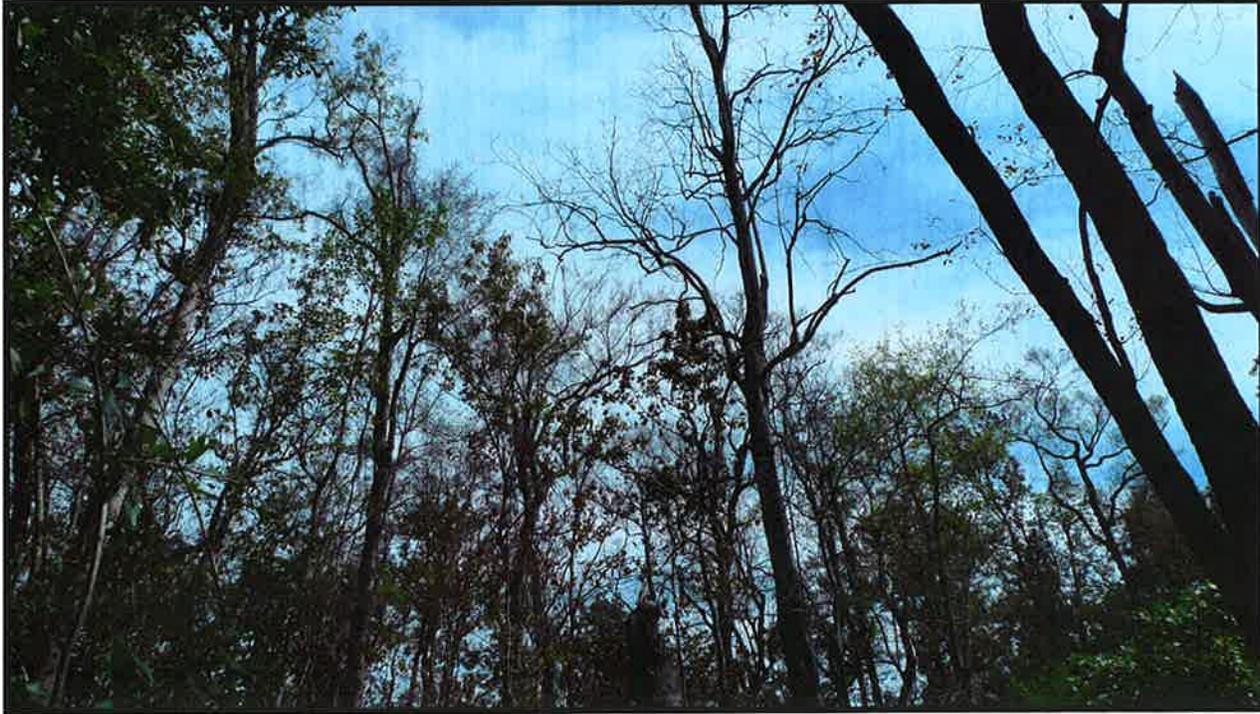
PHOTO 4: Taken from the same location as Photo 3, this angle shows the large openings in the canopy caused by tree death and/or defoliation.

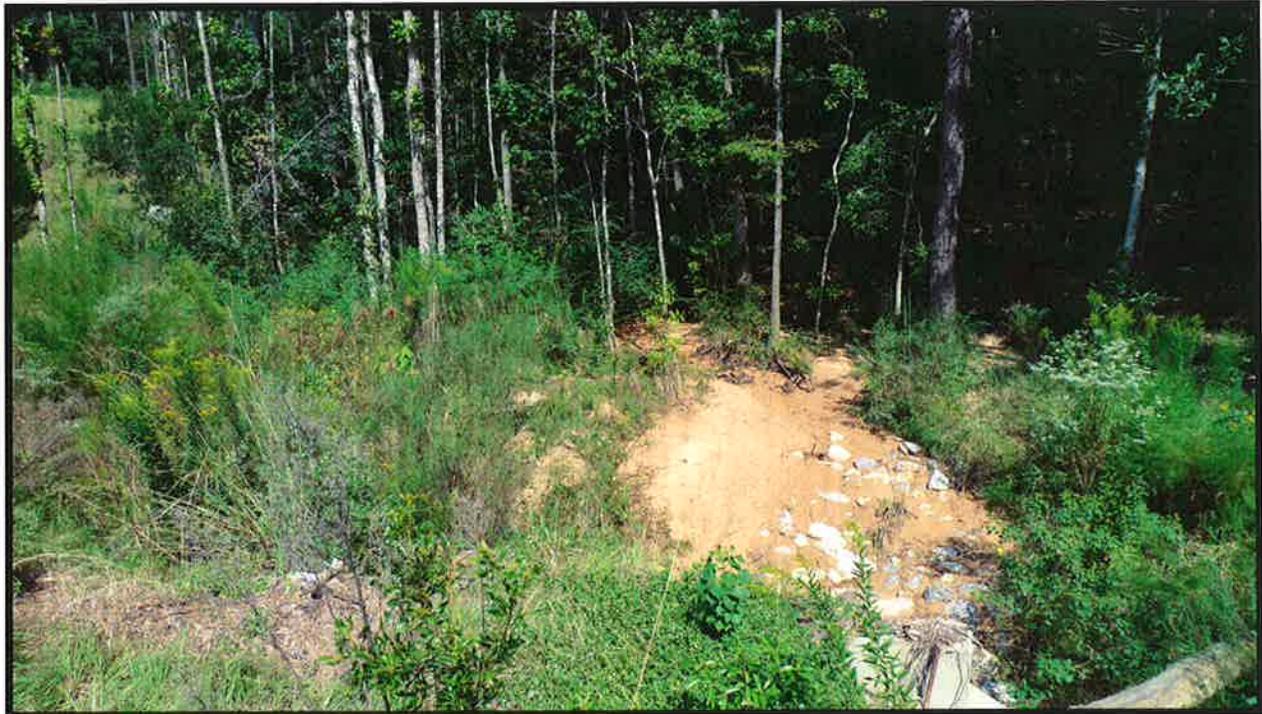
PHOTO 5: Site JB1W looking north. Most significant impact to this area was the heavy sediment deposit and resulting stress in some canopy trees.

Sections of Joe's Branch near survey Sites JB1W and J2W could be enhanced by removal of shallow sediment deposits, and would not require supplemental planting due to the healthy, closed canopy that currently exists in those areas.

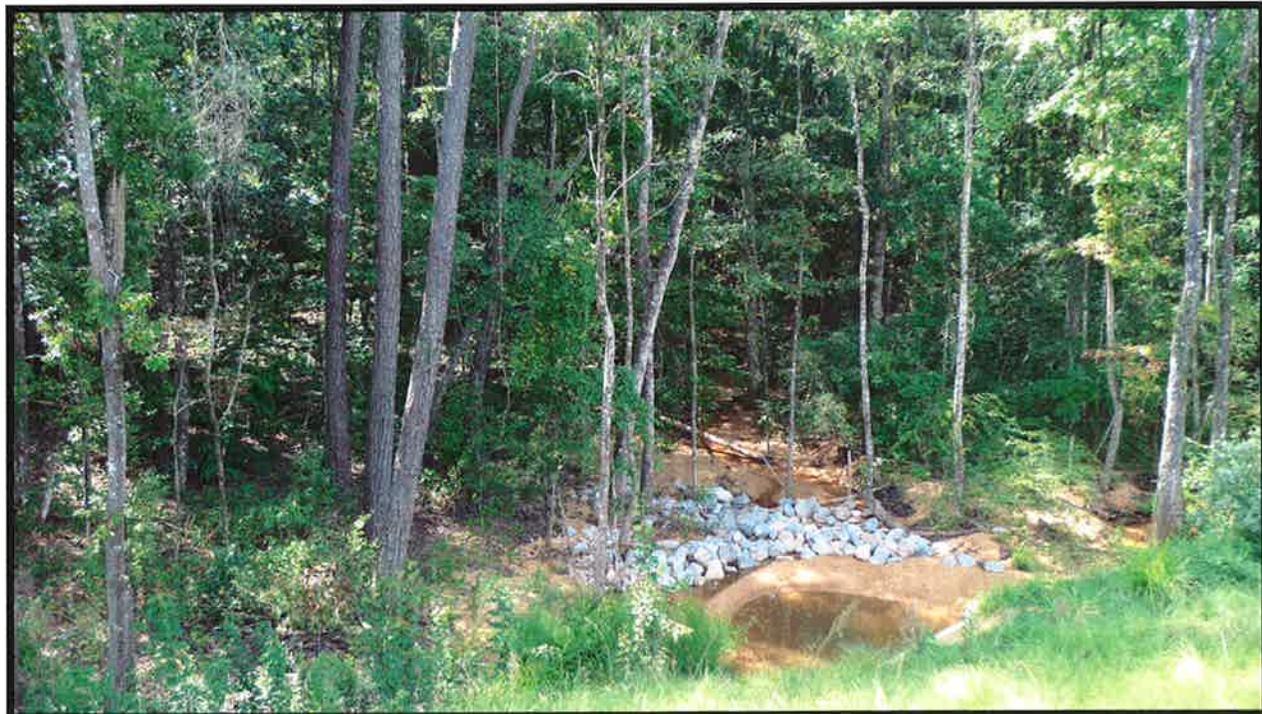
PHOTO 6: Site JB1W looking south. Same situation as seen in Photo 5. Sediment deposits had altered the understory vegetative composition, but were not old/deep enough to kill the canopy trees.

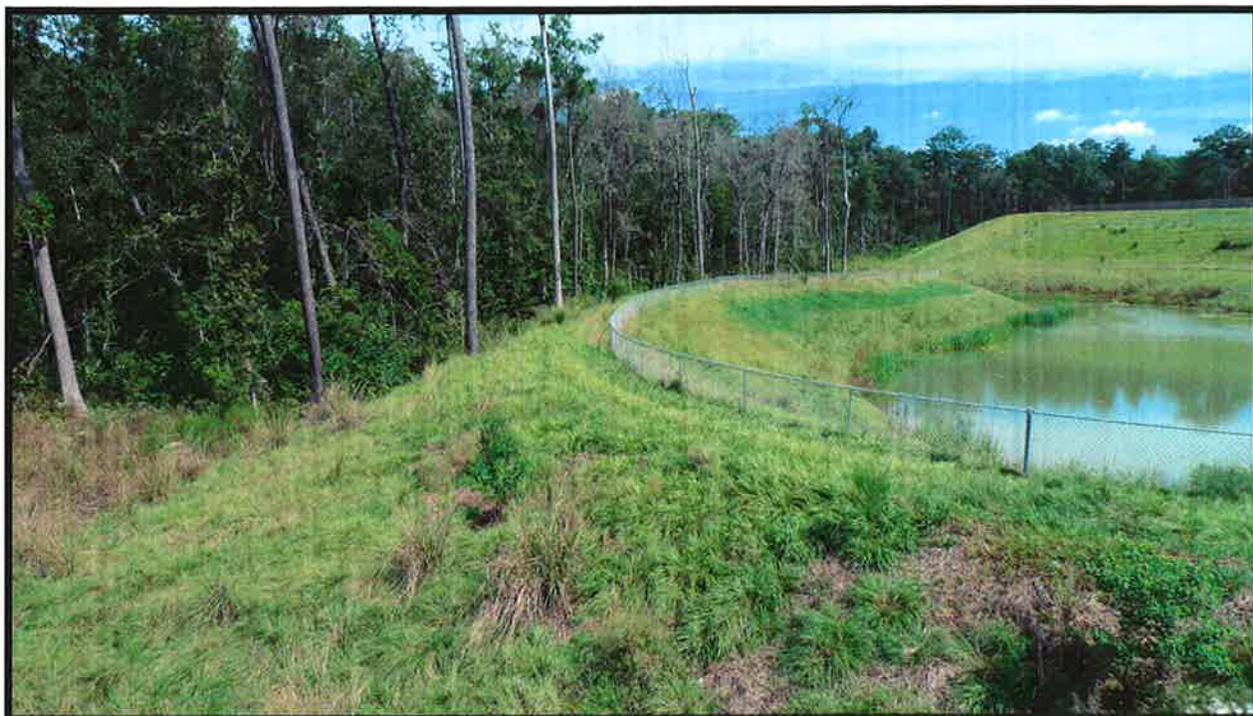
Two locations were sampled north of Site J1W. Sites JB1W and J2W were located approximately 0.5 mile upstream of Site J1W. Site JB1W scored 2 points, and Site J2W scored 3 points using our wetland grading scale. Primary impacts to these two sites were (1) sedimentation due to commercial development and road construction, and (2) exotic species, primarily (*Ligustrum sinense*), in the under and mid-stories. North of the new commercial development and the surveyed sites, aerial photography was used to examine the main branch of Joe's Branch and tributaries JA and JB. Tributaries JA and JB are clearly impacted by fresh layers of sediment and contain very little understory vegetation. The wetlands adjacent to the main stream channel have experienced less sedimentation for approximately 1500 feet, but sedimentation becomes apparent again south of Maury Court. Maury Court is a residential road in the Westminster Subdivision which contains approximately 21 lots. Homes are currently being built on several of the lots, or have been built within the last few years, and a detention pond was built to slow runoff from the Court.

PHOTO 7: Site J2W looking north. Note the re-contouring of the upland buffer to the edge of the wetland line.

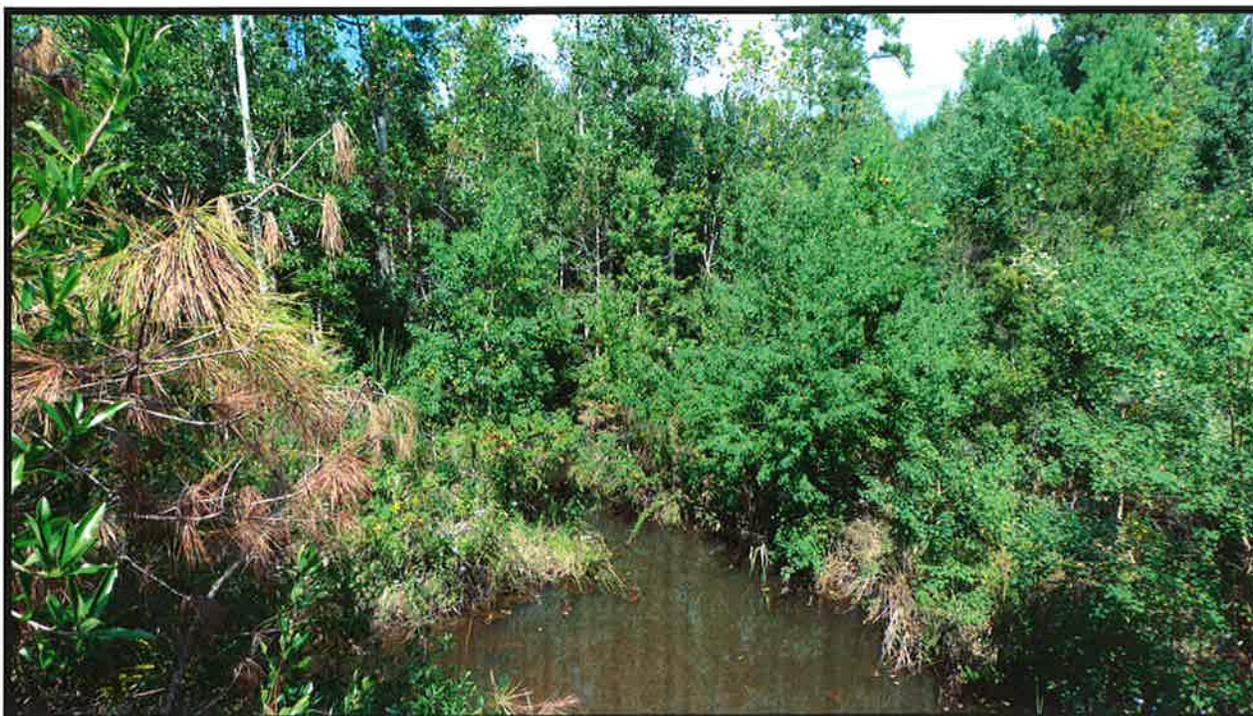
Sites DC1W and D6W, which were located upstream of Site D4W within the Timber Creek subdivision and each scored a 2 on the grade scale, were heavily impacted by sedimentation and exotic species. The native canopy at Site DC1W, had been totally cleared, leaving only small sweetbay (*Magnolia virginiana*), yellow-poplar (*Liriodendron tulipifera*), and Chinese tallowtree (*Triadica sebifera*) in the midstory. Site D6W had numerous large native canopy trees that were dead or dying, most likely due to deep sediment deposits. The wetlands to the east and west of Site D6W had similar characteristics and impacts, and also scored a 2 on the grade scale. The impacts to wetlands north of Site DC1W became less significant towards the headwaters of the tributary, and were graded as a 3, then 4 (see map) as exotic species in the under and mid-stories became less numerous and impacts siltation less severe.

PHOTO 8: Site DC1W looking south. Note the extremely dense Chinese tallowtree (*Triadica sebifera*) in the mid and understories. The canopy had also been cleared of mature trees.

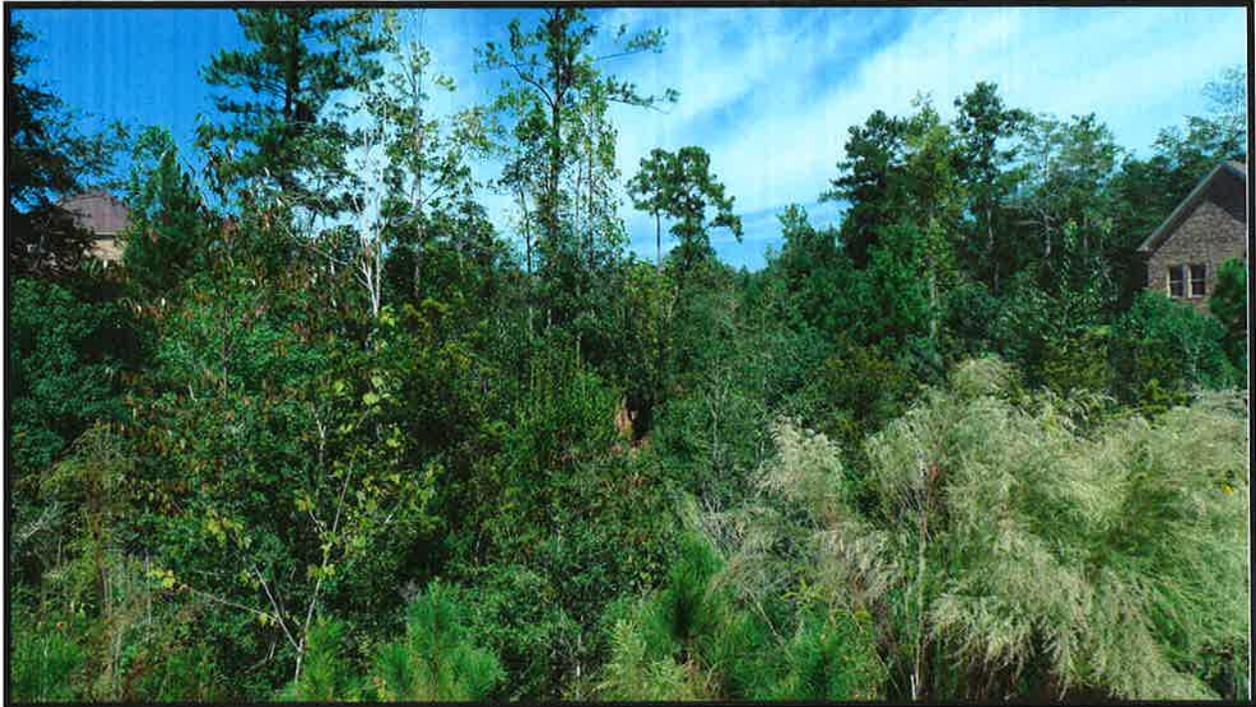
PHOTO 9: Site DC1W looking north. This view shows more clearly the damage done to the canopy of this wetland. The houses in the photo are located in the Timber Creek subdivision.

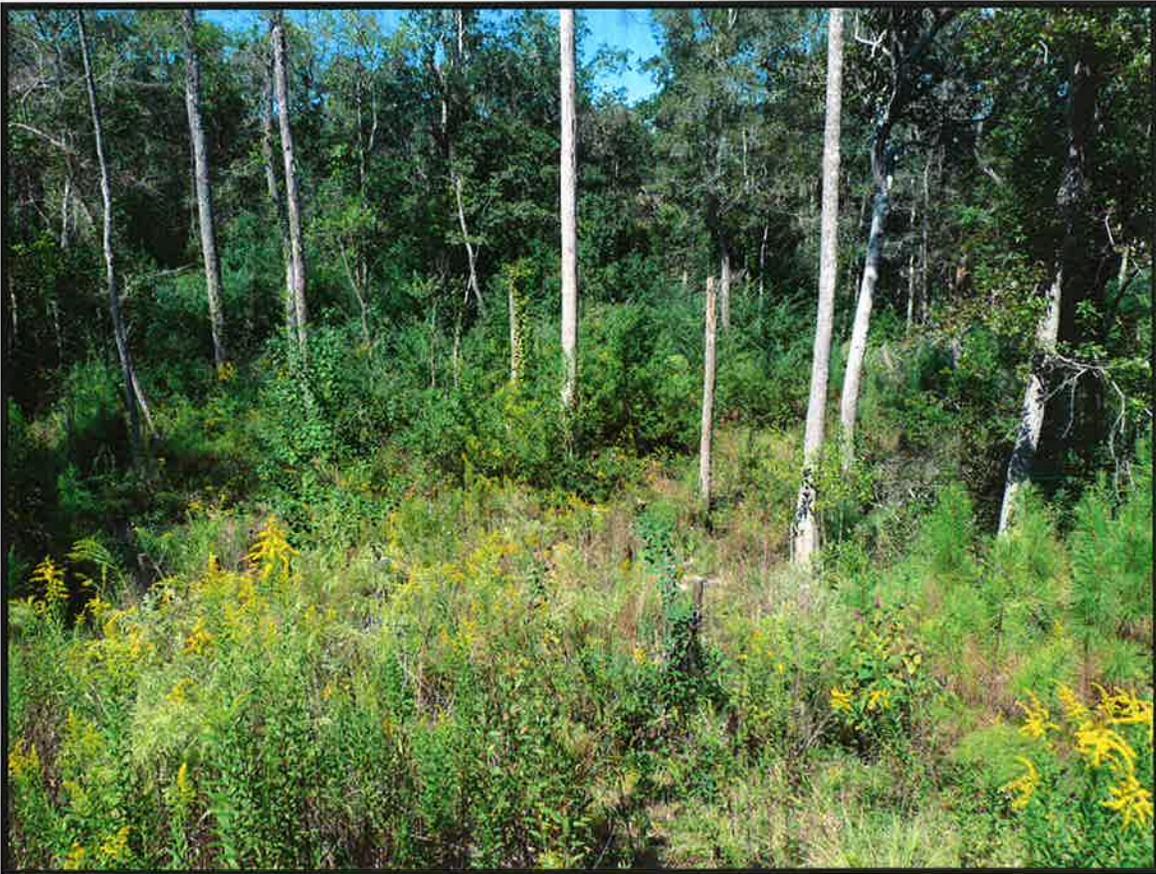
PHOTO 10: Site D6W looking north. Again, sedimentation has severely stressed the canopy and eliminated much of the native understory vegetation in this section of D'Olive Creek.

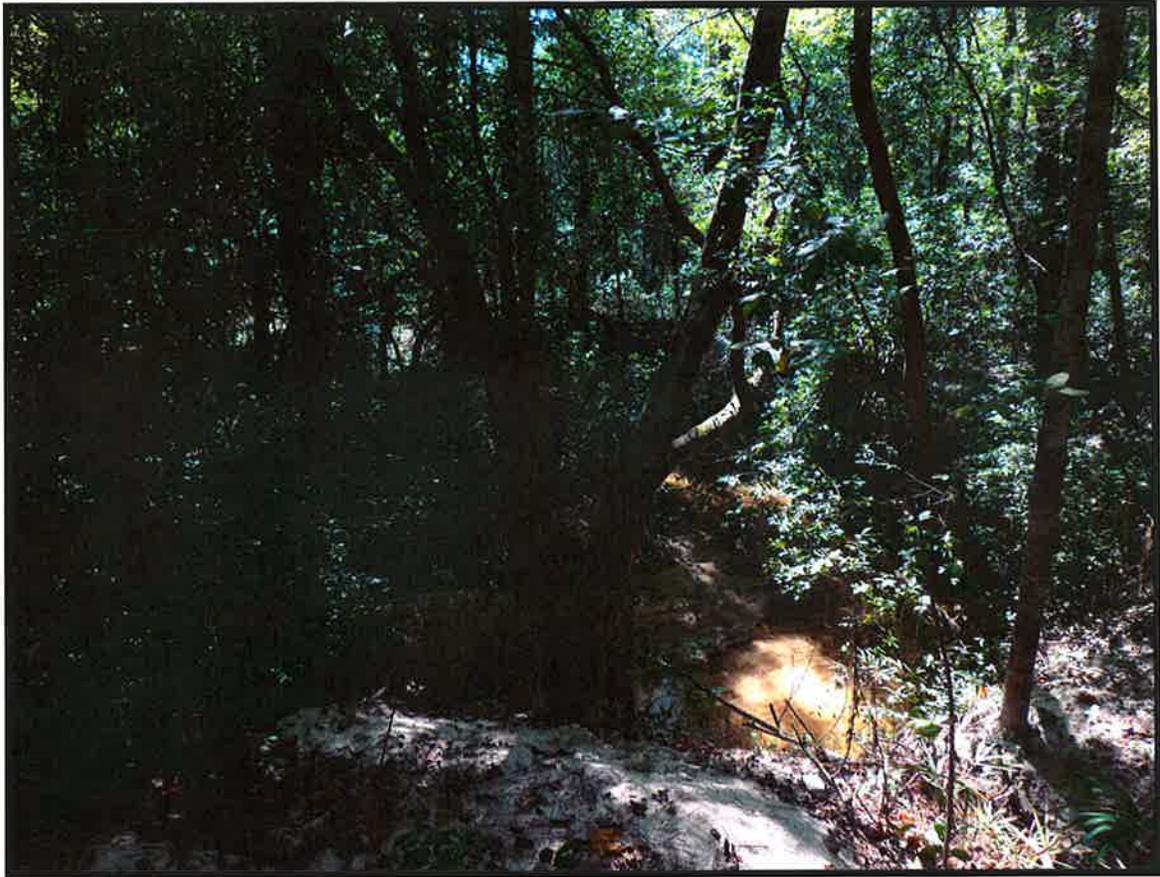
Site D4W was the only surveyed wetland point that we scored as a 5 using our grading methodology. It was vegetated with native species in all strata, sediment deposits were not negatively impacting the health of the desirable tree species at the time of the survey, and the upland buffer was stable and contributing little if any additional sediment to the system. Debris deposits were noted on the shrubs and on tree trunks in the wetlands at Site D4W suggesting that, during heavy rain events, the water level rises very rapidly. The high, fast-moving water could be the reason silt deposits had not accumulated in the area surrounding Site D4W. Another factor contributing to Site D4W's score of 5, despite the fact that it is downstream of wetlands that scored 2, 3, or 4, could be the lack of development in the surrounding upland buffer and the buffer's lack of exotic species.

PHOTO 11: Site D4W was the only location that received a score of 5 on our grade scale. Note the native canopy, mid and understories. Exotic species are extremely sparse in this area of D'Olive Creek.

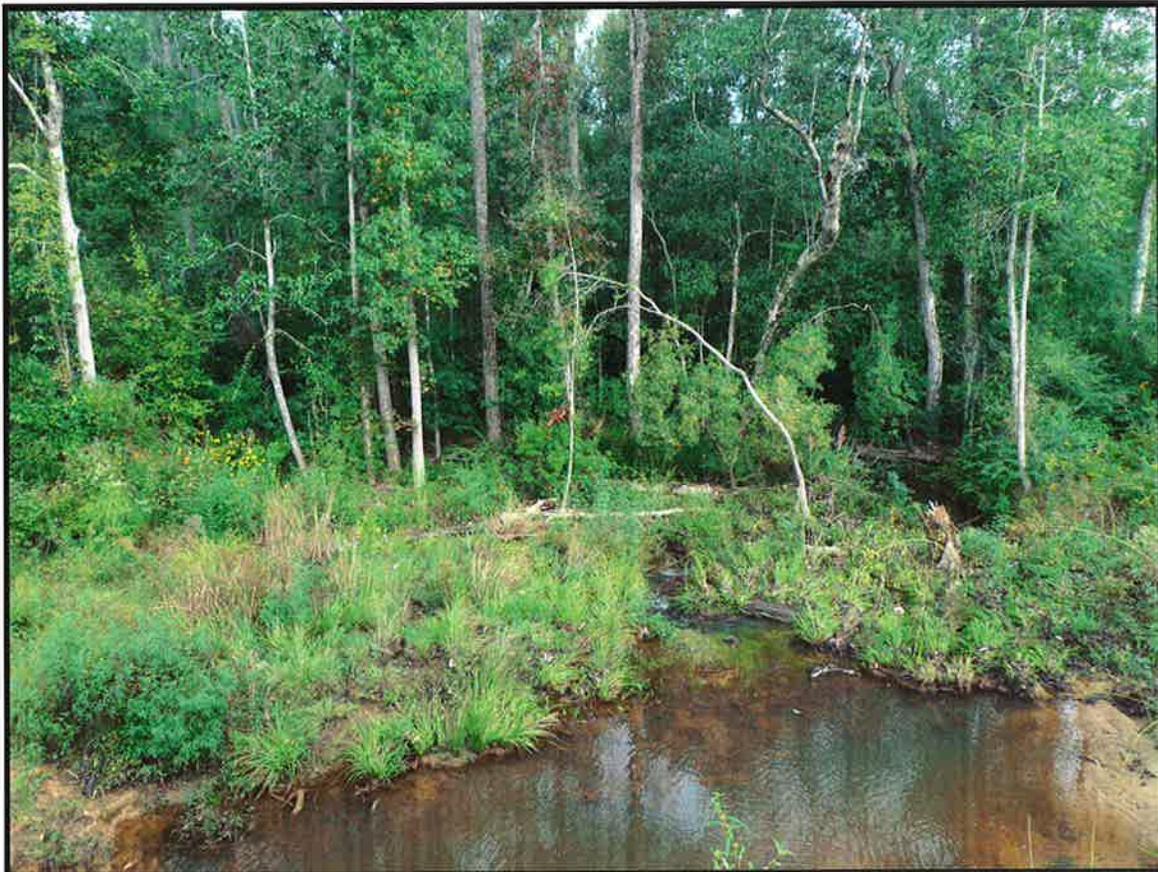
Site T2W, was located near a bridge inside the Tiawasa Subdivision west of Highway 13 and scored a 4 on our wetland grading scale. Although the wetlands have been impacted by sediment, most canopy trees were healthy, and few exotic species have become established along this section of Tiawasee Creek. It should be noted that most of the upland buffer upstream of Site T2W has not been developed for residential housing or commercial purposes. Site TC1W was located southwest of Site T2W just east of Pollard Road, and scored a 3 on the grade scale. It had very similar characteristics to Site T2W, but had a much higher percentage of exotic seedlings in the understory and deeper sediment deposits which might have entered the wetland from an adjacent dirt pit during heavy rain events. Wetlands in the riparian area of Tiawasee Creek east of Tributary TG were relatively undisturbed and the surrounding upland buffer was undeveloped. The only significant impact to wetlands in that section on the Creek was scattered exotics species throughout the understory, resulting in a score of 4 on the grade scale. South of TC1W, wetlands surrounding Tributary TC retain the same characteristics and, therefore, the score of 3 on the grade scale. However, sub-tributary TCC was one of the most heavily impacted wetlands within the study area. TCC flowed through an agricultural field and all native vegetation had been cleared. All wetlands surrounding TCC scored a 1 due to extreme manipulation of the historical wetland system.

PHOTO 12: Site T2W was located on Tiawasee Creek in the Tiawasa Subdivision. Primary impacts to this section of Tiawasee Creek are associated with the establishment of exotic species in the understory.

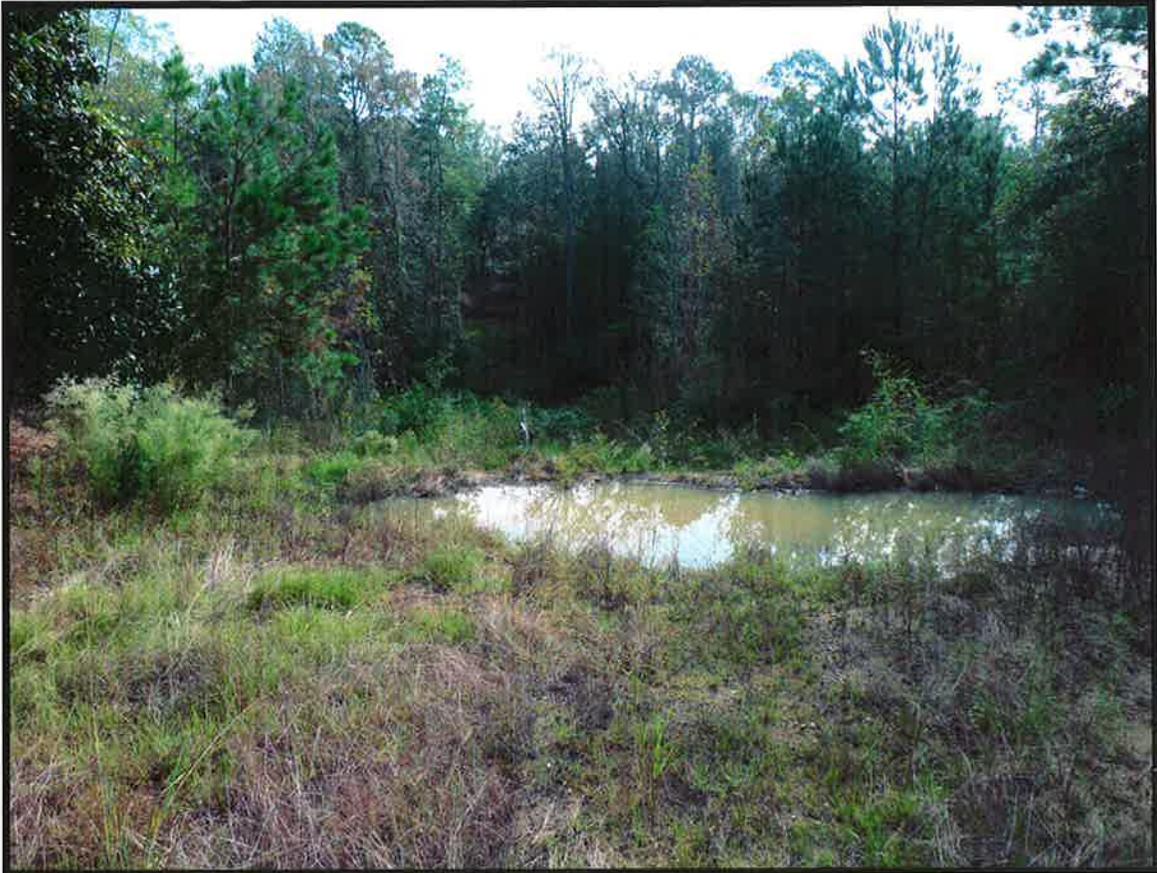
PHOTO 13: This photo was taken from the upland buffer just west of the Site TC1W wetland (visible as the bottom of the hill). Though the canopy trees at Site TC1W were relatively healthy, the understory was dominated by the exotic shrub Chinese privet (*Ligustrum sinense*).

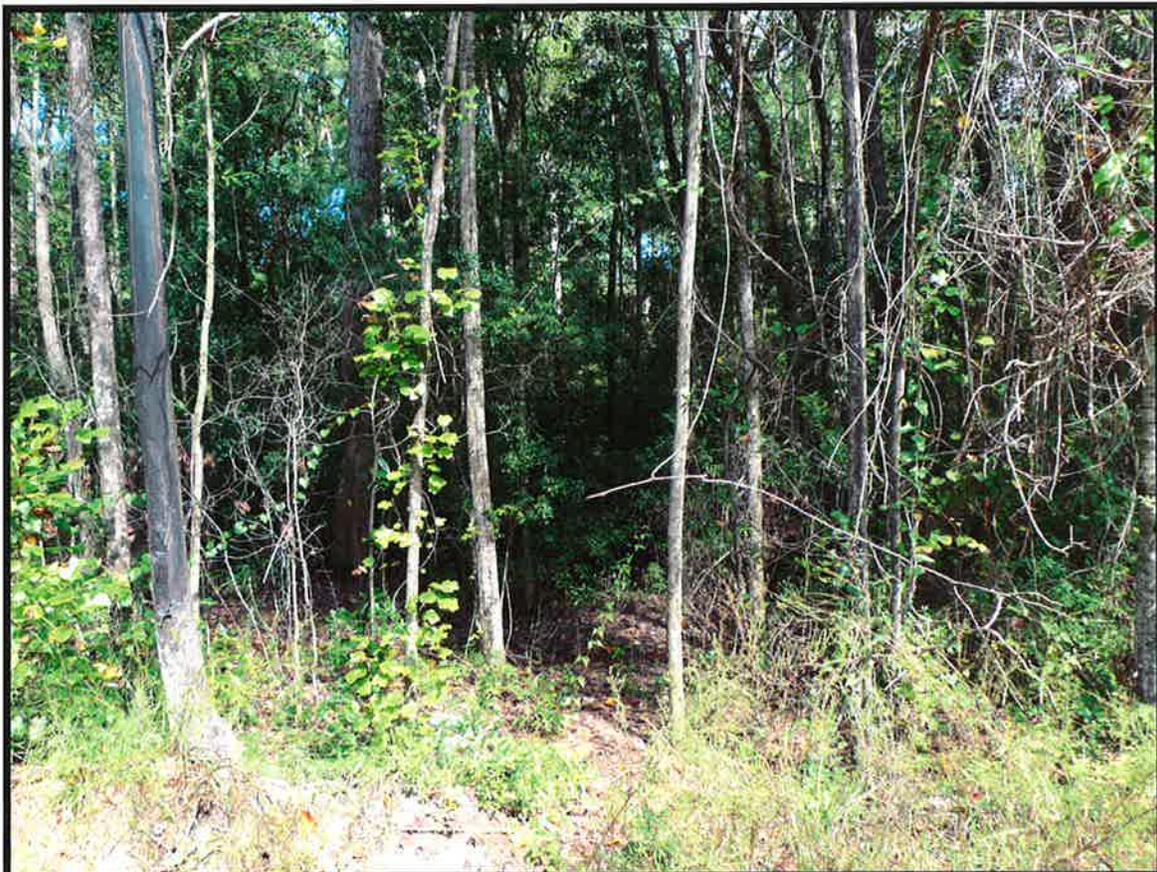
Sites TA1W and T1W were approximately 900 feet apart and located near the center of the Lake Forest subdivision. Site TA1W was located near the tennis courts in a seepage-slope type wetland (adjacent to Tributary TA) that drains into the main branch of Tiawasee Creek. The canopy trees at Site TA1W were very healthy and created a closed canopy, which allowed very little light penetration into the understory. The wetland showed evidence of extreme (>12 inches in many locations) sedimentation that likely

PHOTO 14: Site TA1W was located on a seepage slope near stream TA. Though the area had deep sediment deposits, the native vegetation in all strata had adapted and were relatively healthy.

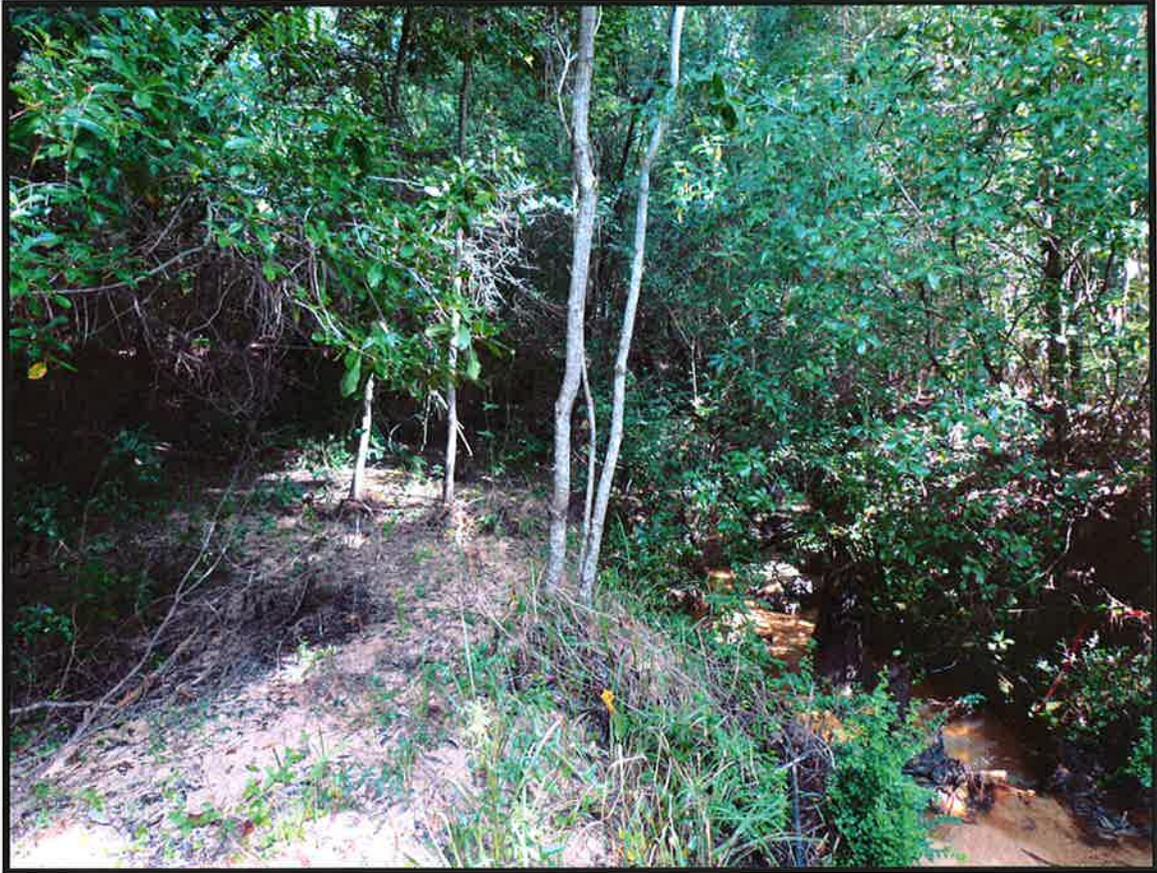
occurred many years ago, but the system has recovered well in terms of species composition. Site TA1W scored a 4 on our grading scale. Site T1W was located approximately 900 feet east of Site TA1W in the riparian area of Tiawasee Creek. Wetlands around Site T1W were heavily impacted by sedimentation and the removal of much of the native/natural vegetation. The dominant canopy tree species is currently planted loblolly pine, and the midstory was dominated by exotics and green titi (*Cyrilla racemiflora*). Sedimentation has altered the natural hydrology to the point that upland exotics such as cogongrass (*Imperata cylindrica*) and camphortree (*Cinnamomum camphora*) have become established in areas along the creek that were historically bottomland hardwood swamp. Site T1W scored a 2, rather than a 1, on our grade scale because the upland buffer is heavily vegetated in most areas and danger of future sedimentation is minor compared to sites surrounded by new development.

PHOTO 15: Wetlands at Site T1W were heavily impacted in several ways. In this photo, you can see exotic cogongrass (*Imperata cylindrica*) and Chinese privet (*Ligustrum sinense*) growing at the waters edge. Also, the nature hardwood canopy had been cleared and loblolly pine (*Pinus taeda*) planted in the riparian area.

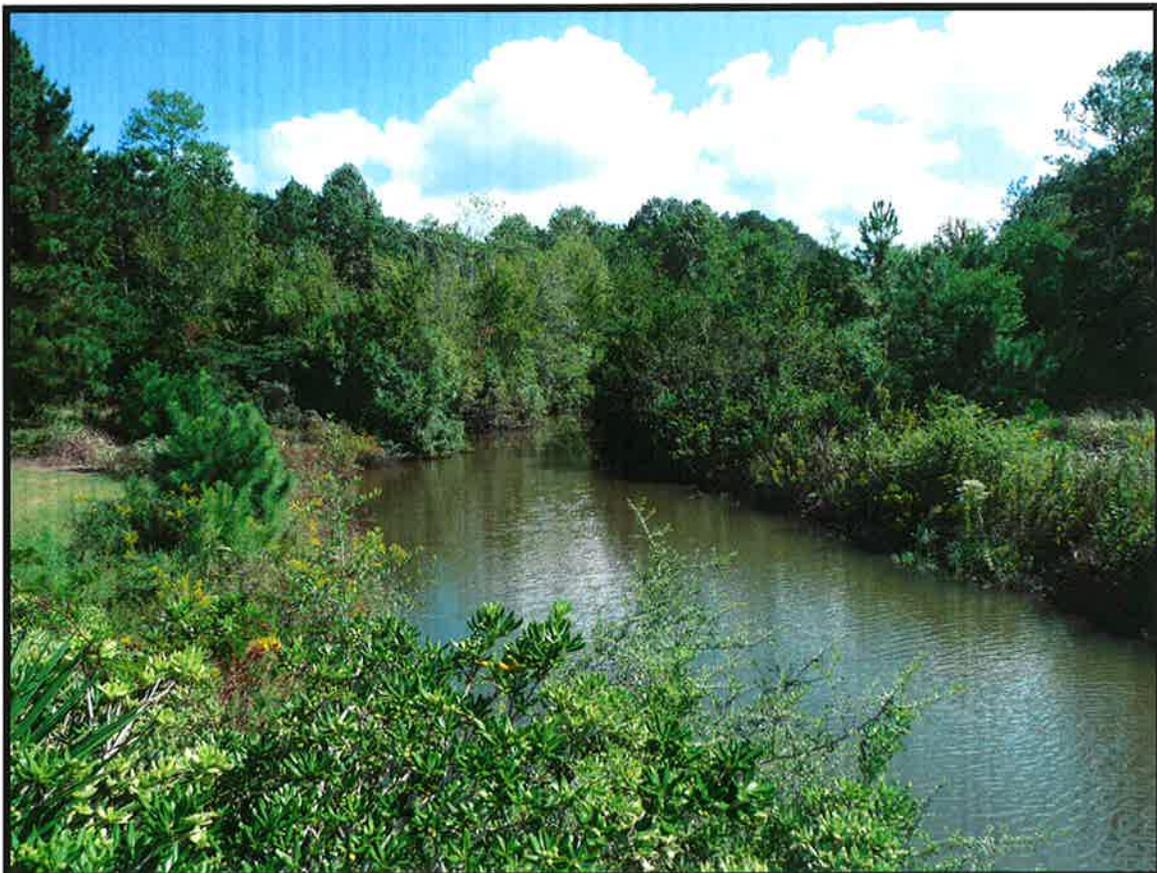
Site D3W was located just east of the eastern tip of the lake in Lake Forest Subdivision. The wetland had been severely altered to the point that it was hard to distinguish what the pre-development conditions might have been. Currently, the wetland is devoid of large canopy trees, is colonized in the midstory by exotic species, and seems to be inundated beyond its natural state due to the impoundment caused by the lake as evidenced by the depth of the creek waters on the surviving trees. The severe hydrologic alteration and exotic species earned Site D3W a score of 2 on the grade scale.

PHOTO 16: Site D3W was located just east of the Lake Forest pond and was dominated by exotic species in all strata. The water level in the wetland also appeared to have been artificially raised due the impoundment of the pond water.
