**D'OLIVE WATERSHED MONITORING STUDY
AND
DEVELOPMENT OF A WATERSHED CONDITION FRAMEWORK**

Prepared for

Mobile Bay National Estuary Program
118 North Royal Street #601
Mobile, Alabama 36602

July 24, 2019

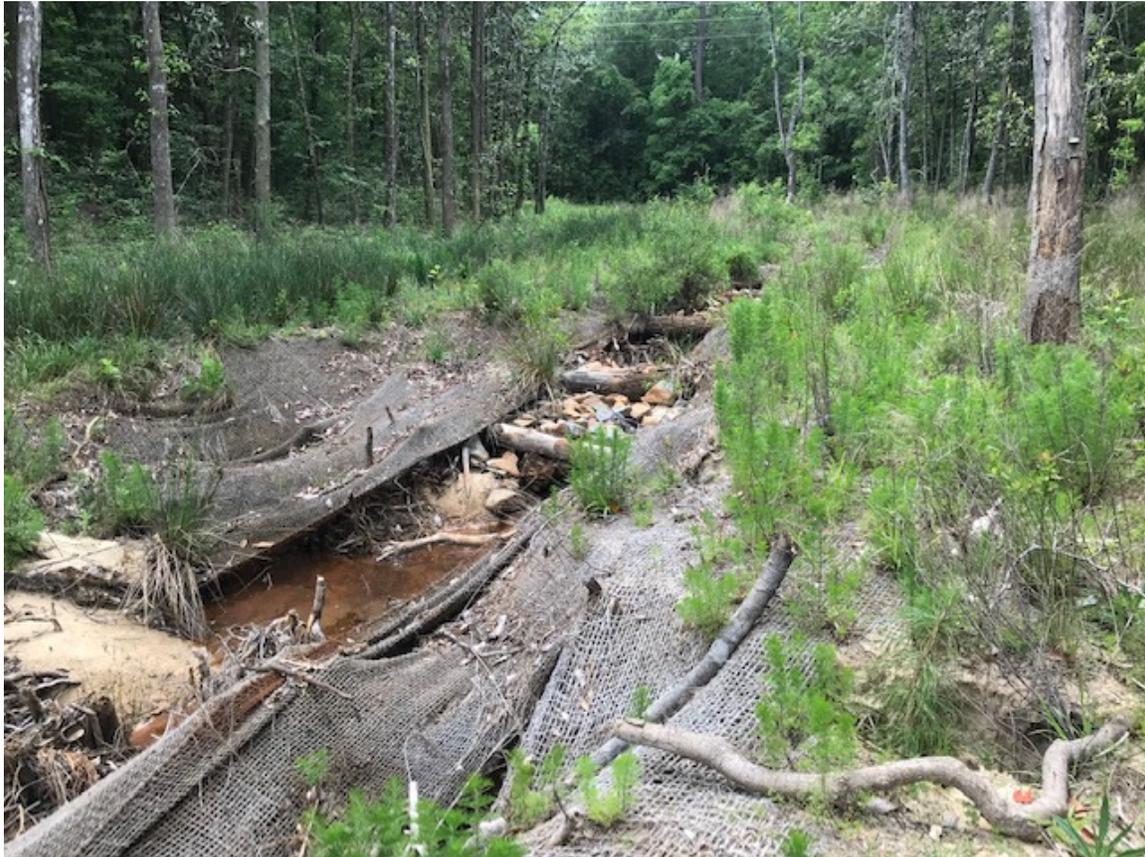
Baseline scores for the stream restoration sites were estimated using the TC2-Tributary restoration site as a model. This site scored lowest of all stream assessment locations in 2019, largely due to poor bank stability, bank vegetative protection, habitat availability, sediment deposition, and habitat smothering (Figure 3-2). The D'Olive restoration sites likely exhibited similar impairments prior to restoration efforts. The low RSA score observed at the TC2-Tributary site represents a good estimate of theoretical pre-restoration conditions.

Figure 3-2. Restoration maintenance problems at the TC2-Tributary restoration site, Spring 2019.

The TC2-Tributary restoration site scored lowest of all stream assessment locations in 2019, largely due to poor bank stability, bank vegetative protection, habitat availability, sediment deposition, and habitat smothering.

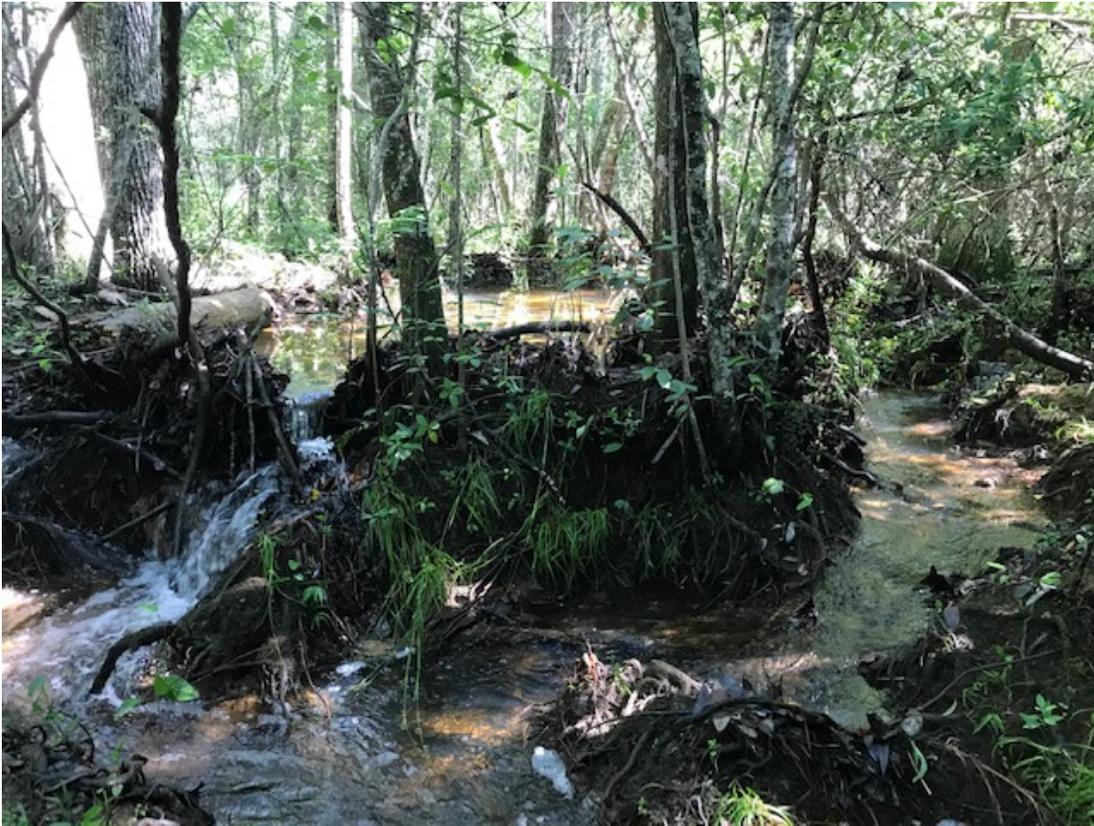
In the assessment for the 2010 WMP, the Joes Branch wetland adjacent to the Bass Pro Shop at Spanish Fort Town Center was among the most degraded areas in the entire D'Olive Watershed. This section of Joes Branch was severely impacted by sedimentation, with approximately 50% of the mature, native canopy trees are dead or dying, and the understory dominated by exotic species. The habitat provided very little cover for any endemic species, due to the extreme amount of silt accumulation and subsequent denuding of the lower vegetative strata. Review of available aerial imagery shows large areas of bare sediment and mostly dead canopy trees as recently as 2013.

The JB Bass Pro Shop site scored well in terms of current stream condition and improvement relative to the other sampling sites. The large decrease in sediment loading originating upstream of this reach (Cook, 2019) has resulted in large improvements to stream habitat (Figure 4-8). The site scored well (“moderate” to “good”) in the categories of habitat availability, sediment deposition, habitat smothering, and bank stability. The favorable scores for these categories, compared to previous observations, show a clear link between restoration efforts upstream, and improved downstream condition.

Figure 4-8. Joes Branch stream and wetland habitat at Bass Pro Shop.

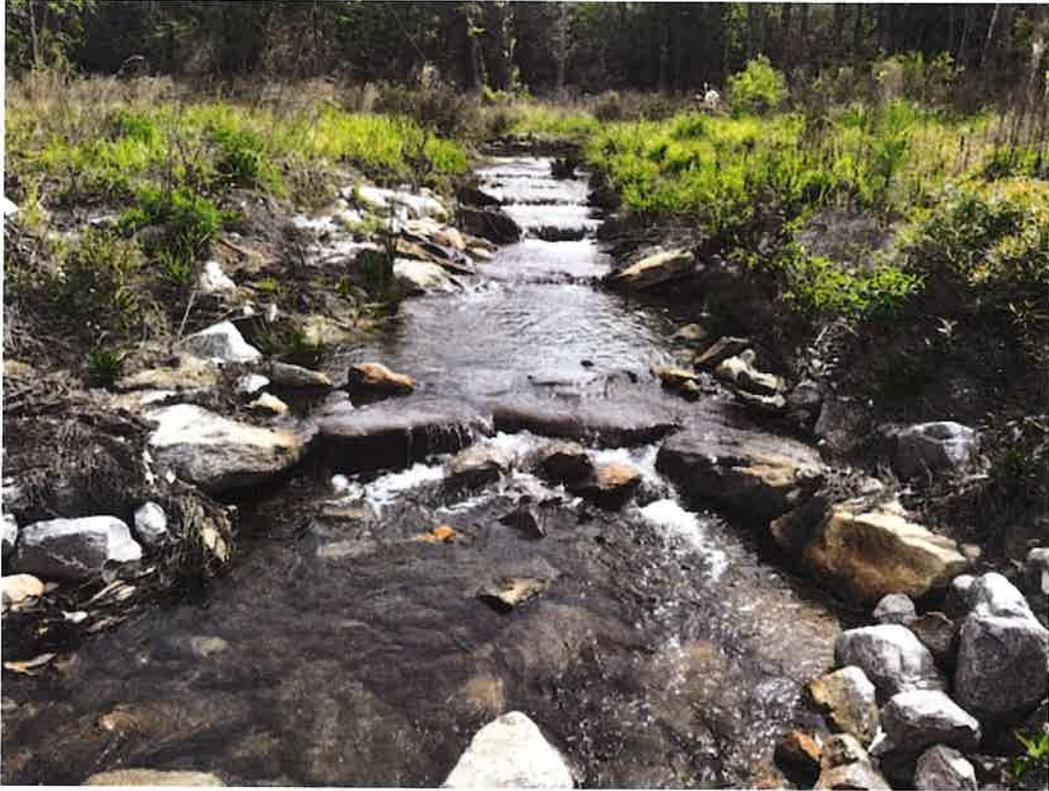
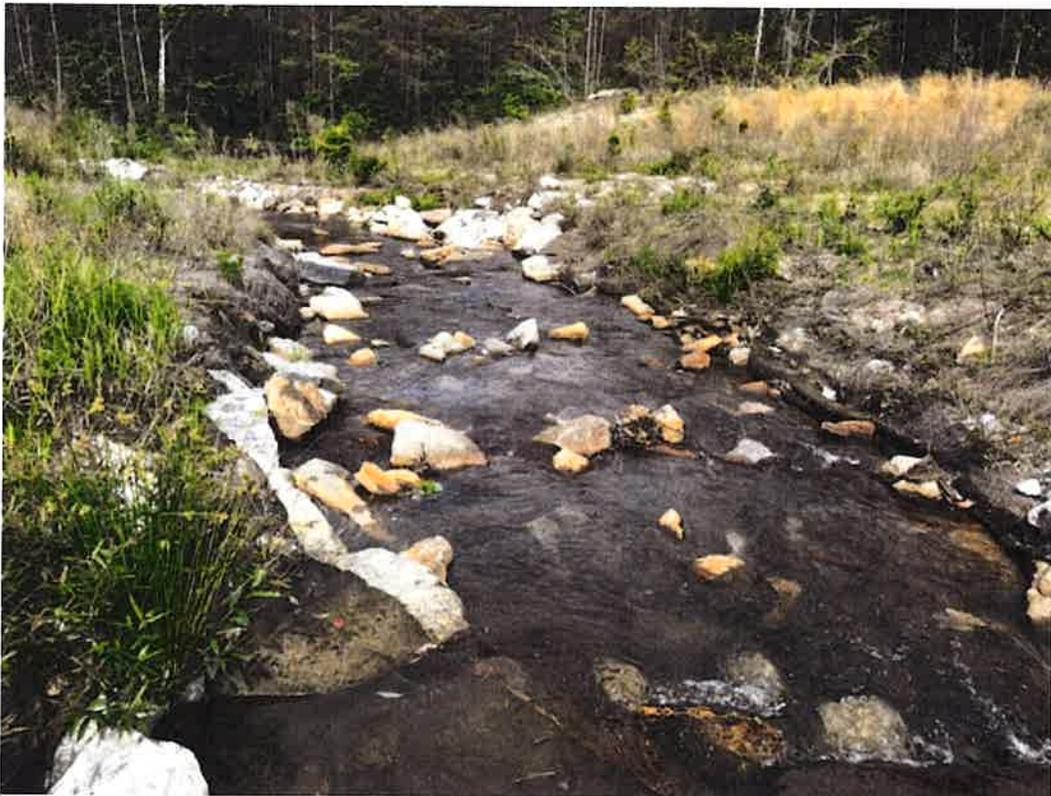
DA3-Restoration Sampling Site

The condition of Site DA3 is classified as Fair (0.54), and scored “good” for sediment deposition and habitat smothering. DA3 scores poorly for canopy cover and riparian zone width, reflecting its recent construction and initial stage of development. Stonefly and caddisfly larvae, insects with high pollution sensitivity and moderate pollution sensitivity, respectively, were collected at DA3, improving its condition score.

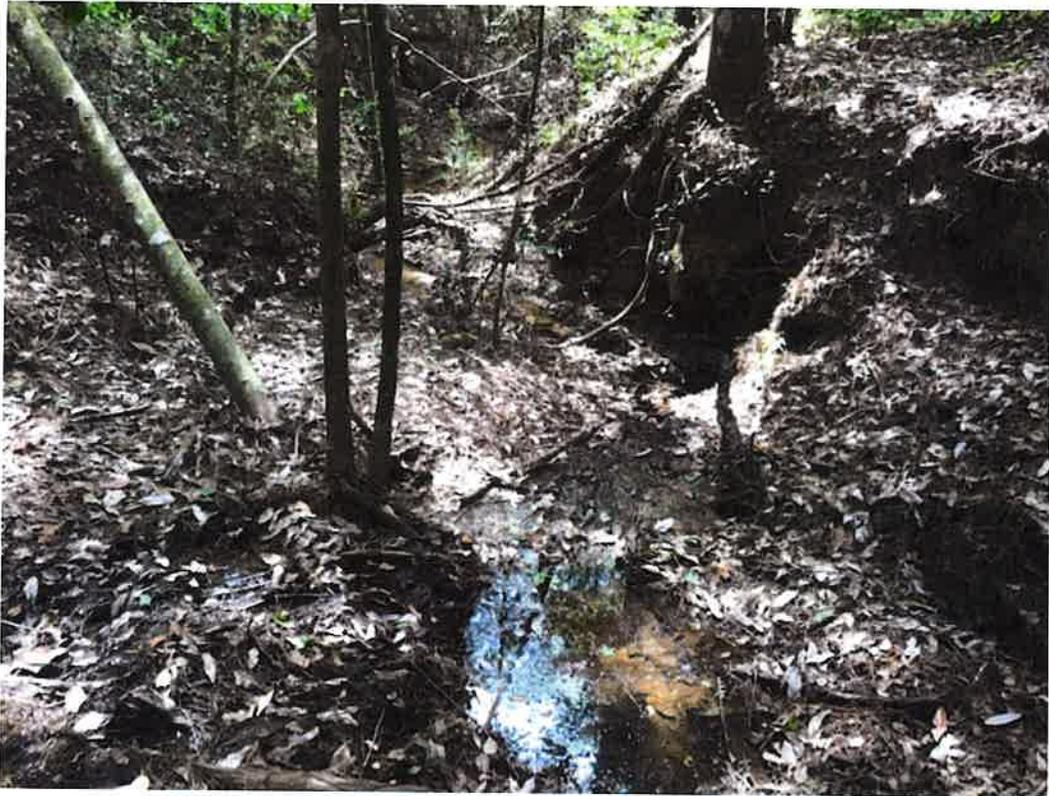
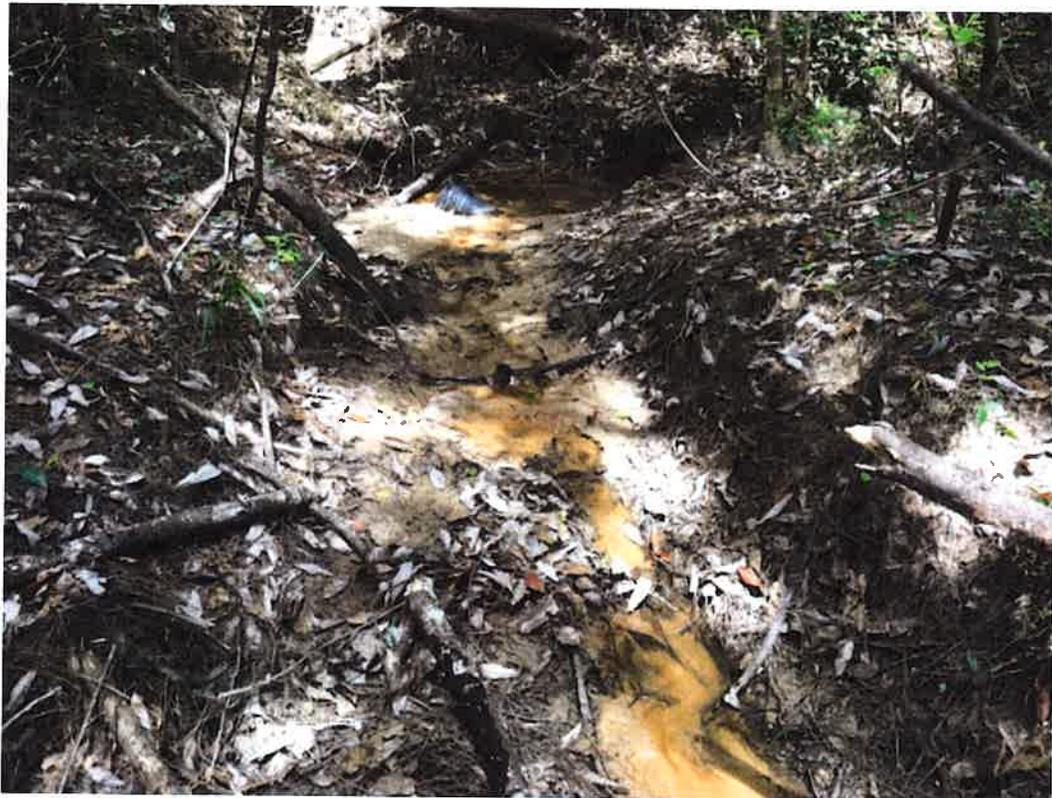
DAE-Downstream Sampling Site

Downstream of restoration site DAE, the stream has a Fair condition (0.52), with “good” scoring for riparian zone width, vegetative quality, and canopy cover. The site scored poorly for habitat availability and sediment deposition, and “moderate” for bank vegetative protection and habitat smothering. The D4D6 downstream site also scored Fair (0.52), and was similar to DAE downstream with respect to sediment deposition (“poor”), but has better stream habitat availability and yielded two macroinvertebrate taxa (damselfly and dragonfly) with moderate pollution sensitivity, increasing its overall condition score.

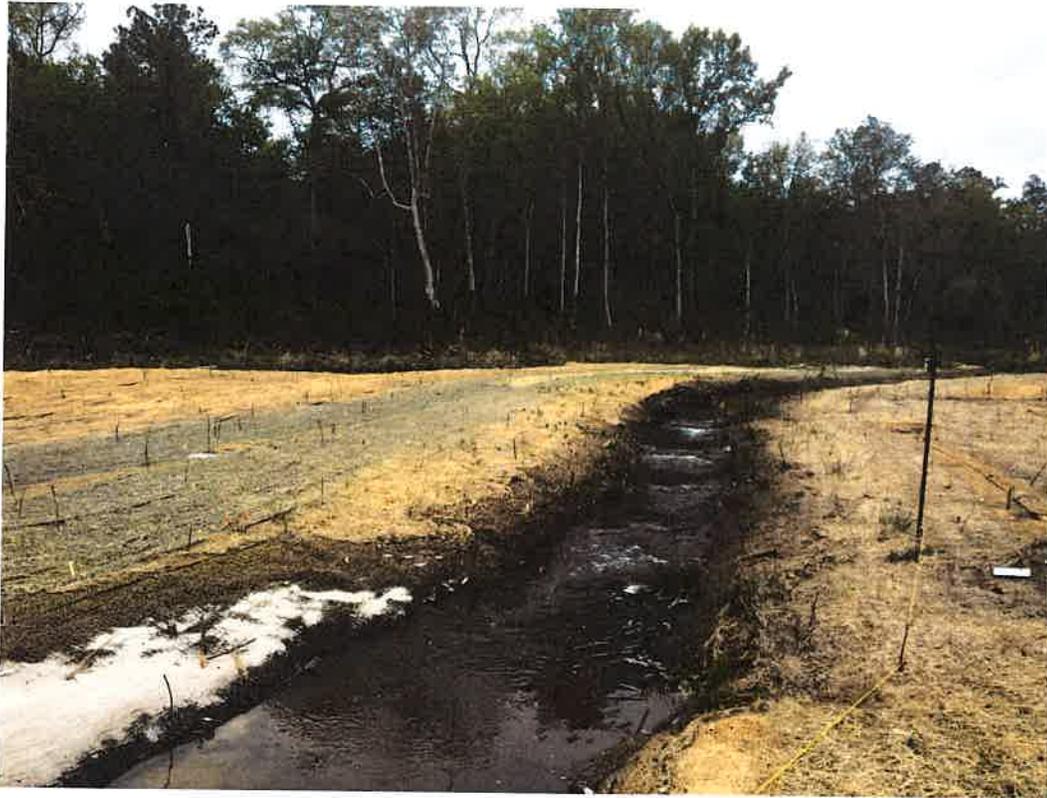
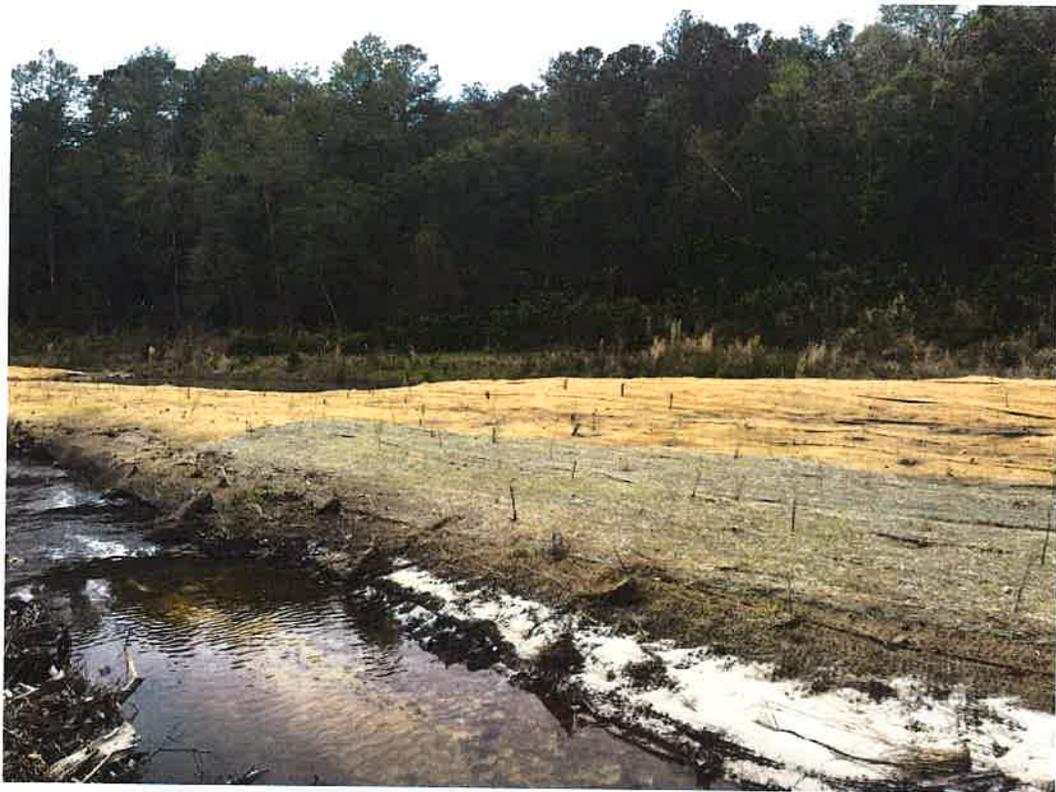
D4-D6-Restoration Sampling Site

The D4D6 restoration site has poor stream quality, with “poor” conditions for bank vegetative protection, canopy cover, and riparian zone width, reflecting the recent construction of the site. D4D6 is rated “good” for stream bank stability, and receives “moderate” scores for channel sinuosity, channel alteration, bank vegetative protection, habitat availability, and habitat smothering.

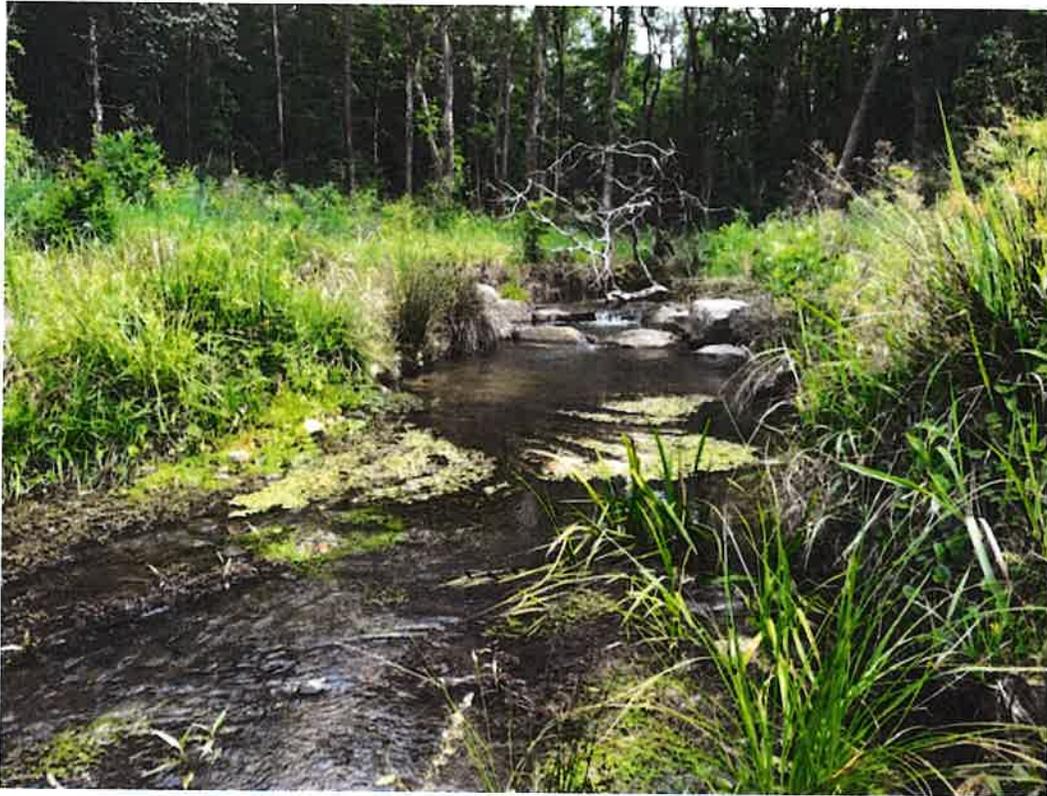
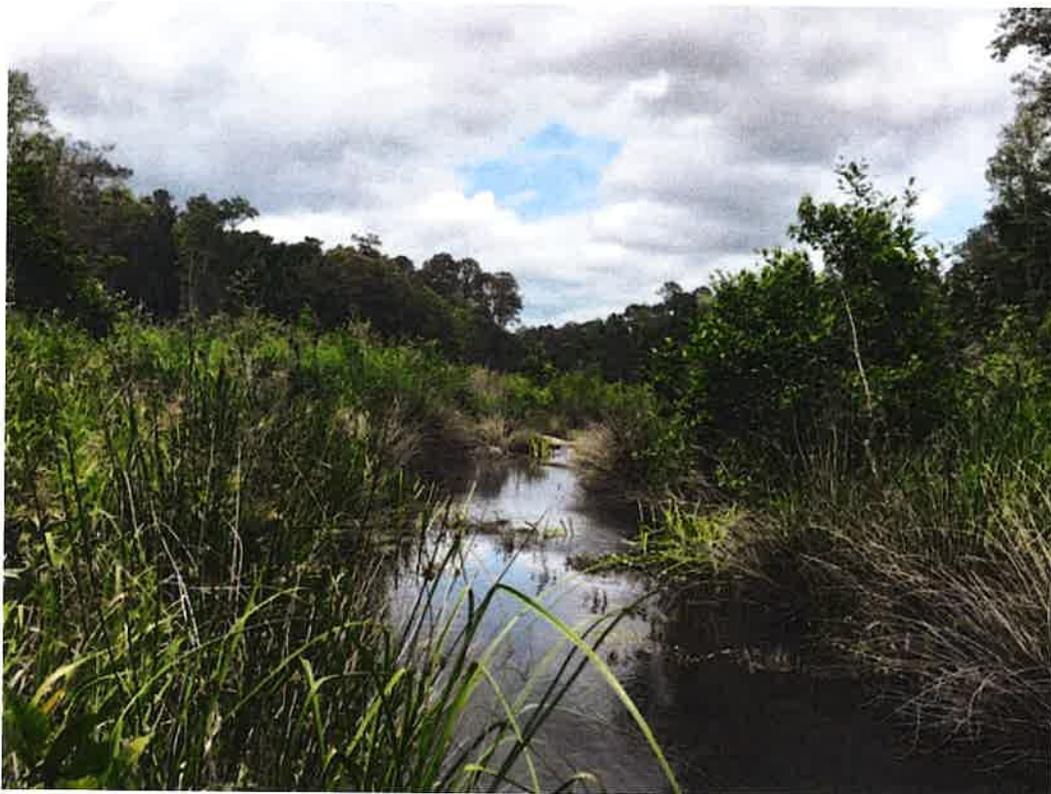
TC(1-2)-Restoration Sampling Site

The TC1-TC2 restoration site is classified as Poor (0.40), primarily due to “poor” scores for riparian zone width, canopy cover, and channel alteration. The site receives a “good” score for bank stability, and “moderate” scores for sediment deposition, habitat smothering, habitat availability, channel sinuosity, and bank vegetative protection. The reach upstream of TC1-TC2 is classified as Fair quality (0.68), scoring high for riparian zone width, canopy cover, and macroinvertebrate taxa.
