**1<sup>st</sup> ANNUAL POST-CONSTRUCTION MONITORING REPORT**

**POST-CONSTRUCTION BATHYMETRY, SHORELINE, AND  
STRUCTURAL MONITORING**

**MON LOUIS ISLAND RESTORATION PROJECT  
USACE FINAL PERMIT# SAM-2014-01046-LET**

**AUGUST 24, 2018**

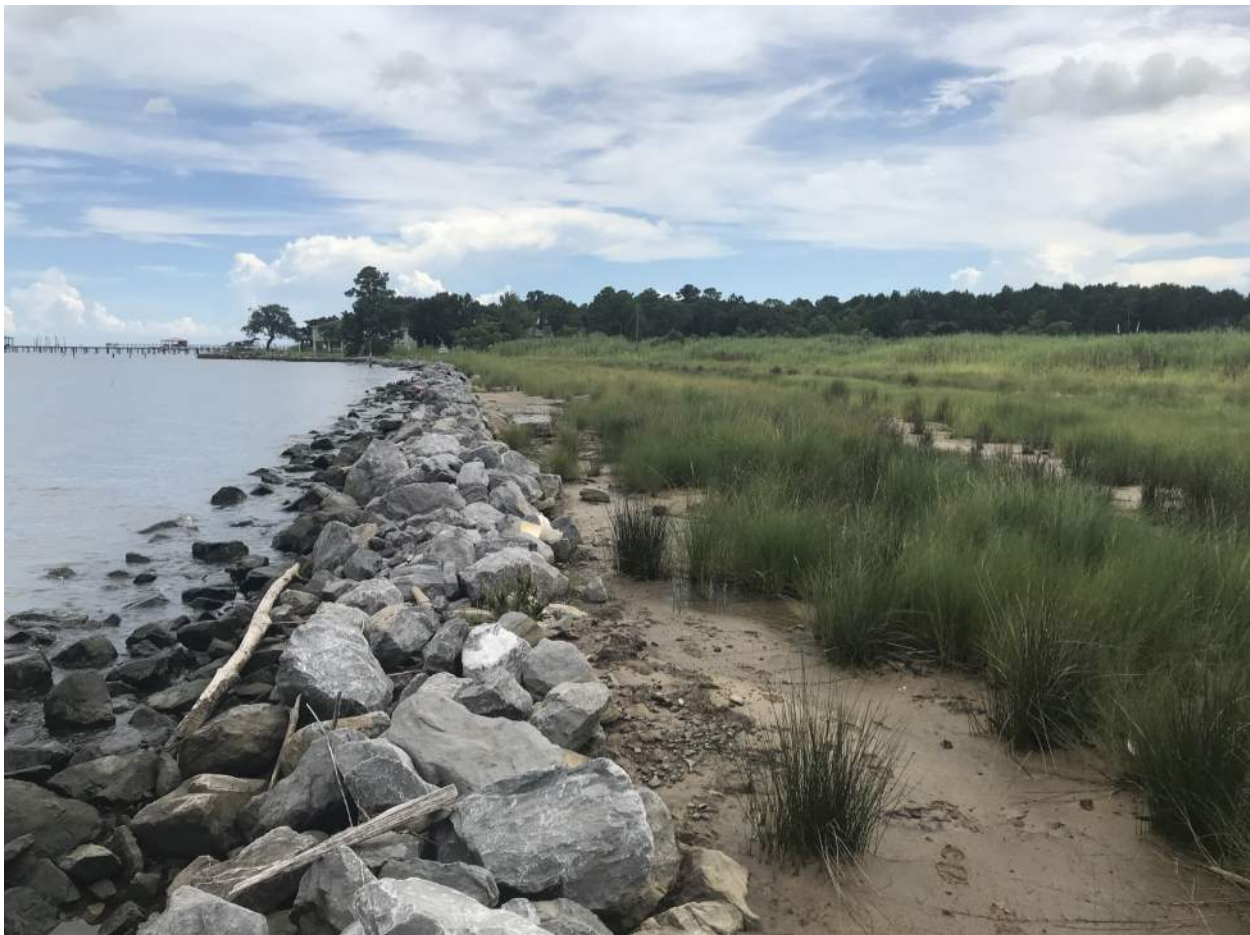
Figure 2. Representative view of rock dike breakwater facing south (marsh on right)

A review of the comparative transects indicate that some of the June 2018 transects are slightly lower than some of the December 2016 transects. This may indicate some slight settlement at these areas. Potential sources of vertical error to consider include, relative positioning of comparative cross section survey lines, GPS error, and the large rock size. Because some of the rip rap pieces are three to four feet in diameter, the specific spot that a cross section elevation shot is taken may result in different transect line shapes. Field observations do not indicate any

displacement or fracturing of rip rap, nor do they indicate any changes on overall cross section. Figures 2 and 3 provide a representative view of the rubble mound breakwater. These photographs were taken on August 9, 2018.

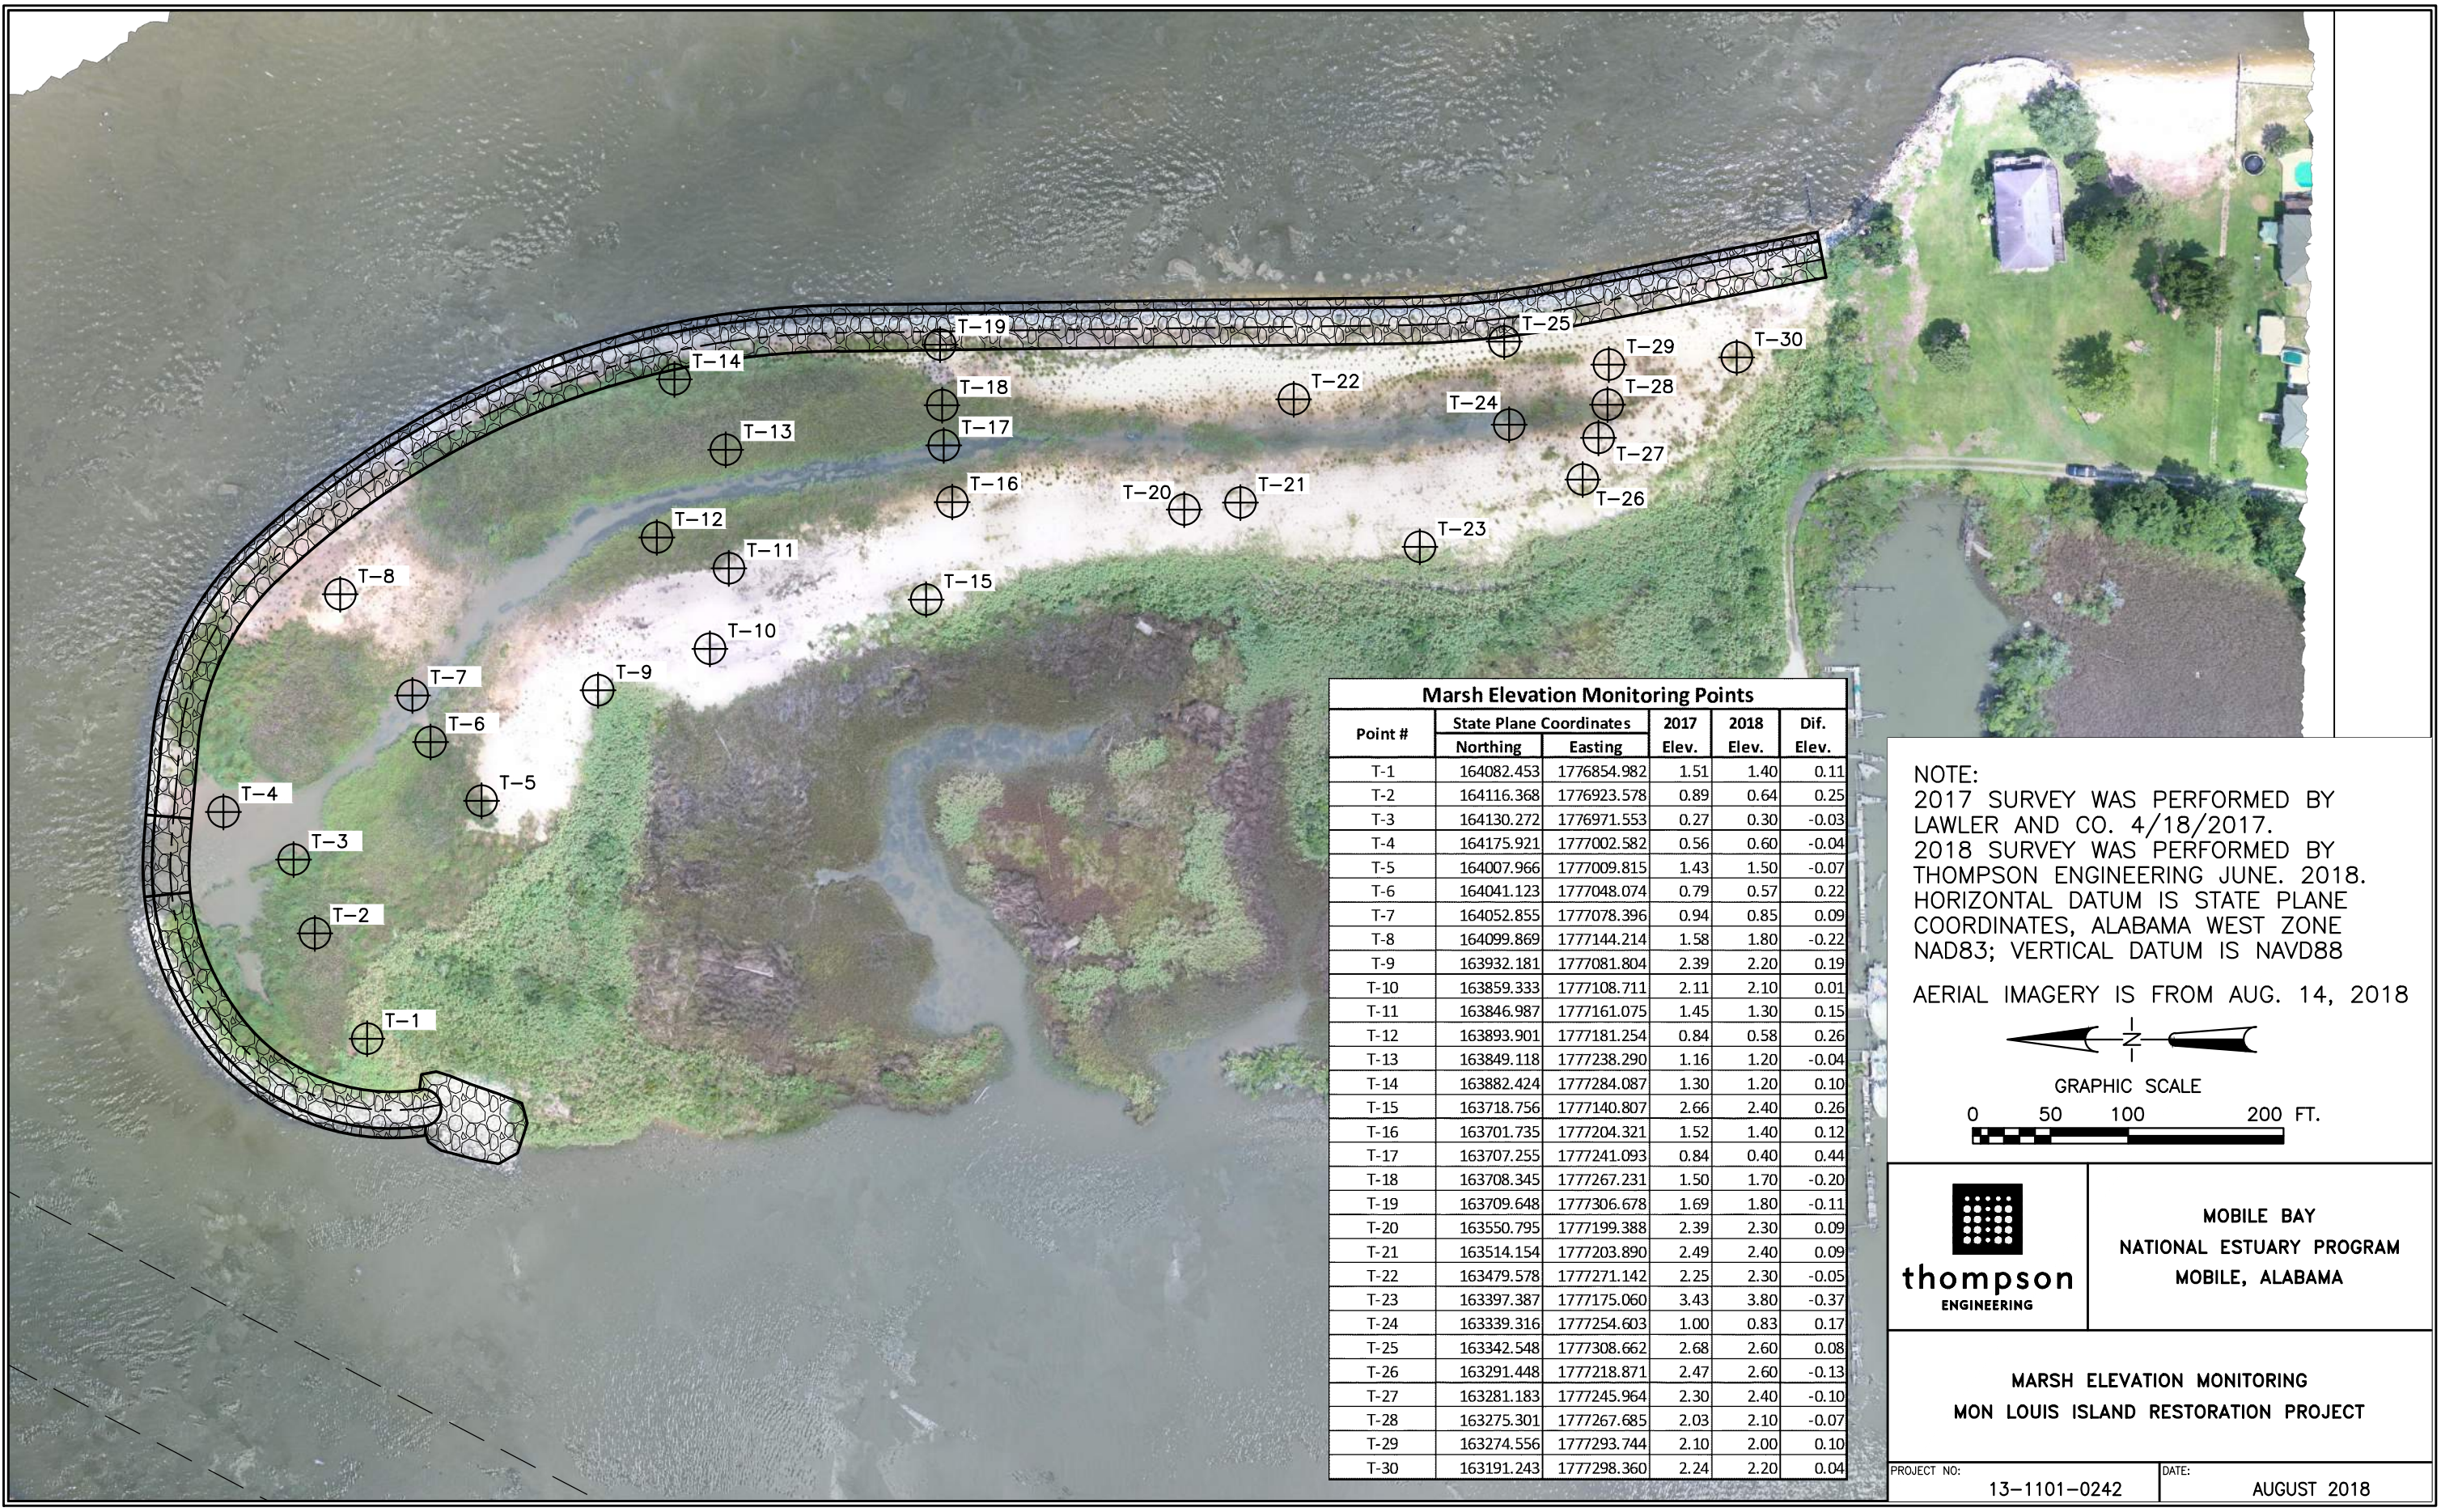
## Marsh Elevation Monitoring Figures

Of these 30 points 18 (60%) points fell within one tenth of one foot (1.2 in.) of their closest relatable points and 25 (83%) fell within one quarter of one foot (3 in.) of their closest relatable points. The average of all 30 points from the 2018 survey was five one hundredths of a foot (0.6 in.) higher than the average of all 30 points from the 2017 survey. Potential sources of vertical error to consider include, relative positioning of comparative points, GPS error, and marsh surface survey instrument impacts.

A review of the data indicated very little change in marsh surface elevations. As described in the Post-Storm Monitoring section of this report, erosion of the protective berm along the eastern side of the marsh (adjacent to the rock breakwater) during Tropical Storm Cindy caused a lowering in elevation at the berm location and a raising of surface elevations just to the west. It is possible that wave action from this event, and from Hurricane Nate also caused other minor shifts in fill material within the marsh. Generally, however, the survey data along with field observations do not indicated any appreciable changes in marsh surface elevations.
