2nd ANNUAL POST-CONSTRUCTION MONITORING REPORT

POST-CONSTRUCTION BATHYMETRY, SHORELINE, AND STRUCTURAL MONITORING

**MON LOUIS ISLAND RESTORATION PROJECT
USACE FINAL PERMIT# SAM-2014-01046-LET**

October 25, 2019

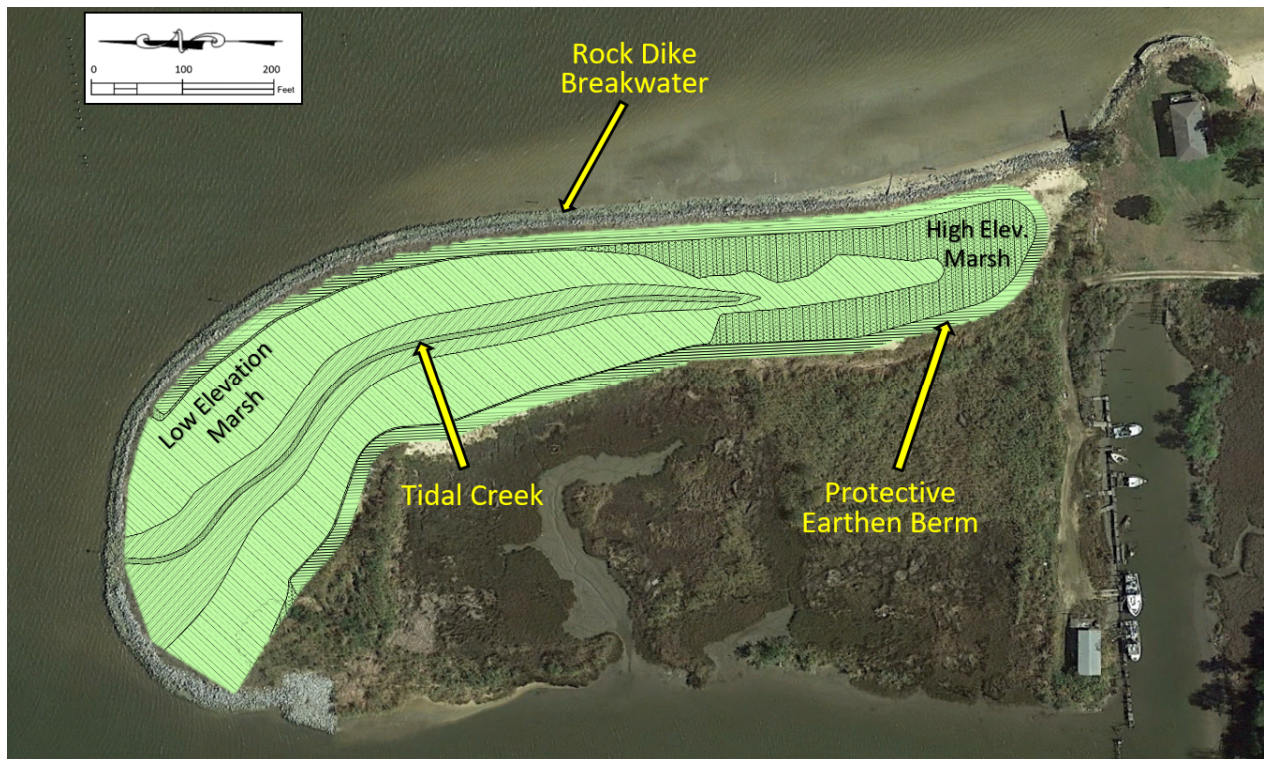
Figure 1. Constructed marsh and other site features.

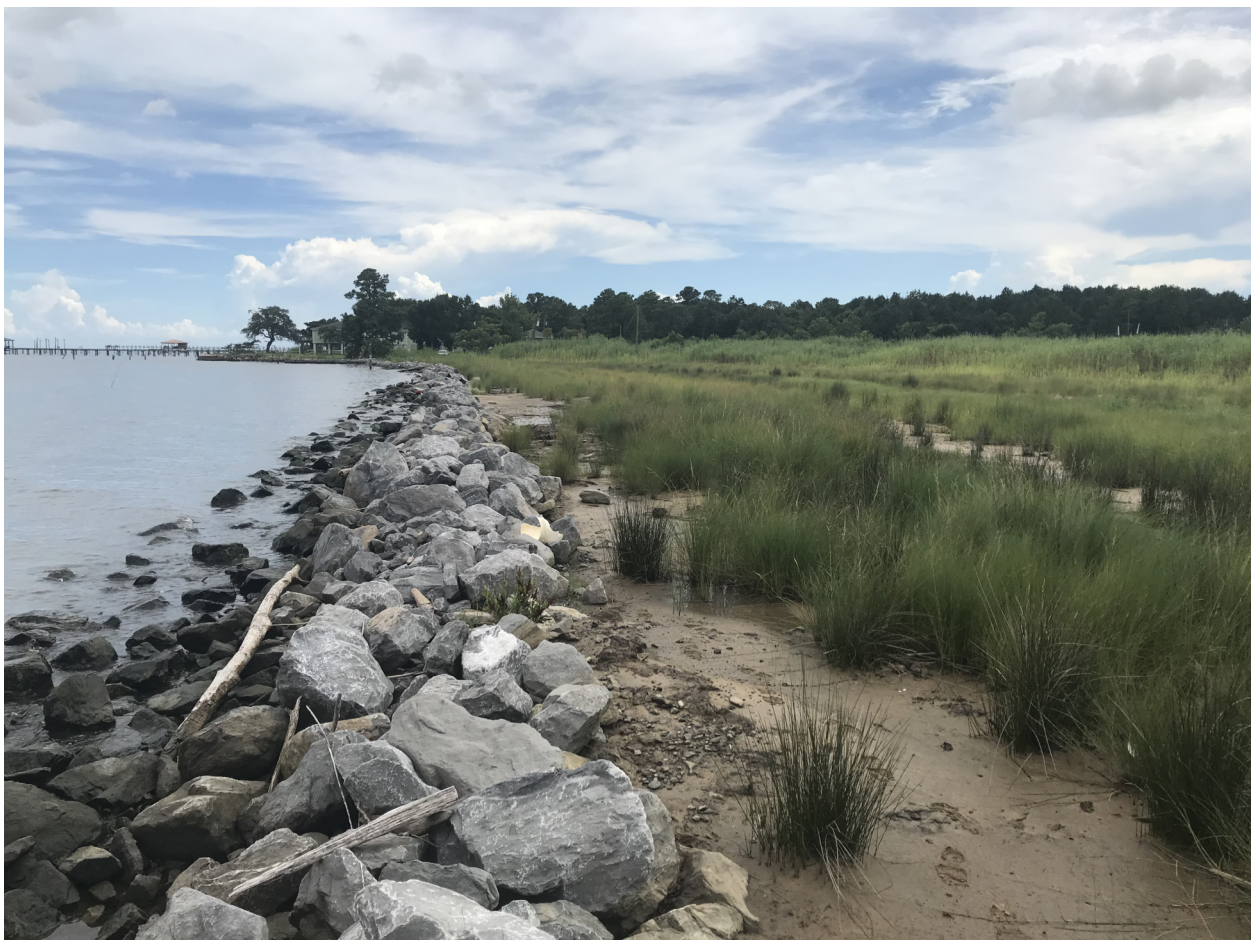
Figure 2. Representative view of rock dike breakwater facing south (marsh on right)

A review of the comparative transects indicated some of the June 2018 transects are slightly lower than some of the December 2016 transects. This may indicate some slight settlement at these areas. Potential sources of vertical error to consider include, relative positioning of comparative cross-section survey lines, GPS error, and the large rock size. Because some of the

rip-rap pieces are three to four feet in diameter, the specific location a cross-section elevation shot is taken may result in different transect line shapes. Field observations did not indicate any displacement or fracturing of rip-rap, nor did they indicate any changes on overall cross-section.

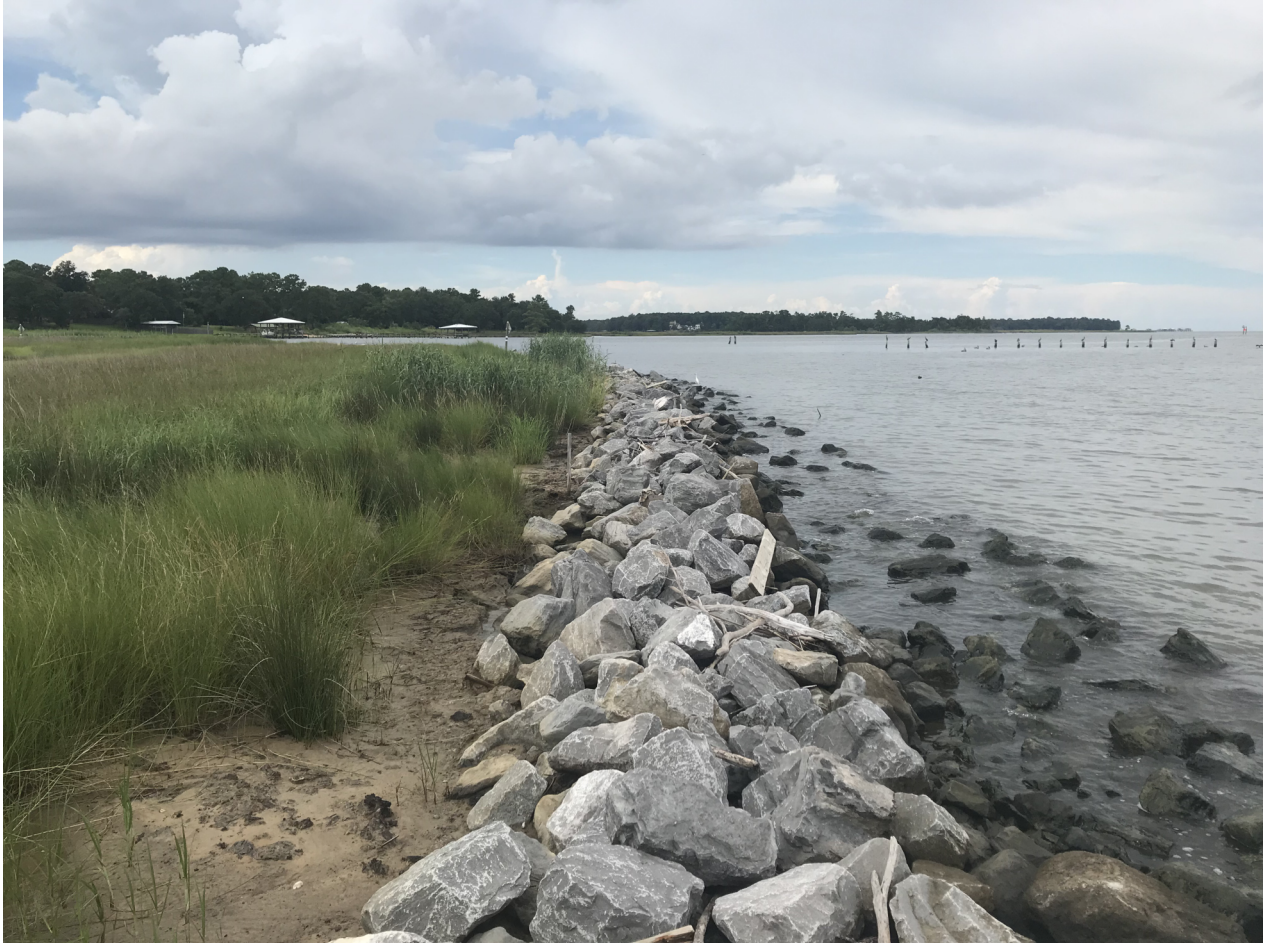
Figure 3. Representative view of rock dike breakwater facing north (marsh on left)
