**FOURTH ANNUAL POST-CONSTRUCTION MONITORING
REPORT**

**POST-CONSTRUCTION BATHYMETRY, SHORELINE, AND
STRUCTURAL MONITORING
MON LOUIS ISLAND RESTORATION PROJECT
USACE FINAL PERMIT# SAM-2014-01046-LET
FOWL RIVER, MOBILE COUNTY, ALABAMA**

April 27, 2022

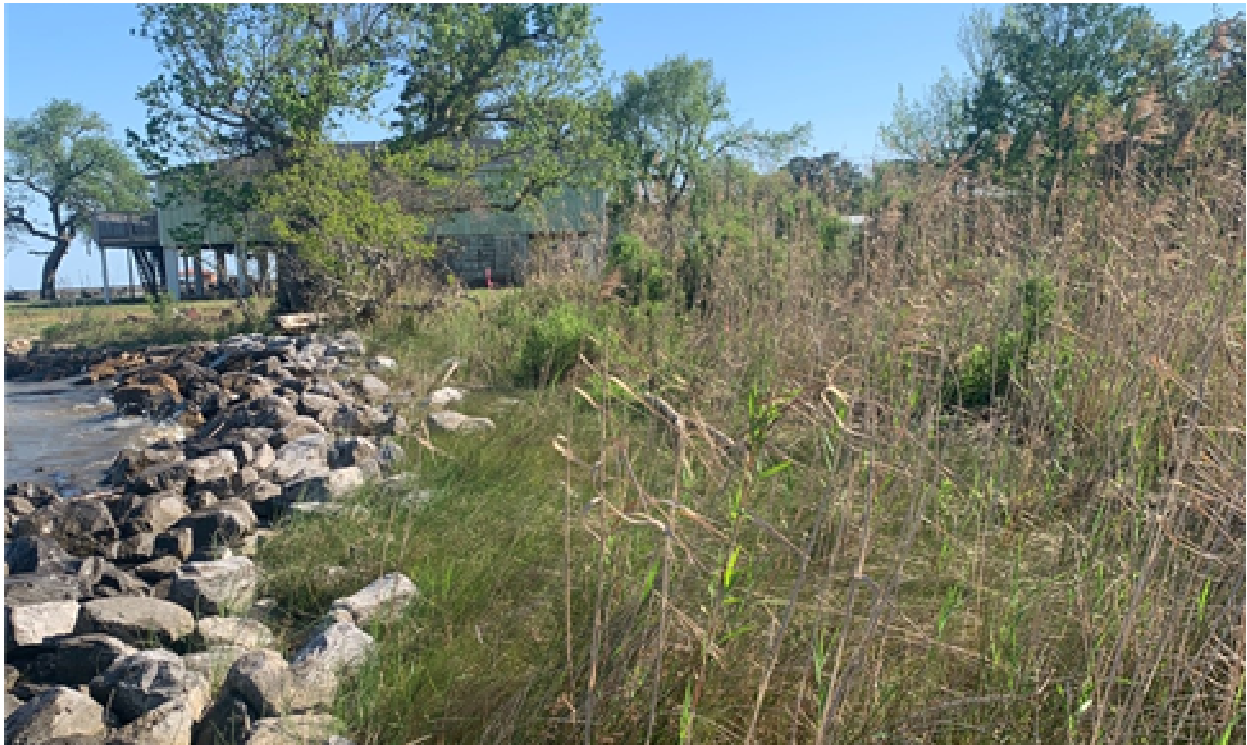
Figure 2. Rock dike breakwater, view south.

A review of the comparative transects indicated some of the June 2018 transects are slightly lower than some of the December 2016 transects. This may indicate some slight settlement at these areas. Potential sources of vertical error to consider include, relative positioning of comparative cross-section survey lines, GPS error, and the large rock size. Because some of the rip-rap pieces are three to four feet in diameter, the specific location a cross-section elevation shot is taken may result in different transect line shapes. Field observations did not indicate any displacement or fracturing of rip-rap, nor did they indicate any changes on overall cross-section.

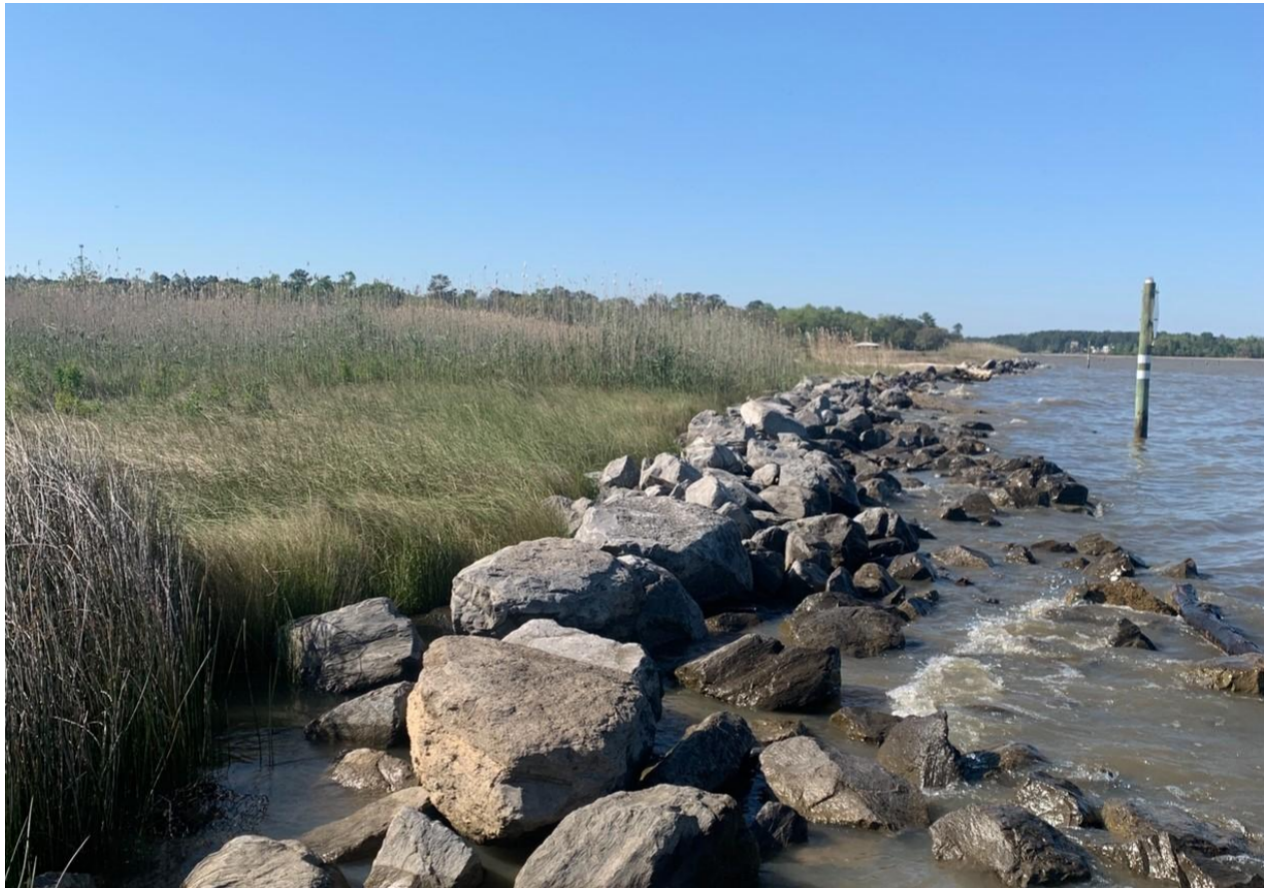
Figure 3. Rock dike breakwater, view north.

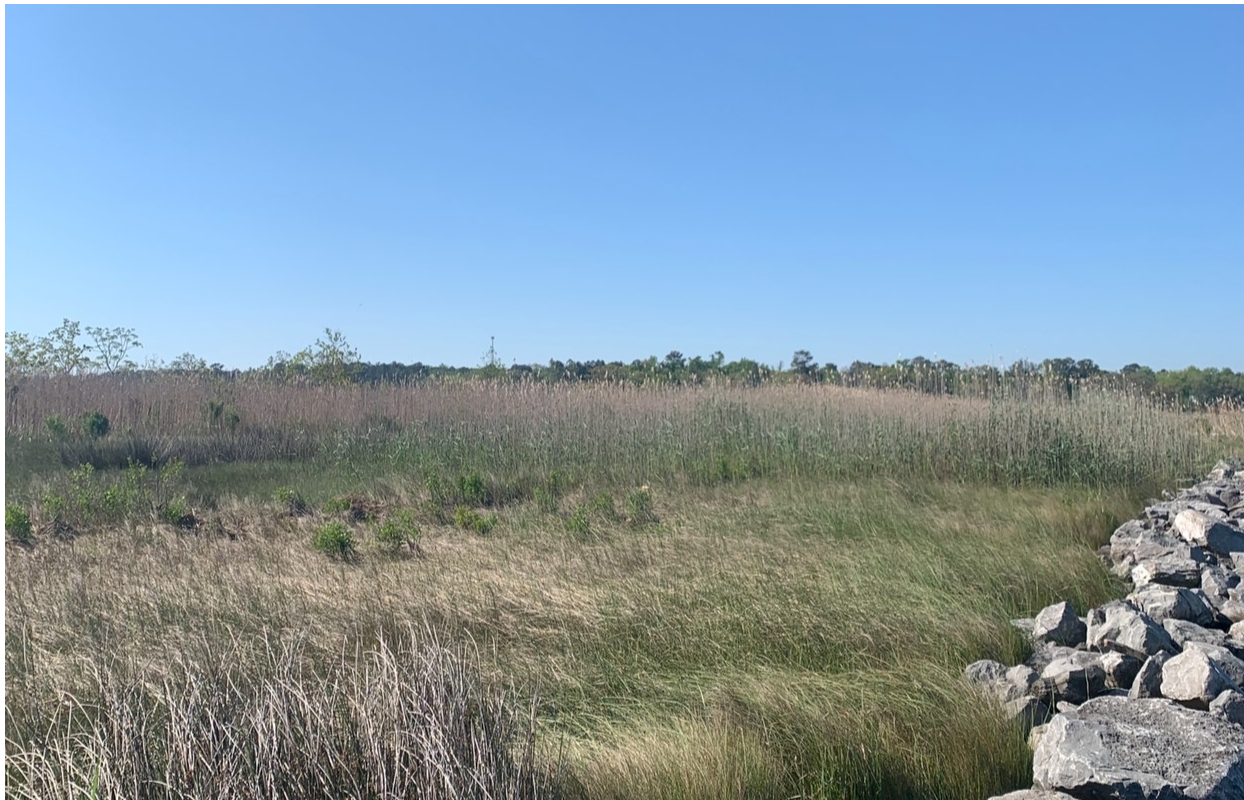
Figure 4. Marsh, view north.

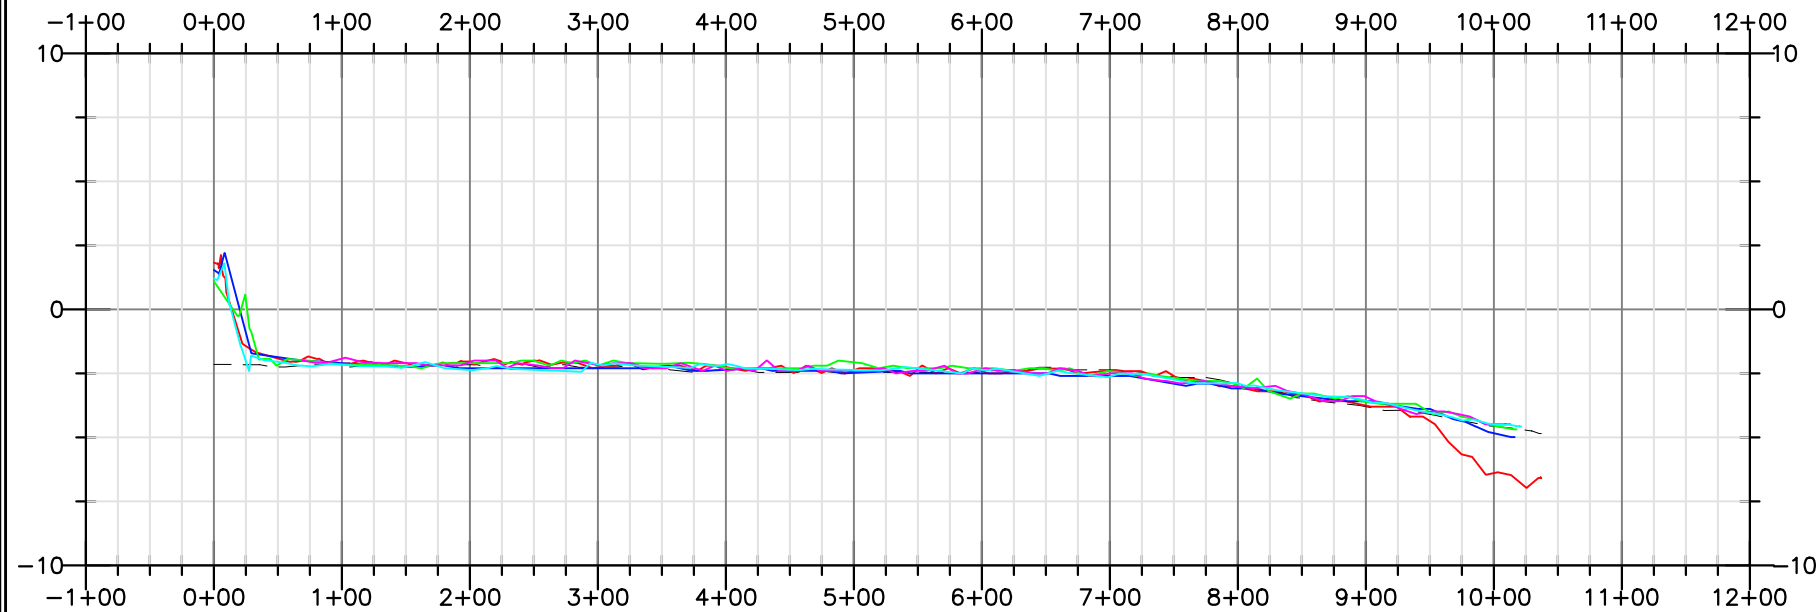
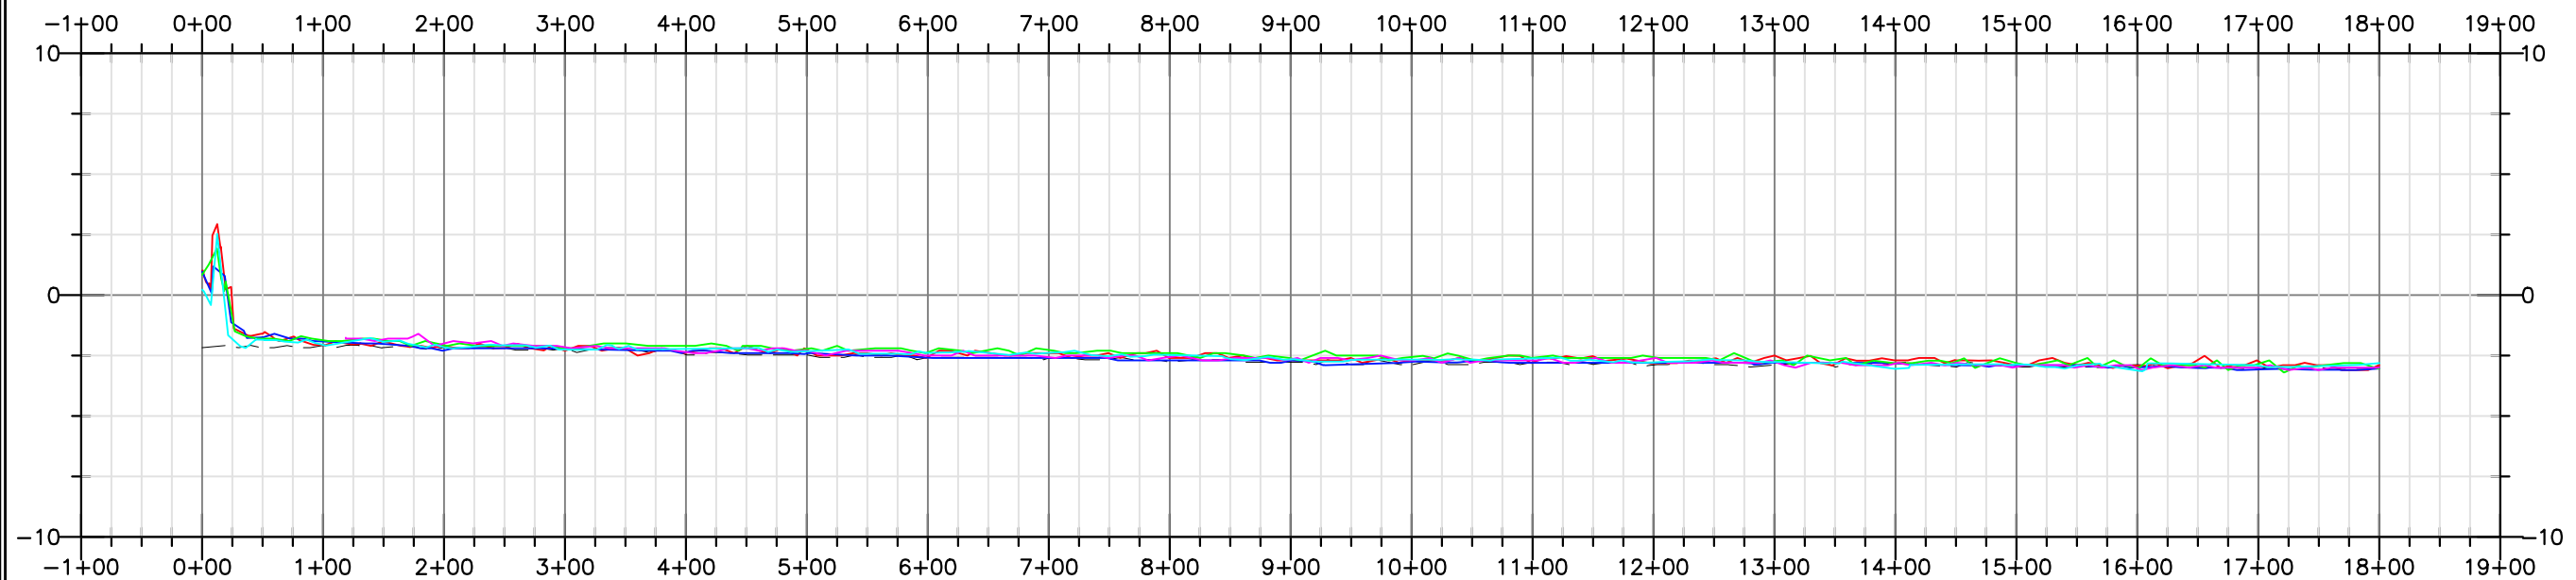
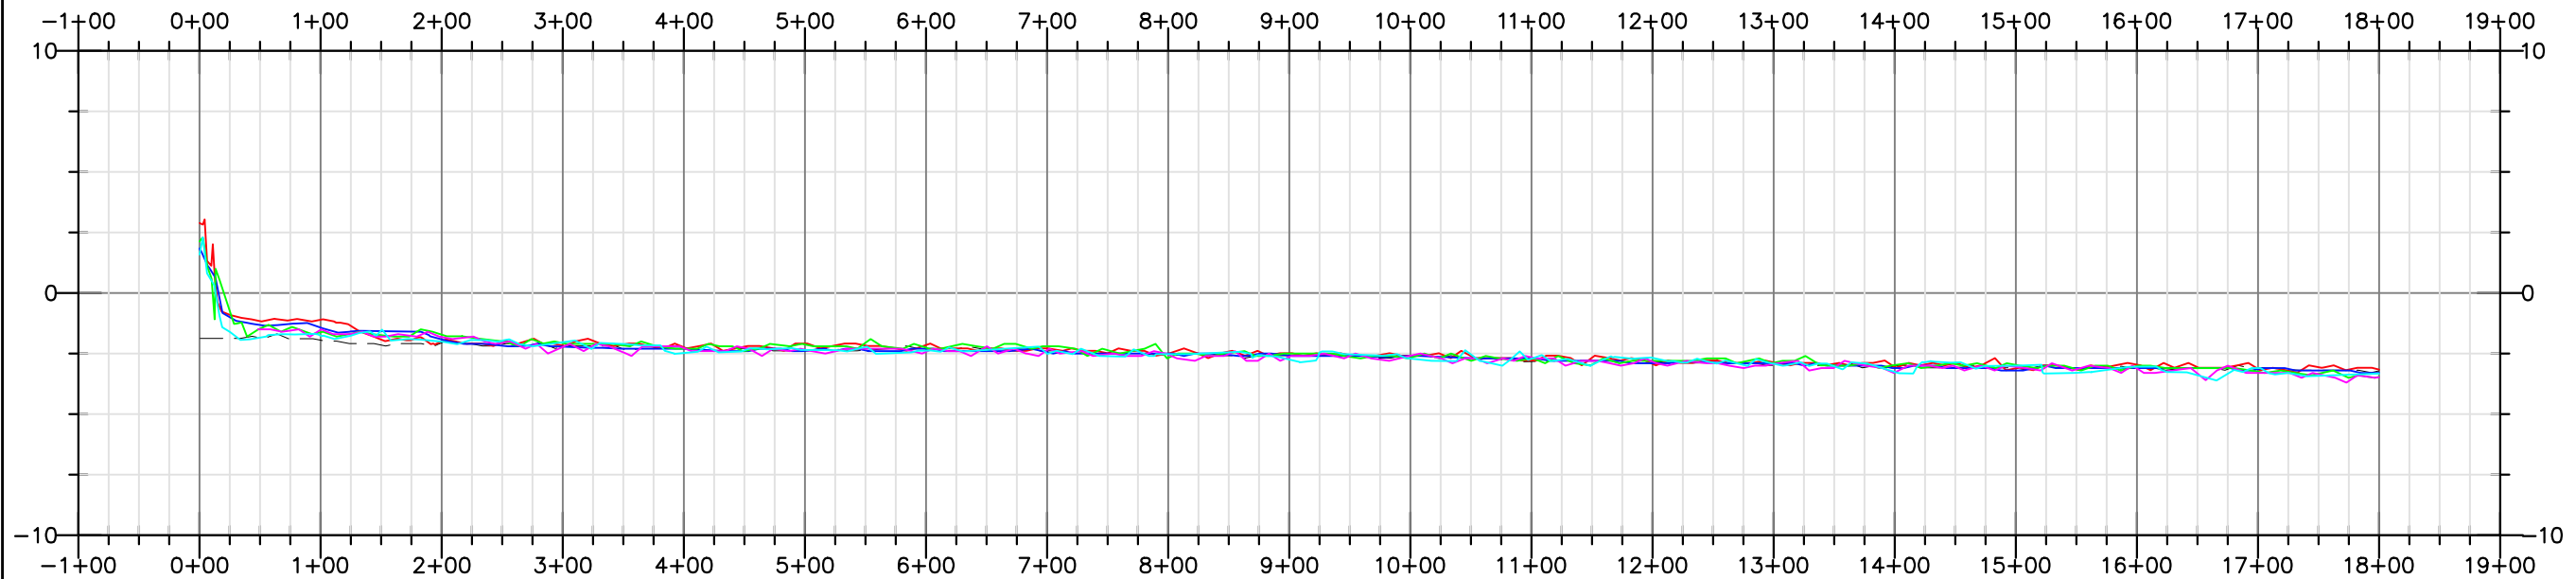
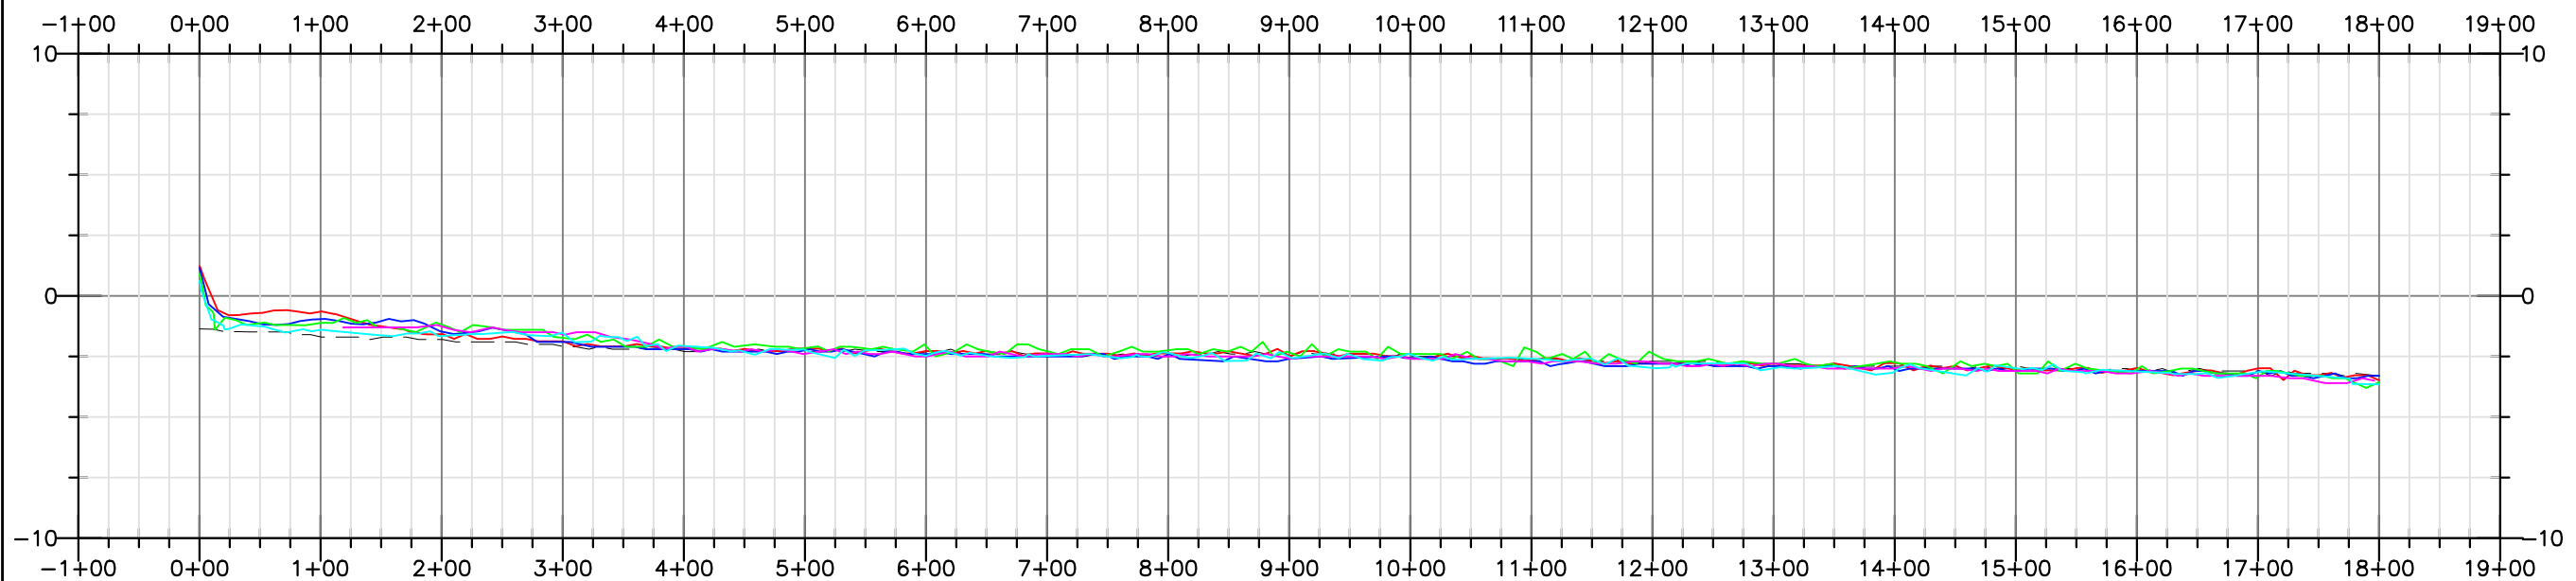
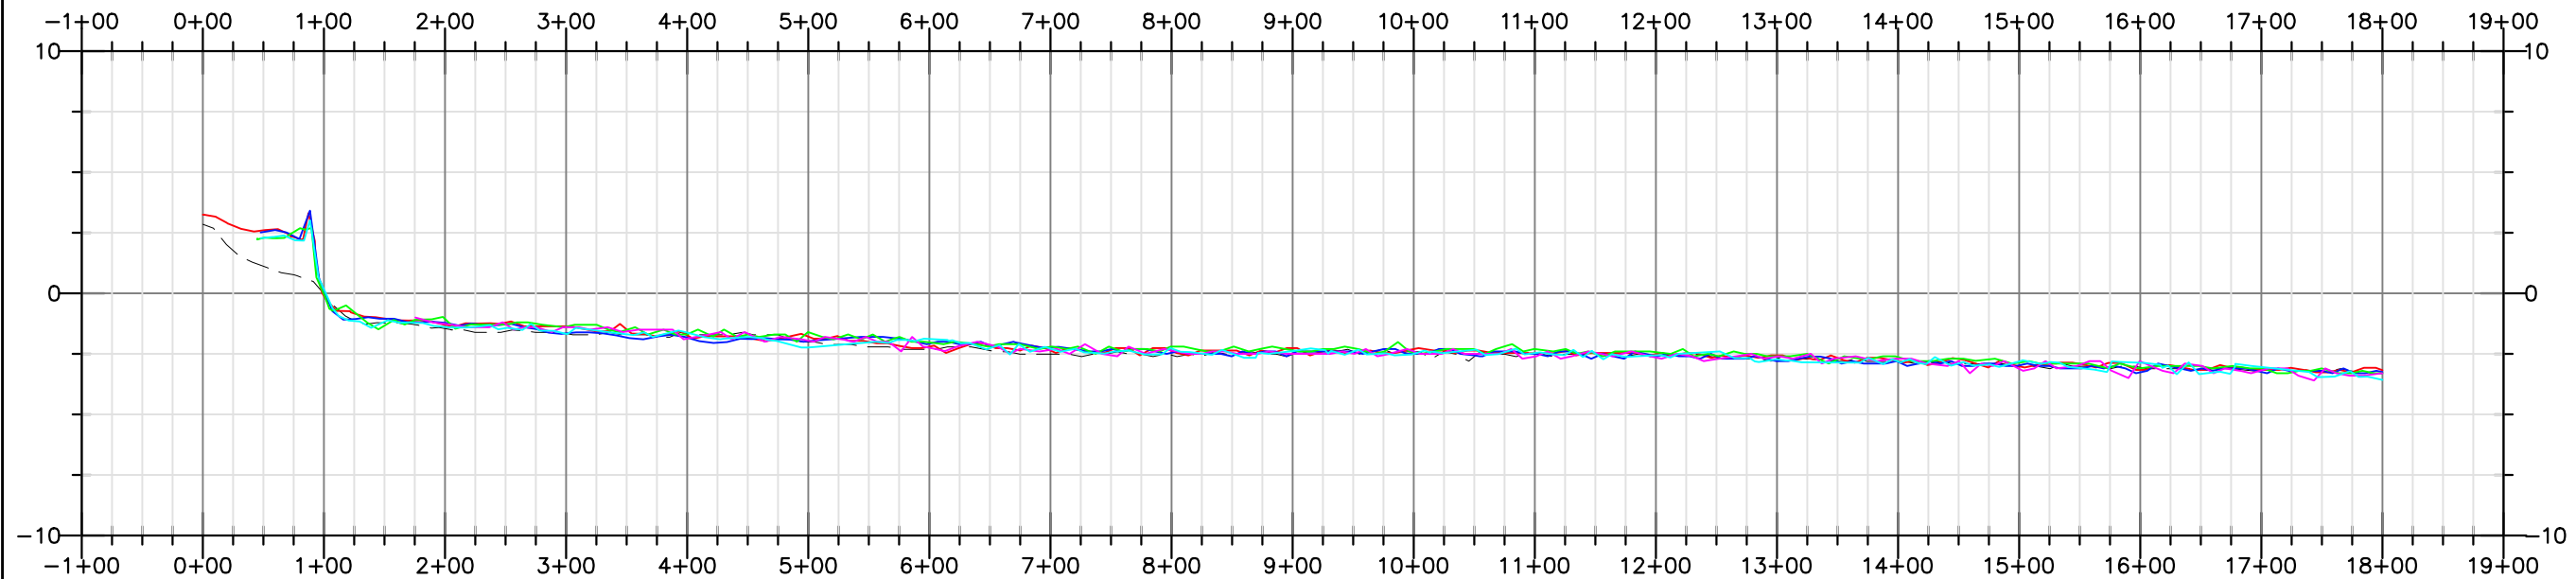
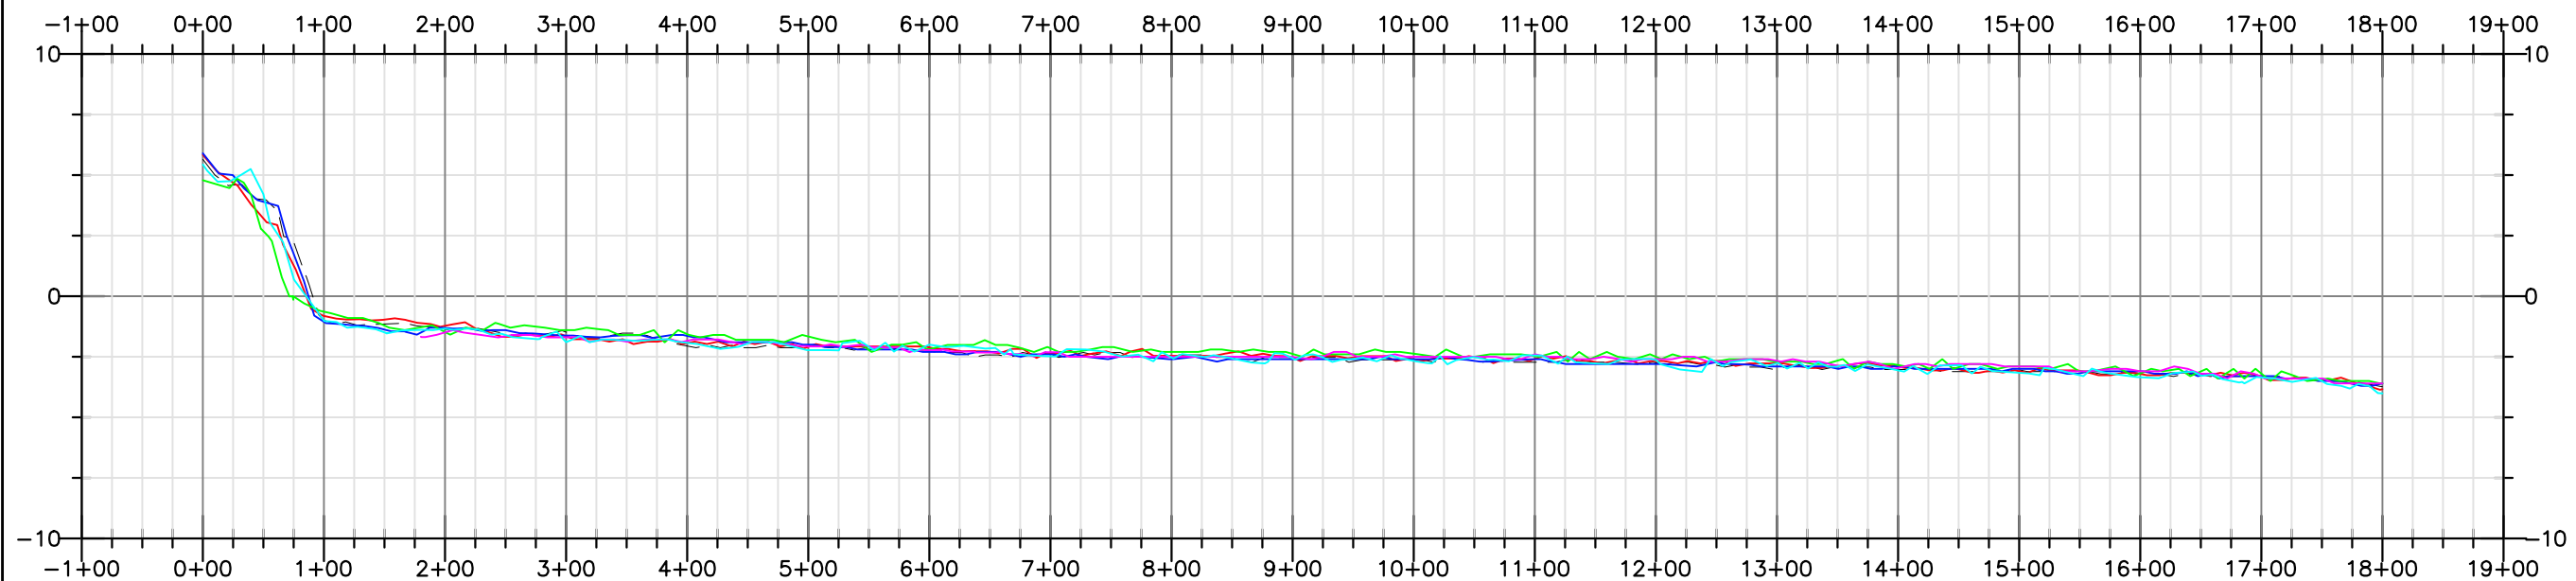
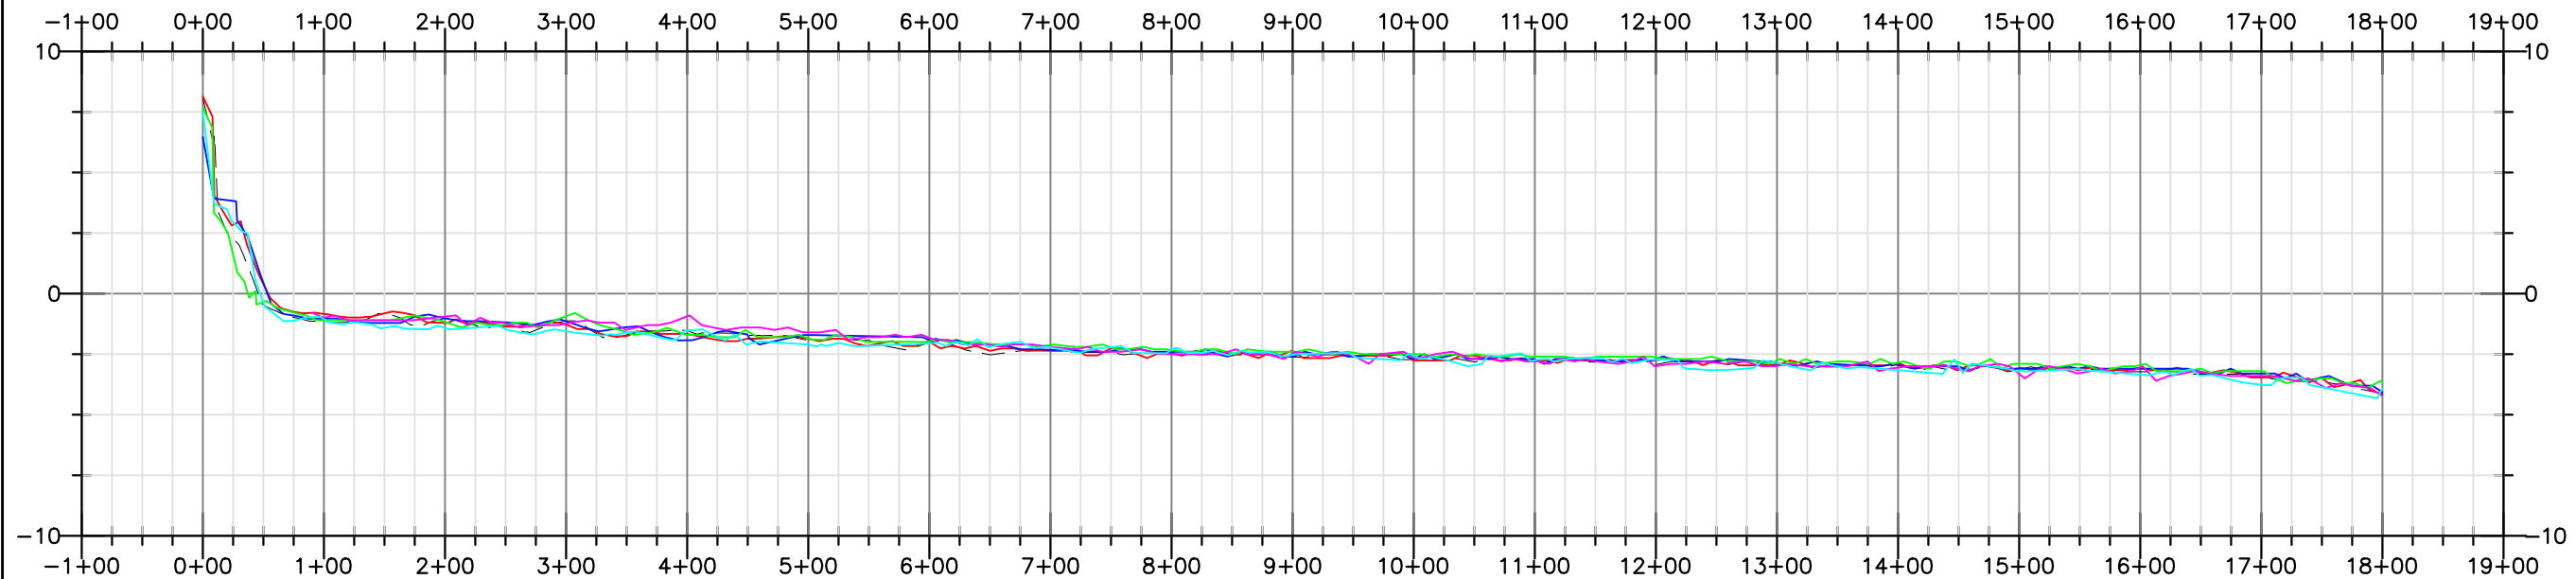
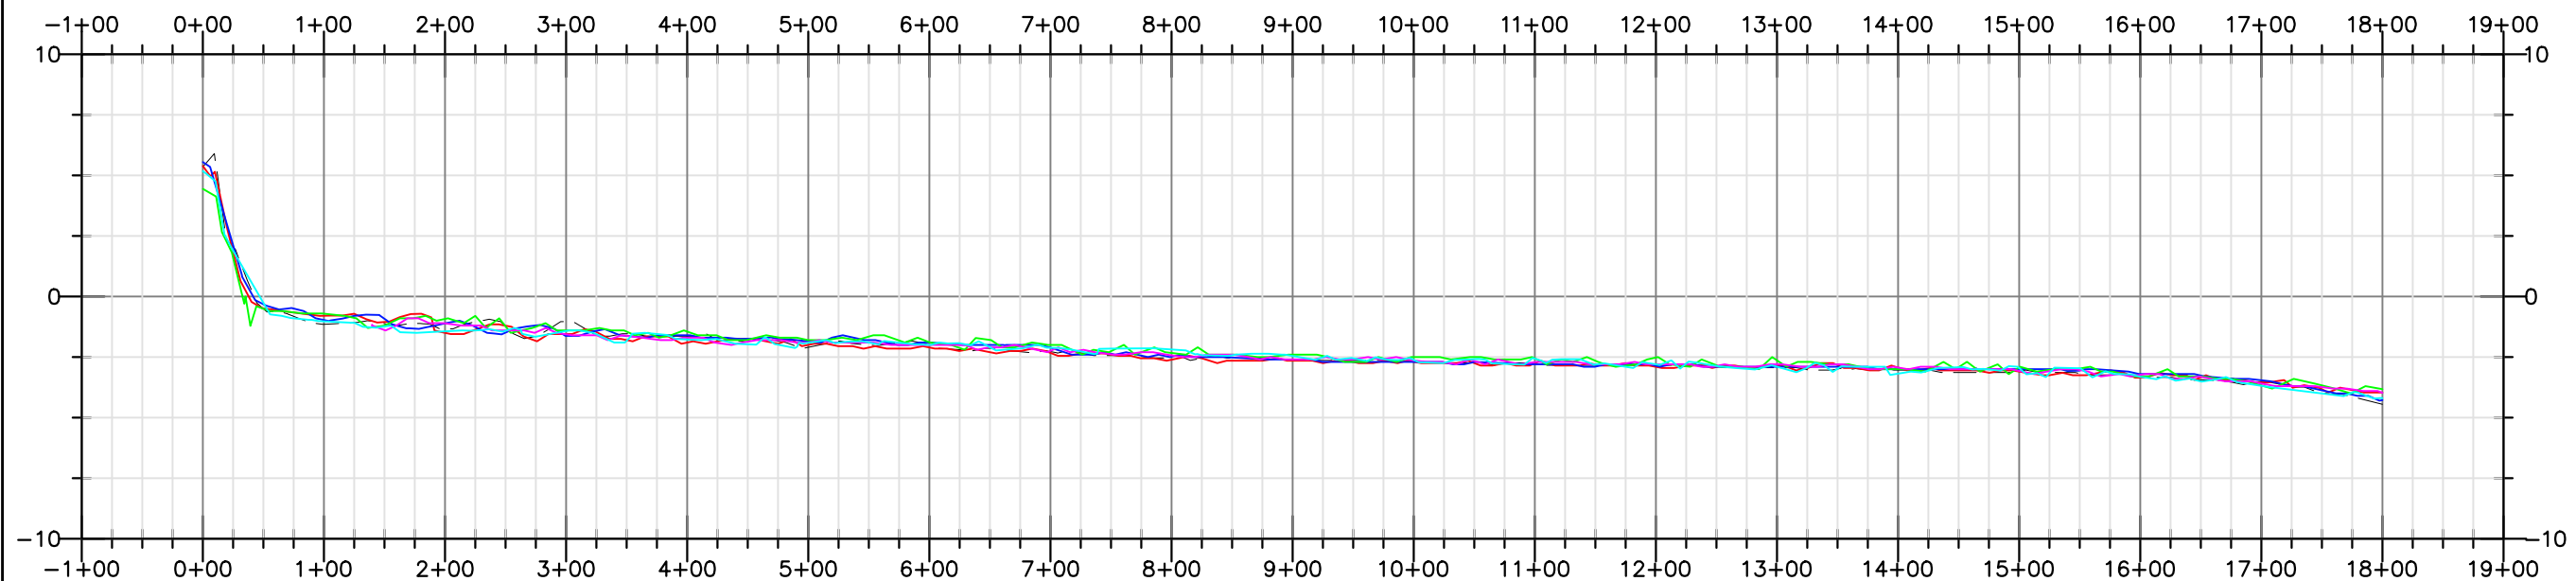
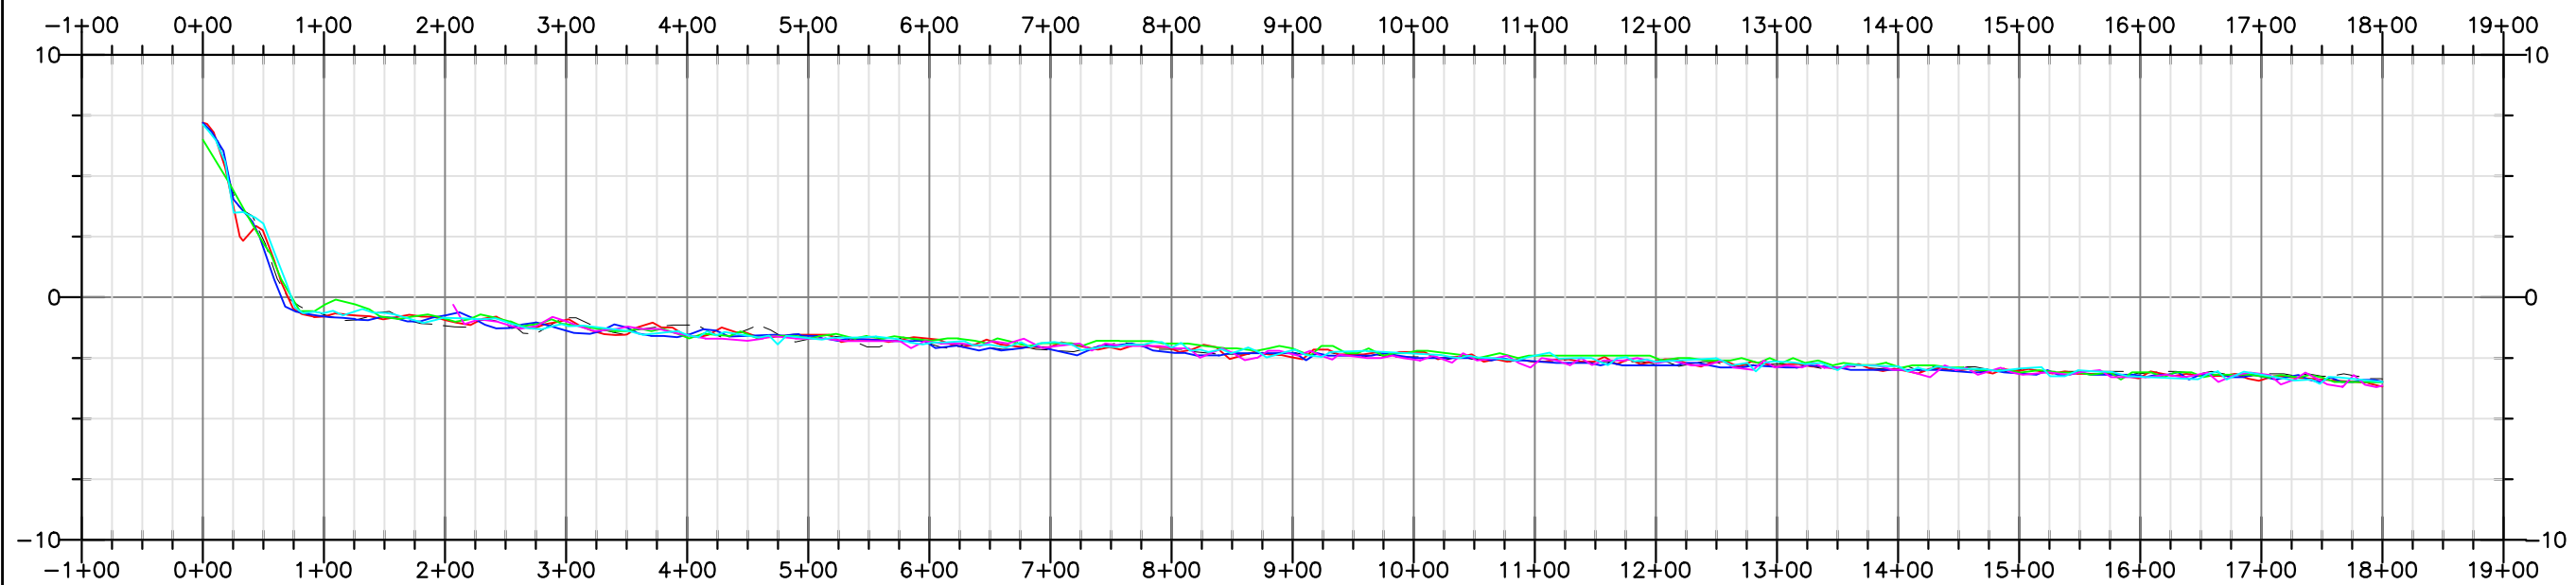
A review of the transects {June 2016, June 2018, October 2019, October 2020 (post Hurricane Sally), November 2020 (post Hurricane Zeta), and February 2022} adjacent to and south of the marsh restoration construction indicated no discernable bottom changes (Appendix A).
