Report of Findings

Prichard Drainage Study Toulmin Springs Branch and Gum Tree Branch

For
**Mobile Bay National Estuary Program
Mobile County Commission
Project No. MCP-101-15**

May 2016

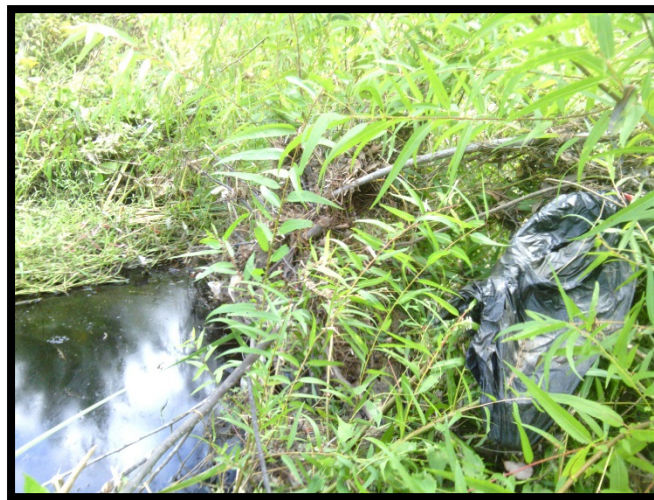
Figure 3.1 – Between S Leeds Avenue and I-65

Toulmin Springs Branch has several concentrated areas of concern. The section between South Leeds Avenue and I-65 is heavily vegetated. Field investigators observed ponded water upstream due to sediment and debris traps downstream, and possible grading issues. Based on aerial photography, the section between I-65 and Hinson Avenue appears to have been a sloped concrete channel (or similar material) in the past, but heavy vegetation growth has narrowed its footprint preventing proper drainage through this section.

To simplify analysis and understanding of the Toulmin Springs Branch *project* area, it has been divided into three sections (Figures 6.1-6.8). The northern section is an earthen channel from South Leeds Avenue to Hinson Avenue. This section is classified by heavy vegetation that constricts flow with the potential to cause upstream flooding northwest of I-65. The channel is partially defined through this section, but could alter without regular maintenance. This section would highly benefit from short-term improvements that include removal of all overgrown vegetation and sediment accumulation. All invasive vegetation species, such as Chinese Tallow (*Triadica sebifera*), should be removed along this section as well.

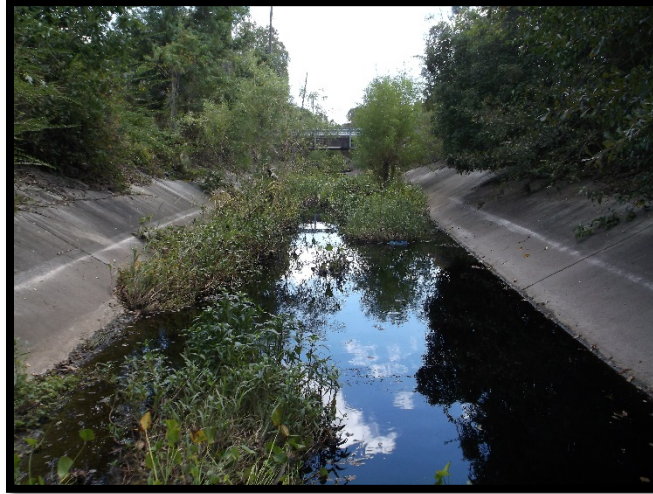
Figure 3.2 – Hinson Avenue looking south

From Hinson Avenue to South Thomas Avenue the channel is a trapezoidal concrete ditch. This section has vegetation growing through sections of concrete that will ultimately cause a shortened life span if maintenance is neglected. The concrete ditch has a 12-foot wide bottom, 22-foot wide top, and is 5.5 feet in height.

The second section identified can be classified as a concrete ditch from Hinson Avenue to just south of Wilson Avenue. The concrete channel routinely increases in geometrical size as more stormwater flow is received from various outfall locations. There are several concrete areas in this section that are recommended for long-term improvements to damage caused by improper maintenance and erosion. LID, such as replacement of concrete with rock and sand bottomed conveyances, should be considered at each of the damaged sections before repairs are made.

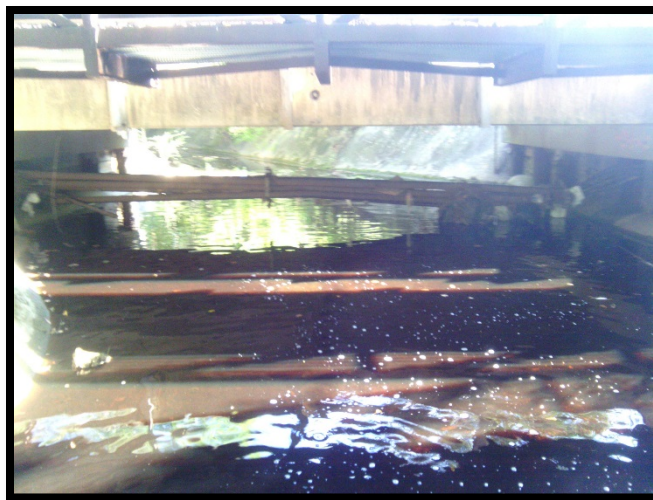
Figure 3.3 - Garrison Avenue Bridge

Several bridges have utilities that pass under them, directly in the way of water flow, which cause debris to accumulate at these locations. Areas that have extensive debris caught under the bridge are noted in the summary of findings tables in Appendix A.

Depending on the stability of concrete channel downstream, replacement of the damaged concrete with new concrete may be the most structurally sound alternative. Utility crossings under bridges in this section serve as collection points for debris and constrict the channel. Typically, the utilities crossed one foot to three feet above the bottom of the ditch, ultimately catching debris flowing in the channel. These areas should receive regular maintenance to remove trapped debris. Relocation of these utilities would have long-term benefits in this section of the branch. Another obstacle hindering stormwater flow is the skew of several bridges throughout the length of the branch. Some bridges are skewed more than 30 degrees, reducing the amount of flow that can be conveyed from upstream to downstream. Locations where this occurs have been identified in Figures 6.1 through 6.8 (Section 6). NSI recommends that channel approaches and bridge skew be addressed if any of the identified bridges are to be replaced in the future.

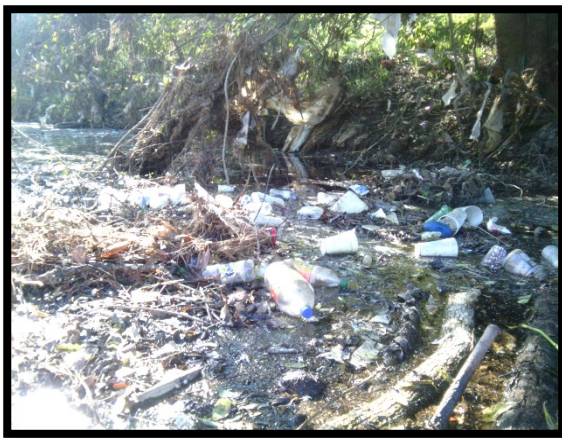
Figure 3.4 - 400 Feet southeast of Wilson Avenue

Just downstream from South Wilson Avenue, the concrete section ends, and Toulmin Springs Branch returns to an earthen channel through its intersection with Three Mile Creek. This portion has experienced obvious erosion, ponding due to misplaced riprap, heavy vegetation growth, and large amounts of debris deposits. Field investigators determined ponding was largely found around the bridge at South Craft Highway, where riprap has been placed. Investigators also noted leaves caught in residential fences on top of the bank of Toulmin Springs Branch, which indicated constricted flow in the channel, causing flash flooding impacts to this area during inclement weather events. Removing debris and vegetation downstream may relieve much of the congestion upstream.

The southern third section of Toulmin Springs Branch, from Wilson Avenue to Three Mile Creek, is an earthen channel that seems to have accumulated much of the debris from the concrete section. Overgrown, heavy vegetation serves as a collection point for debris flowing through the channel. Short-term recommendations for this section include maintenance of the channel through routine removal of overgrown vegetation and debris. Should routine maintenance not reduce debris accumulation and flash flooding in adjacent residential areas, long-term improvements to the stream should be considered. LID rock and sand bottom conveyances could be constructed to transfer some surface water flow to groundwater flow and allow for increased stormwater flow rates. Cost estimates for this type of structure are provided for approximately 2,300 linear feet. Should this course of action not be feasible or in the best interest of the City and its residents, estimates for concrete ditch conversion are provided as well. The remainder of Toulmin Springs Branch as a natural channel until its intersection with Three Mile Creek should be routinely cleared of debris and overgrown and invasive vegetation.

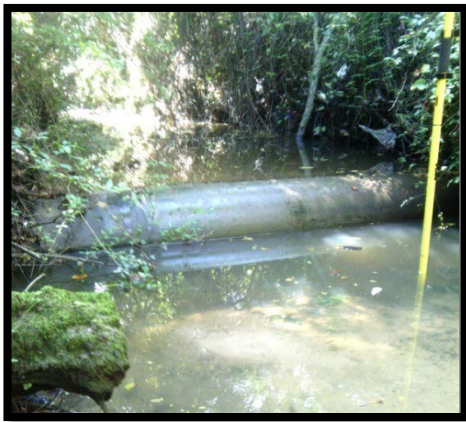
Figure 4.1 - Between West Main Street & West Turner Road

Gum Tree Branch contains multiple restrictions along the length of the project area. Most of the culverts, mainly pipe culverts, are deteriorating due to age and wear. Most of the first section of Gum Tree Branch has low water levels, indicating sufficient grading in this area of the creek. A portion from Thompson Boulevard to I-65 narrows and is deep throughout, when observed at normal flow conditions. The increased water depth in this area is most likely due to damming by riprap at the bridge on Thompson Boulevard.

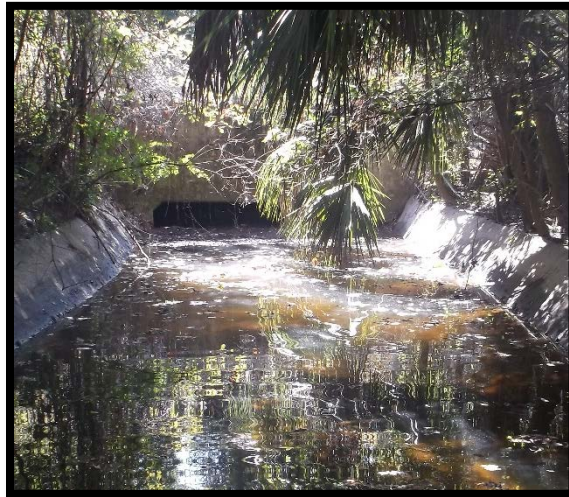
Figure 4.4 - Culvert at Whistler Street

Field investigators also observed heavy sediment accumulation between East Turner Road and Whistler Street. While this is a relatively short portion of the branch, it has caused upstream damming noted by the limited freeboard of adjacent box culverts.

Several road crossing culverts have been identified to potentially limit flow and cause upstream flooding. Culverts can vary in construction cost due to size, material, and placement. In order to provide an accurate cost estimate, further analysis and design work would be needed. A preliminary estimate of construction improvements can be found in Tables 5.5 and 5.6.
