THEODORE SHIP CHANNEL PROJECT

Historical Report

MARCH 1987

THEODORE SHIP CHANNEL PROJECT
MOBILE, ALABAMA
DESIGN, CONSTRUCTION AND MAINTENANCE

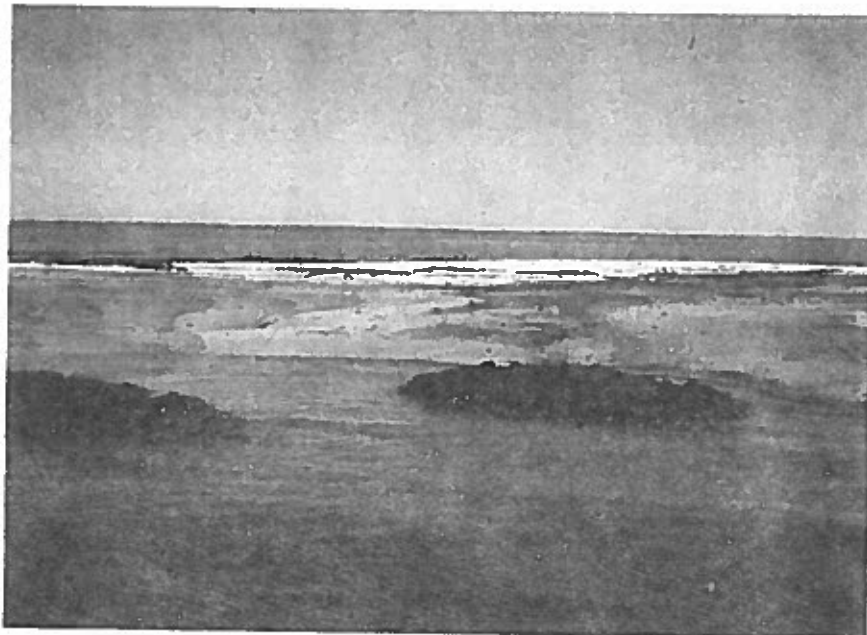
Photo - 6

Mud waves around perimeter of emergent disposal island; produced by displacement of soft bottom materials.

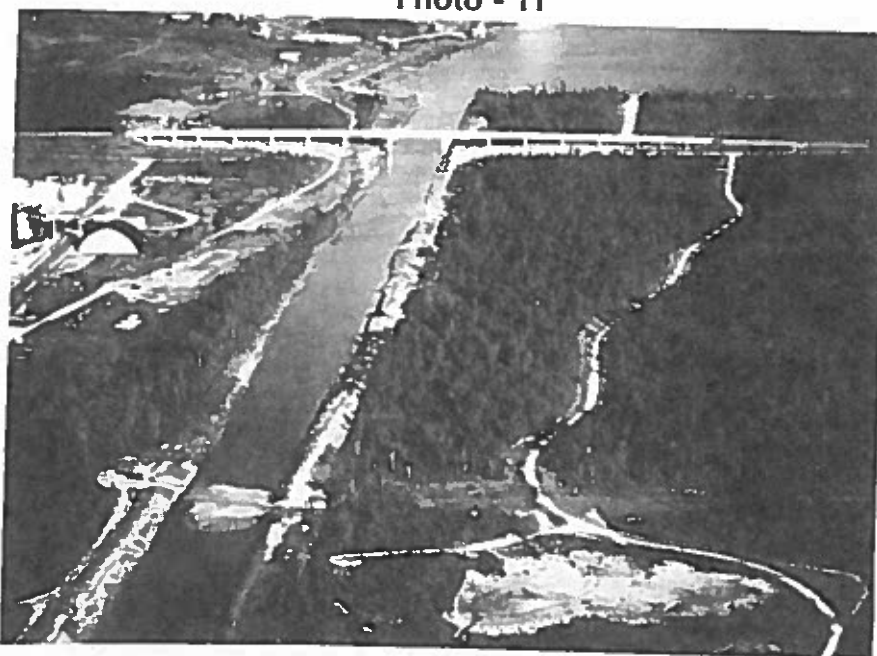
Photo - 11

72. Unfortunately, on 18 May 1980, within six months of construction completion, a storm which exceeded the design storm occurred and all of the structures suffered damage to some degree. The largest structure, located on the south side at Station 38+70, was apparently flanked by the excessive flow and completely washed out. The eroded material formed a bar in the canal which almost closed it. The other structures were undermined to some degree at the lower edge of the sack riprap. The damage can be directly attributed to the greater than design storm but in hindsight, it can probably be stated that the structures would probably have failed eventually anyway, if not from storm runoff then probably from wake and propeller wash as traffic developed on the canal. The extreme erodibility of the sandy soils in the canal cut was underestimated and the sack riprap forming the flumes was terminated at too high above the toe of the slope. This will be treated further under Lessons Learned.

Aerial view of barge canal showing washed out drainage structure at Station 38+70, south side.

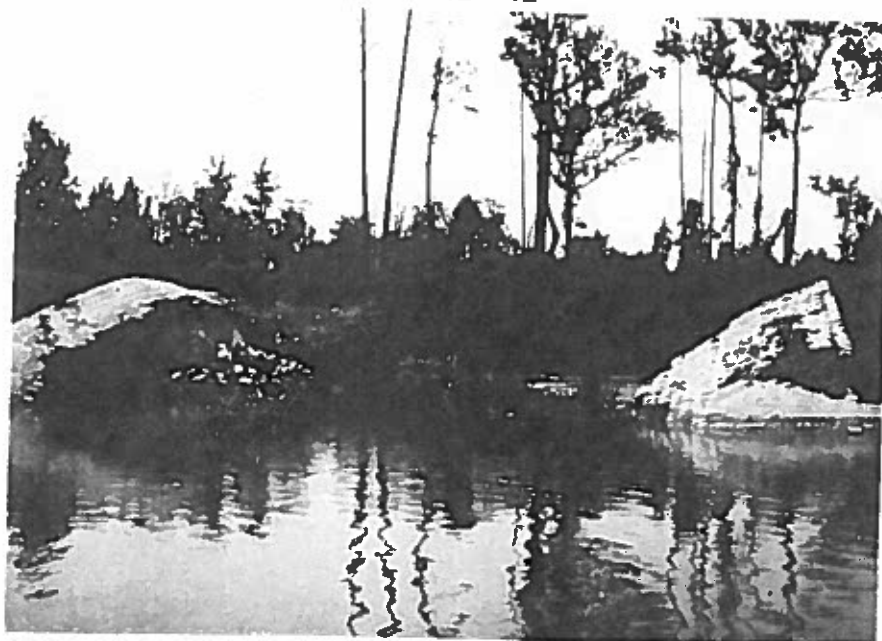
Photo - 12

156. Damage to the drainage structures is discussed in paragraph 72 and repairs are discussed in paragraph 116. The large structure at Station 38+70 failed completely with not enough remaining to allow speculation on

the mode of failure. The ones which were damaged but remained, probably provided the best evidence. In all cases the sack riprap apron was undermined indicating a progressive failure by undermining and sloughing. In any case the structures were apparently too fragile to withstand the flow which occurred.

Close up view of washed out drainage structure at Station 38+70.

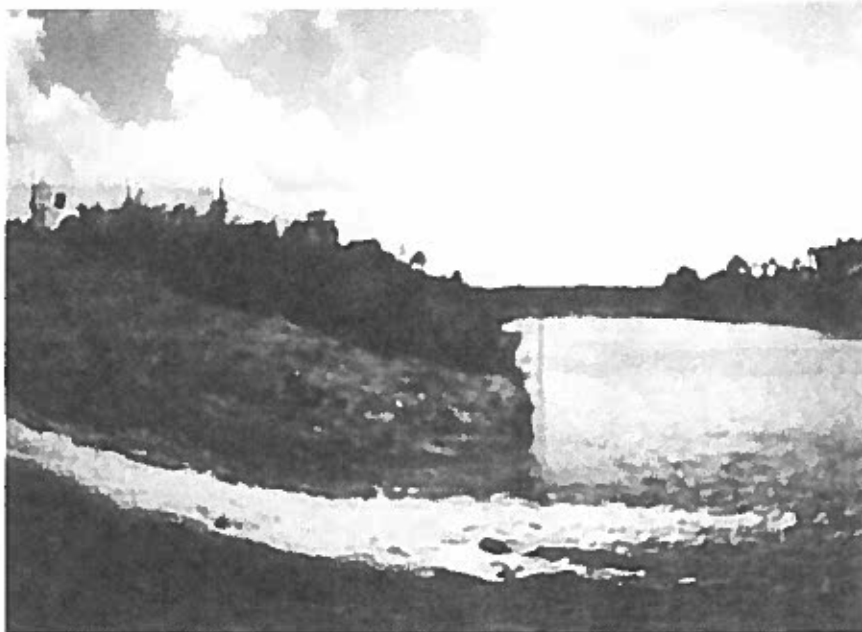
Photo - 13

Restoration and replacement of drainage structure at Station 38+70.

116. A contract was awarded in January 1983 to repair the damage caused by the May 1980 storm. The contract amount was \$375,851 and covered the replacement of the washed-out drainage structure at Station 38+70 (photo 13), upgrading of four others, restoration and lining of collector ditches, grading and sodding of five badly eroded areas in the canal slopes and seeding and mulching other disturbed areas. The washed-out structure was replaced with one of a different design which should be much more durable. It was continuous steel sheet pile wall driven at the waters edge with a grouted riprap flume sloping up from the sheet pile to a 10 foot wide crest at elevation 10. It also has a grouted riprap back slope which extends down to the ditch bottom at elevation 0, forming a dam. Ten feet of water is impounded behind the dam which serves as a settling basin for sediments carried by the ditch which can be cleaned out with a dragline. A considerable quantity of seepage is passing through and under the dam and is exiting at concentrated points behind the sheet pile wall. It was running clear when observed and is probably concentrated because of the limited openings through the grouted riprap rather than because of piping through the sand fill. All of the structures should be closely observed, however, and if piping is detected drains should be drilled through the grouted riprap and filtered well screens installed. At the other four drainage structures a sheet pile wall was added at the waterline and the remaining sack riprap was grouted. Collector ditches which were eroded by the storm were restored to lines and grades and paved with grouted riprap and/or sod. The five gullied areas in the canal slopes were restored to grade with compacted backfill, topsoiled, and solid sodded.

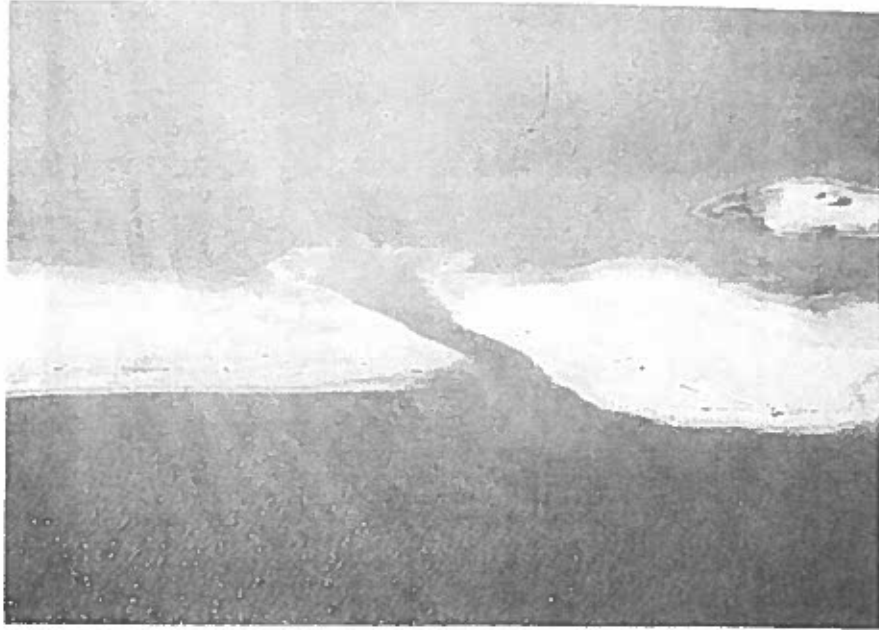
Photo - 15

119. Dike Raising. From the comparison of as-built dike dimensions given in paragraph 109, it is evident that the east leg received the least amount of material. A number of cross sections showed the crest elevation to be only slightly above +4 and the entire leg only averaged 6.2. The high rate of settlement plus rapid erosion of the sandy crest, both from water and wind, caused it to recede rapidly. On the south leg, between Stations 50+00 and 60+00 where the gap was left in the dike to permit barge/haul traffic, the contractor encountered difficulty in getting the dike up to grade. There had been recent and extensive shell dredging in the dike foundation, leaving deep depressions. The gap was closed late in the contract with the lesser quality bay cut material and the result was a narrow dike section with a lower than average crest and steep slopes down to berms on either side not much above tide level. In February 1982 the dike was breached in this area. The mechanics of failure could not be reconstructed and it is not known for certain whether it overtopped from inside or out; but, considering the fact that it occurred in February when strong north winds prevail, it is likely that it occurred from the inside. With an extreme low tide level in the bay the head differential was likely in the range of 3 to 4 feet. This was sufficient to cause highly erosive velocities through the breach and it was washed out to -2 to -3 MLW and up to 25 feet wide. One of the earlier concerns was that if the dike breached, the soft material confined inside would run out. It was apparent after the break that the only material lost was that which had been eroded by the escaping water. The dust pan material adjacent to the break appeared quite stable.

East leg of island dike showing breach which occurred in spring 1982.

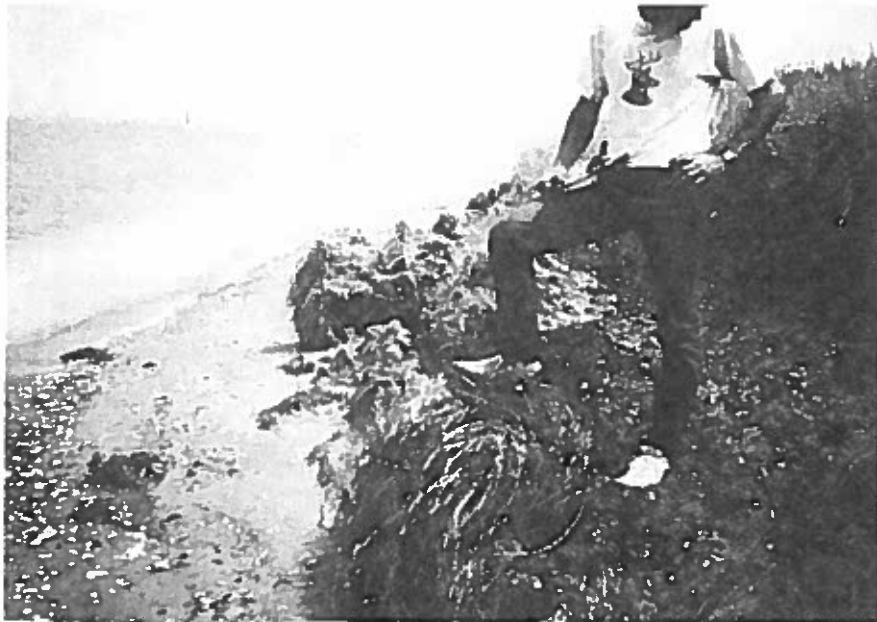
Photo - 16

126. The clay balls are composed of fat clay (CH), from soft to moderately firm in consistency, which are composed of up to 90% montmorillonite. In its natural state this clay, though weak in shear, is very sticky, tough, and resistant to erosion. When it is allowed to dry, however, and again comes in contact with water it practically dissolves. Wetting and drying, to some degree, takes place in the splash zone and this is the cause for deterioration of the clay rather than erosion in the usual sense. In one cycle -- consisting of a period of calm seas, low tides and good drying conditions, followed by high tides and wave action -- the loss of several inches can occur. The deterioration stops whenever there is sufficient sand mixed with the clay balls to form a protective veneer over the clay and maintain a constant water content. In fact, the area described above later received another layer of fill containing some sand and is now characterized by either a sand beach with no scarp or a beach up to elevation +2 to +3 in front of a clay ball scarp from 1 to 4 feet high (photo 16). The deterioration described above is continuing near the base of the scarp due to wave runup. It undermines the face and causes cracking and sloughing from above. The encroachment has slowed dramatically but continues at a rate which could probably not be tolerated over the long haul.

Island shoreline at northeast corner showing characteristic beach slope beneath a clay ball escarpment.

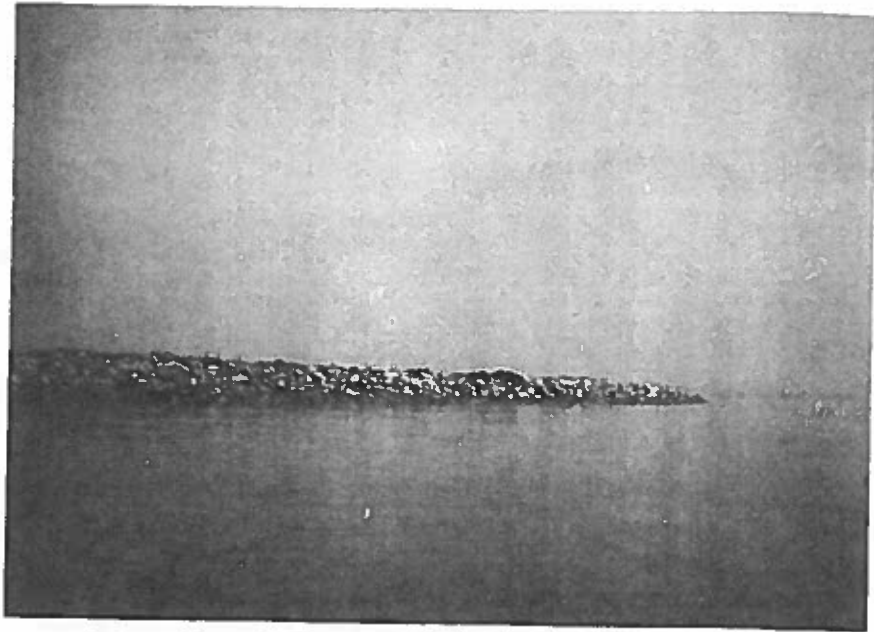
Photo - 17

133. The revetment test section was inspected on 29 August 1984, and the Types I, IA, II, IV and VI sections look good (photo 17). There remains a band of turbidity 50- to 75-feet wide beyond the riprap indication that some erosion is still occurring. This is probably a result of slope disturbance down slope from the riprap which hopefully will clear up when sorting is complete and a veneer of sand is reestablished. If it continues beyond a year or so it can possibly be taken as indicative of undermining of the riprap and would ultimately lead to failure.

Completed revetment test section at southeast corner of island.

134. Based on cost, performance to date, and constructability, it appears that Type I, or possibly Type IA, is probably the best of the sections installed. It is too early to compare the two but so far there is no apparent difference in performance. If the Type IA does not fail by undermining in the first two to three years it will be clearly advantageous over the others. By the end of that time it will be approaching the Type I in toe elevation due to settlement, and the riprap stone saved initially by the higher toe can be used to restore the top to grade. It appears that the governing principal here should be placement at the highest elevation that will withstand initial undermining since settlement is inevitable and the top elevation will have to be restored periodically.
