Pre-Restoration Stream Assessment for Schoolhouse Branch

Lower Fish River Watershed

April 17, 2024

Thompson Engineering (BVA Group)
Project No.: 23-1126-0013

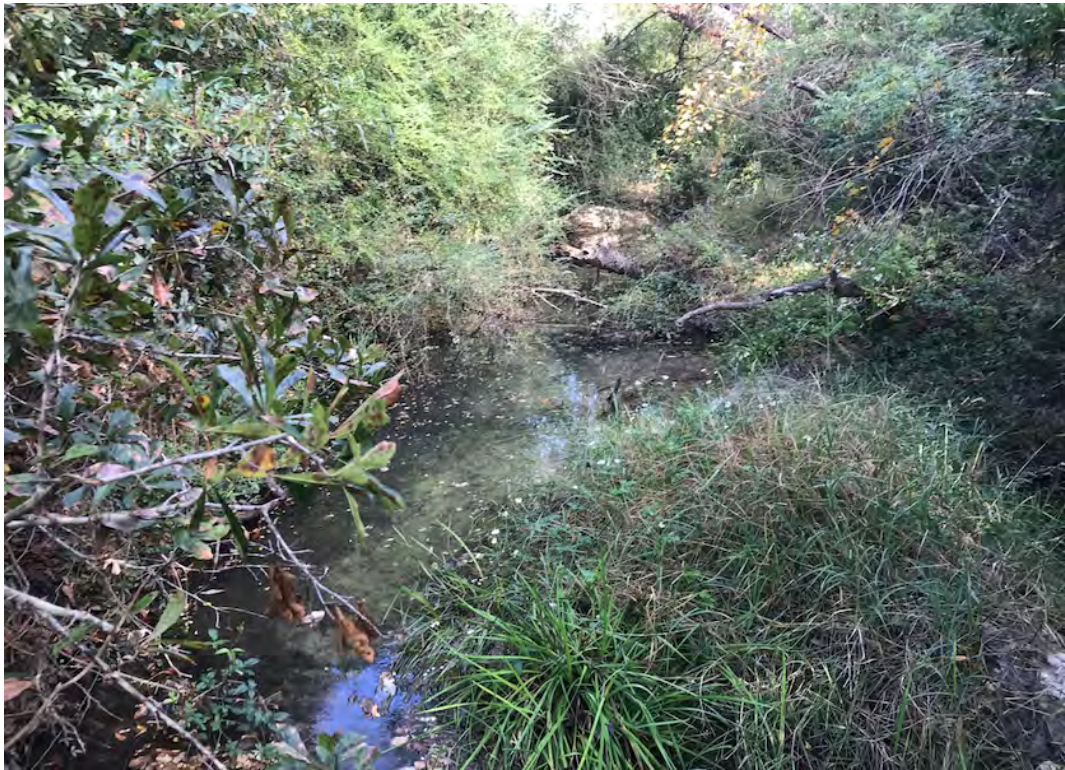
Photo B1. RSA1, upstream view near the top of the reach.

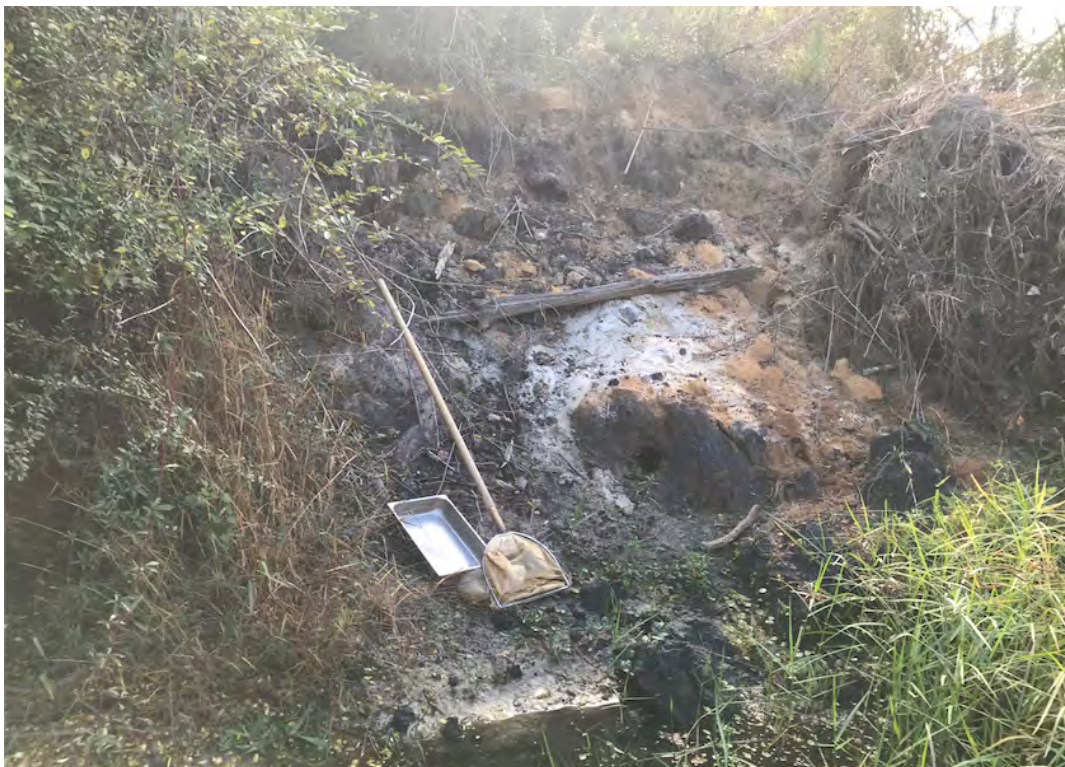
Photo B2. RSA1, downstream view, mid-transect.

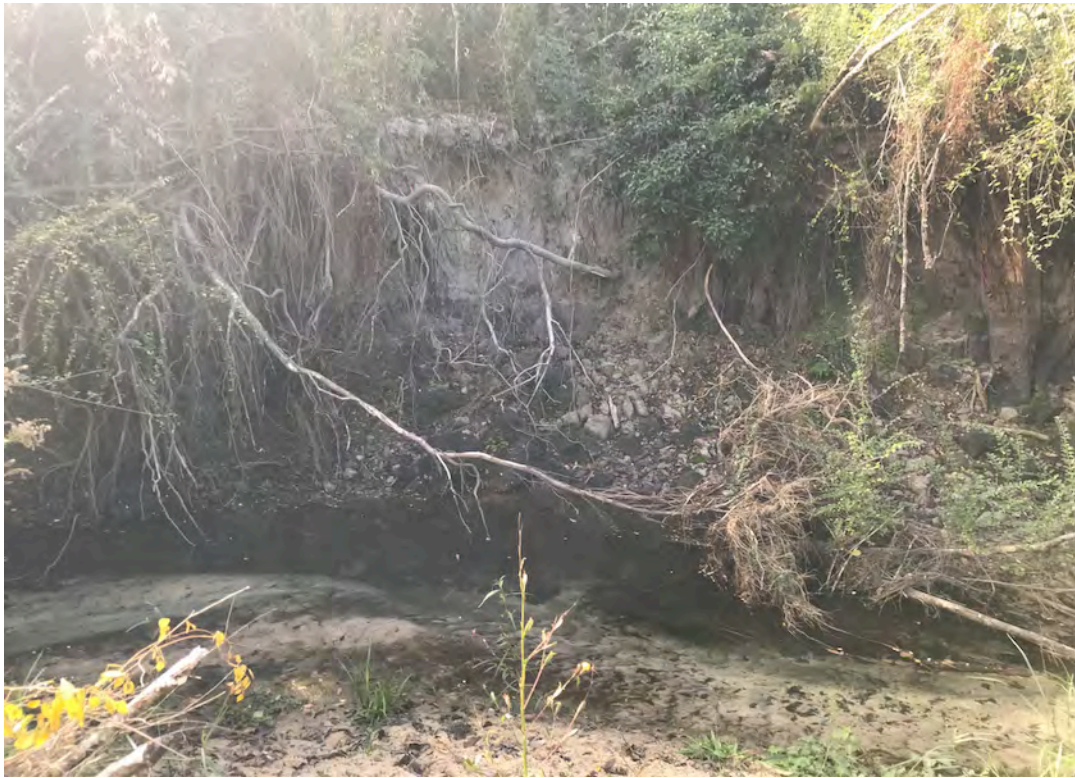
Photo B3. RSA1, downstream portion of the survey transect.

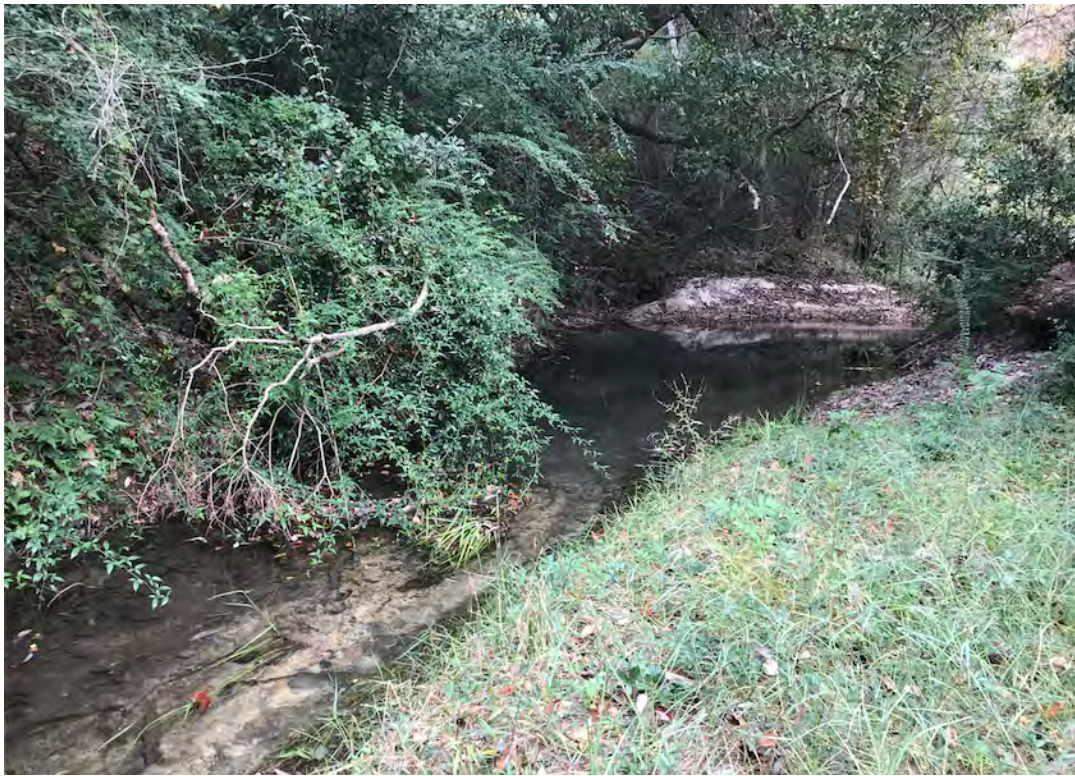
Photo B4. RSA2, uppermost portion of the survey transect.

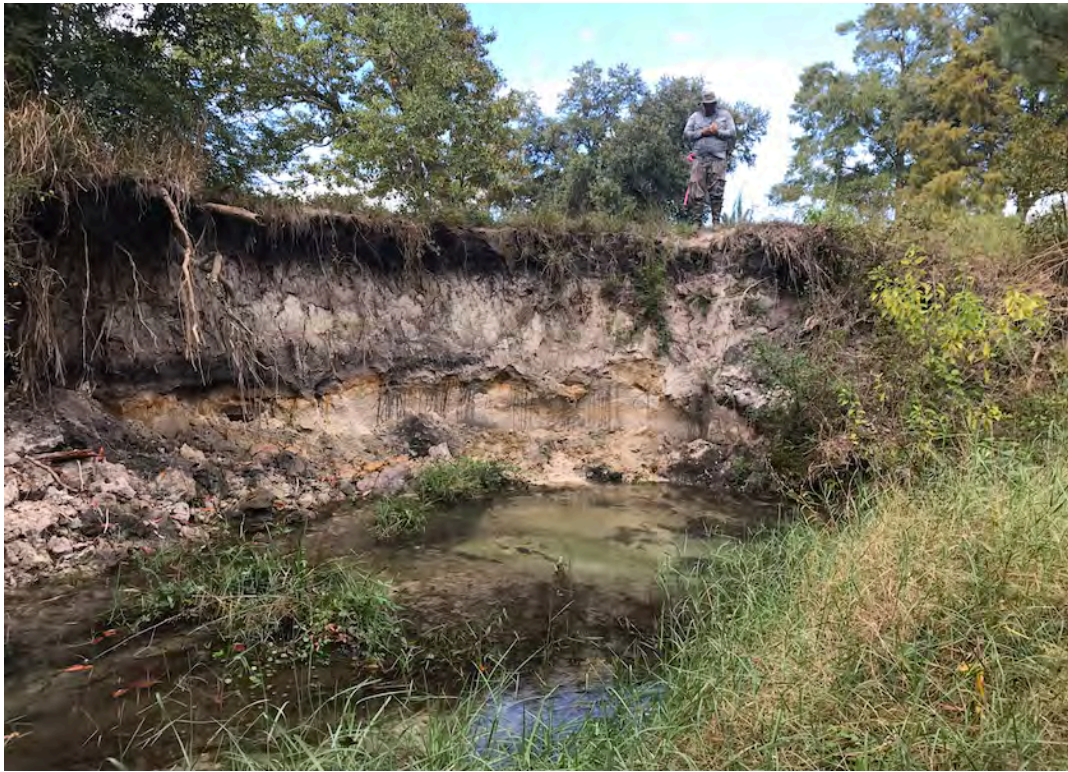
Photo B5. RSA2, approximate mid-point of the survey transect.

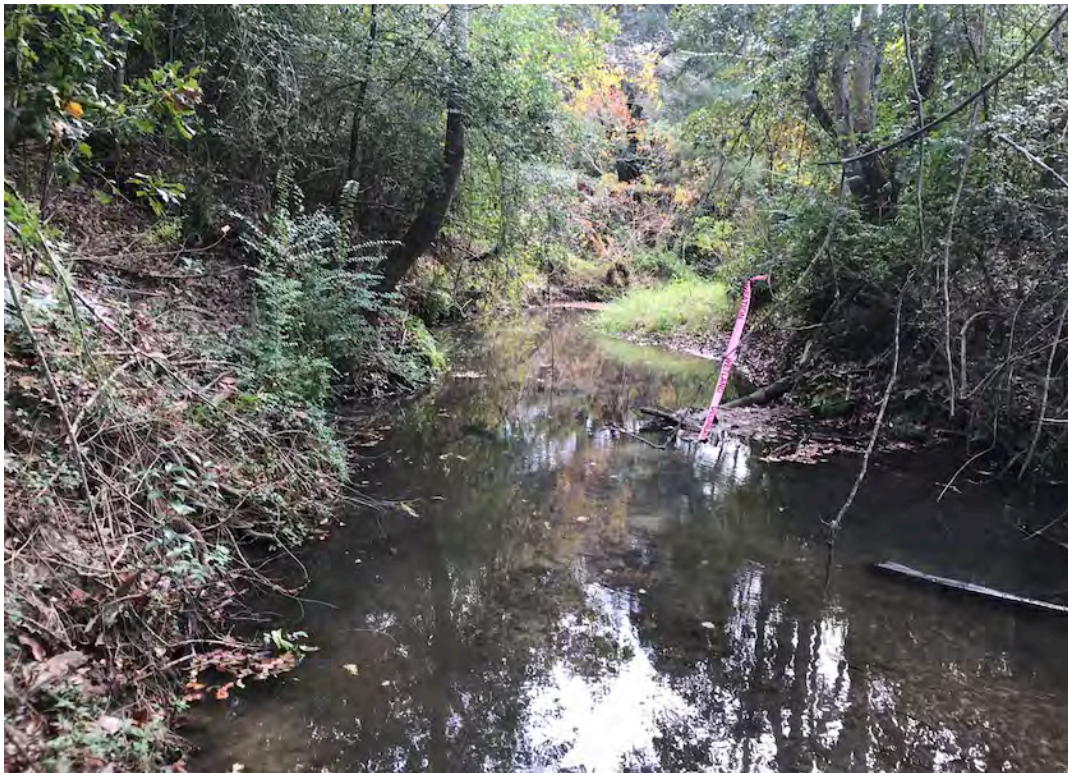
Photo B6. RSA2, downstream end of the survey transect.
