**WETLAND CONDITION EVALUATION:
D'OLIVE CREEK, TIAWASEE CREEK, AND JOE'S
BRANCH WATERSHEDS
(BALDWIN COUNTY, ALABAMA)**

Prepared for

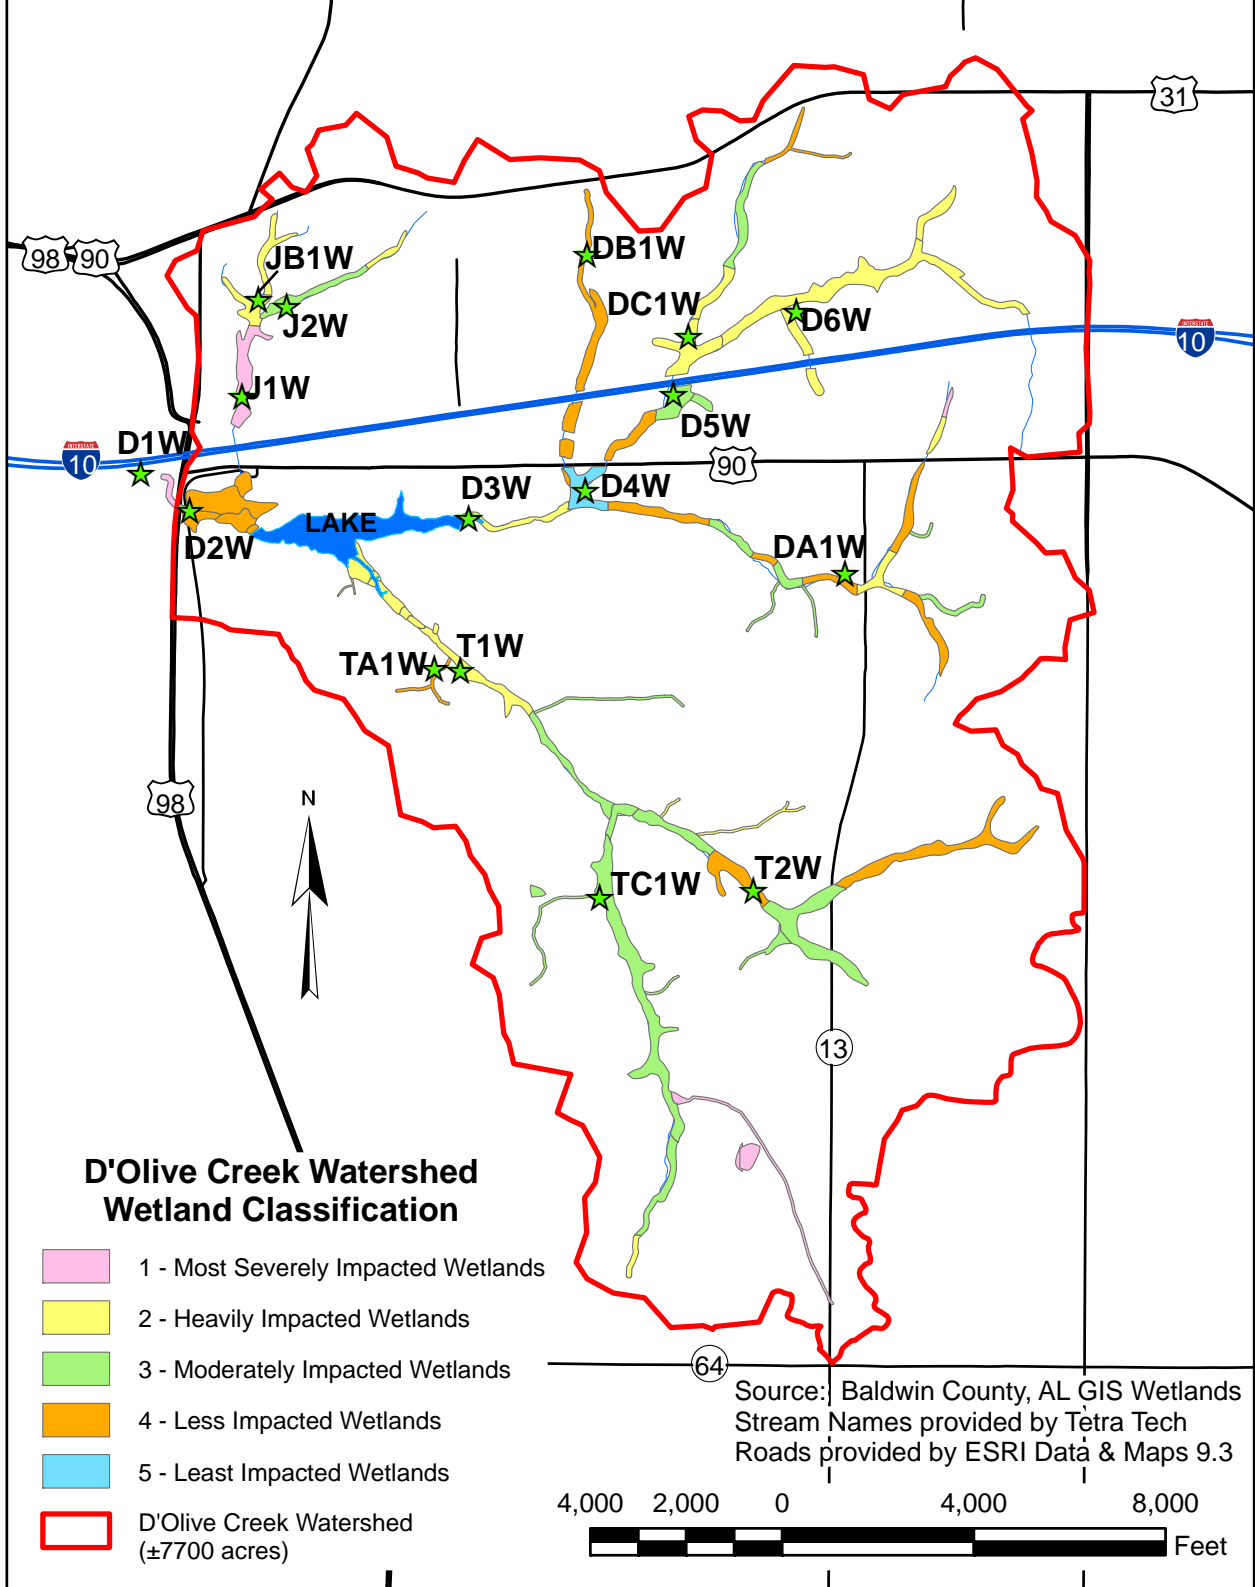
D'OLIVE CREEK WATERSHED, STREAM NAMES AND WETLAND CLASSIFICATION

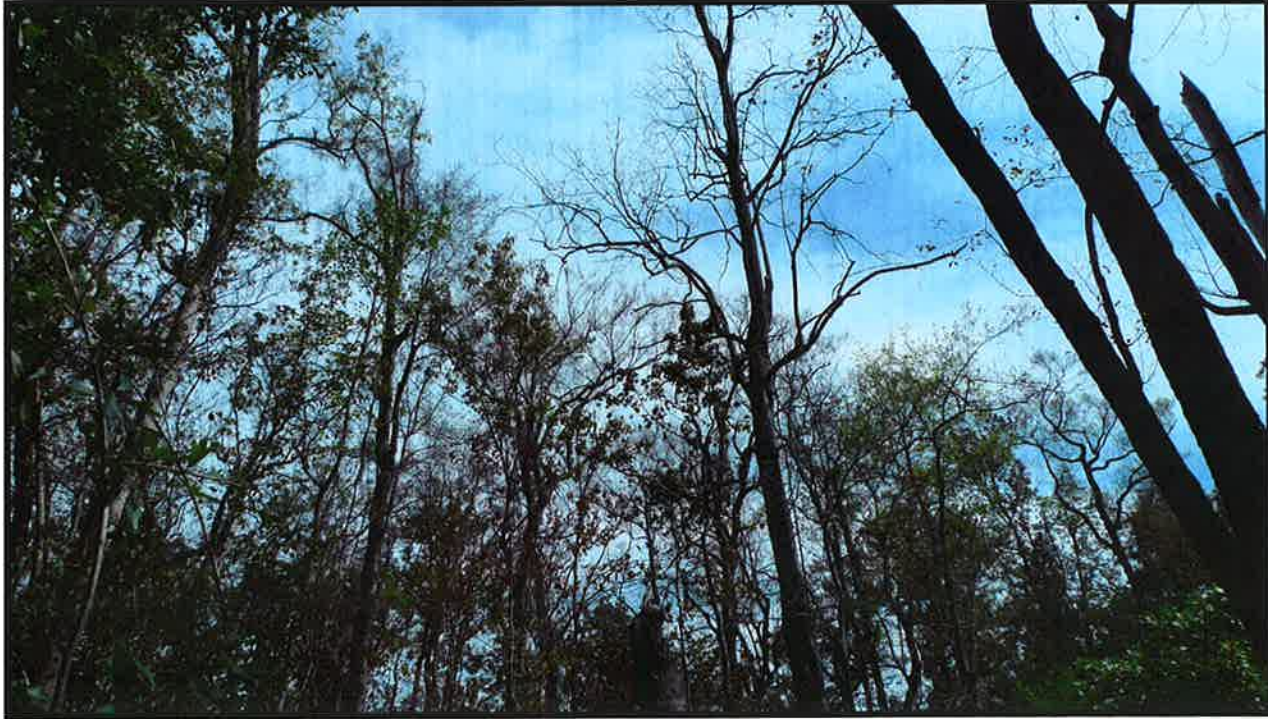
PHOTO 4: Taken from the same location as Photo 3, this angle shows the large openings in the canopy caused by tree death and/or defoliation.

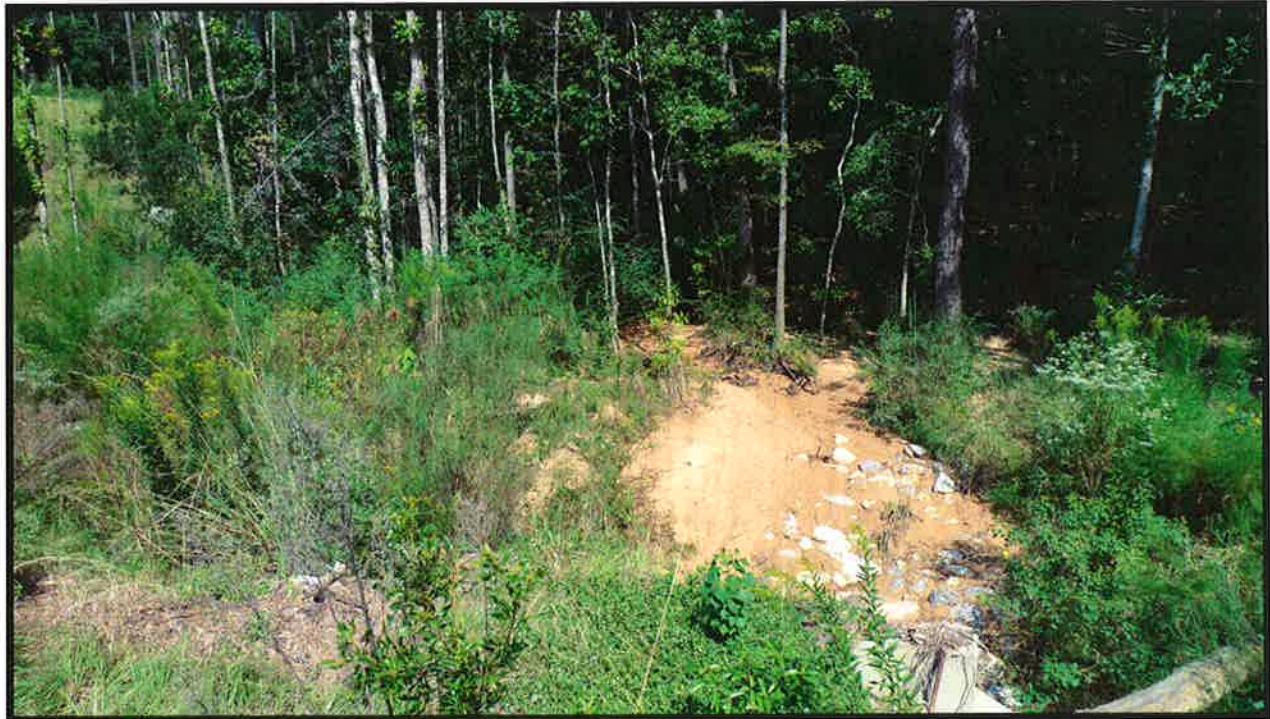
PHOTO 5: Site JB1W looking north. Most significant impact to this area was the heavy sediment deposit and resulting stress in some canopy trees.

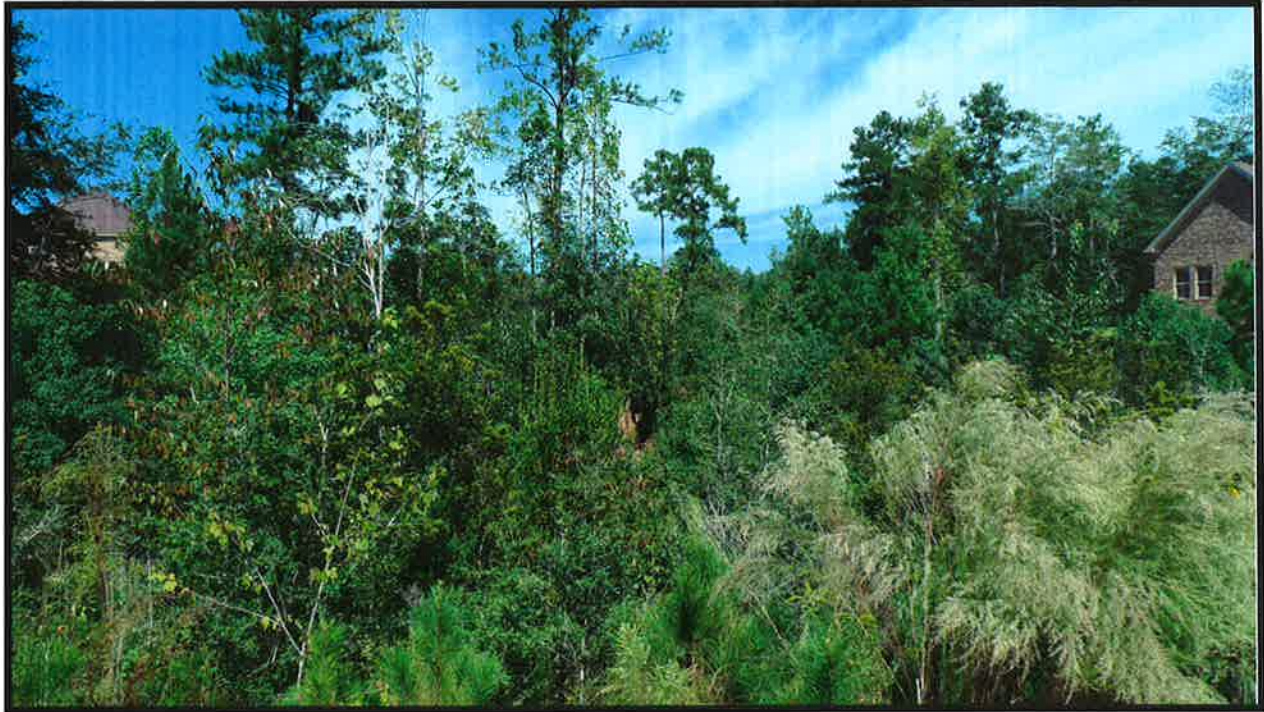
PHOTO 9: Site DC1W looking north. This view shows more clearly the damage done to the canopy of this wetland. The houses in the photo are located in the Timber Creek subdivision.

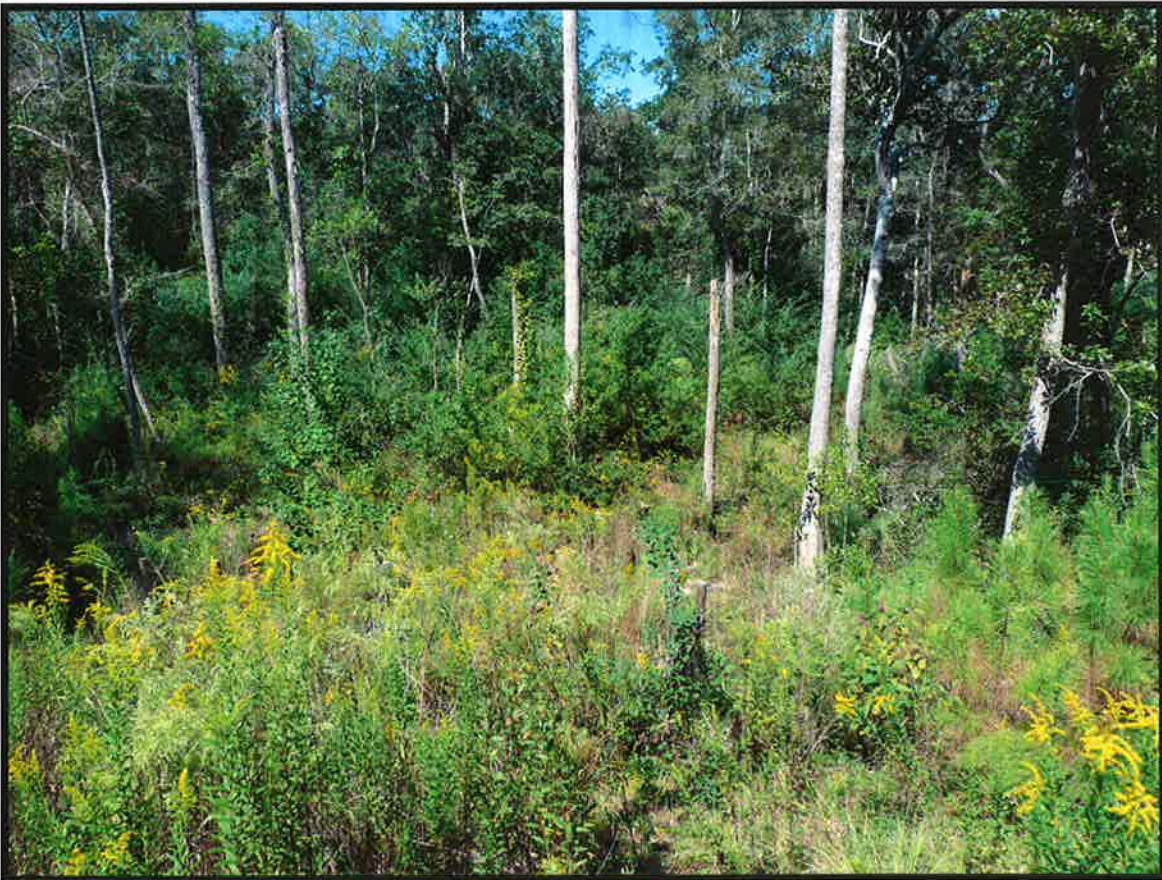
PHOTO 10: Site D6W looking north. Again, sedimentation has severely stressed the canopy and eliminated much of the native understory vegetation in this section of D'Olive Creek.
