Project Report

A Shoreline Assessment of the Upper Fish River

Prepared by:
The Alabama Coastal Foundation

For:
The Mobile Bay National Estuary Program

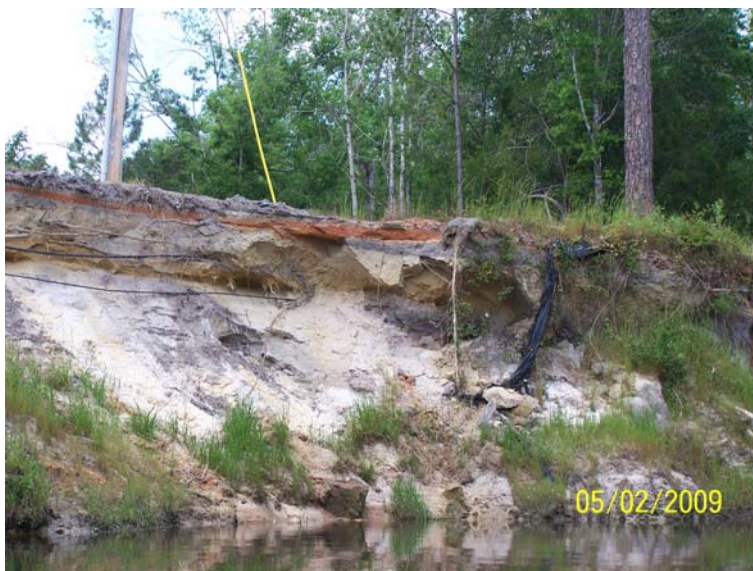
GPS: N 30°33°30.522, W 87°48.486

Description: CS3 - Sediment Fence in Disrepair
E2 - Moderate Erosion of Bank

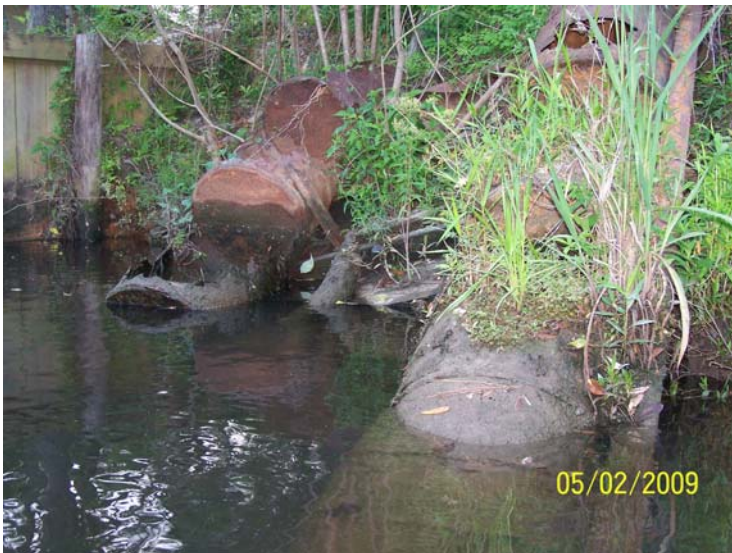
GPS: N 30°30.519, W 87°48.485

Description: Outfall – clear, no odor

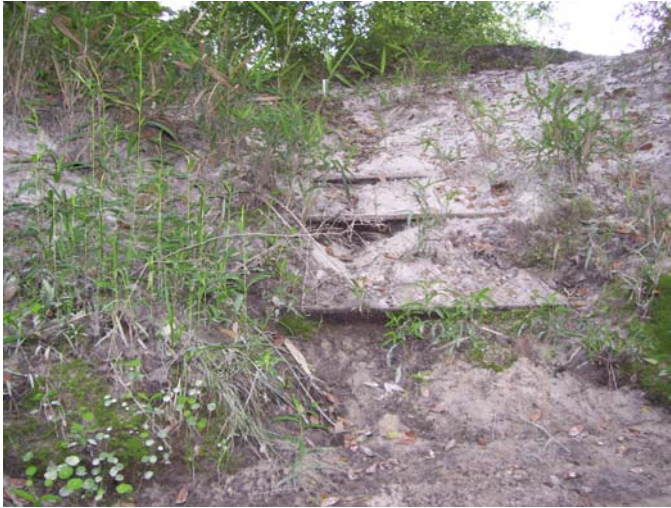
GPS: N 30° 30.516, W 87° 48.484

Description: E3 – Moderate erosion of bank - 3 board steps

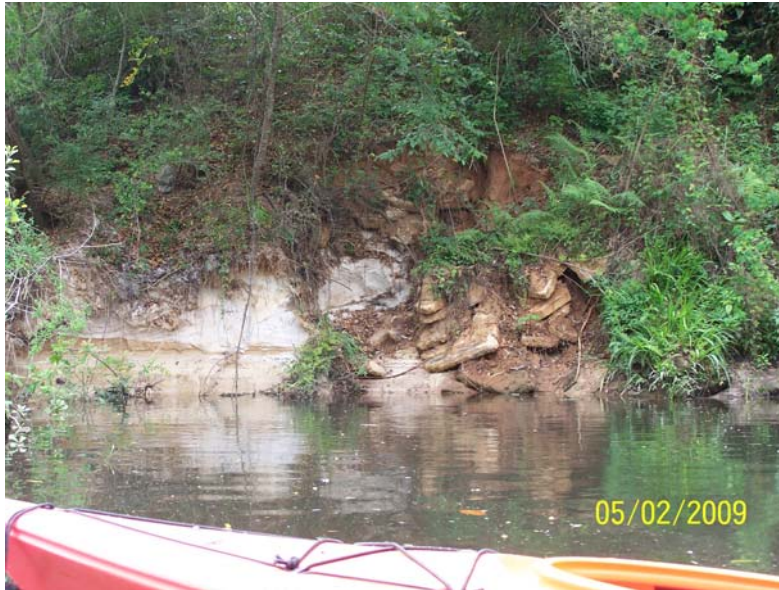
GPS: N30° 30.334, W87° 48.470

Description: E2 - moderate erosion of bank

I5 - Popcorn Trees; I6 - Chinese Privet; I7 - Cogongrass – residential large yard

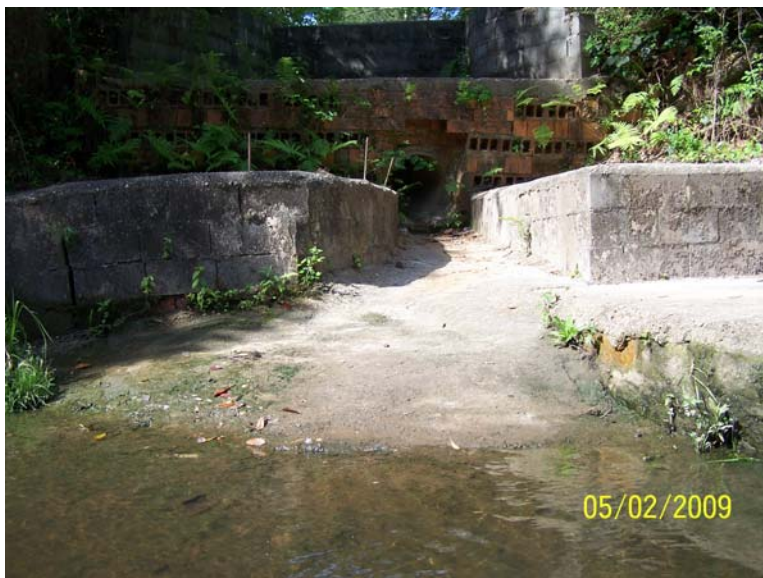
GPS: N 30 30.336, W 87 48.472

Description: Outfall-clear discharge

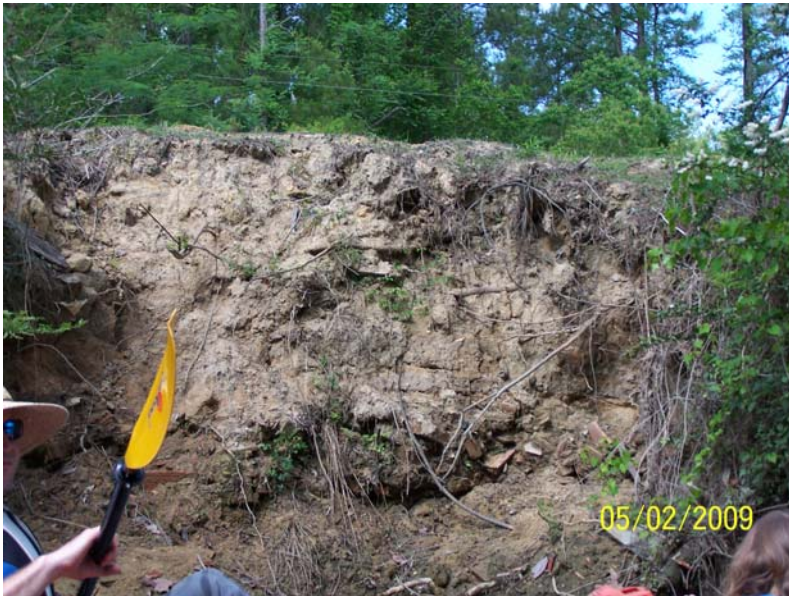
GPS: N 30° 30.240, W 87° 48.441

Description: E1 – Severe erosion of bank

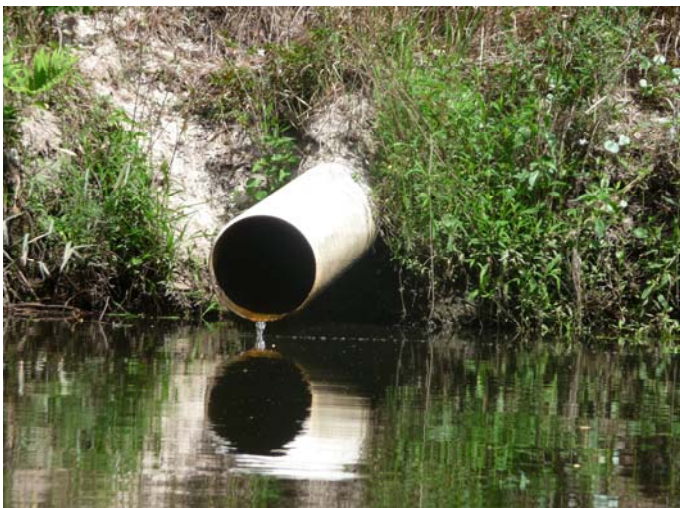
GPS: N 30°30.157

Description: Outfall – no odor, clear trickle
E1 – Severe erosion of bank

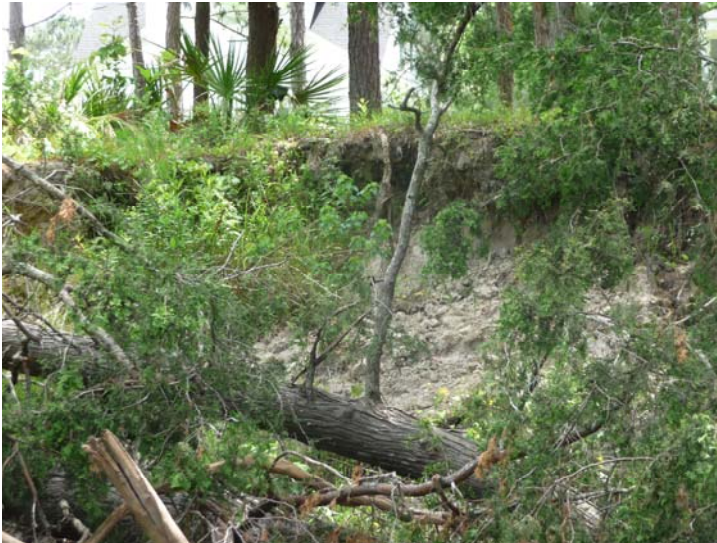
GPS: N 30°30.055

Description: E2 - Moderate erosion of bank – residential

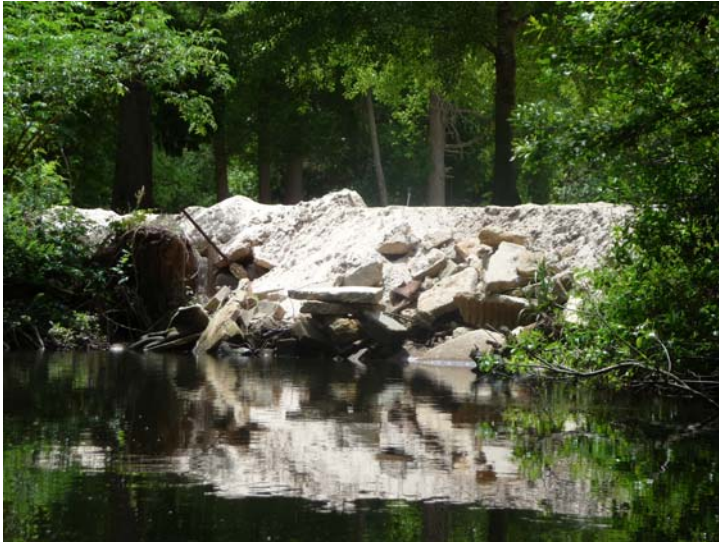
GPS: N 30°30.001

Description: E1 severe erosion of bank – near residential site/trailer park, concrete blocks near waterline

CS1- Construction Activity at 120 ft.— cut logs

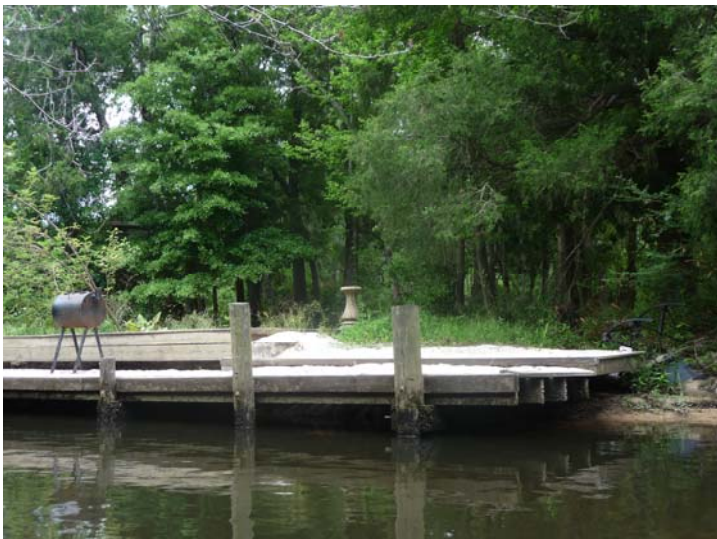
GPS: 30°29.929

Description: E1 – severe erosion of bank; residential

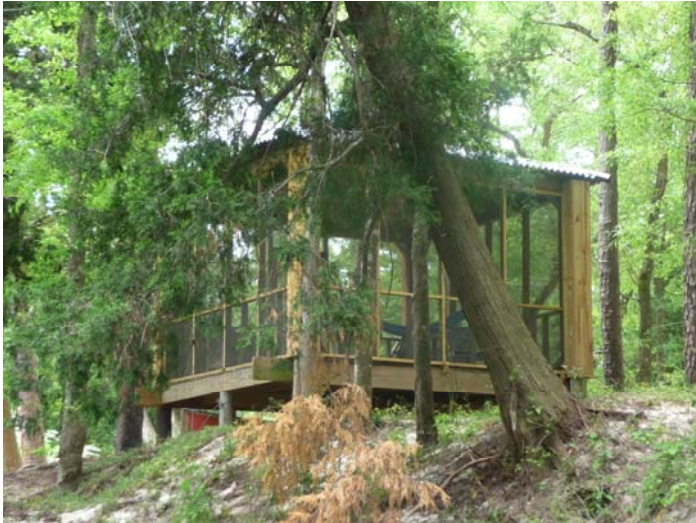
GPS: 30°29.906

Description: E1 – severe erosion of bank; screened porch, room

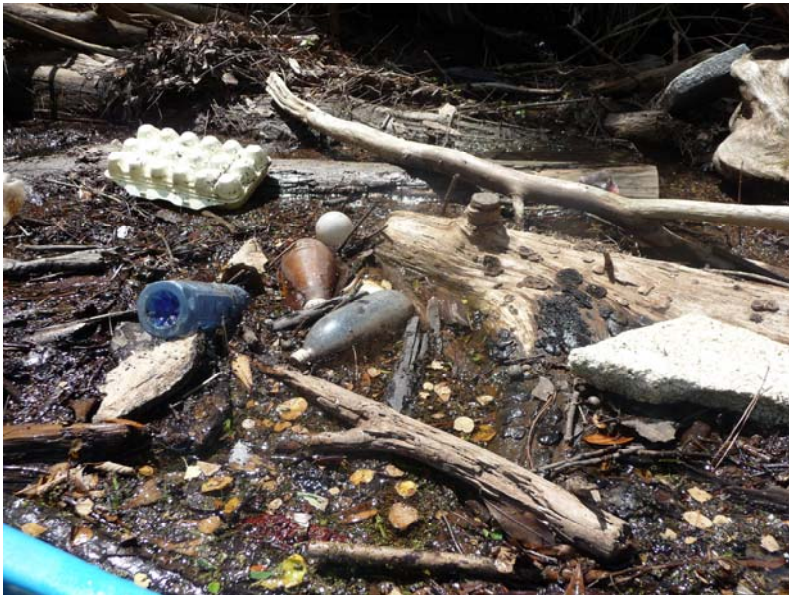
GPS: 30°29.895

Description: CS3 – sediment fence in disrepair: highland put-in; G2 - metals; G3 – paper/styrofoam; G4 – at log jam-didn't block passage; O2 – outfall: no odor, no flow, old

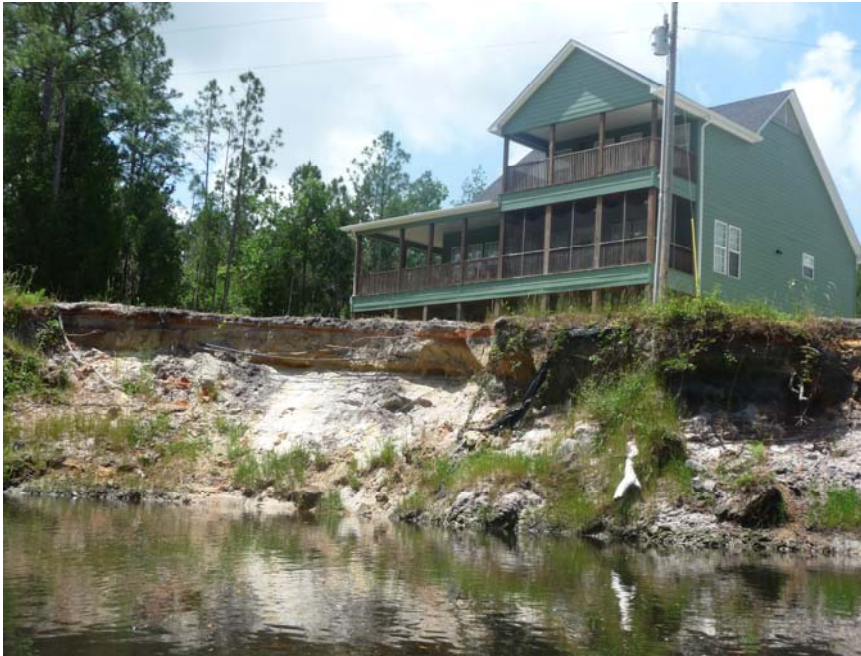
GPS: 30°29.852

Description: E1 – severe erosion of bank

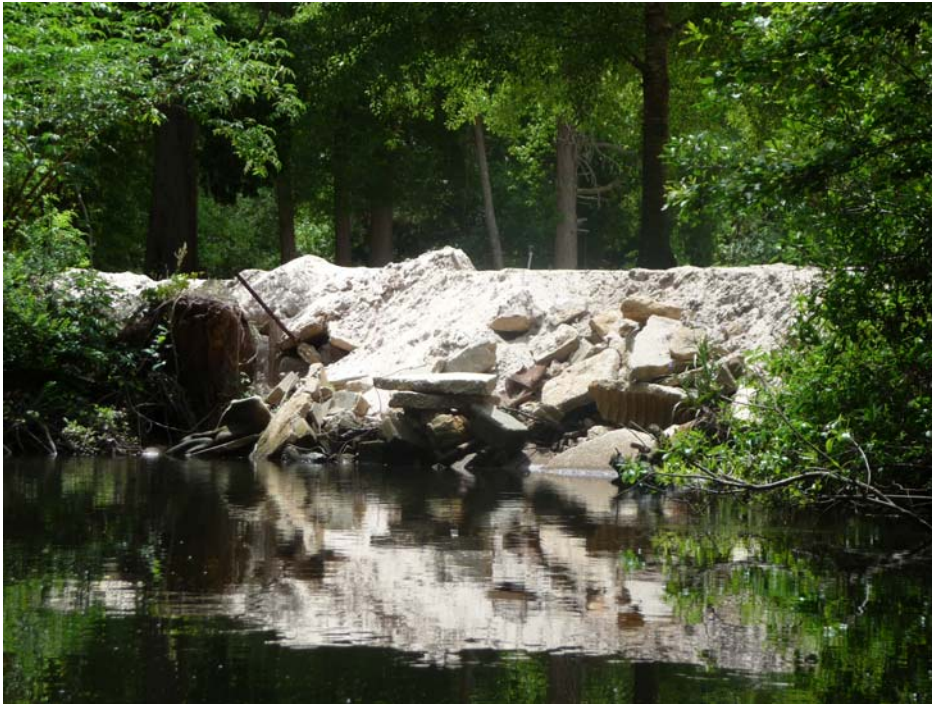
GPS: 30°29.703

Description: G2 – metal drum; G4 – concrete blocks; T- trail, to house; D- dock, floating; E1 – severe erosion of bank

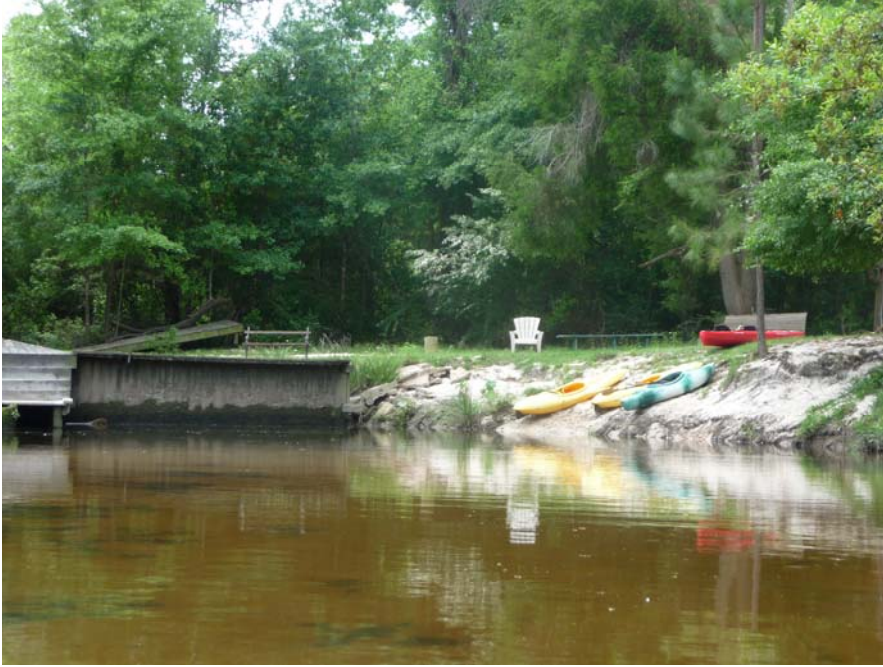
GPS: 30°29.586

Description: E1 – severe erosion of bank, residential; I5 – Popcorn Tree on left bank

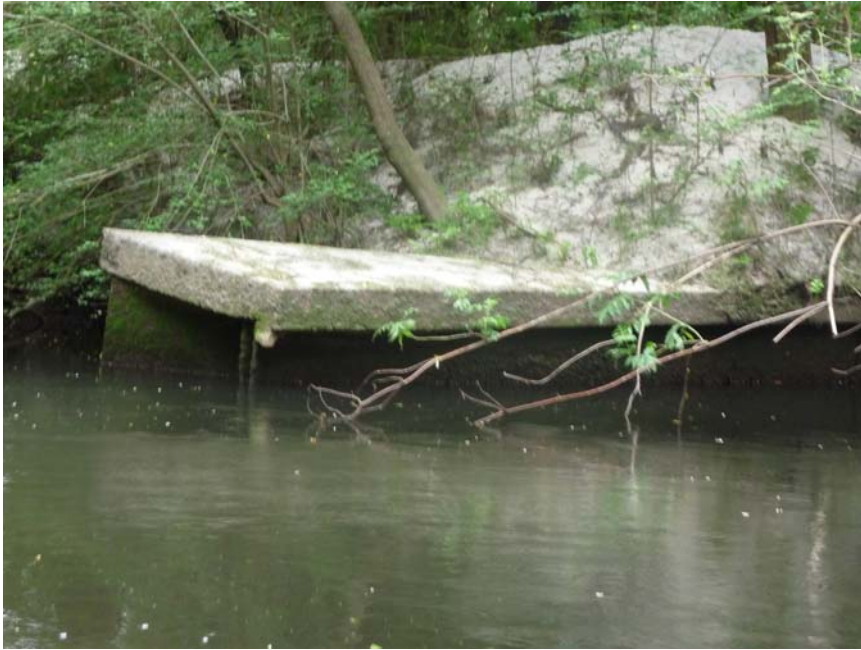
GPS: 30°29.587

Description: D – dock, dilapidated

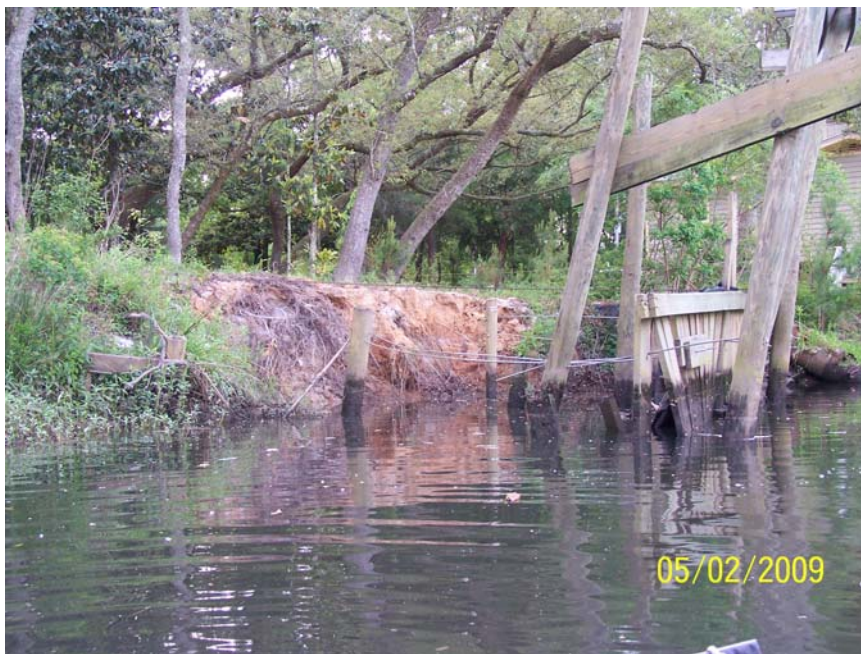
GPS: N 30°29.599, W 87°48.463

Description: CS3 – sediment fence in disrepair, exposed wires; E1 – severe erosion of bank

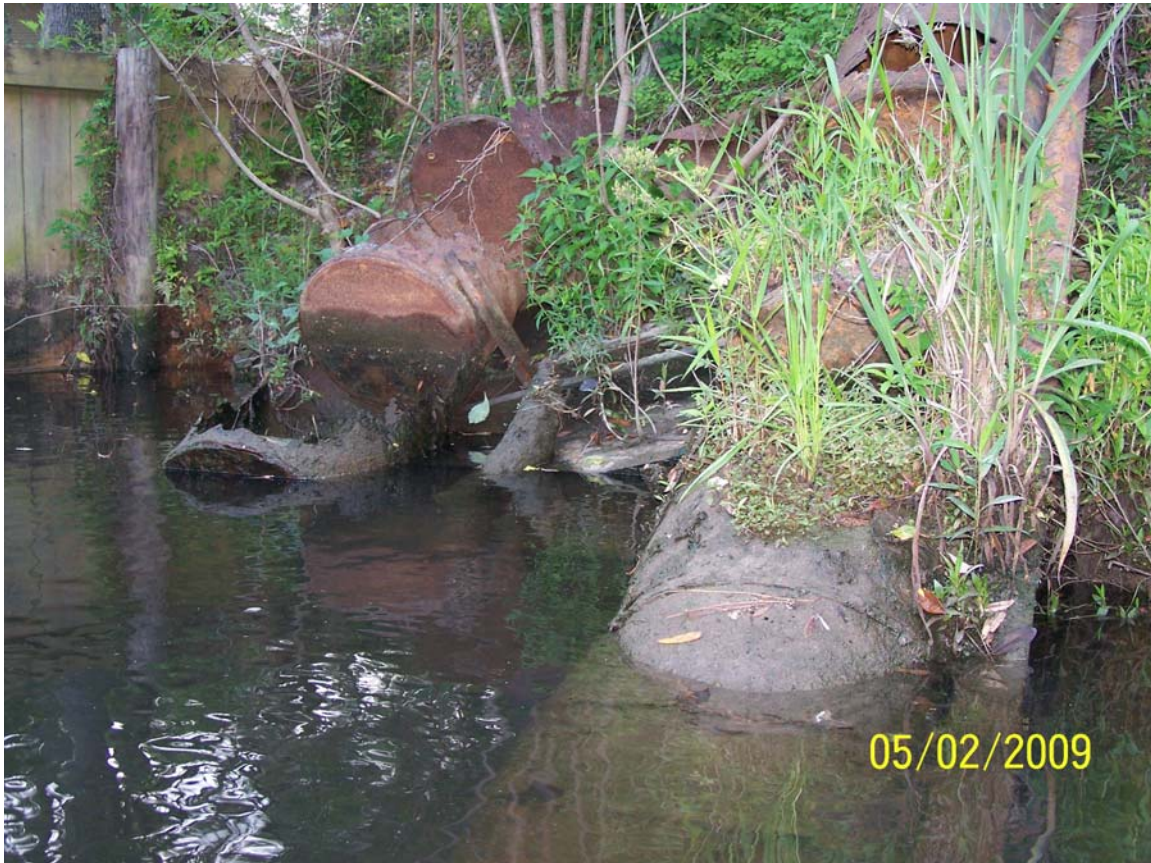
GPS: N 30°29.242, W 87°48.312

Description: G2 – rusted drums in water

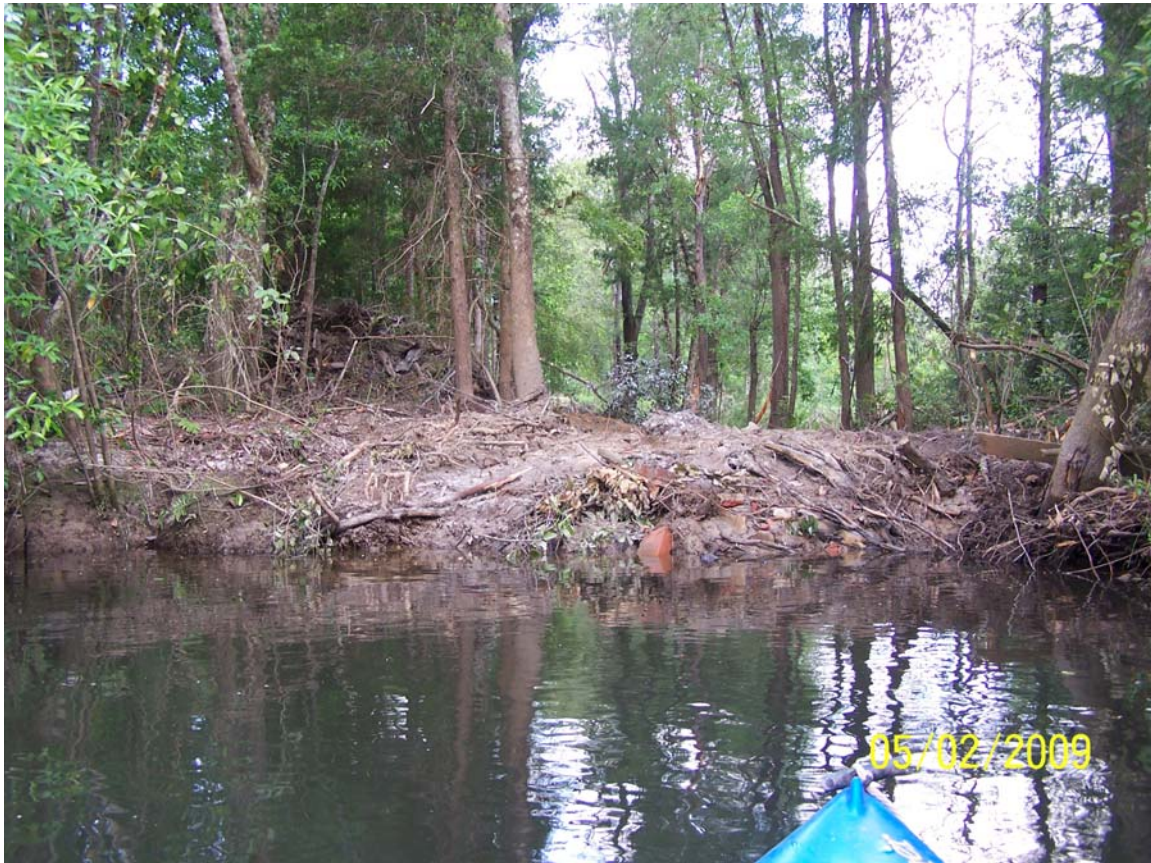
GPS: N 30°29.229, W 87°48.361

Description: CS1 – exposed, disturbed soils, recent land stripping on bank

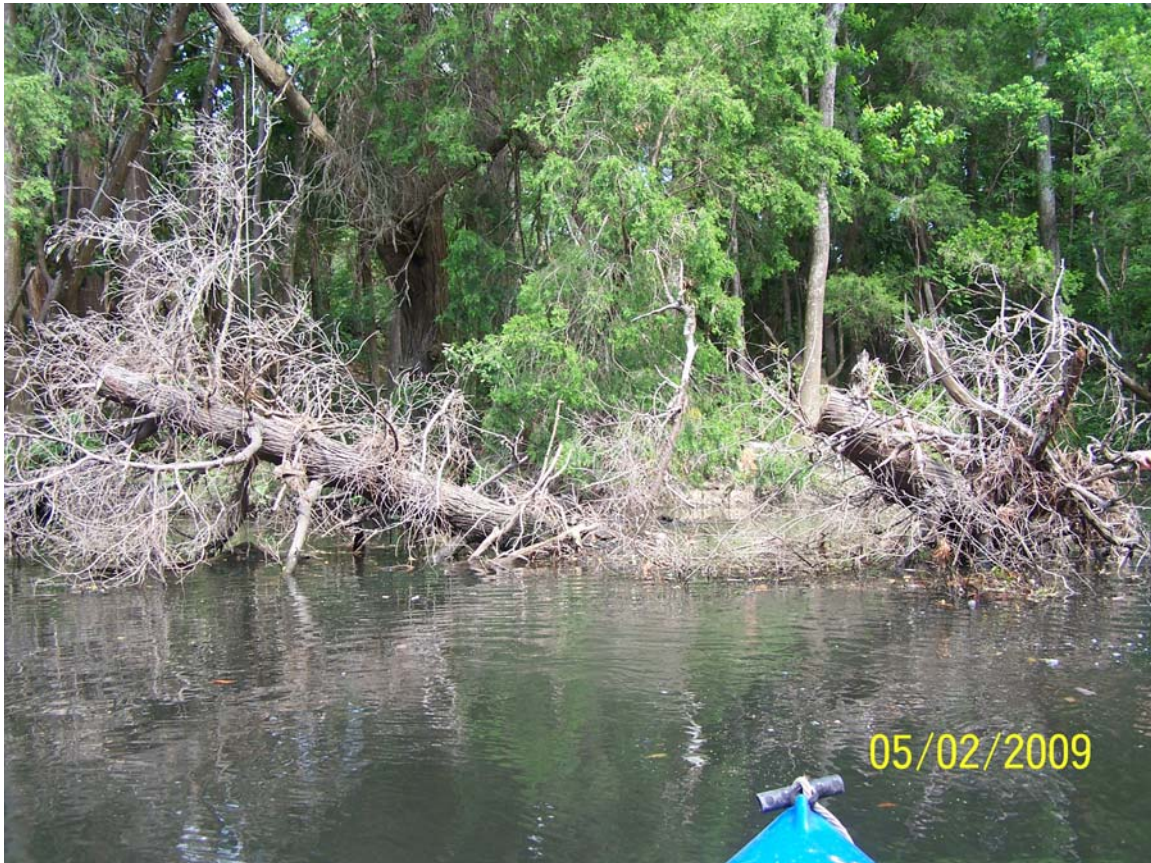
GPS: N 30°29.166, W 87°48.375

Description: snag

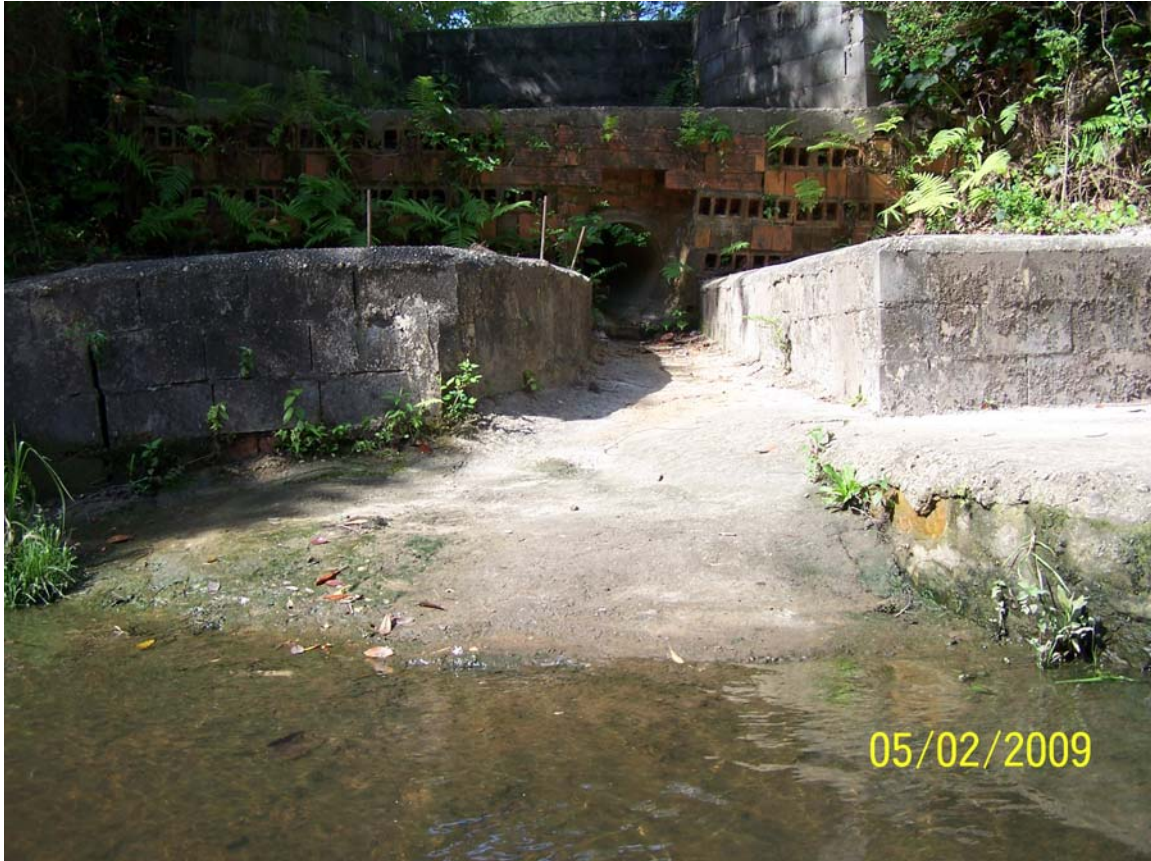
GPS: N 30°29.154, W 87°48.383

Description: outfall

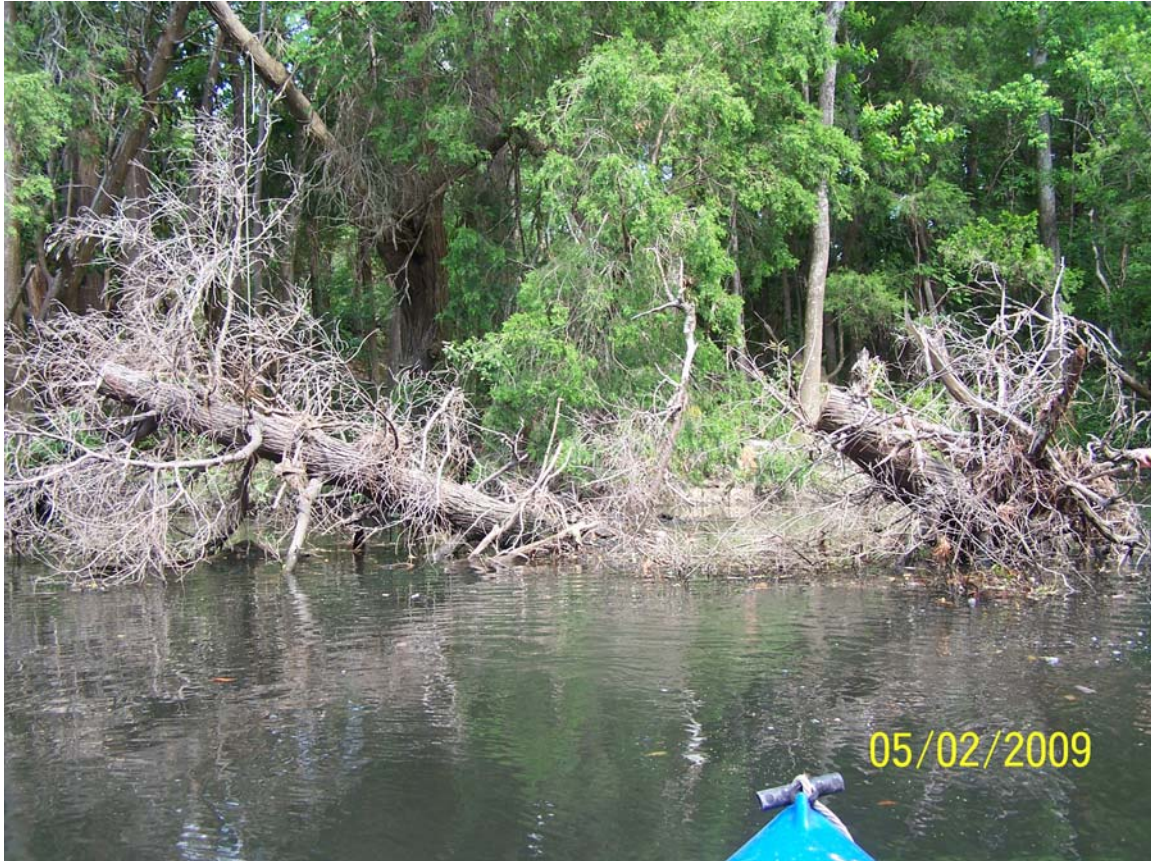
GPS: N 30°29.202, W 87°48.383

Description: snag

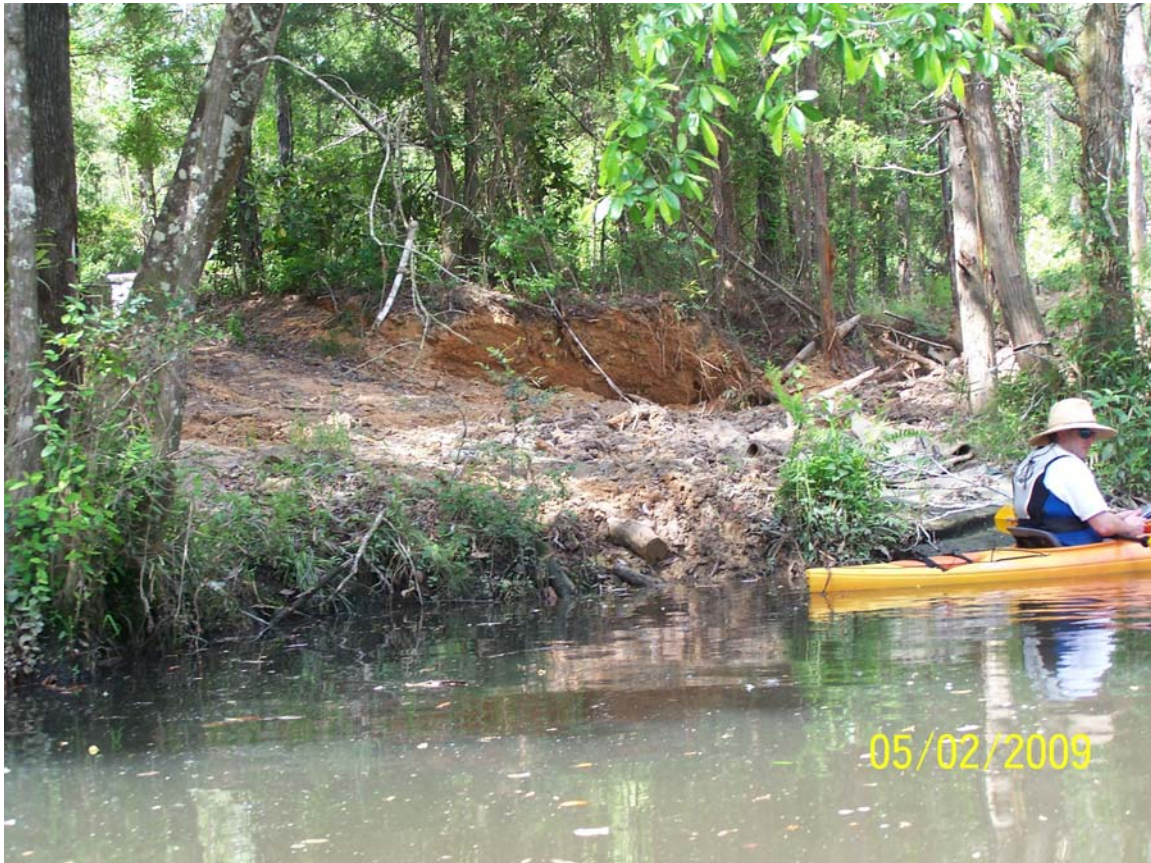
GPS: N 30°29.247, W 87°48.412

Description: E1 – severe erosion of bank

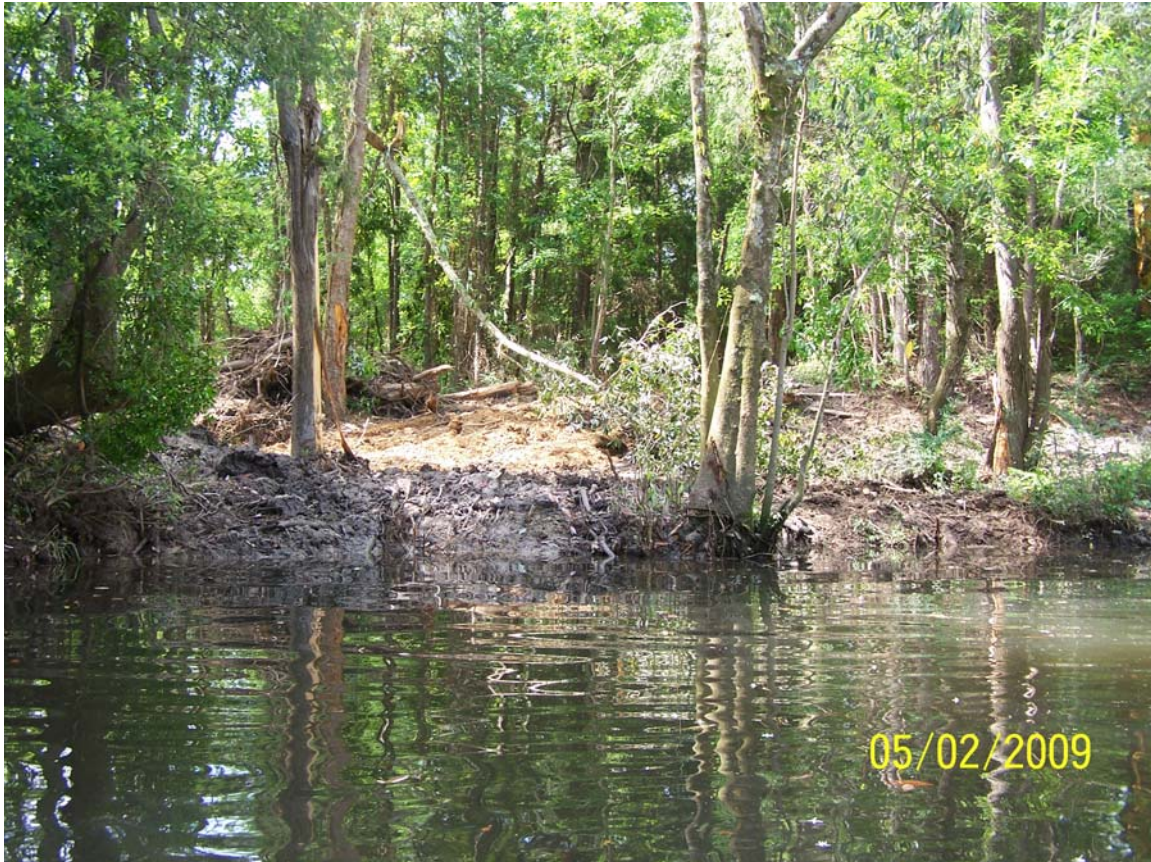
GPS: N 30.29.283, W 87°48.412

Description: CS1 – exposed, disturbed soils; E1 – severe erosion, major issue: land clearing, pier present that crosses river to other piece of land

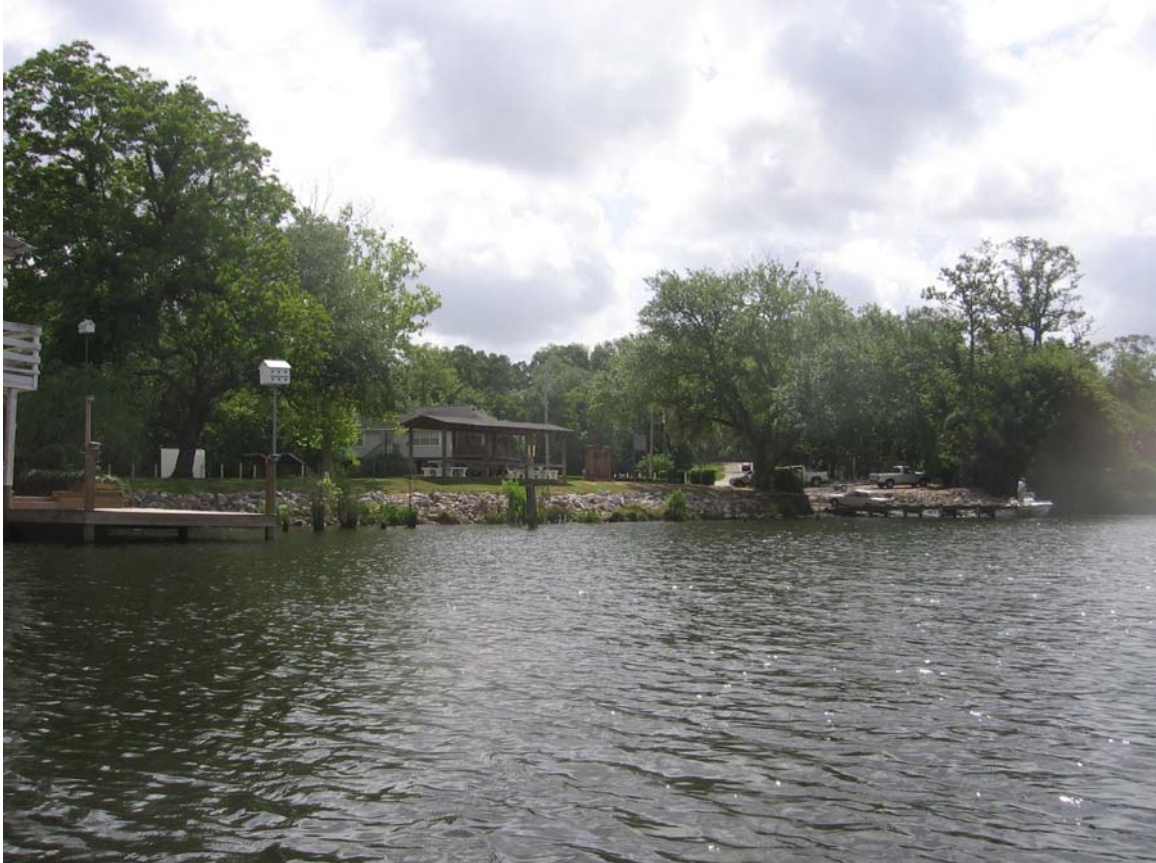
Description: bulkhead and rip rap, entire shoreline between grids 21 and 22

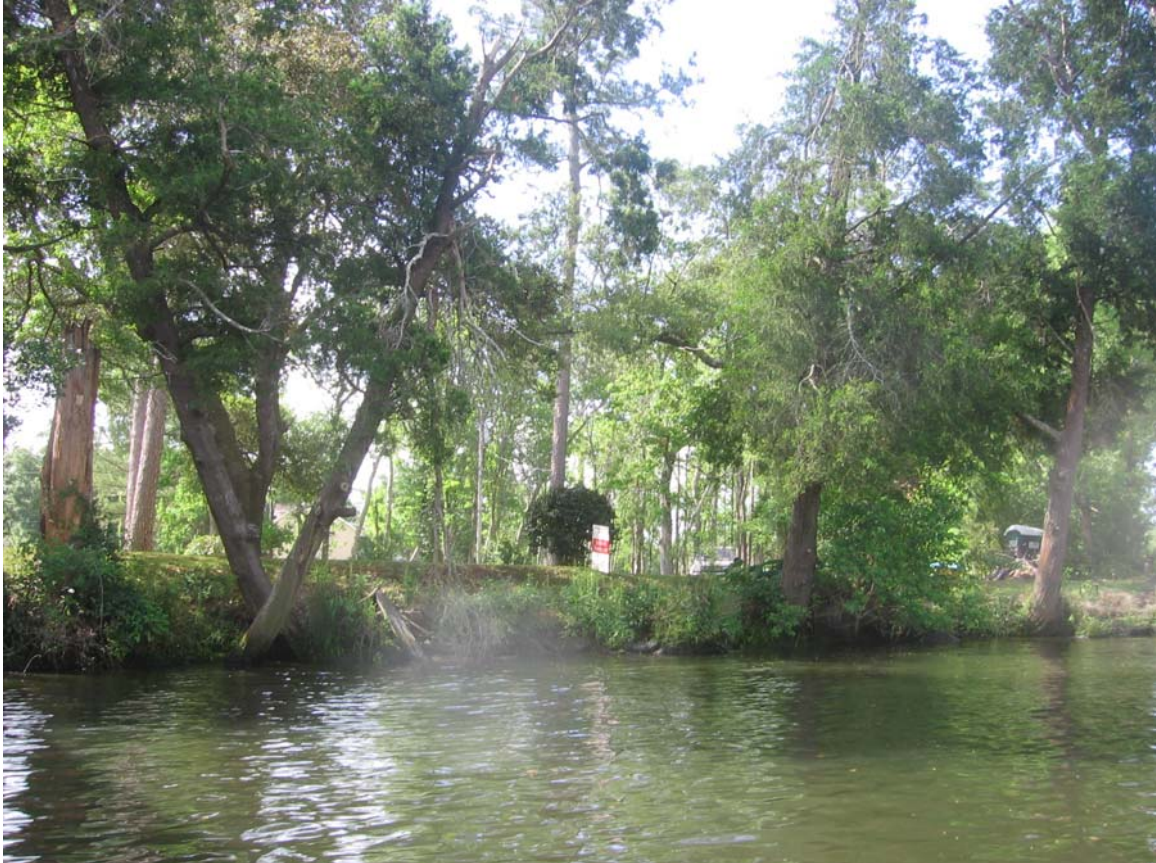
GPS: na – E on map

Description: bulkhead washout, erosion behind a residential lot

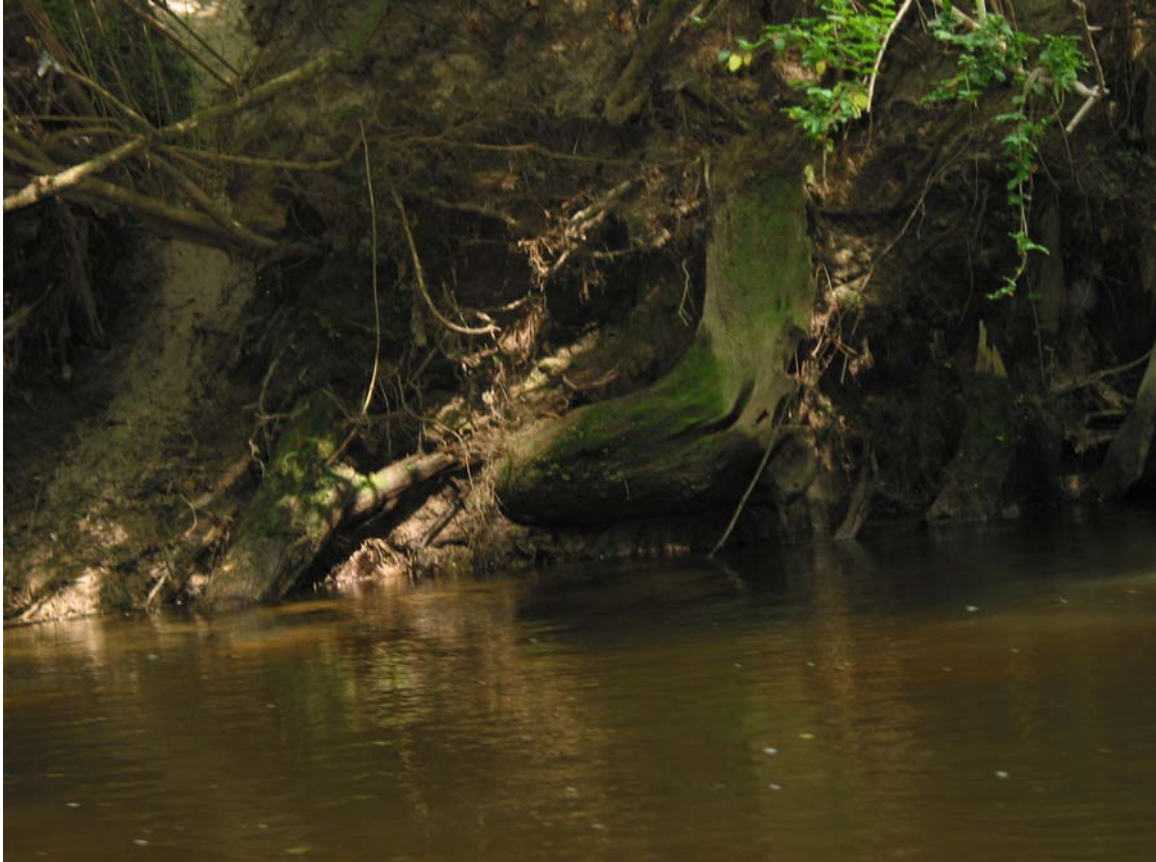
GPS: N 30.53458, W 87.80010

Description: E2 – moderate erosion of right bank; I6 – Chinese Privet; I4 – Japanese Climbing Fern on left bank

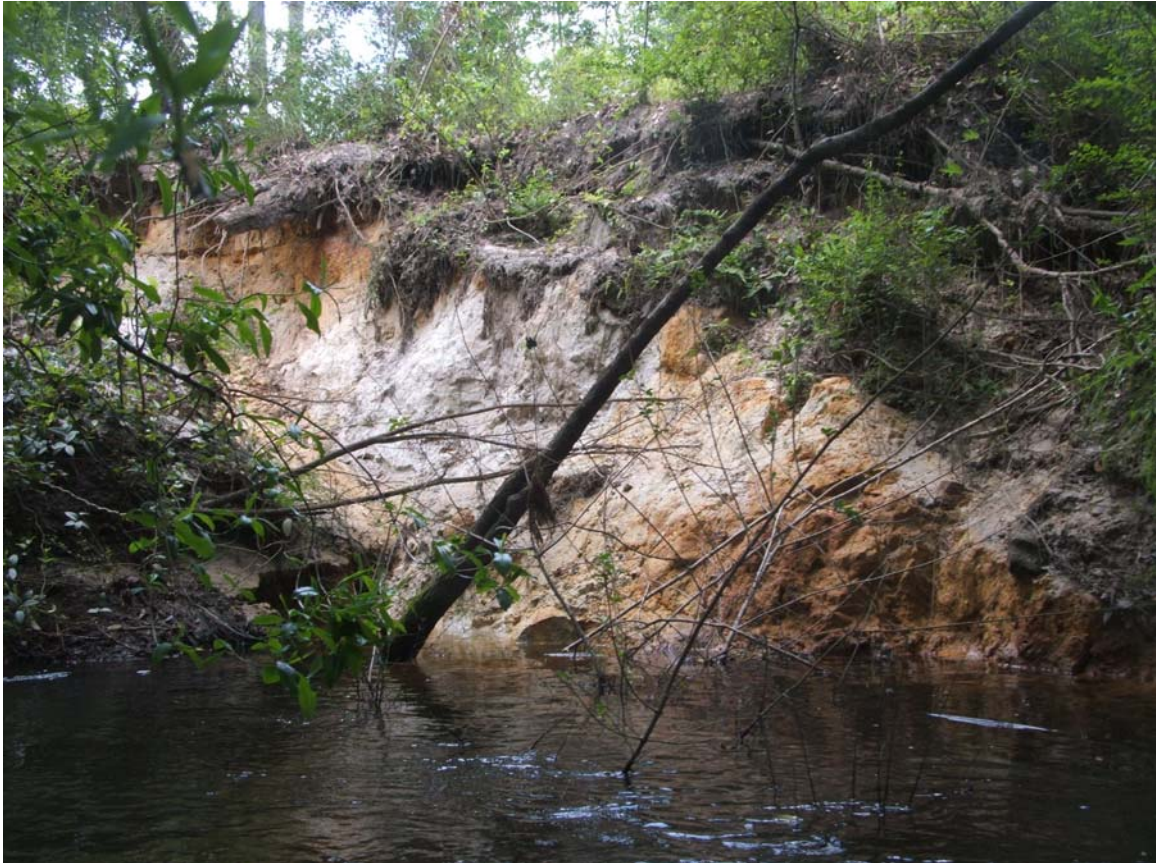
GPS: N 30°32'17.9, W 87°47'55.4

Description: E1- severe erosion of bank: bank gullied through more than 15 ft., trees washed out, lots of exposed roots; I6 – Chinese Privet: omnipresent throughout areas 29-30

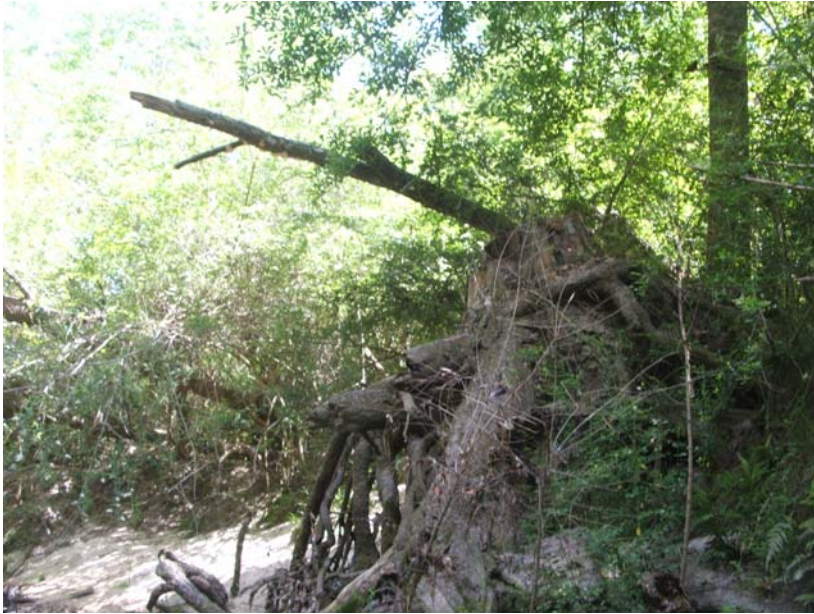
GPS: N 30°32'32.8, W 87°47'51.4 – PI#5 on map

Description: E3 – mild erosion of bank: erosion of west bank on outside of bend, lots of tree roots visible; I6 – Chinese Privet: omnipresent; I5 – Popcorn Tree: large, on east bank
