D'OLIVE WATERSHED MONITORING STUDY AND DEVELOPMENT OF A WATERSHED CONDITION FRAMEWORK

Prepared by

December 31, 2019

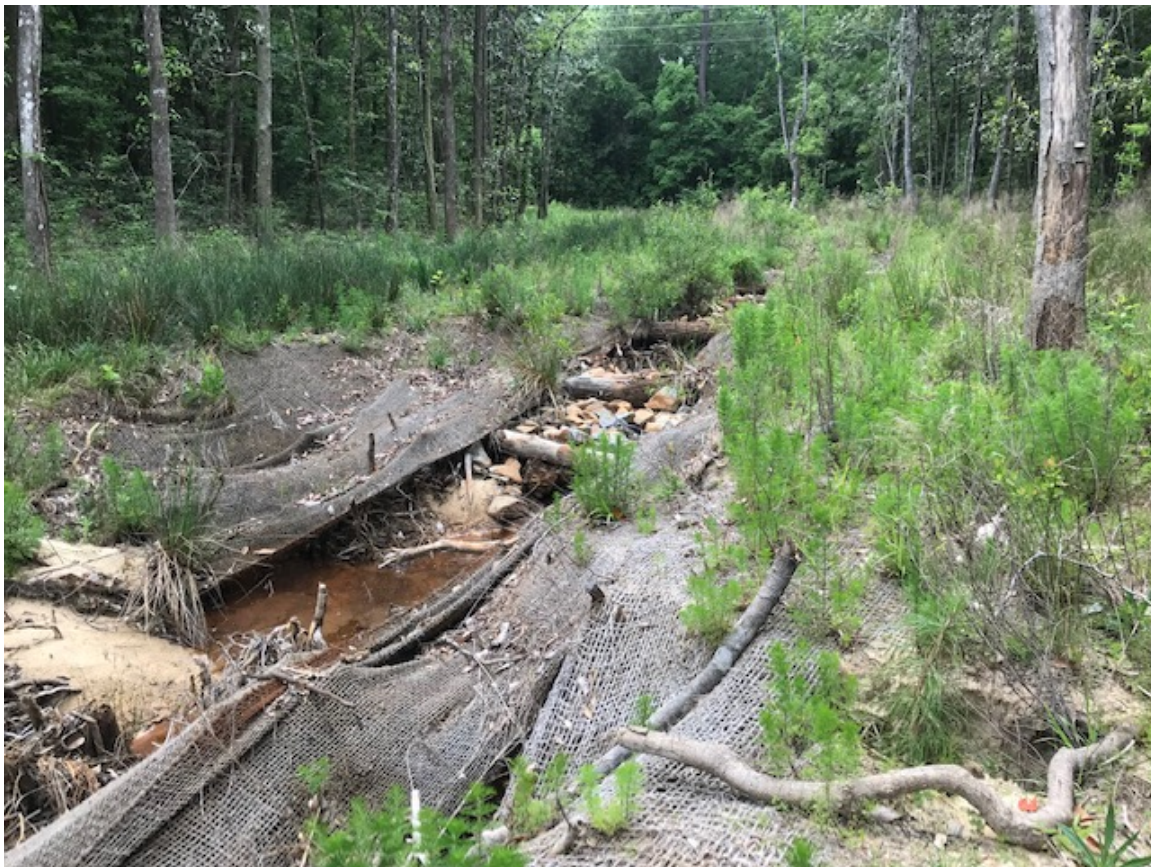
Baseline scores for stream restoration reaches were estimated using the TC2-Tributary restoration site as a model. This site scored lowest of all stream locations in 2019, due to poor conditions for bank stability, bank vegetative protection, habitat availability, sediment deposition, and habitat smothering (Figure 3-2). Prior to restoration the D'Olive stream sites exhibited similar impairments. The TC2-Tributary site therefore provides a good representation of baseline conditions.

Figure 3-2. Restoration maintenance problems at the TC2-Tributary restoration site, spring 2019.

The TC2-Tributary restoration site scored lowest of all stream assessment locations in 2019, largely due to poor bank stability, bank vegetative protection, habitat availability, sediment deposition, and habitat smothering.

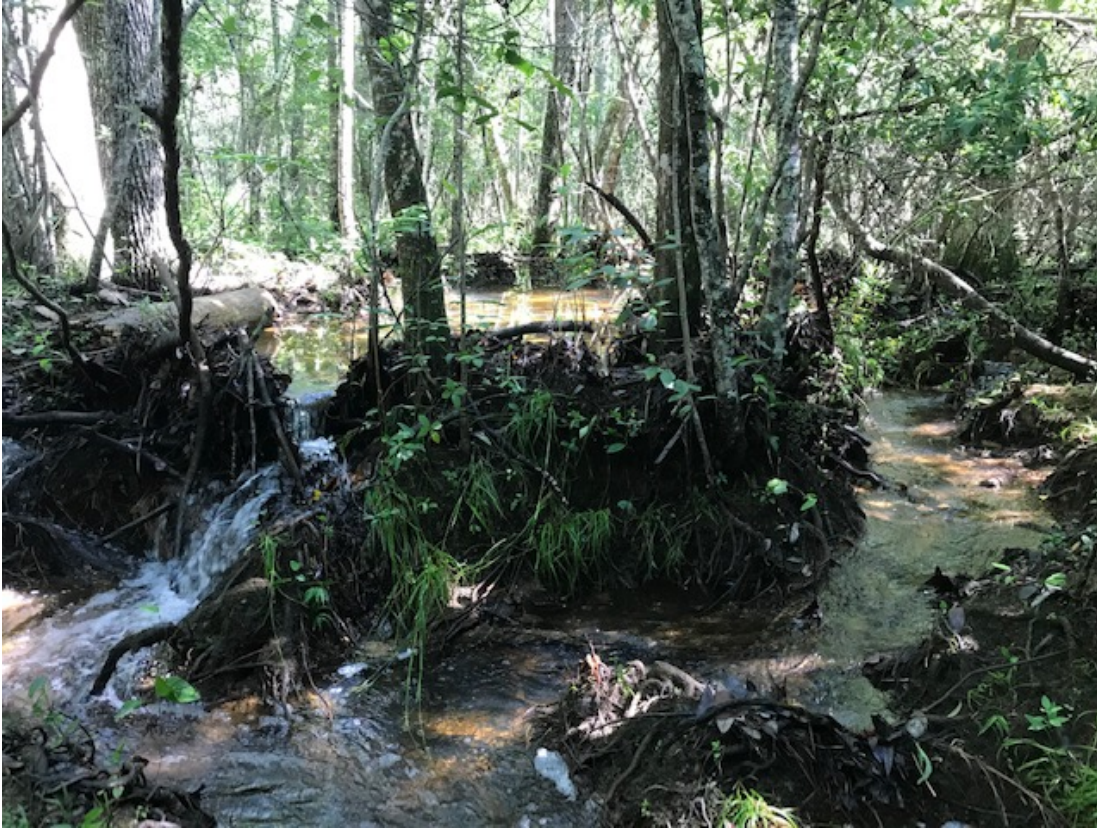
The JB Bass Pro Shop site scored well in terms of current stream condition and improvement relative to the other sampling sites. The large decrease in sediment loading originating upstream of this reach

(Cook, 2019) has resulted in large improvements to stream habitat (Figure 4-8). The site scored well (“moderate” to “good”) in the categories of habitat availability, sediment deposition, habitat smothering, and bank stability. The favorable scores for these categories, compared to baseline, show a clear link between restoration efforts upstream, and improved downstream condition.

Figure 4-8. Joe’s Branch stream and wetland habitat at Bass Pro Shop.

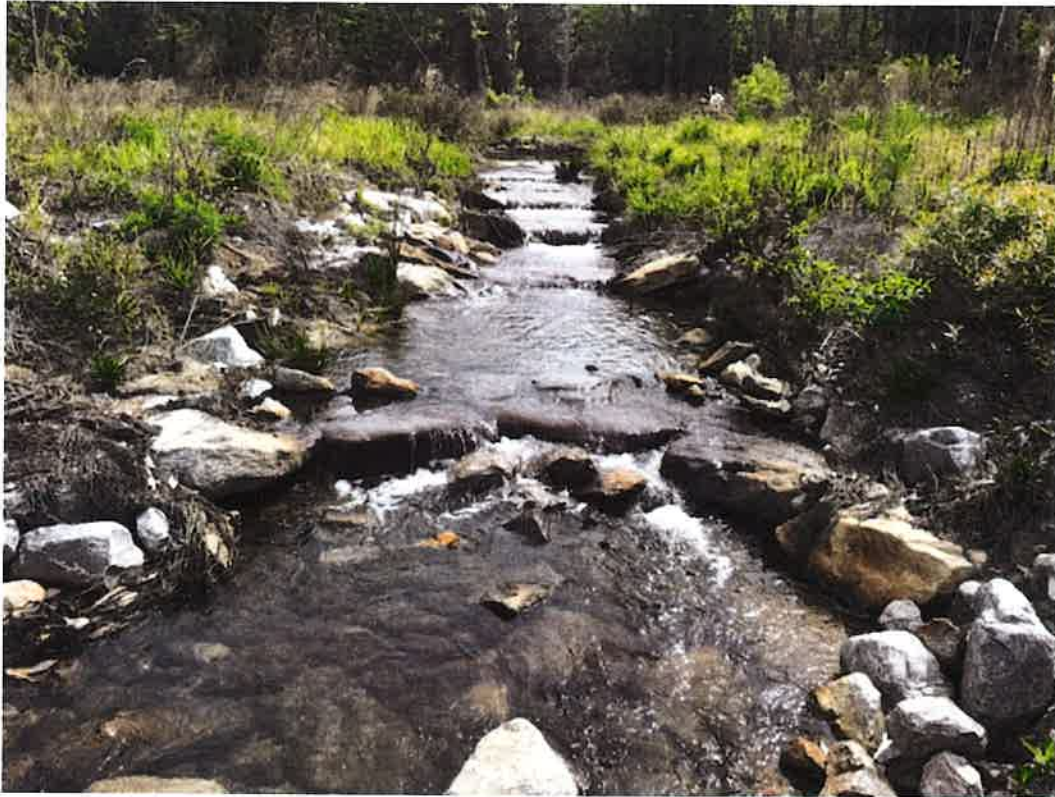
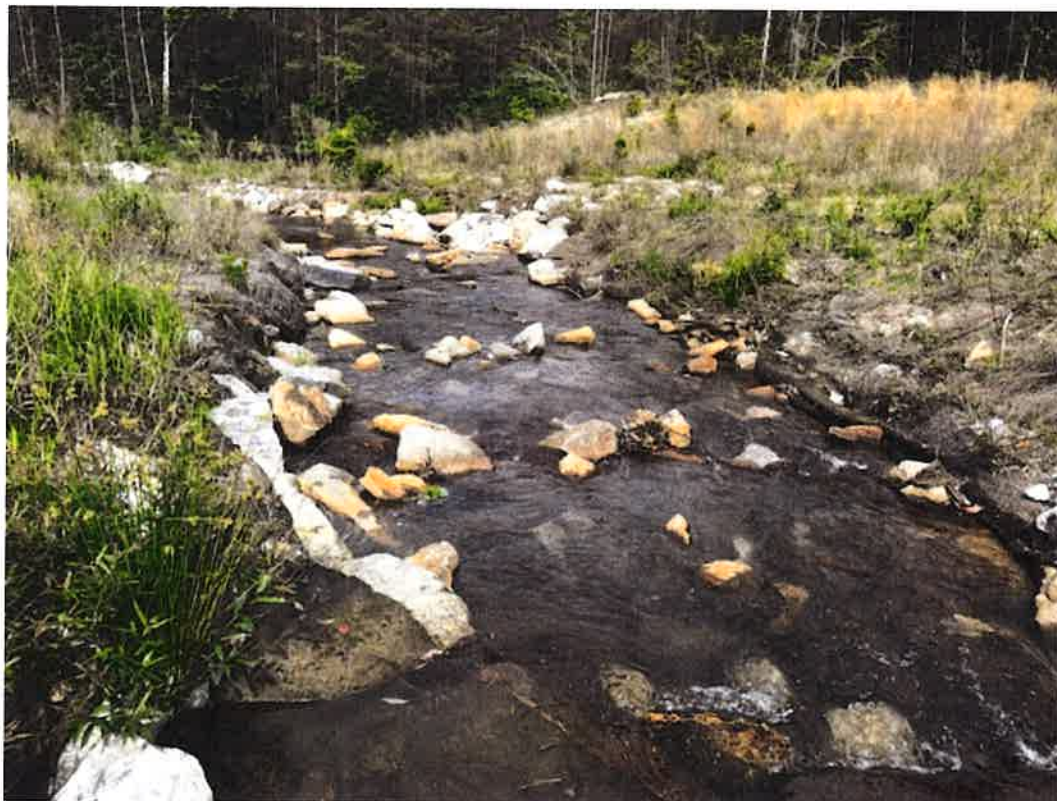
DA3-Restoration Sampling Site

The condition of Site DA3 is classified as Fair (0.54) and scored “good” for sediment deposition and habitat smothering. DA3 scores poorly for canopy cover and riparian zone width, reflecting its recent construction and initial stage of development. Stonefly and caddisfly larvae, insects with high and moderate pollution sensitivity, respectively, were collected at DA3, improving its condition score.

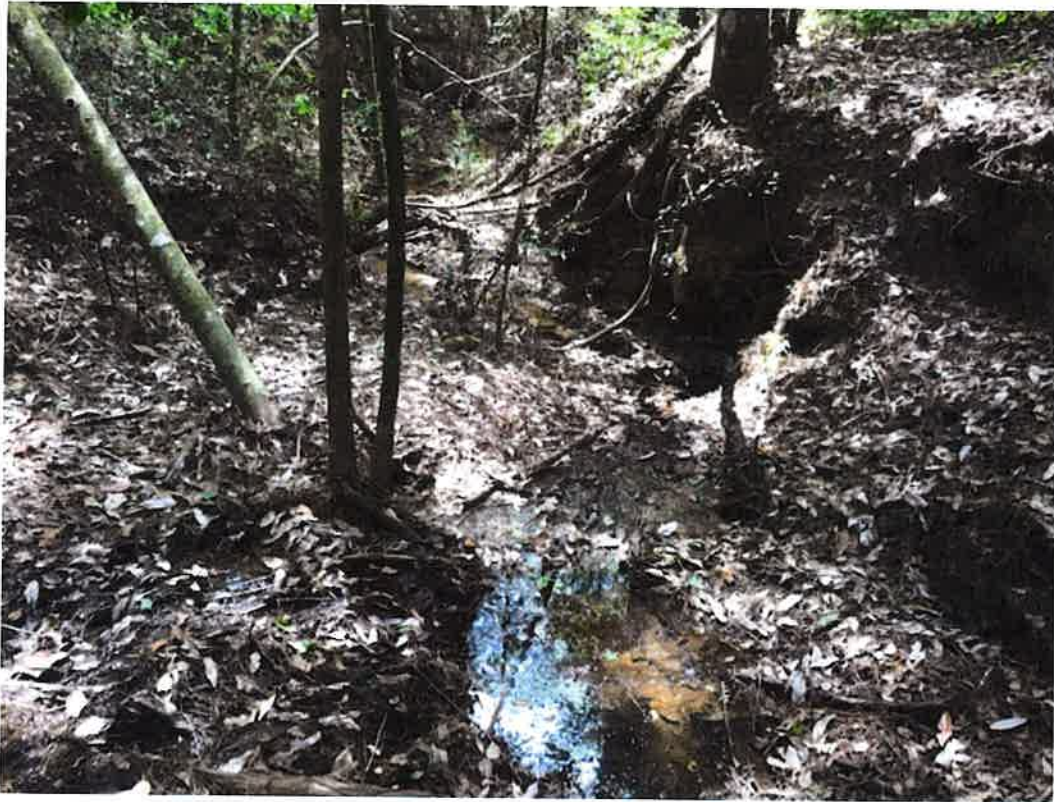
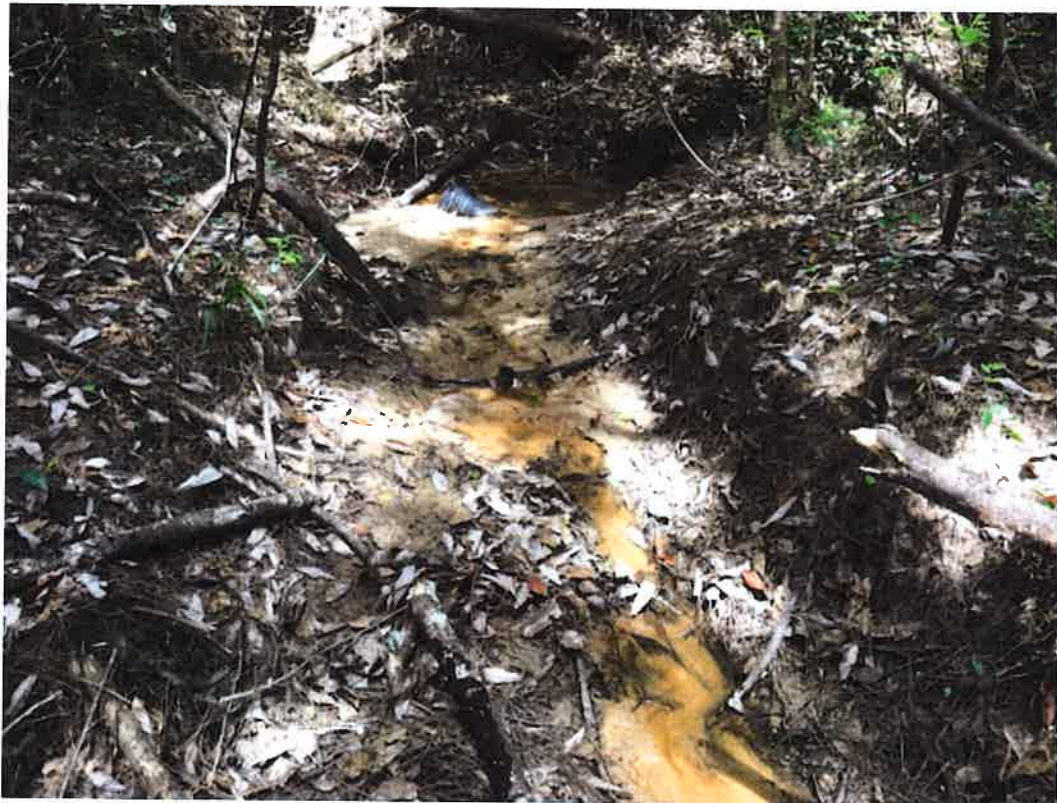
DAE-Downstream Sampling Site

Downstream of restoration site DAE has a Fair condition (0.52), with “good” scoring for riparian zone width, vegetative quality, and canopy cover. The site scored poorly for habitat availability and sediment deposition and “moderate” for bank vegetative protection and habitat smothering. The D4D6 downstream site also scored Fair (0.52) and was similar to DAE downstream with respect to sediment deposition (“poor”), but has better stream habitat availability and yielded two macroinvertebrate taxa (damselfly and dragonfly) with moderate pollution sensitivity, increasing its overall condition score.

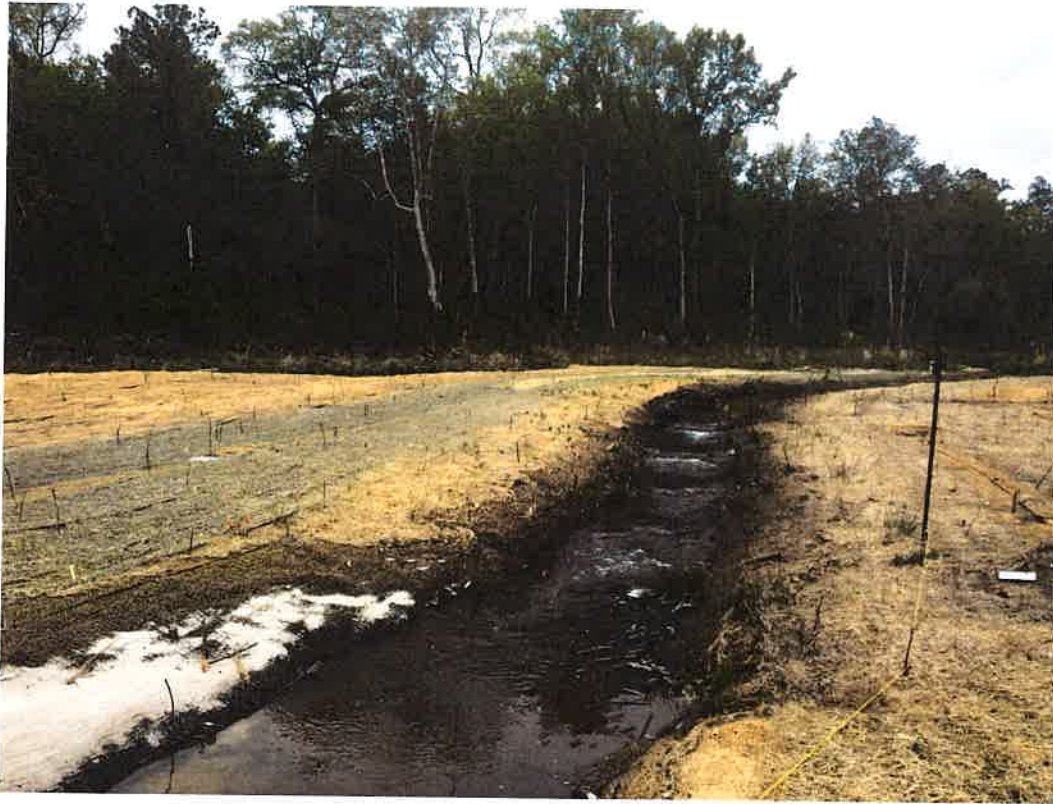
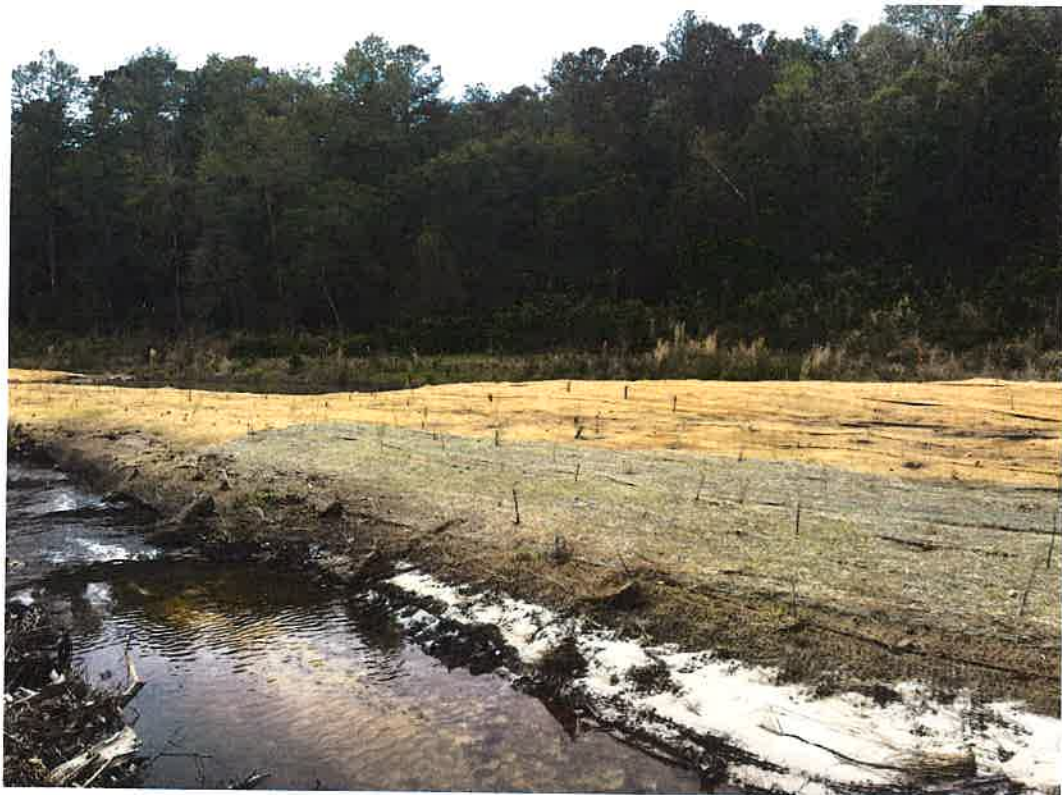
D4-D6-Restoration Sampling Site

The D4D6 restoration site has poor stream quality, with “poor” conditions for bank vegetative protection, canopy cover, and riparian zone width, reflecting the recent construction of the site. D4D6 is rated “good” for stream bank stability, and receives “moderate” scores for channel sinuosity, channel alteration, bank vegetative protection, habitat availability, and habitat smothering.

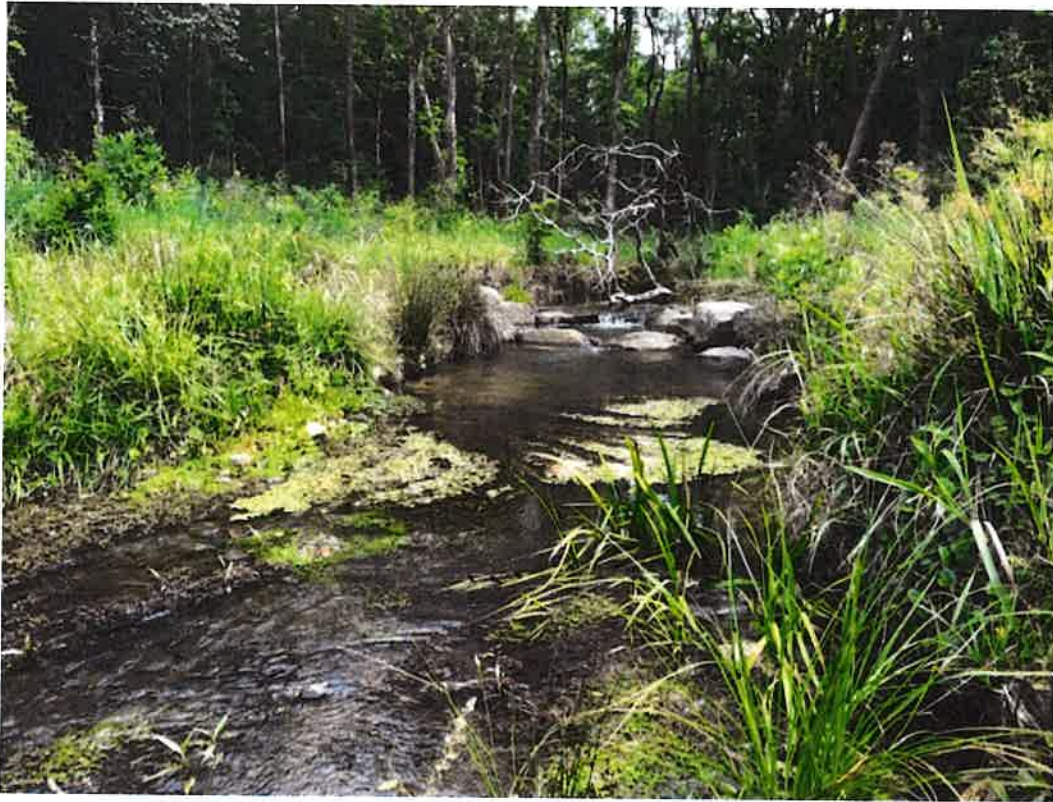
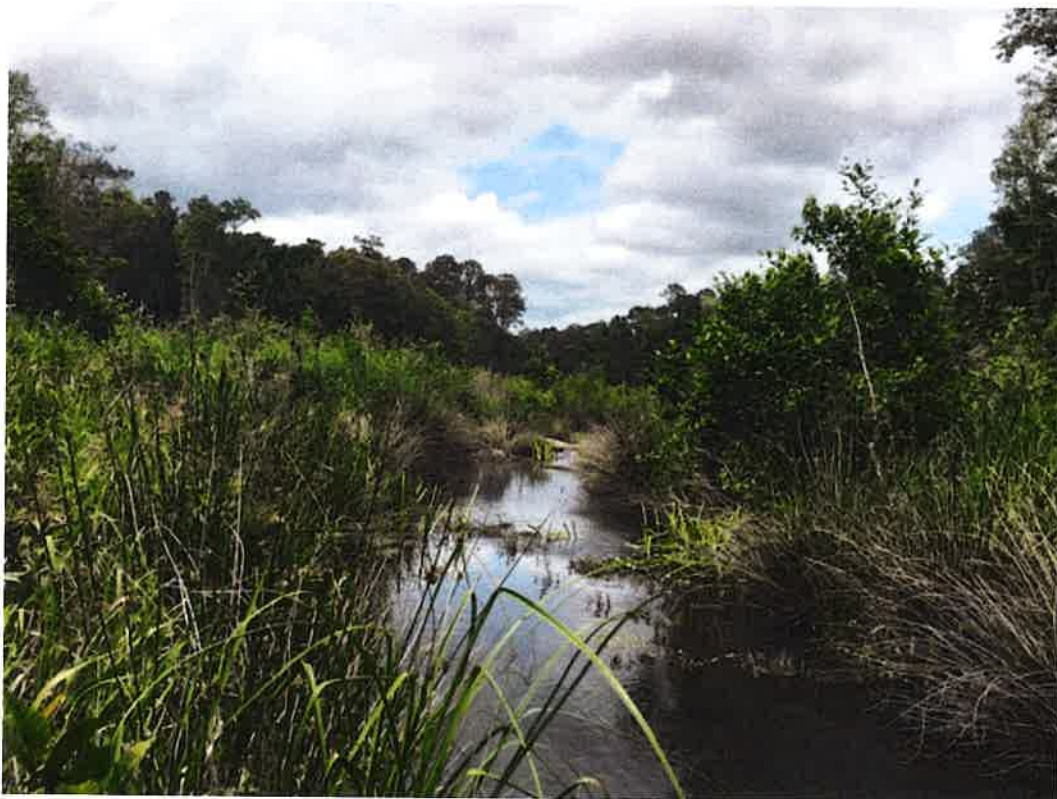
TC(1-2)-Restoration Sampling Site

The TC1-TC2 restoration site is classified as Poor (0.40) (Table 4-6 and Figure 4-6), primarily due to “poor” scores for riparian zone width, canopy cover, and channel alteration. The site receives a “good” score for bank stability, and “moderate” scores for sediment deposition, habitat smothering, habitat availability, channel sinuosity, and bank vegetative protection. The reach upstream of TC1-TC2 is classified as Fair quality (0.68), scoring high for riparian zone width, canopy cover, and macroinvertebrate taxa.
