Pre-restoration Stream and Wetland Assessments for the Spring Branch System Lower Fish River Watershed Restoration

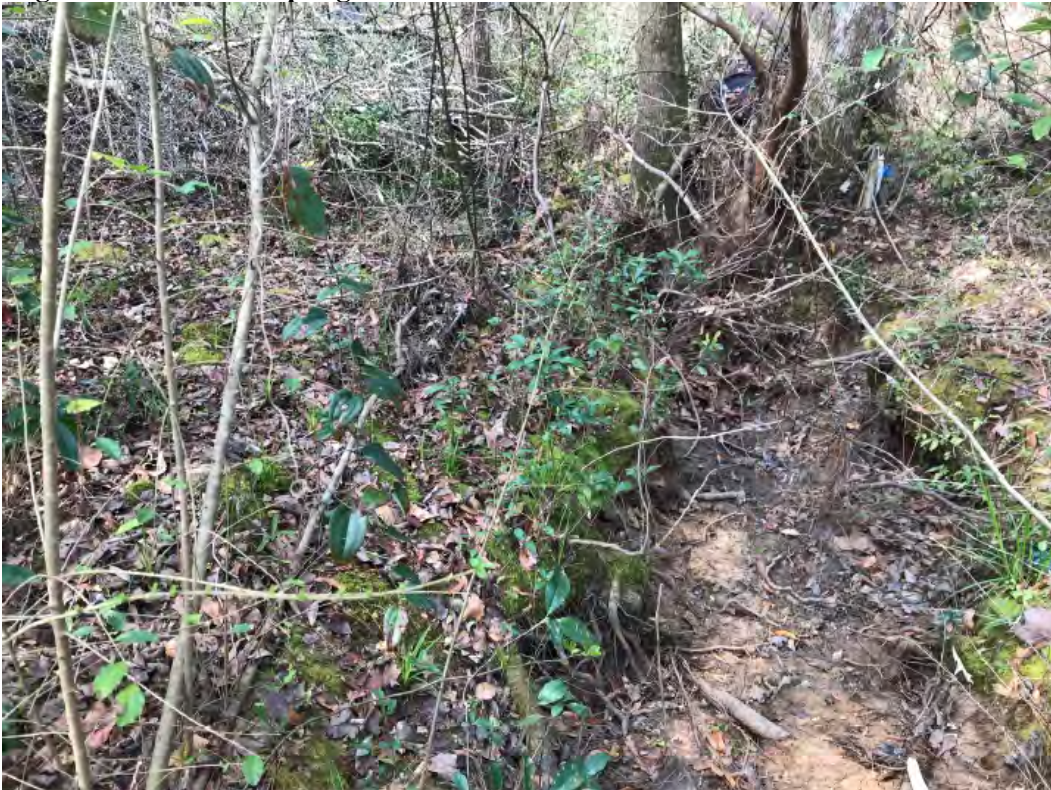
Figure B2. RSA 1 sampling site.

Table 3 provides the stream habitat assessment scores for each site. The main differences between the transects were related to the condition of the streambanks and bank vegetative protection, as well as the width of the vegetated riparian buffer, which all scored lower at RSA 2 compared to RSA 1. Sediment deposition was apparent along both survey reaches (See Photographs B2 and B4, **Appendix B**).
