Pre-Restoration Stream Assessment for Magnolia Bluffs

Lower Fish River Watershed

April 22, 2024

Thompson Engineering (BVA Group)
Project No.: 23-1126-0013

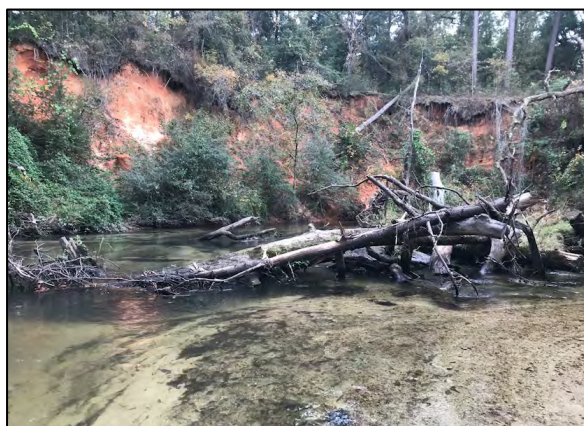
RSA results are presented in **Table 2**. Canopy cover, local watershed erosion, and bank stability all scored as “poor” along the RSA1 transect. The reach has an extremely high, incised bank with bare, eroded dirt on the south side of the river (**Figure 3.1**). Despite the poor condition of the bank, the stream is very clear, with moderate sinuosity, good habitat availability and very little habitat smothering. The RSA1 riparian zone width, in-stream habitat availability, and channel alteration scored as “good”. The remainder of the metrics scored as “moderate”, including riparian vegetative quality, sediment deposition, habitat smothering, channel sinuosity, and bank vegetative protection. The pollution-sensitive stonefly (Plecoptera) was collected at RSA1.

Figure 3.1 Eroded bluff at RSA1 (MB 1)

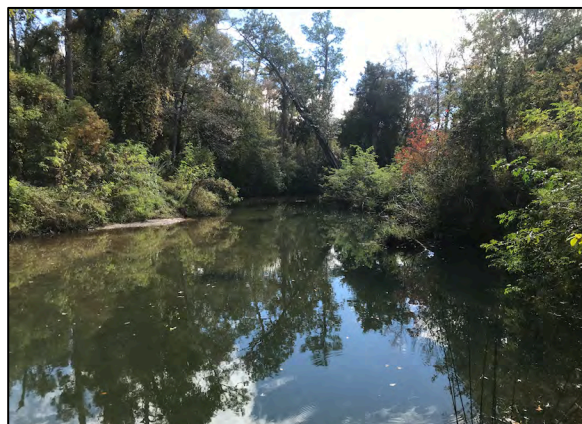
Figure 3.2 Vegetated banks along RSA2/3 (MB 2)

RSA2/3 (MB 2 and MB 3) received low scores for instream cover (= RSA habitat availability) channel sinuosity, and condition of the banks. Several areas of the reach area have bank instability and eroded areas of the river bluff (**Figure 3.2**), despite having generally good bank vegetation and riparian zone, and generally minor habitat smothering. RSA2/3 had moderate scores for pool variability and riparian zone width (right bank).

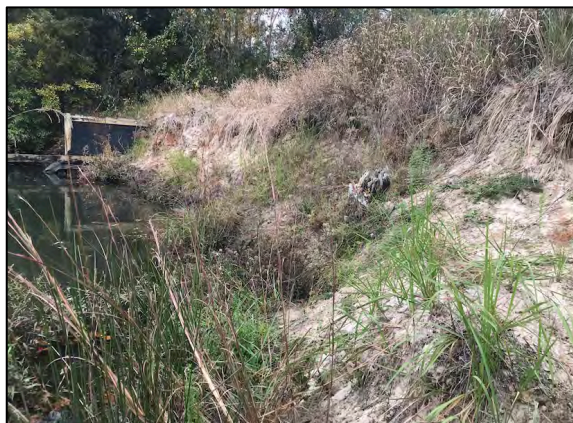
RSA4 received low scores for instream cover, channel flow status, and condition of its banks, as well as bank vegetative protection. The riparian zone and the right bank in particular are in poor condition (**Figure 3.3**). Riparian vegetative zone width scored poorly on both sides of the highly degraded portion of the RSA4 reach (**Table 3**).

Figure 3.3 Poor quality bank condition at RSA4 (MB 4)

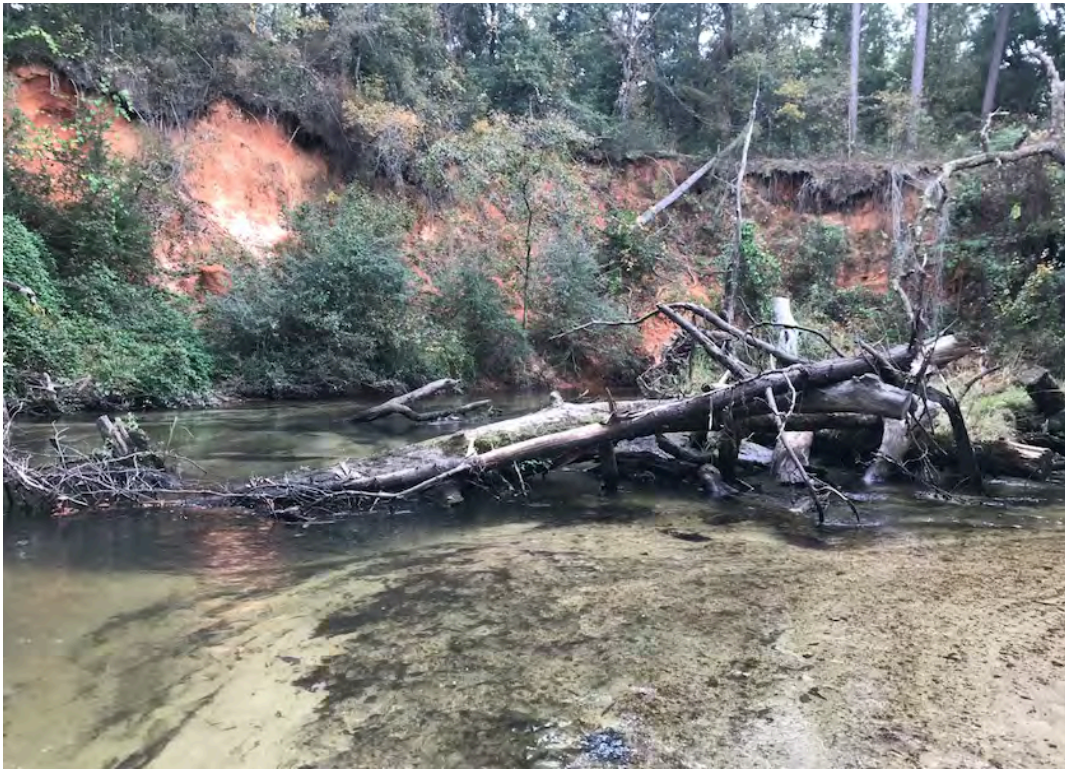
Photo B1. Bluff 1, view downstream near the upstream portion of the RSA1 survey reach.

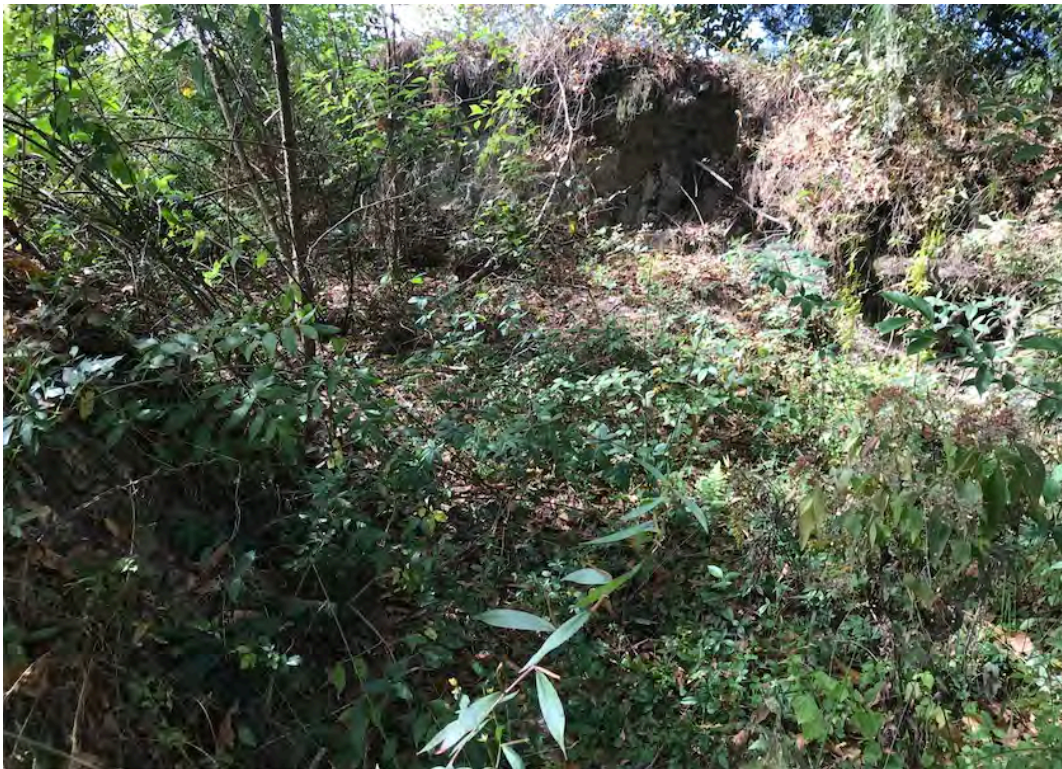
Photo B4. Bluff 2 downstream portion of the survey transect with eroding bluff.

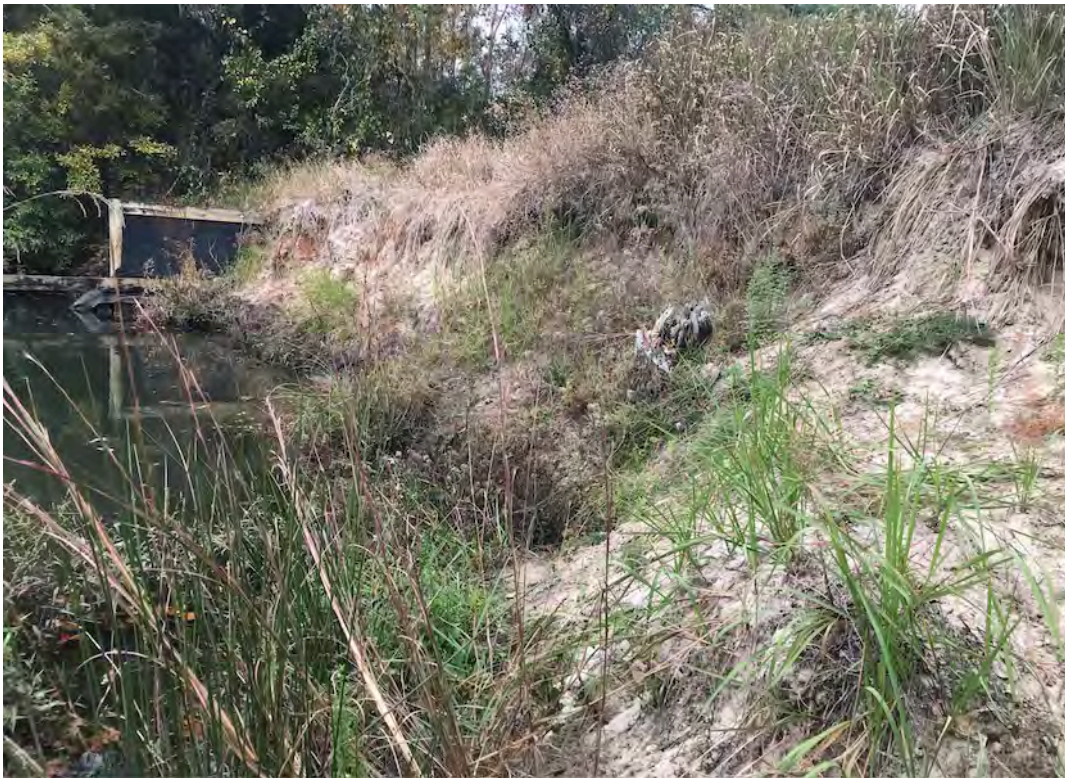
Photo B8. Bluff 4, downstream end of the survey transect.
