The Tide Doesn't Go Out Anymore- The Effect of Bulkheads on Urban Bay Shorelines

Scott L. Douglass and Bradley H. Pickel

*Civil Engineering and Marine Sciences Departments
University of South Alabama*

Shore & Beach Vol. 67, No. 2&3, April & July 1999, pp. 19-25

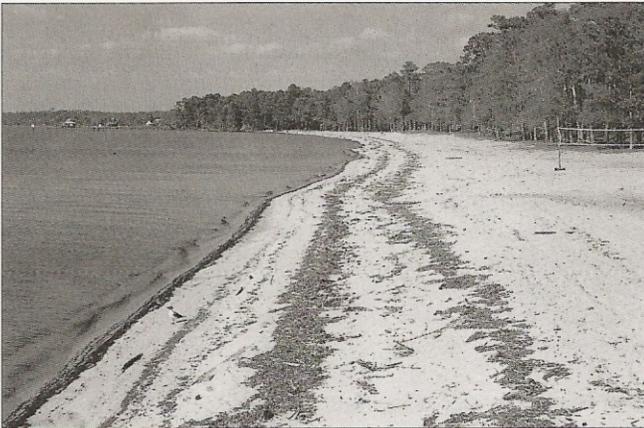
Figure 7. Photo and beach profile showing intertidal zone at the Fairhope public beach on the eastern shore of Mobile Bay.

Figures 7 and 8 are examples that show some of the Mobile Bay shorelines that have not yet been armored. Figure 7 is a public swimming beach in the City of Fairhope on the eastern shore of Mobile Bay. The photograph shows several debris lines from previous high tides. The beach profile shows that the intertidal zone here is fairly narrow due to the relatively steep beach slope (about 1:12).

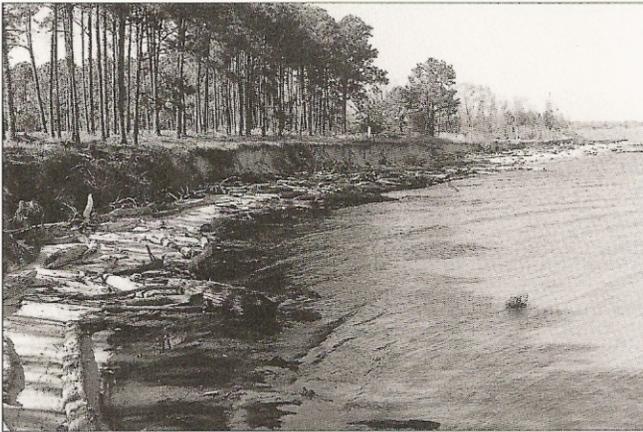
Figure 8. Photo and beach profile showing intertidal zone at the Gulf Pines Golf Course on the western shore of Mobile Bay.

Figure 8 is an eroding bluff on the northwestern shore of Mobile Bay. This area is typical of unarmored shorelines throughout the bay. There is a steep bluff that actively erodes during high water storms. The one-year recurrence water level is about +3 ft above mean sea level (MSL) or 2 ft above mean high water in Mobile Bay. These high water levels typically occur due to strong southeast winds for several days that set the shelf of the Gulf of Mexico up several feet and also cause some wind setup in Mobile Bay. Much higher water levels occur during tropical storms. The 100-year flood level is about +12 ft

above MSL. Figure 8 shows a beach at the base of the bluff that is littered with logs and trees that have floated out of the Mobile/Tensaw River systems. The profile shows that the intertidal beach is very wide here. More than 200 ft of tidal flat is exposed at low tide. The land shown in Figure 8 is managed as a golf course by the University of South Alabama.
