GEOLOGICAL SURVEY OF ALABAMA

**COMPREHENSIVE SHORELINE MAPPING,
BALDWIN AND MOBILE COUNTIES, ALABAMA:
PHASE III**

OPEN FILE REPORT 1204

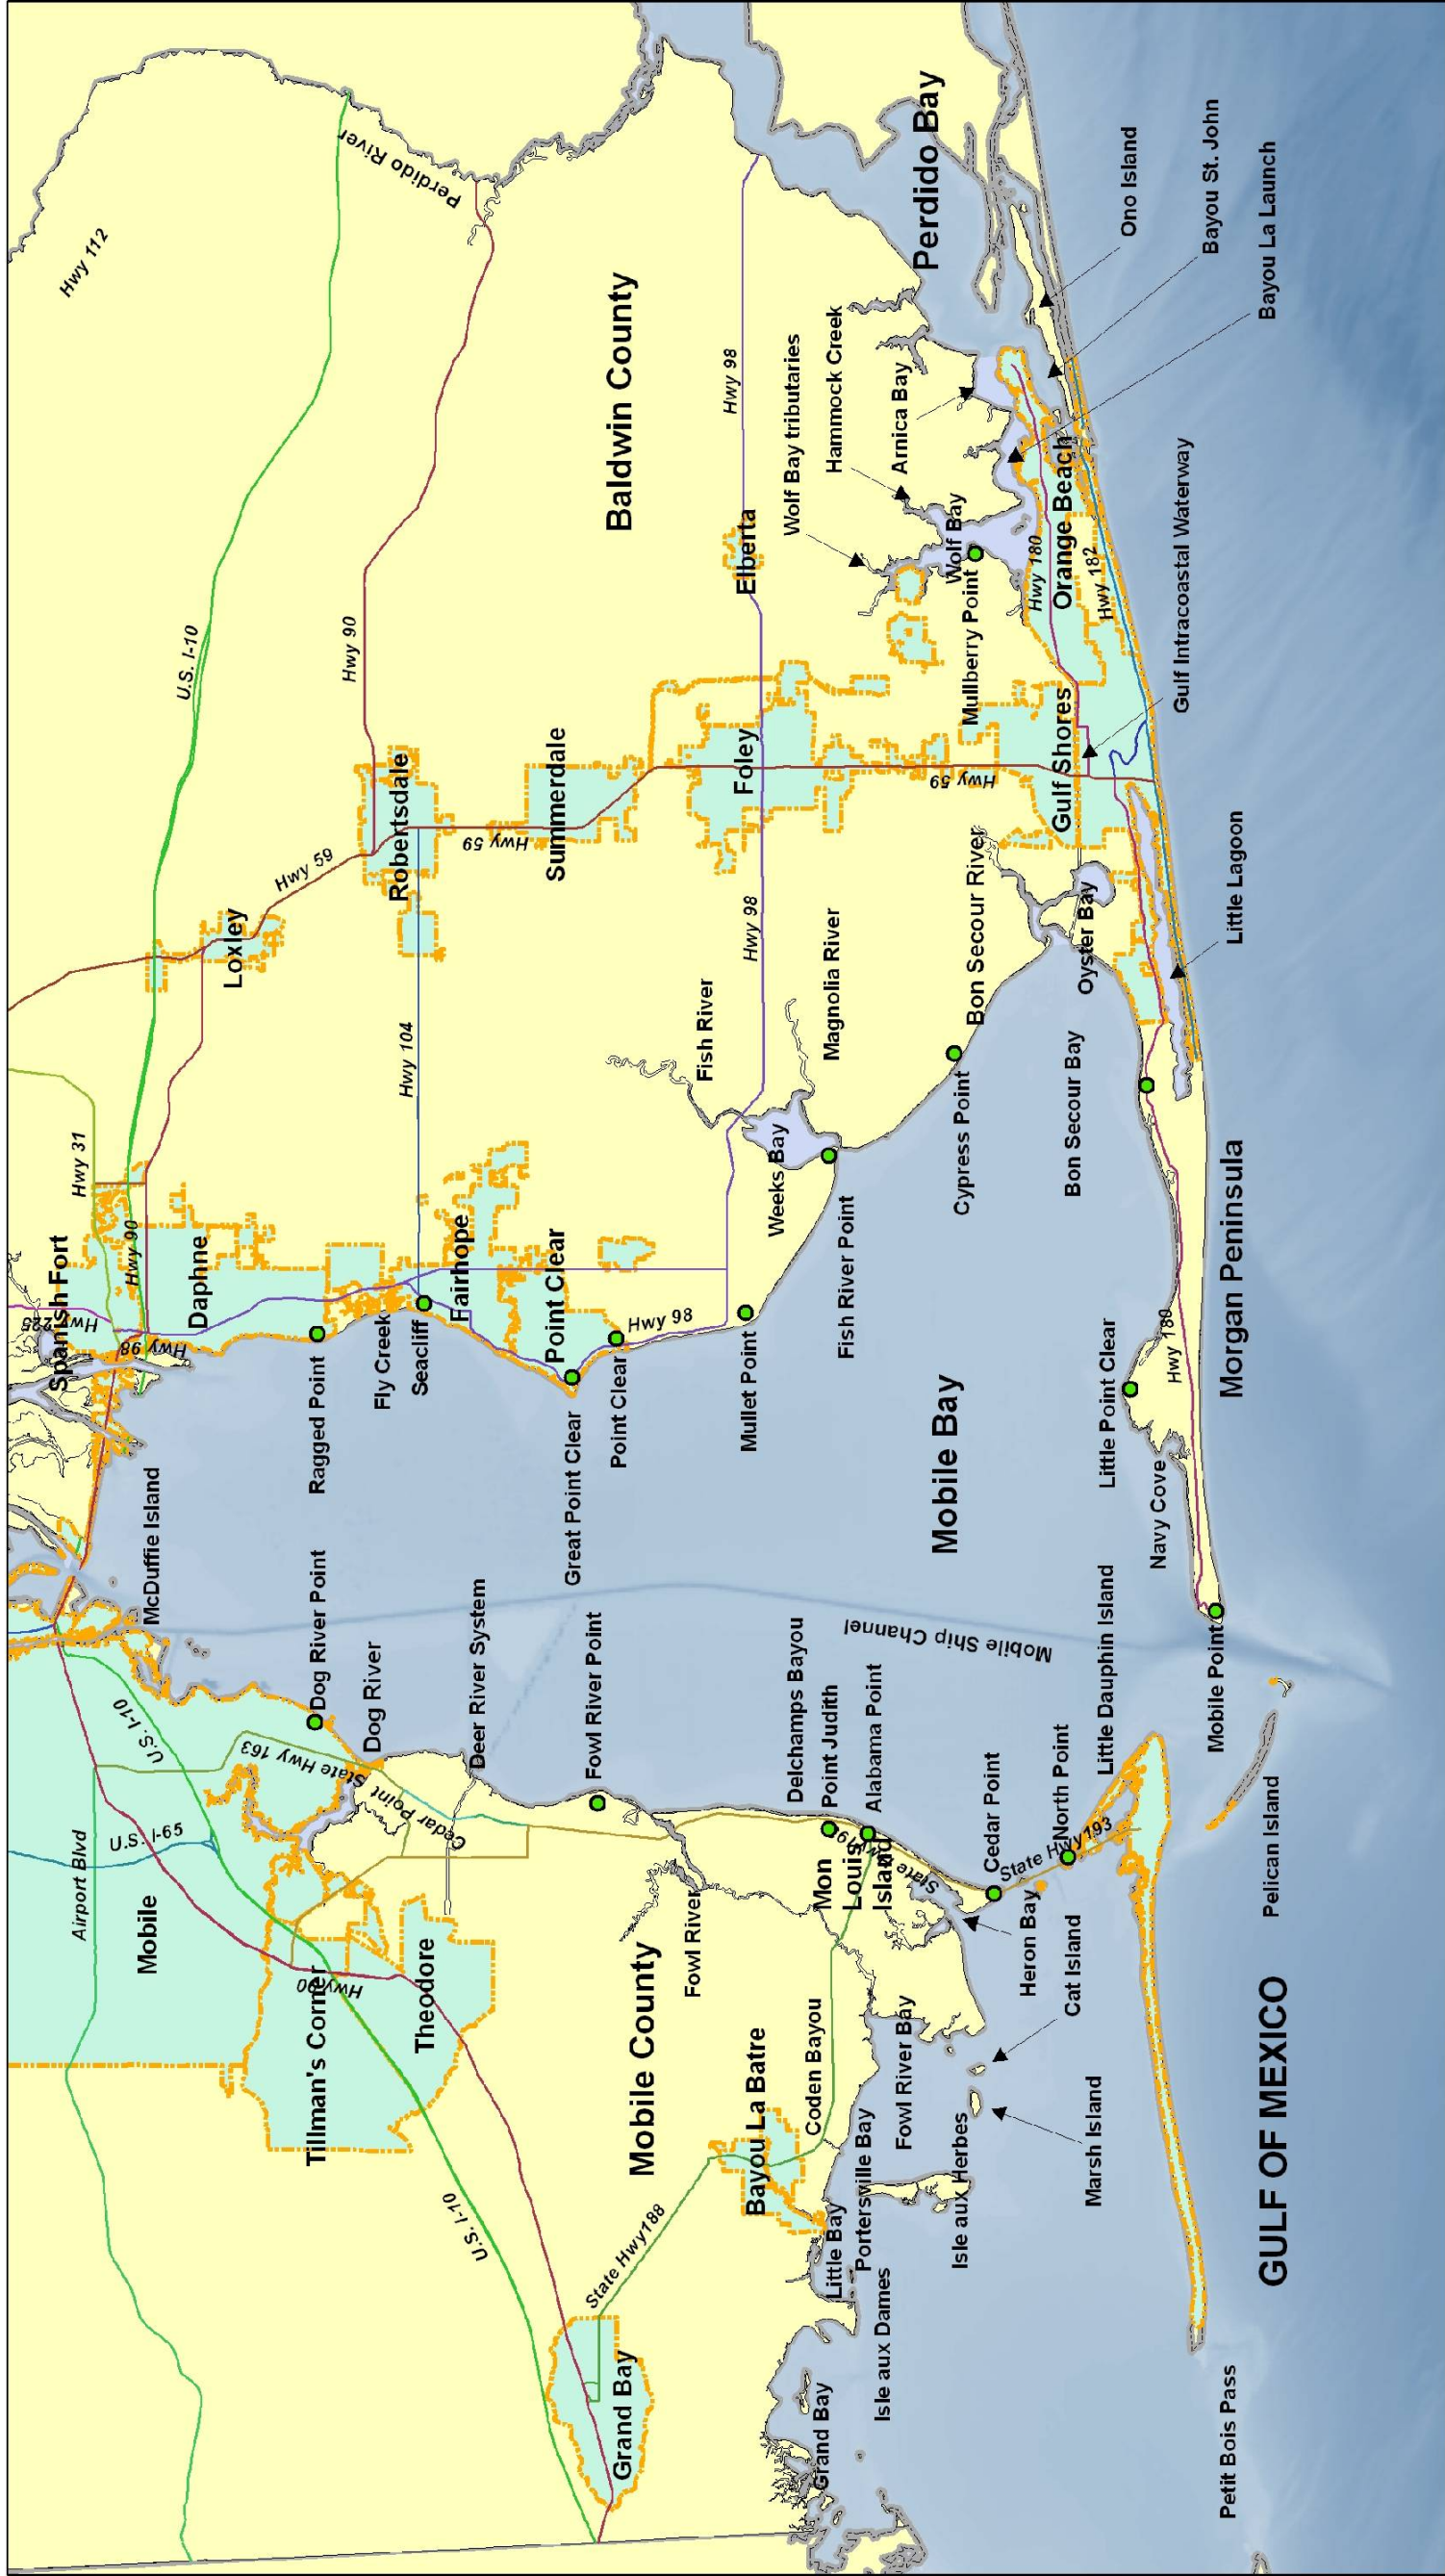
Figure 2.--Study area map.

The study areas for Phase III and described herein are Ono Island, Bayou St. John, Northeast Perdido Bay, Southwest Perdido Bay and adjoining tributaries, Arnica Bay, Bay La Launch and South Wolf Bay, Hammock Creek, Wolf Bay tributaries, North Fowl River, South Fowl River, Herron Bay, Fowl River Bay and Portersville Bay, Grand Bay, Bayou La Batre, Coden Bayou, Isle aux Herbes, Dauphin Island and Baldwin Beaches (fig2).

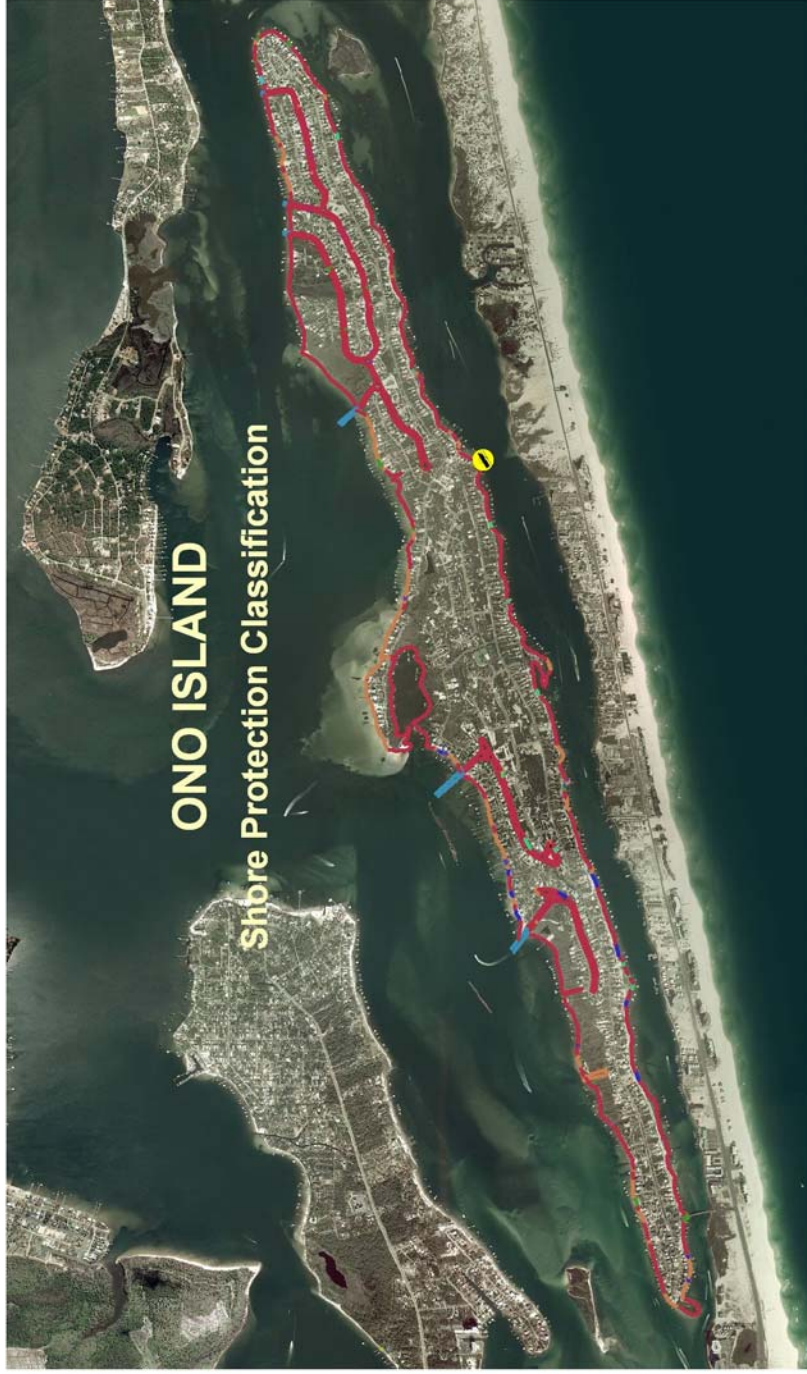
Figure 3.--Shore protection map of Ono Island.

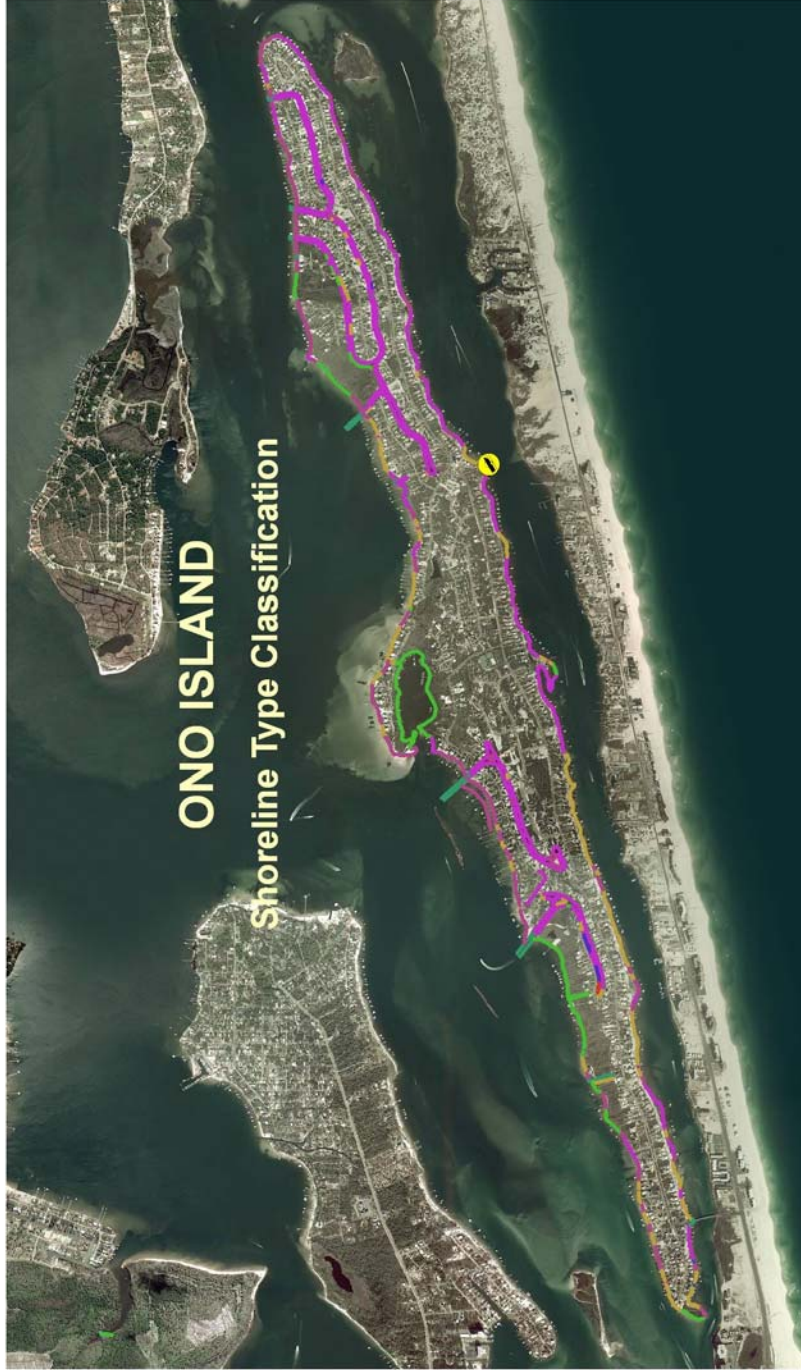
Figure 4.--Shoreline type map of Ono Island.

Organic shoreline type makes up about 75,521 feet (14.3 miles) or about 59.5 percent of the total. Sediment bank shoreline type makes up about 23,639 feet (4.5 miles) or about 18.6 percent of the total. Vegetated bank shoreline type makes up about 20,964 feet (4.0 miles) or about 16.5 percent of the total on Ono Island. Artificial and pocket beach shoreline types makes up about 6,467 feet (1.2 miles) or about 5.1 percent and about 173 feet or less than 0.1 percent of the total shoreline type on Ono Island, respectively. There were five inlets identified.

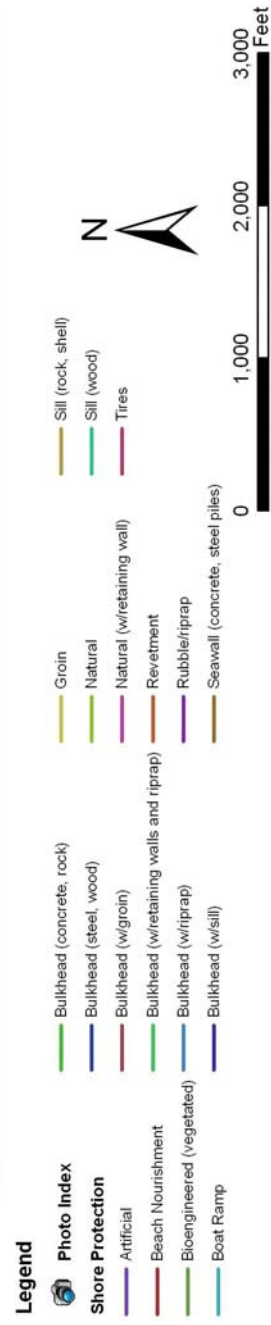
Figure 5.--Shore protection map of Bayou St. John.

Bayou St. John consists mainly of bulkhead shoreline having about 77,577 feet (14.7 miles) or about 53.9 percent of the total. Bulkhead (steel, wood) shore protection, longest of the five bulkhead subtypes observed, makes up about 71,966 feet (13.6 miles) or about 50.0 percent of the total. Natural, unretained shore protection makes up about 51,164 feet (9.7 miles) or about 35.5 percent of the total shore protection in Bayou St. John. Rubble/riprap shore protection makes up about 8,972 feet (1.7 miles) or about 6.2 percent of the total shore protection in Bayou St. John. There were 10 private boat ramps and 11 public boat ramps encountered in Bayou St. John (fig. 6). The remaining 4.3 percent of the shoreline is armored through various methods listed above and tabulated in table 8.

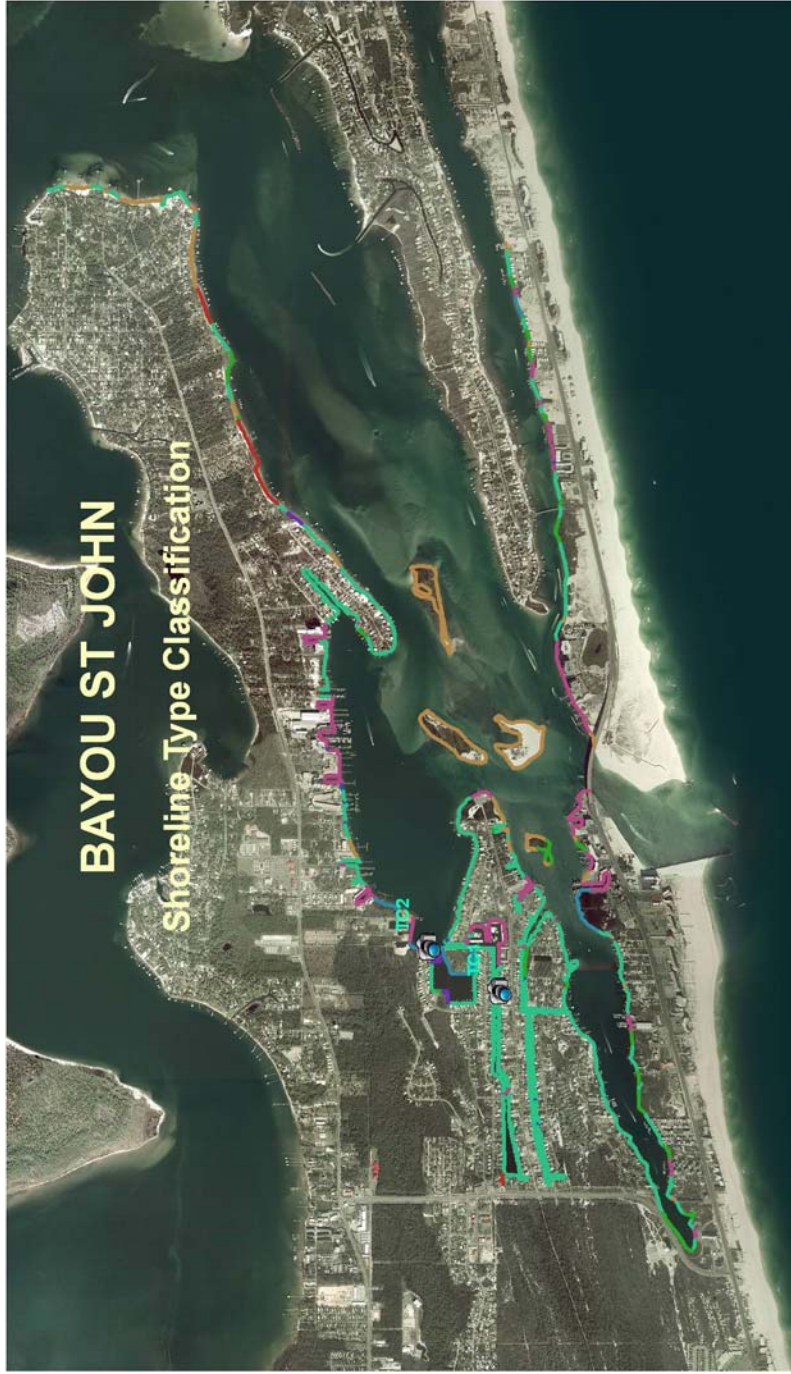
Figure 7.--Shoreline type map of Bayou St. John.

There were nine different shoreline types found in Bayou St. John (table 9) making up 140,653 feet or about 26.6 miles mapped. Figure 7 illustrates the distribution of the shoreline types in Bayou St. John. Vegetated bank shoreline type makes up about 82,719 feet (15 miles) or about 58.8 percent. Artificial shoreline type makes up about 21,906 feet (4.1 miles) or about 15.6 percent of the total shoreline type in Bayou St.

John. Sediment bank shoreline type makes up about 21,713 feet (4.1 miles) or about 15.4 percent of the total shoreline type in Bayou St. John. Organic shoreline type makes up about 13,338 feet (2.5 miles) or about 9.5 percent of the total shoreline type. Pocket beach makes up about 900 feet or 0.6 percent of the total shoreline type mapped in Bayou St. John. There were six inlets observed in Bayou St. John.

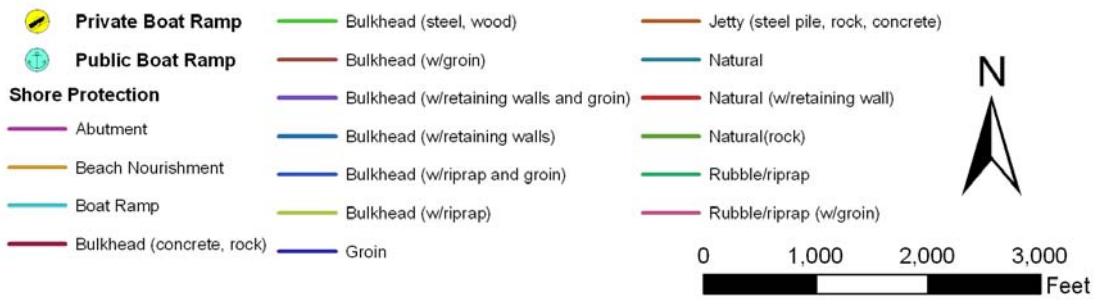
Figure 8.--Shore protection map of Northeast Perdido Bay.

Northeast Perdido Bay consists mainly of natural, unretained shoreline having about 33,769 feet (6.4 miles) or about 63 percent of the total. Bulkhead (steel, wood) shore protection, longest of the seven bulkhead subtypes observed, makes up about 6,631 feet (1.3 miles) or about 12.4 percent of the total. Rubble/riprap shore protection makes up about 2,776 feet or about 5.2 percent of the total shore protection in Northeast Perdido Bay. There were seven private boat ramps and one public boat ramp encountered in Northeast Perdido Bay. The remaining 19.4 percent of the shoreline is armored through various methods listed above and tabulated in table 10.

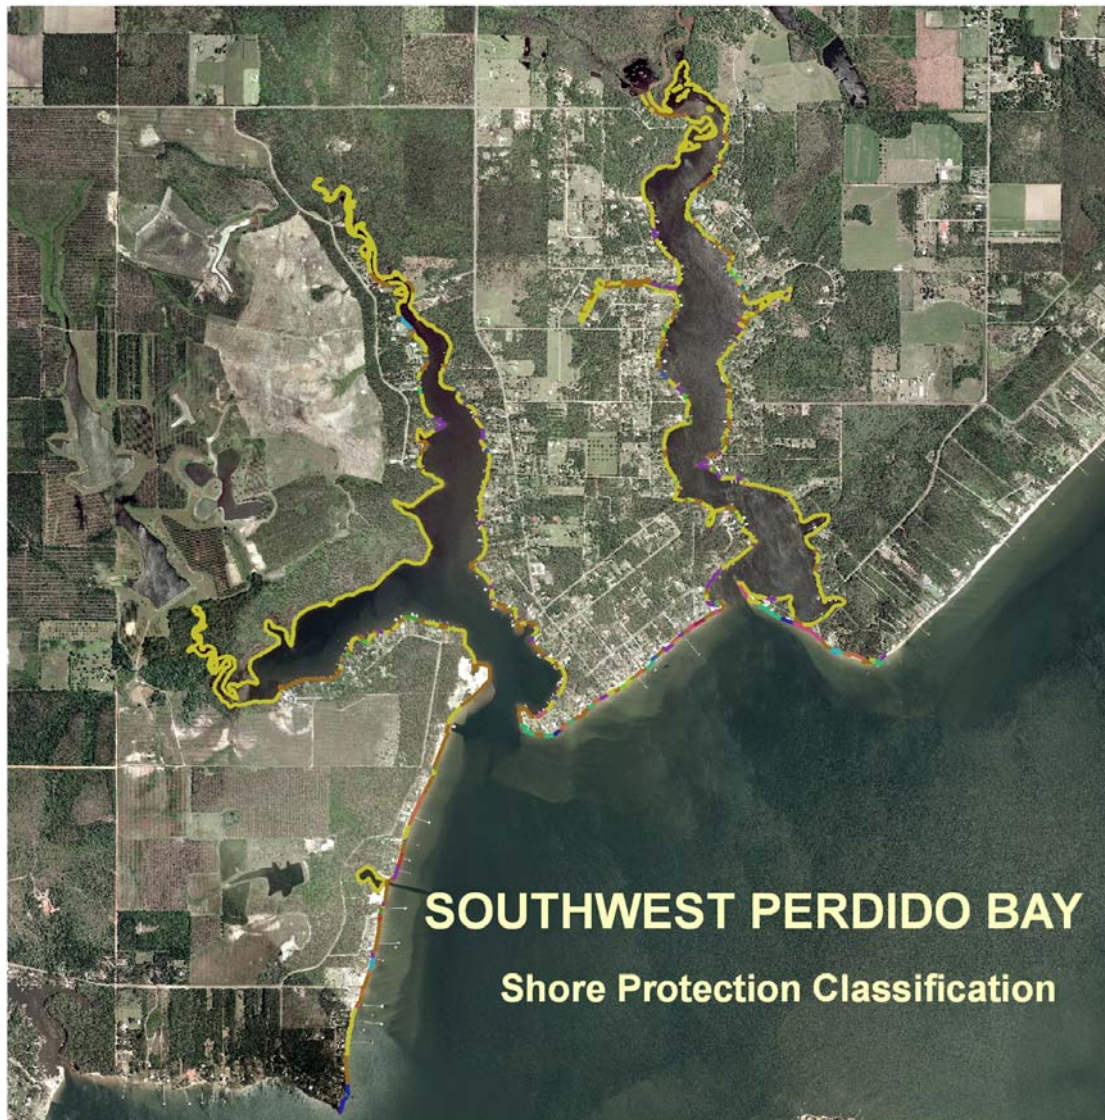
Figure 10.--Shore protection map of Southwest Perdido Bay.

Shore protection classifications in Southwest Perdido Bay are numerous. Seventeen different classification types were observed, including beach nourishment, boat ramp, bulkhead subtypes, cement, groin, natural subtypes, rubble/riprap subtypes and sill subtypes. Detailed shore protection data are provided in table 12 where about 113,720 feet (21.5 miles) of shoreline were mapped for Southwest Perdido Bay. Figure 10 illustrates the distribution of shore protection as mapped in Southwest Perdido Bay.

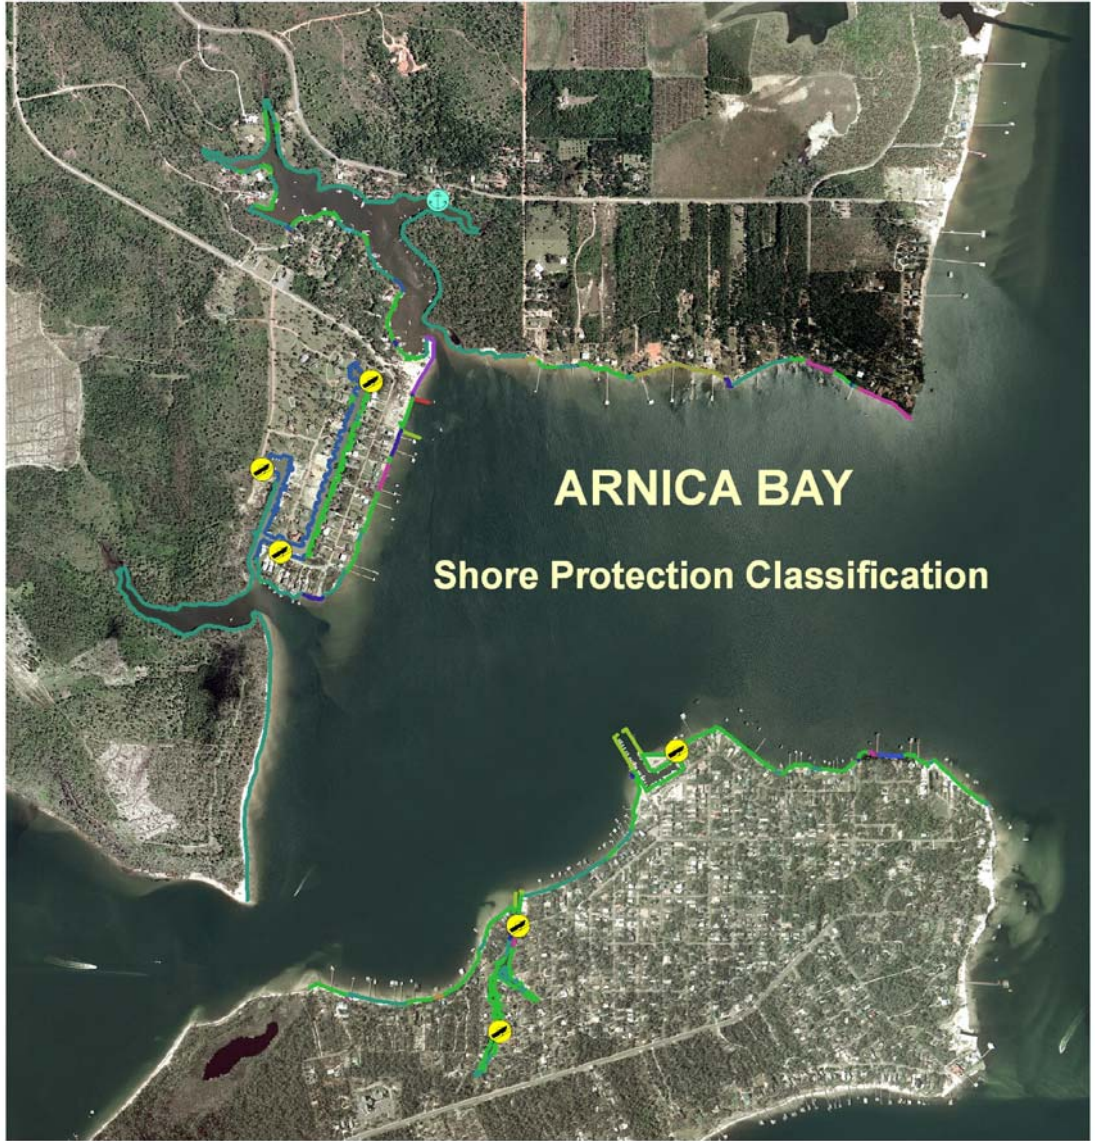
Sixteen different shore protection classifications were mapped in Arnica Bay. These included boat beach nourishment, boat ramp, bulkhead subtypes, cement, groin, jetty (steel pile, rock, concrete), natural, unretained, revetment, rubble/riprap subtypes, and sill (wood). Shore protection estimates for Arnica Bay are listed in table 14, and figure 13 depicts the distribution.

Bulkhead shore protection is the longest mapped at 52.7 percent of the total; the bulkhead (steel, wood) subtype mapped had about 20,998 feet (4 miles) or 36.5 percent of the total. Natural, unretained shoreline makes up about 23,314 feet (4.4 miles) and 40.6 percent of the total shore mapped under the shore protection classification. Rubble/riprap shore protection makes up about 1,317 feet or about 2.3 percent of the total shore protection in Arnica Bay. The remaining 4.4 percent of the shoreline is armored through various methods listed above and tabulated in table 14. There were six private boat ramps and one public boat ramp observed in Arnica Bay.

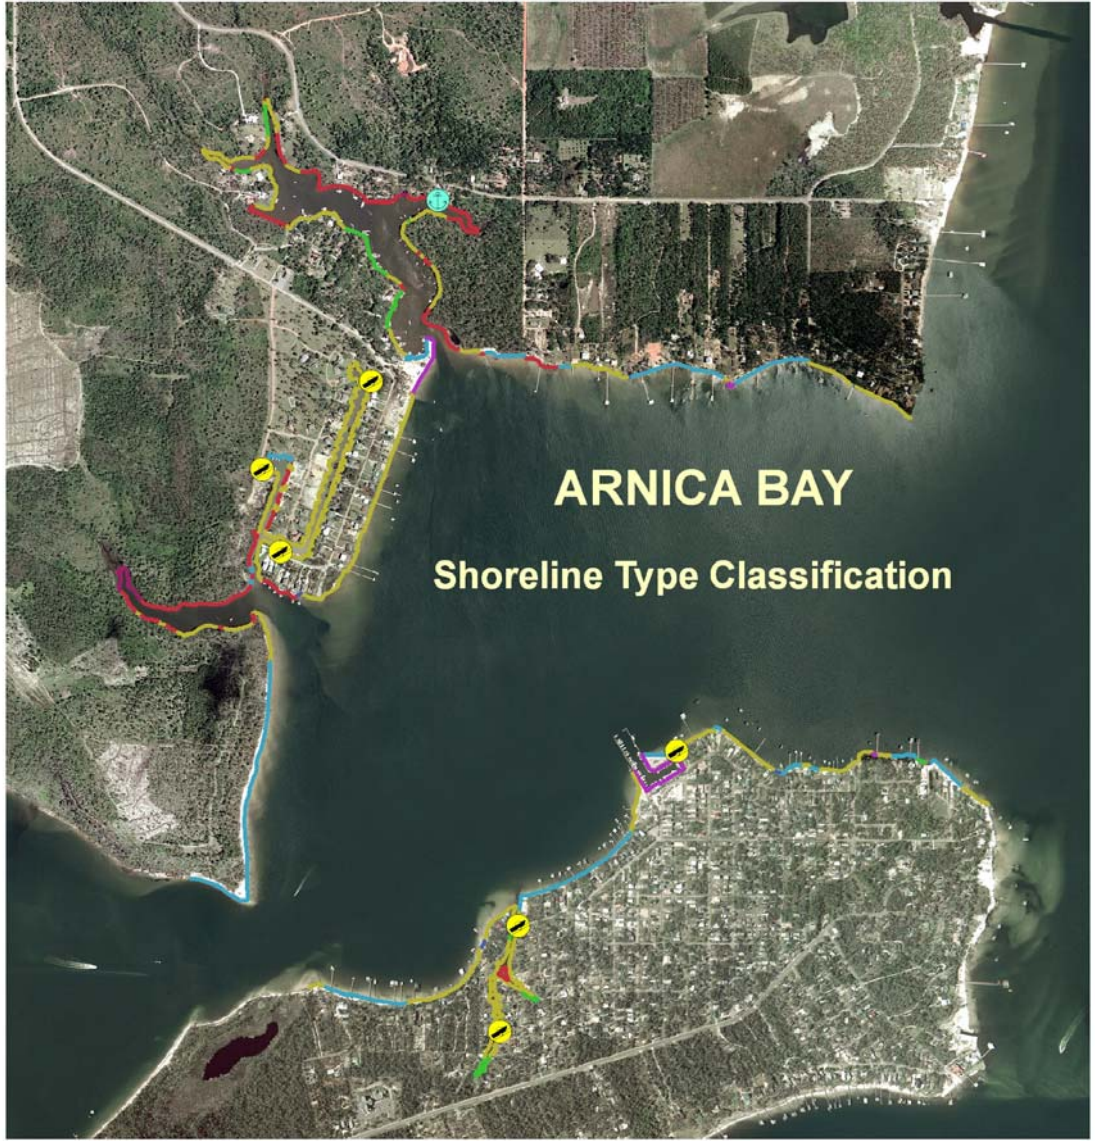
Figure 14.—Shoreline type map of Arnica Bay.

Eight different shoreline type classifications were identified in Arnica Bay including artificial, inlet, organic (marsh), organic (open, vegetated fringe), pocket beach, sediment bank (low), and vegetated bank (high and low). Specific shoreline type values are listed in table 15. Figure 14 illustrates the distribution of Arnica Bay shoreline types.

The dominant shoreline type in Arnica Bay is vegetated bank making up about 32,724 feet (6.2 miles) or about 57.8 percent of the total in Arnica Bay with most classified in the low subtype. Sediment bank (low) shoreline, the second longest mapped, makes up about 10,729 feet (2 miles) or about 19 percent of the total. Organic shoreline type makes up about 10,082 feet (1.9 miles) or about 17.8 percent. There were seven inlets identified in Arnica Bay.

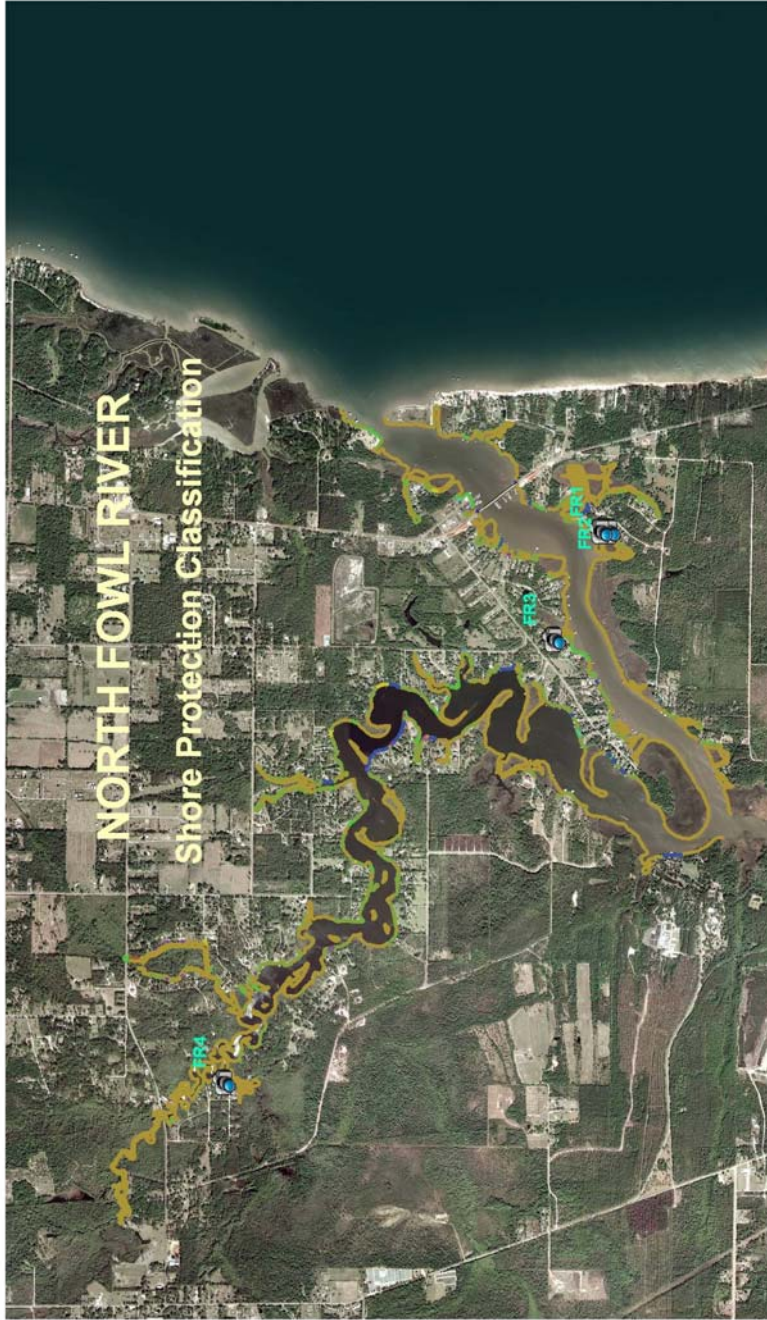
Figure 24.—Shore protection map of North Fowl River.

North Fowl River consists mainly of natural, unretained shoreline having about 147,326 feet (27.9 miles) or about 72.9 percent of the total shore protection mapped. Bulkhead shore protection subtypes, the second largest, make up about 46,143 feet (8.7 miles) or about 22.7 percent of the total shore protection in North Fowl River, with bulkhead (steel, wood) being the largest. Rubble/riprap shore protection subtypes make up about 6,230 feet (1.2 miles) or about 3 percent of the total shore protection in North Fowl River, with rubble/riprap being the largest. The remaining 1.3 percent of the shoreline is armored through various methods listed above and tabulated in table 22. There were 28 private and four public boat ramps observed in North Fowl River (fig. 25).

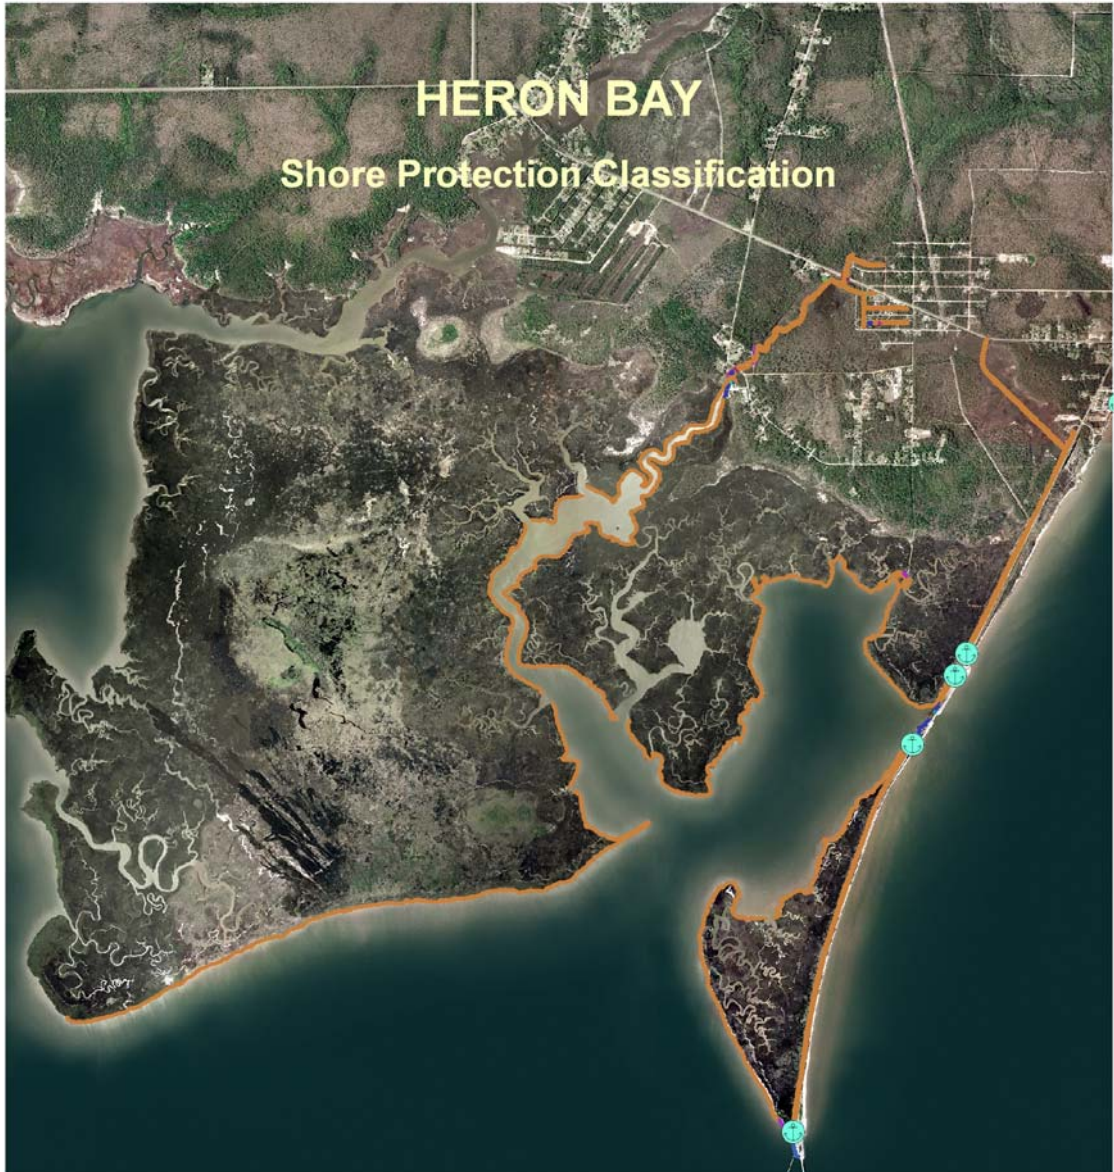
Figure 30.—Shore protection map of Heron Bay.

Ten different shore protection classifications were mapped in Heron Bay. These included abutment, boat ramp, bulkhead subtypes, natural, unretained, oyster shells, revetment, rubble/riprap, and sill (wood). Shore protection estimates for Heron Bay are listed in table 26, and figure 30 depicts the distribution.

Heron Bay consists mainly of natural, unretained shoreline having about 140,803 feet (26.7 miles) or about 96.5 percent of the total. Bulkhead shore protection makes up about 1,698 feet or about 1.2 percent of the total shore protection in Heron Bay. Rubble/riprap shore protection makes up about 1,687 feet or about 1.2 percent of the total shore protection in Heron Bay. The remaining 1.2 percent of the shoreline is armored through various methods listed above and tabulated in table 26. There were four public boat ramps observed in Heron Bay.

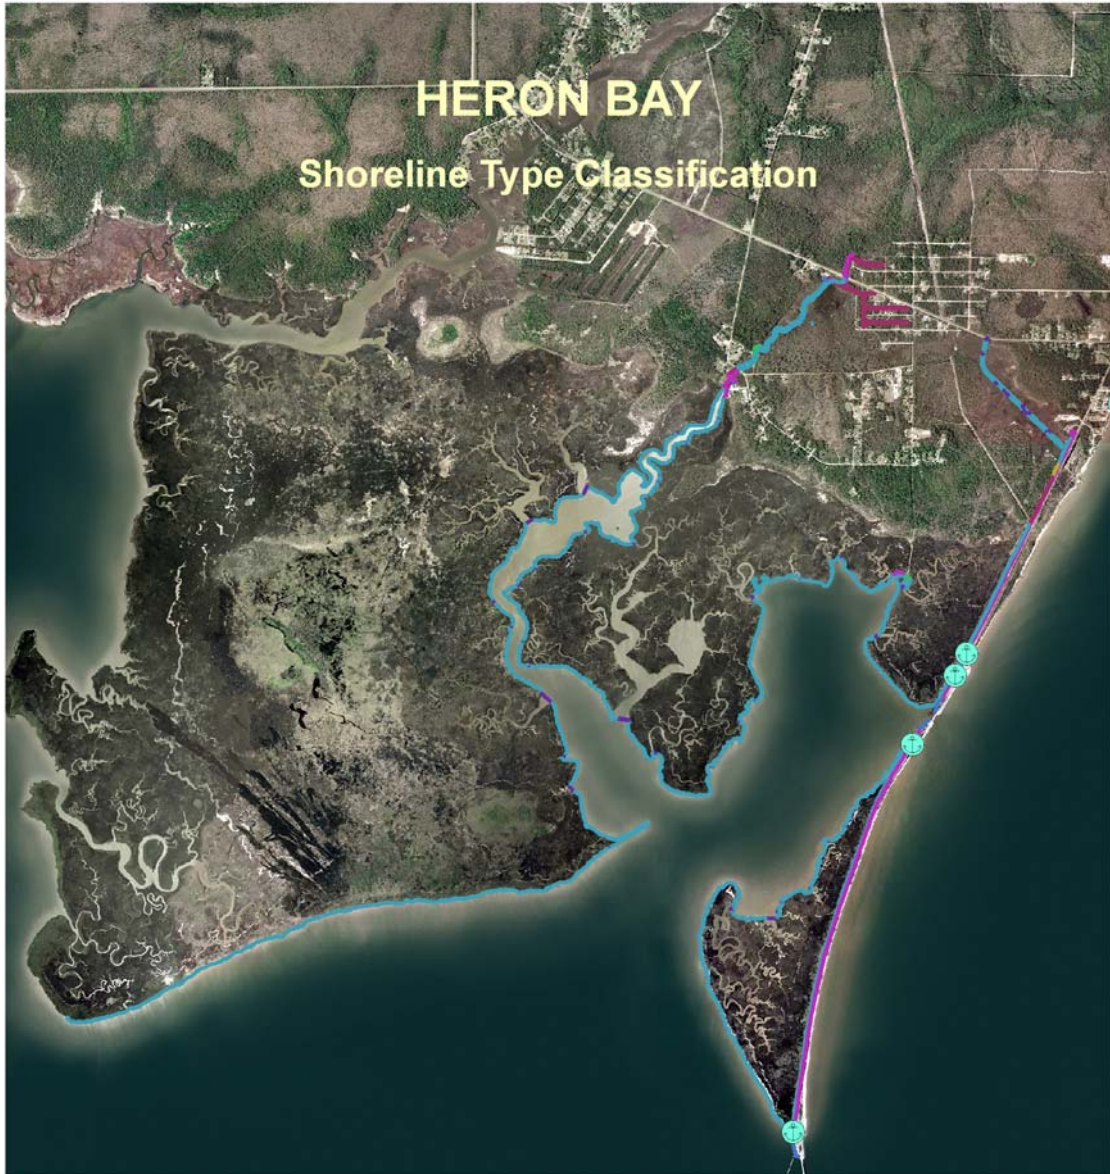
Figure 31.--Shoreline type map of Heron Bay.

The dominant shoreline type in Heron Bay is organic shoreline types making up about 132,530 feet (25.1 miles) or about 80.2 percent of the total in Heron Bay with most classified as marsh. Vegetated bank (low) shoreline, the second longest mapped, makes up about 14,046 feet (2.7 miles) or about 8.5 percent of the total. Sediment bank shoreline types makes up about 11,308 feet (2.1 miles) or about 6.9 percent. There were 66 inlets identified in Heron Bay.

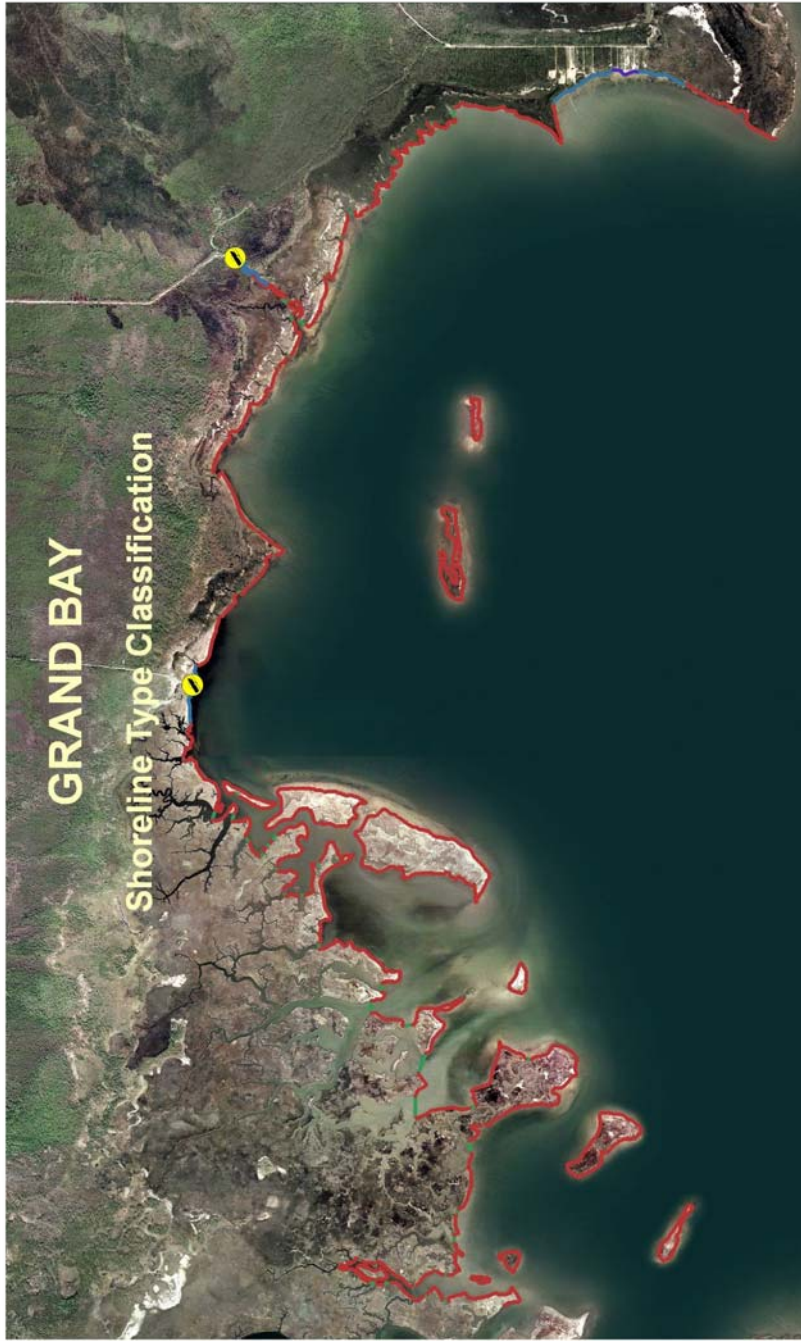
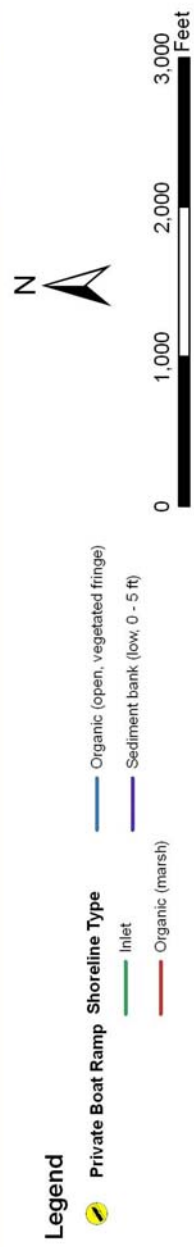
Figure 35.—Shoreline type map of Grand Bay.

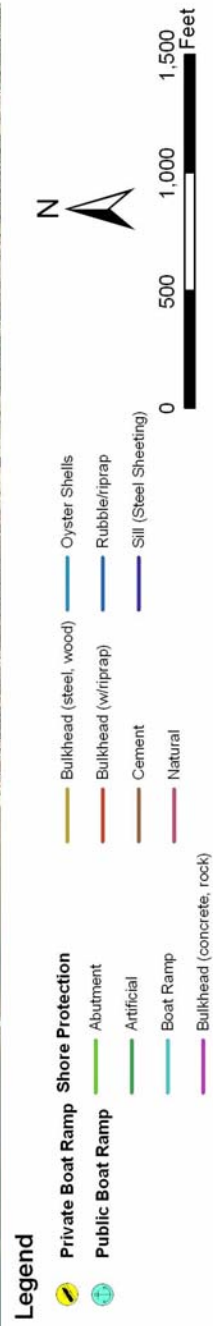
Figure 36.—Shore protection map of Bayou La Batre.

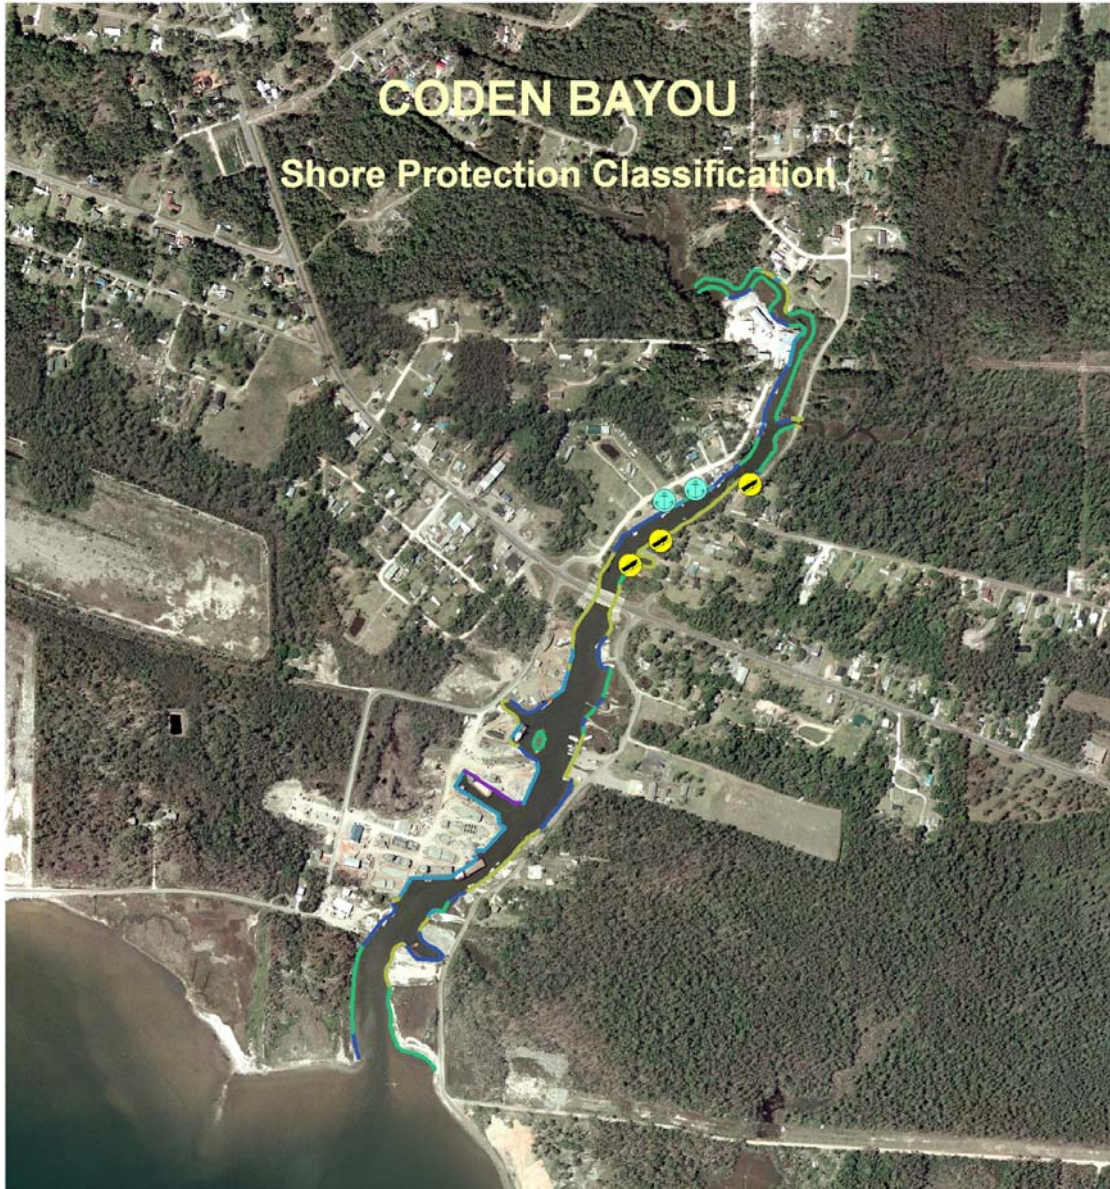
Coden Bayou		
Shore protection classification	Length (ft)	Percent
Boat Ramp	95	0.7
Bulkhead (concrete, rock)	352	2.6
Bulkhead (steel, wood)	2,257	16.7
Cement	28	0.2
Natural, unretained	4,004	29.7
Oyster Shells	3,192	23.6
Rubble/riprap	3,570	26.5
Total	13,497	100.0

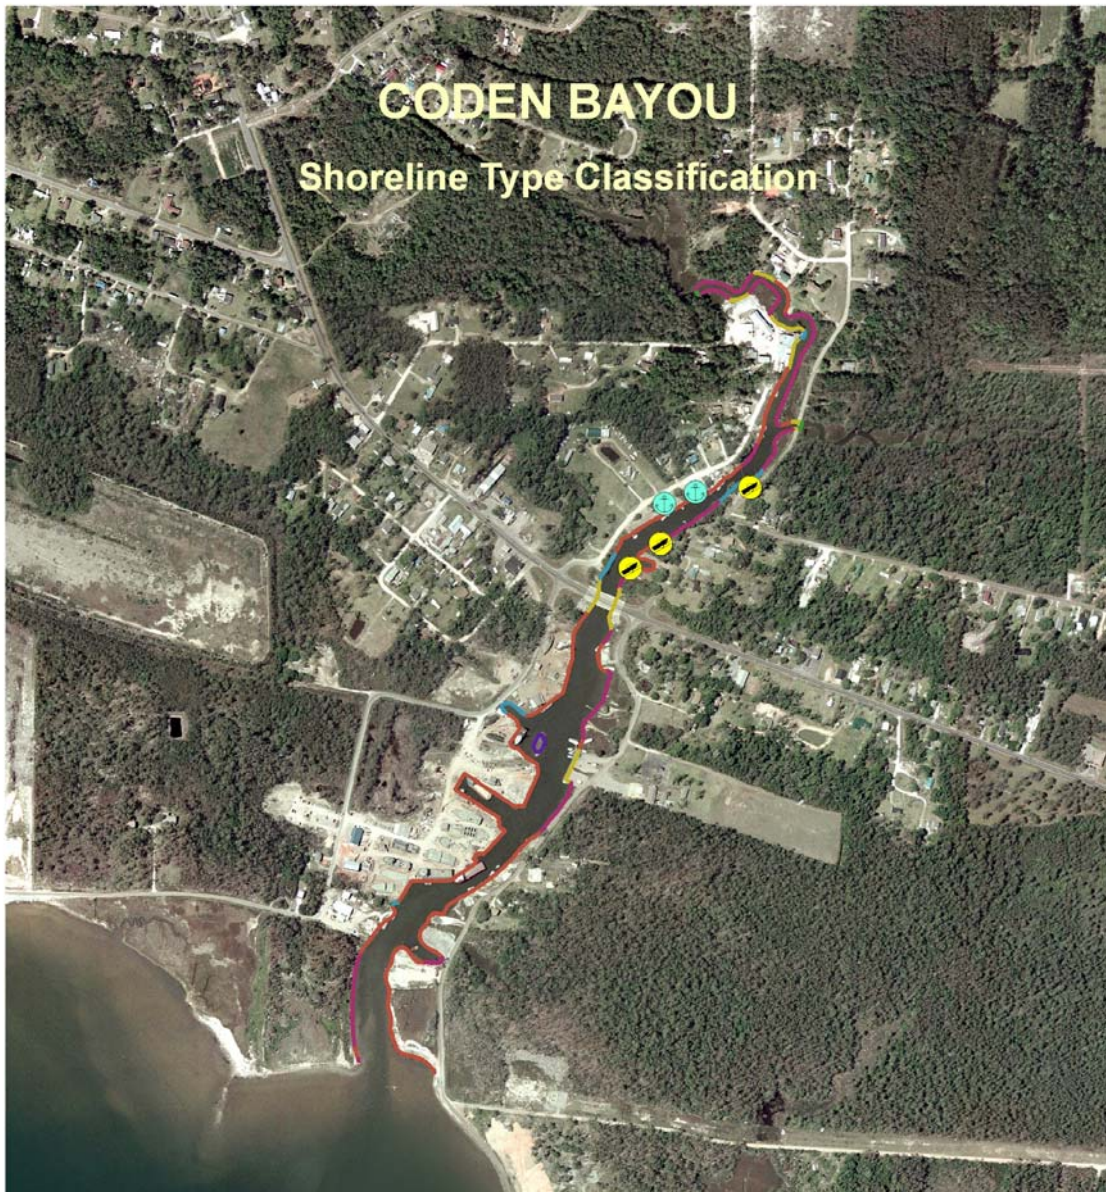
CODEN BAYOU
Shoreline Type Classification

Coden Bayou		
Shoreline type classification	Length (ft)	Percent
Artificial	1,326	9.8
Inlet	98	0.7
Organic (marsh)	224	1.7
Organic (open, vegetated fringe)	3,842	28.3
Sediment bank (low, 0 - 5 ft)	7,347	54.2
Vegetated bank (low, 0 - 5 ft)	728	5.4
Total	13,565	100.0

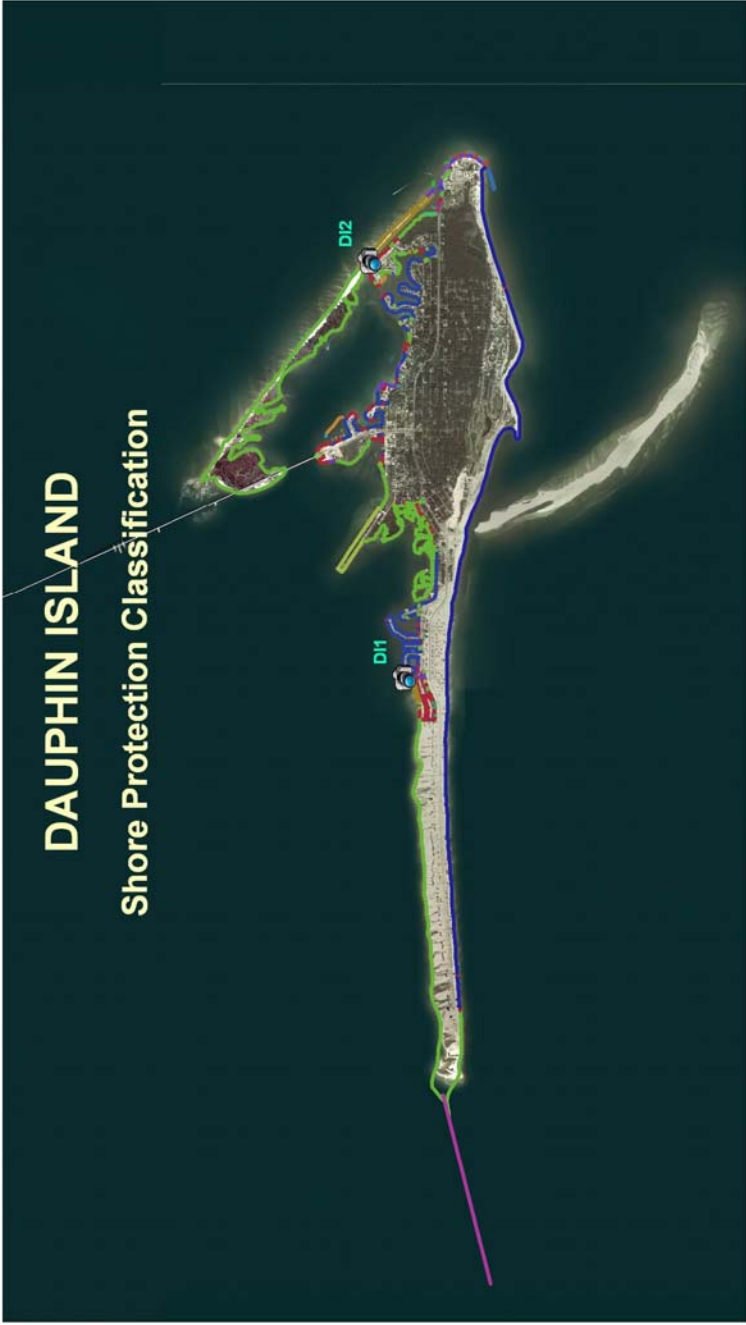
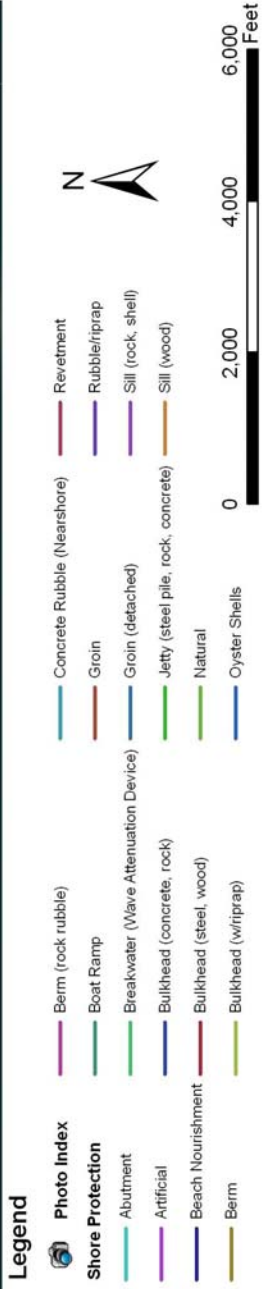
Figure 42.—Shore protection map of Dauphin Island.
