GEOLOGICAL SURVEY OF ALABAMA

**COMPREHENSIVE SHORELINE MAPPING,
BALDWIN AND MOBILE COUNTIES, ALABAMA:
PHASE III**

OPEN FILE REPORT 1204

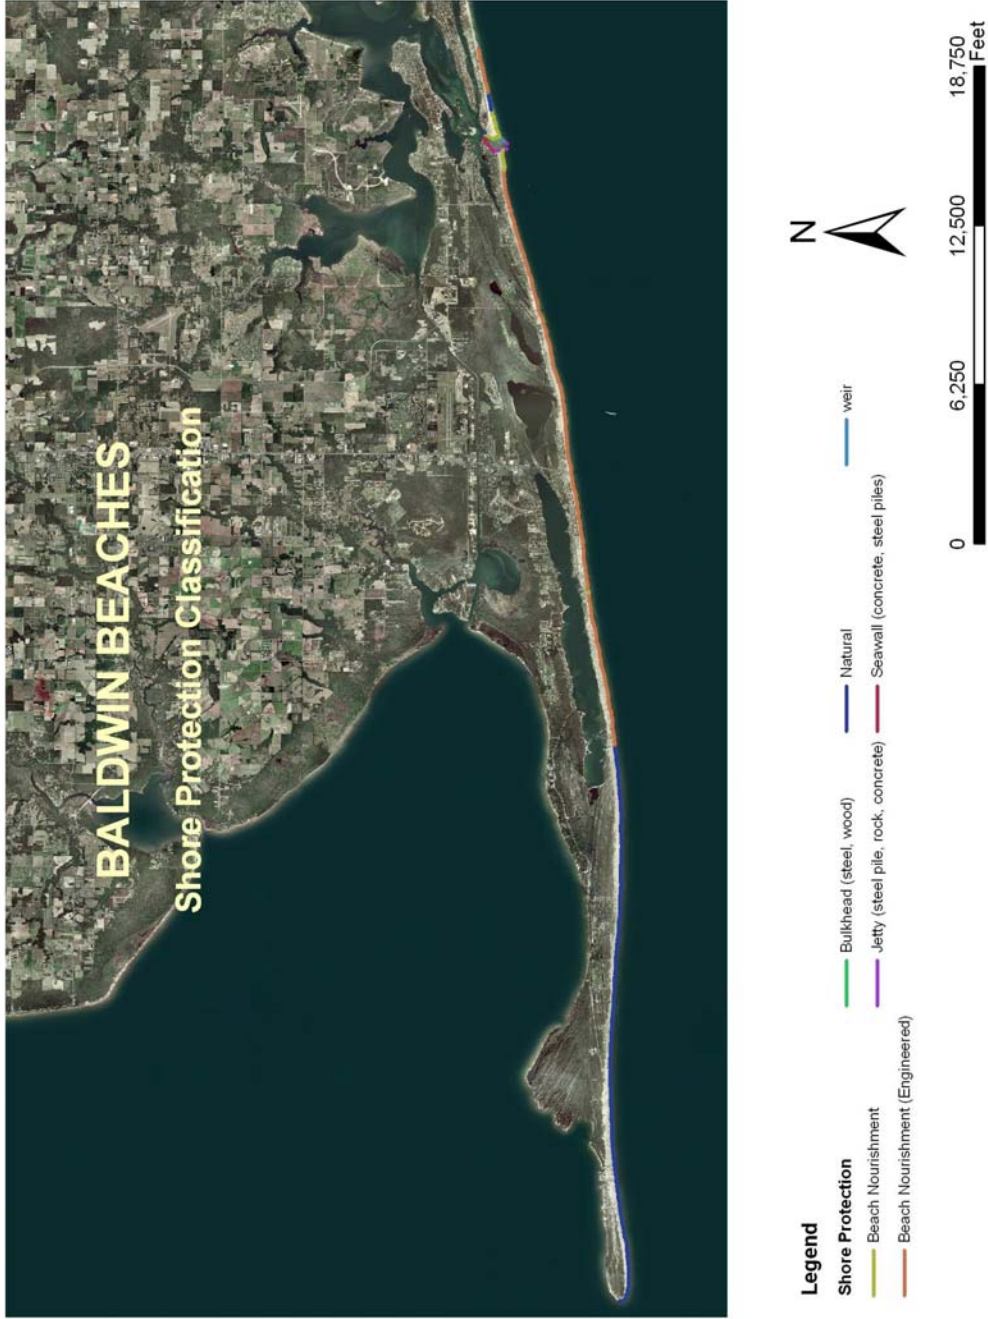
Figure 45.—Shore protection map of Baldwin Beaches.

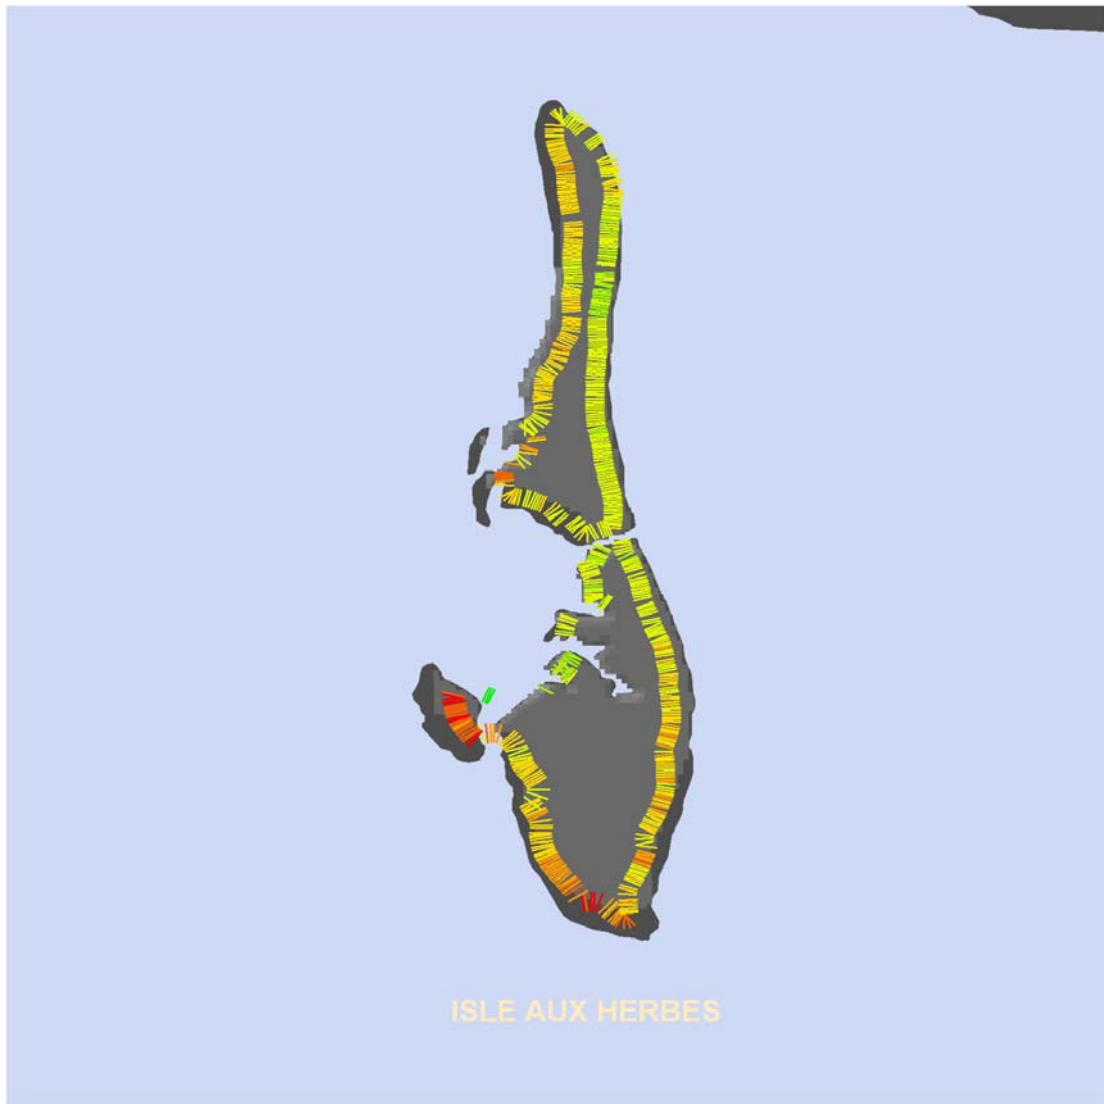
Figure 51.—Isle aux Herbes results from Digital Shoreline Analysis System (1996 through 2010).
