Lake Forest Mapping

ANALYSIS OF SHOALING AND POOL VOLUMES

Analysis of Shoaling and Pool Volumes

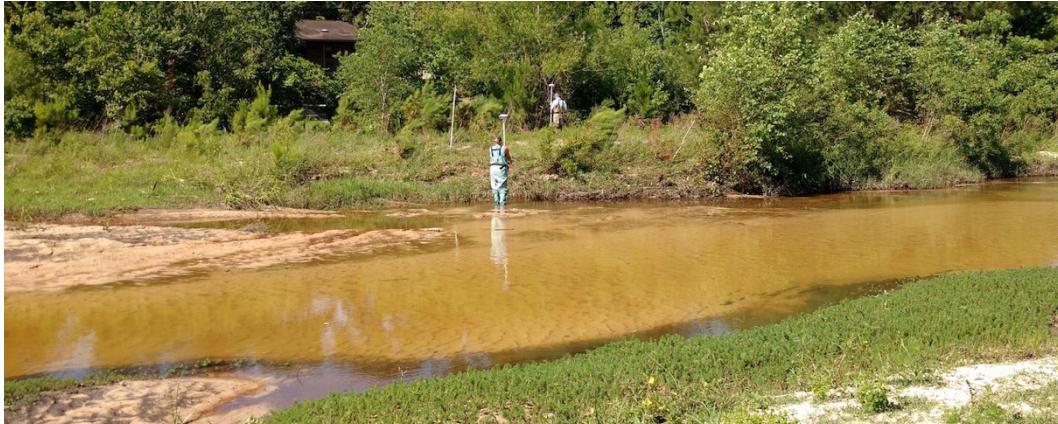
Figure 3. Topographic RTK GNSS mapping in D'Olive Creek on May 24, 2016.

Topographic and very shallow water (i.e., waist-deep water and shallower) elevations were collected by wading survey (see Figure 3). Elevations were sampled at discrete locations (>1500 points) using two Magellan (Ashtech) ProMark 500 Global Navigation Satellite System (GNSS) receivers and MobileMapper CX field terminals. Each of the GNSS receivers were equipped with cellular connections to the Alabama Department of Transportation (ALDOT) Continuously Operating Reference Station (CORS) network, thereby providing Real Time Kinematic (RTK) corrections to the position data. Typical horizontal and vertical root mean square errors were commonly 0.1 ft or less (i.e., HRMS < 0.1 ft; VRMS < 0.1 ft). Points were sampled and recorded in the Alabama State Plane Coordinate System (in feet) using a vertical datum of NAVD88 (ref. Geoid 12a).

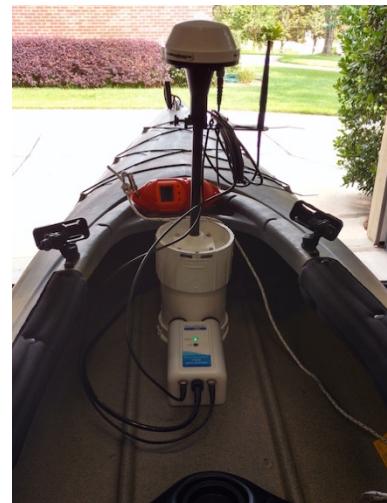
Figure 4. Modified ocean kayak.

Based on the shallow nature of the lake system, presence of vegetation, and lack of access options, the decision was made to proceed with a kayak survey. All of the required instrumentation was transferred from the Jag Ski to a 12-foot-long ocean kayak, which was modified to perform this study (see Figure 4).

The bathymetric mapping was conducted on June 21, 2016 using the modified ocean kayak system. Depth sampling was performed with a SonTek M9 RiverSurveyor Acoustic Doppler Profiler (ADP) and RTK GNSS position referencing system. An RTK base station was established on top of the dam as shown in Figure 5. Samples were obtained and recorded to instrument memory at a rate of 1 sample per second. The resulting sample spacing was typically less than 4 ft. Over 10,400 samples were obtained over a four-hour period.

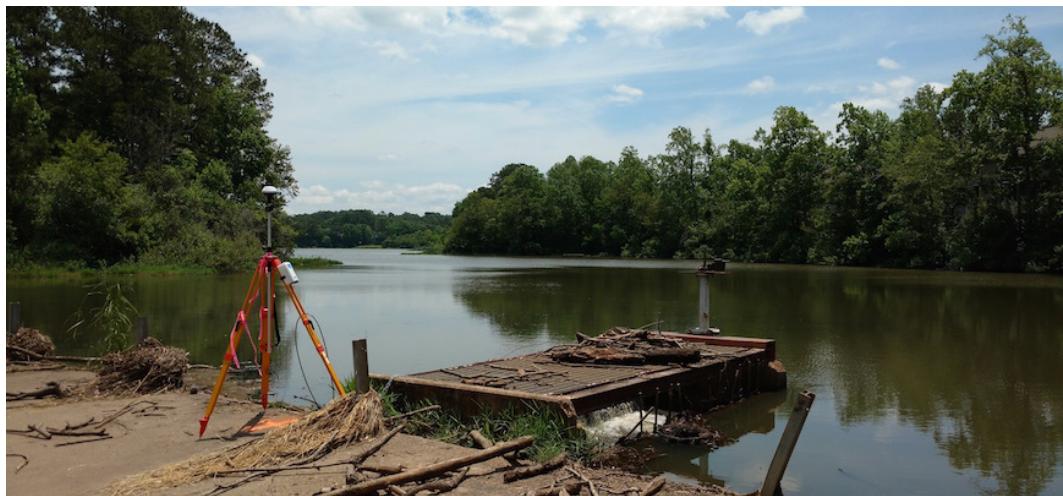
Figure 5. The RTK base station location used for the bathymetric mapping.

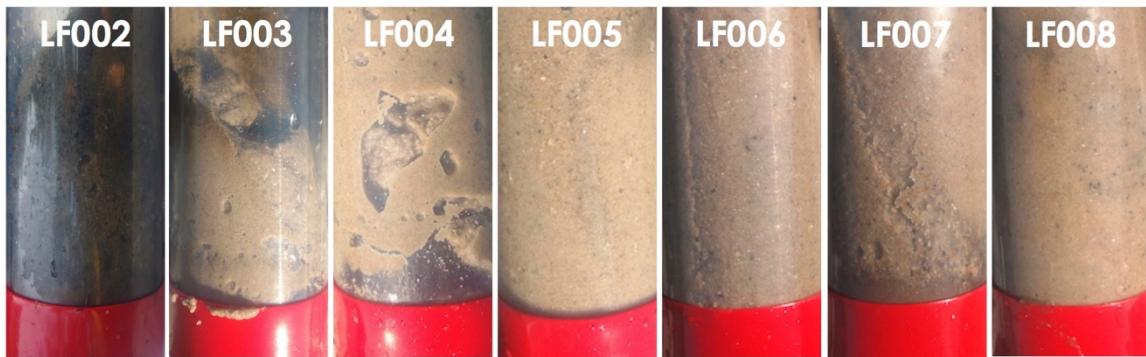
Figure B- 2. Wet sediment core samples obtained from Lake Forest.

Eight (8) sediment samples (see Figure B- 2) were analyzed to determine their grain size distributions. The samples were dried to constant weight in an oven for 15 hours and then left to air dry for another 72 hours (see Figure B- 3). The grain sorting was performed using a standard stack of geotechnical sieves (i.e., 4, 10, 30, 40, 50, 60, 80, 100, 140, 200) set in a Ro-Tap® and allowed to shake for at least 10 minutes.

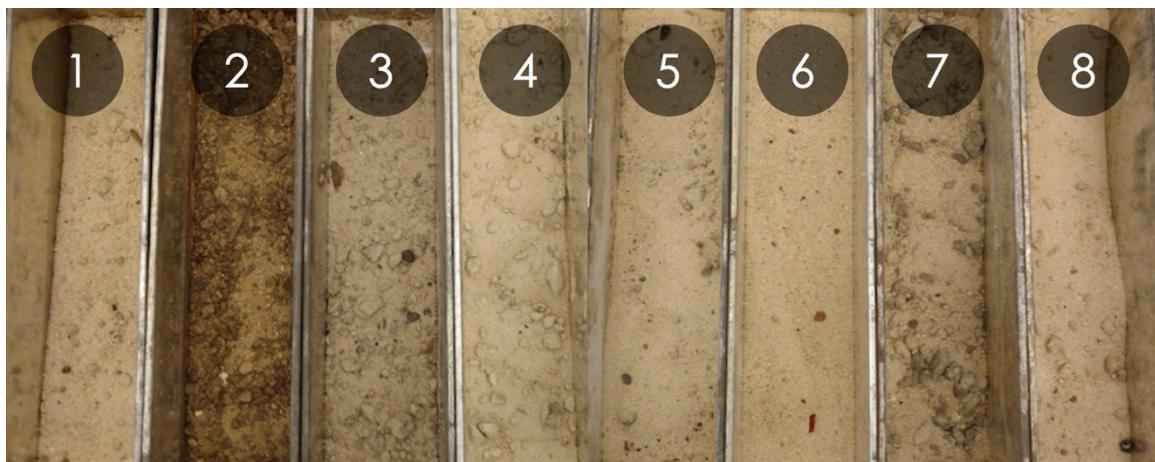
Figure B- 3. Oven and air dried sediment core samples (numbering is LF00x).
