**SHORELINE MONITORING REPORT
MON LOUIS ISLAND RESTORATION PROJECT
USACE FINAL PERMIT# SAM-2014-01046-LET**

**FOWL RIVER,
MOBILE COUNTY, ALABAMA**

January 24, 2020

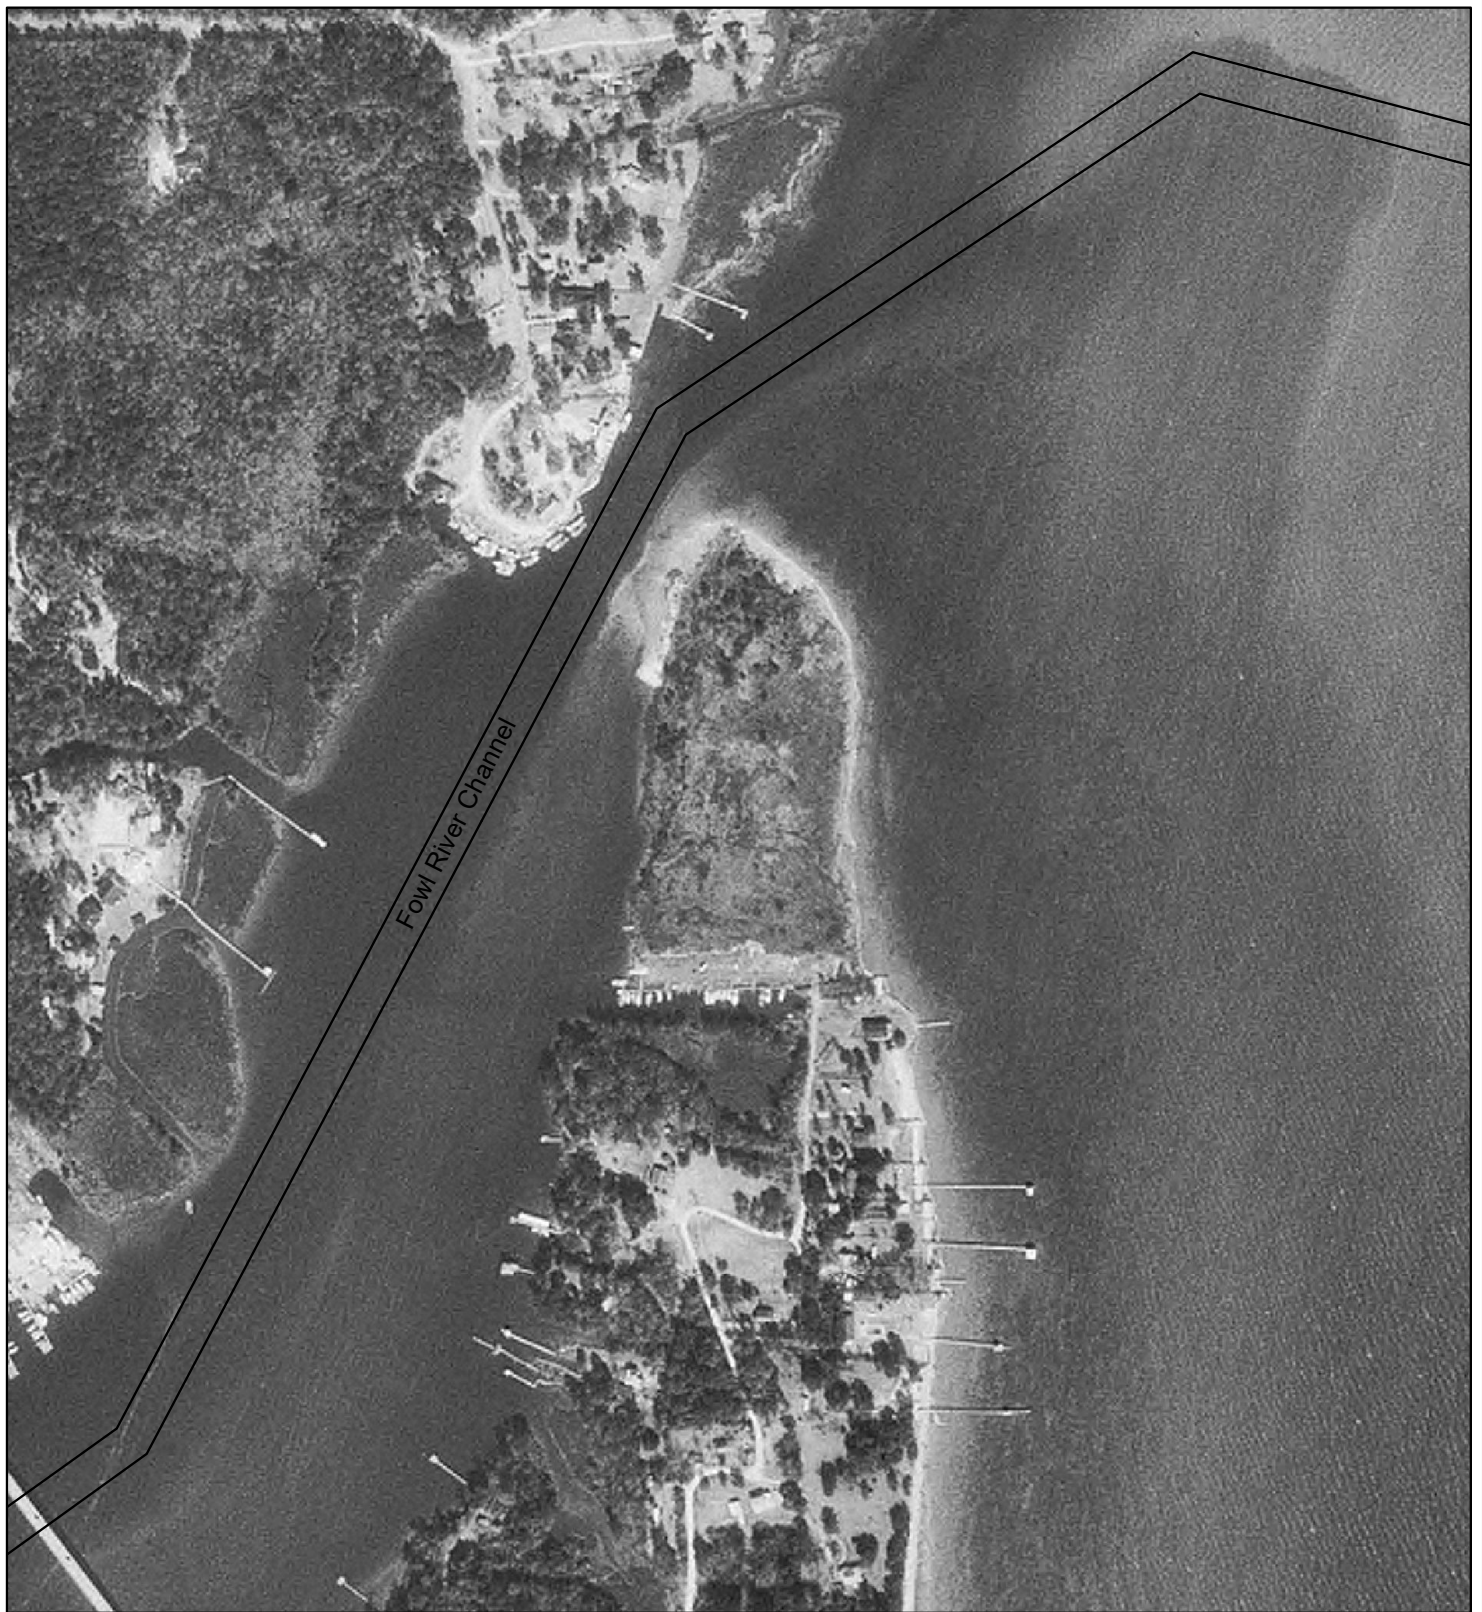
1997 USDA/NRCS DOQ Mosaic - 1 Meter Resolution

A review of historical aerial imagery of the tip of MLI revealed continuous erosion over the past few decades. For reference, a 1997 Historical Aerial from the United States Department of Agriculture/Natural Resources Conservation Service may be found in Appendix A. These changes are a result of both natural and manmade processes. Examples of natural processes include wave action, wind, and tropical systems. Manmade processes that can affect shoreline change might include bulkheads and other armoring, boat wakes, and dredging, among others.

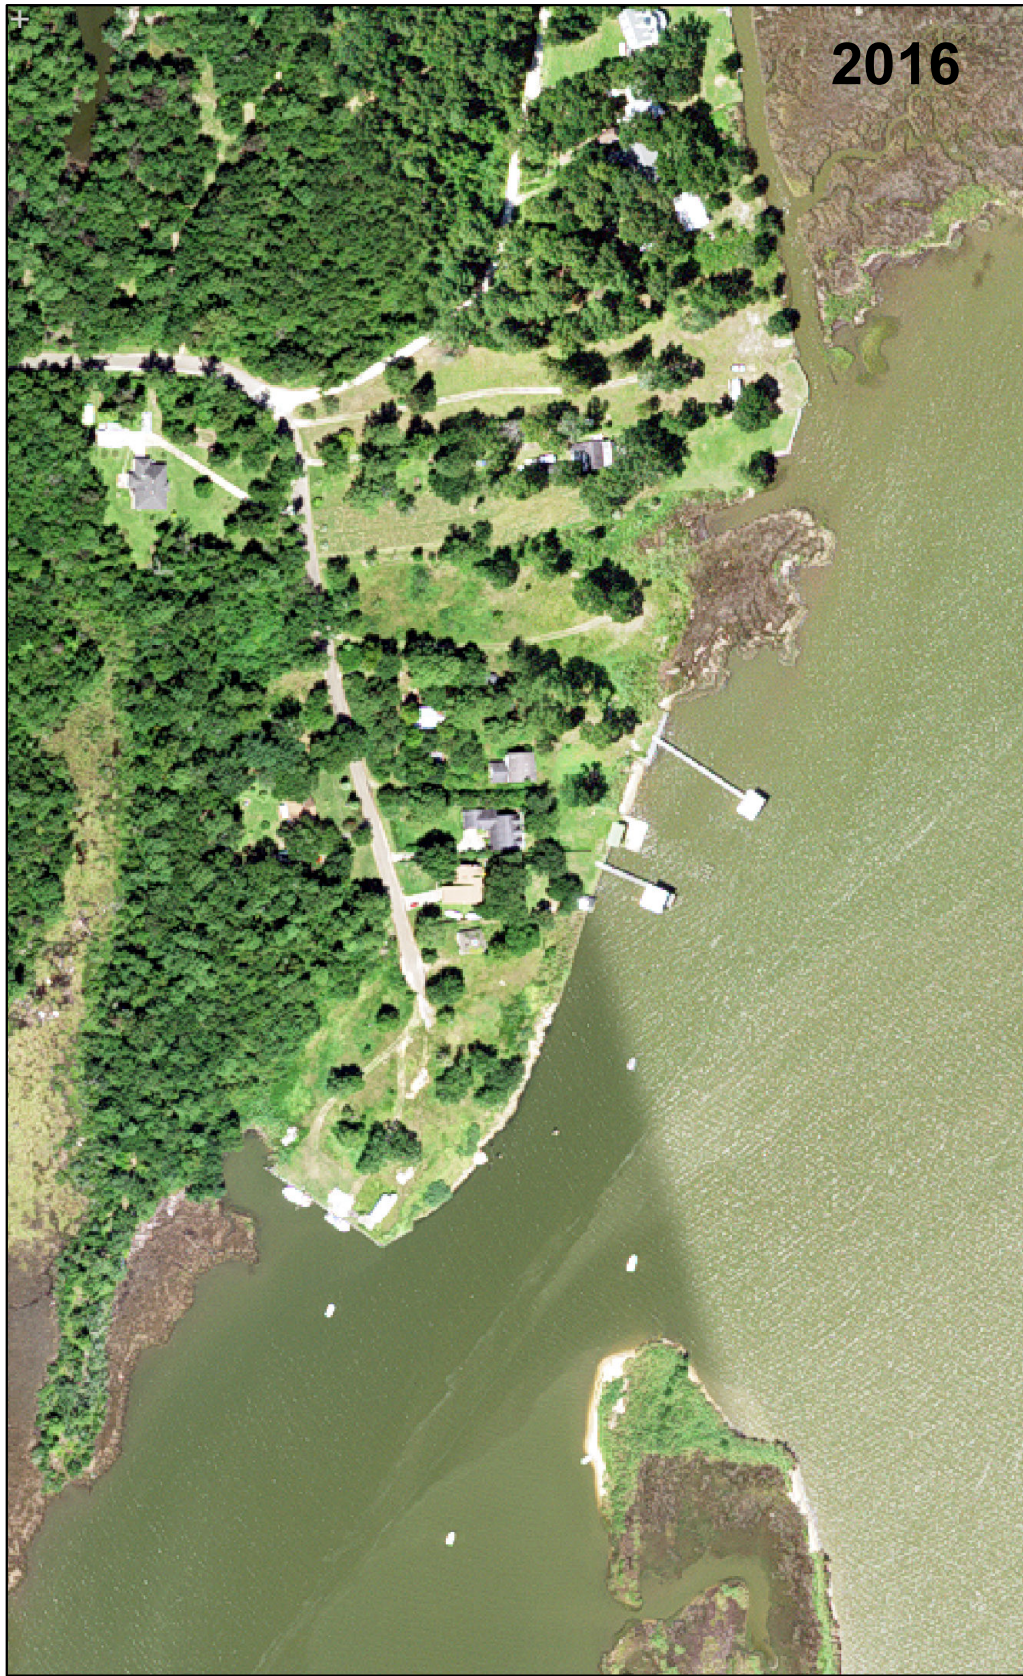
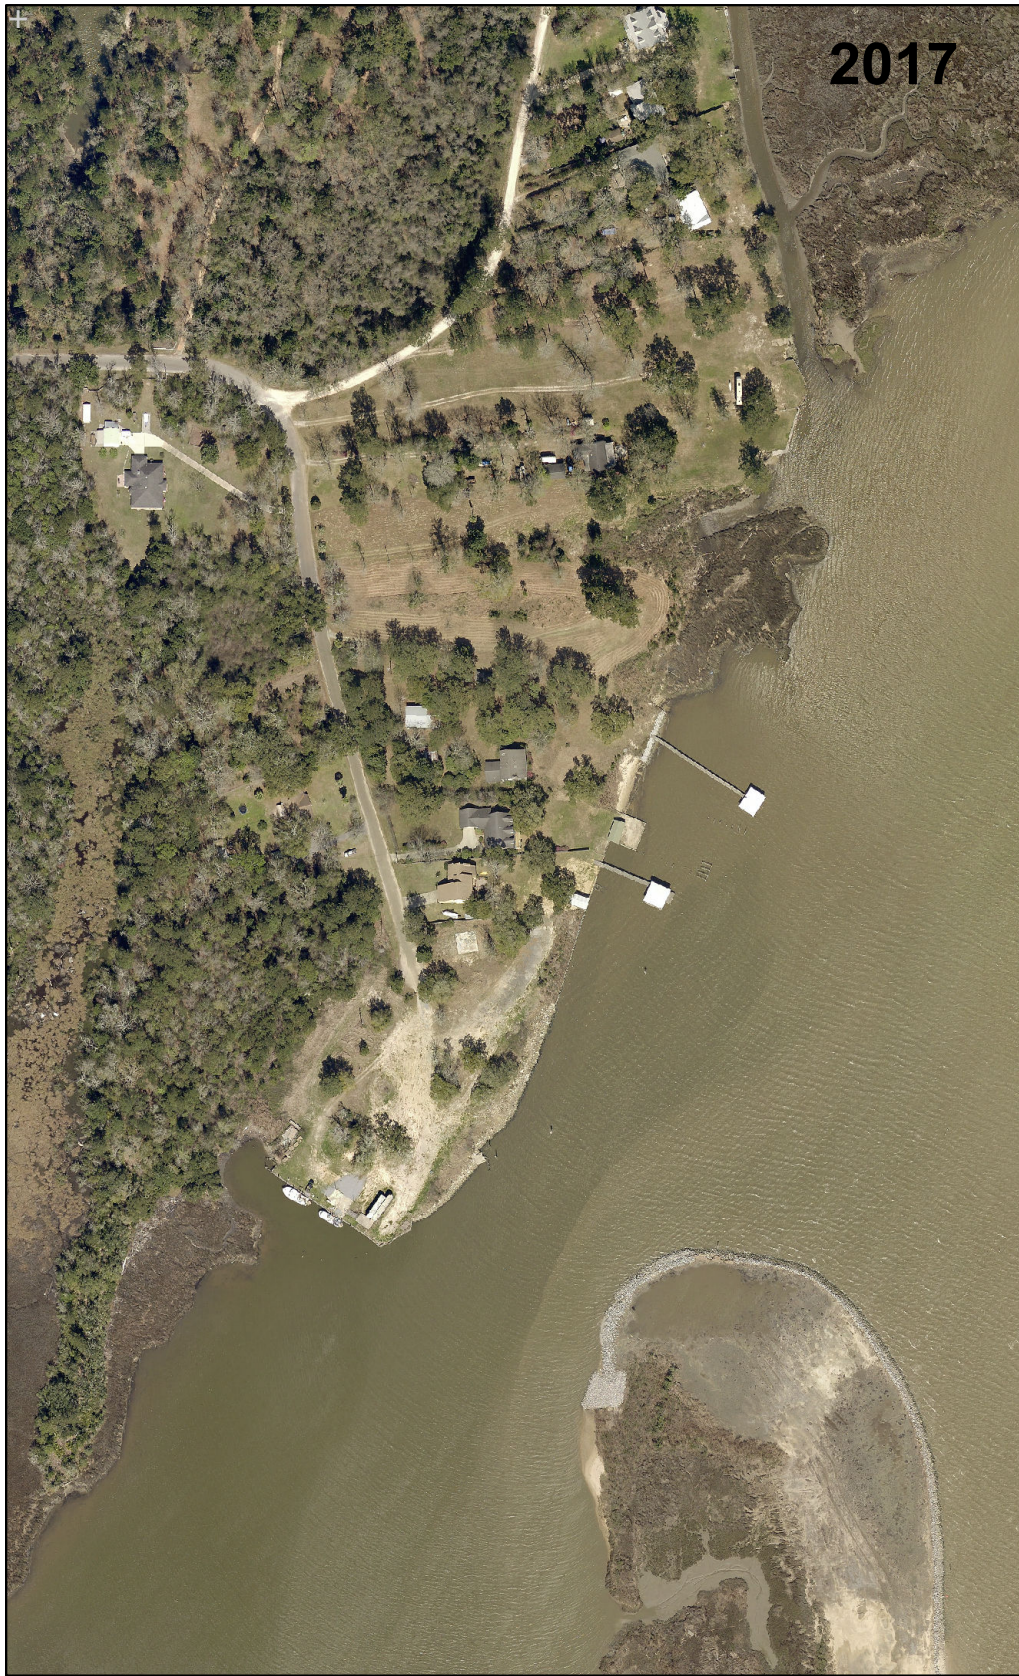
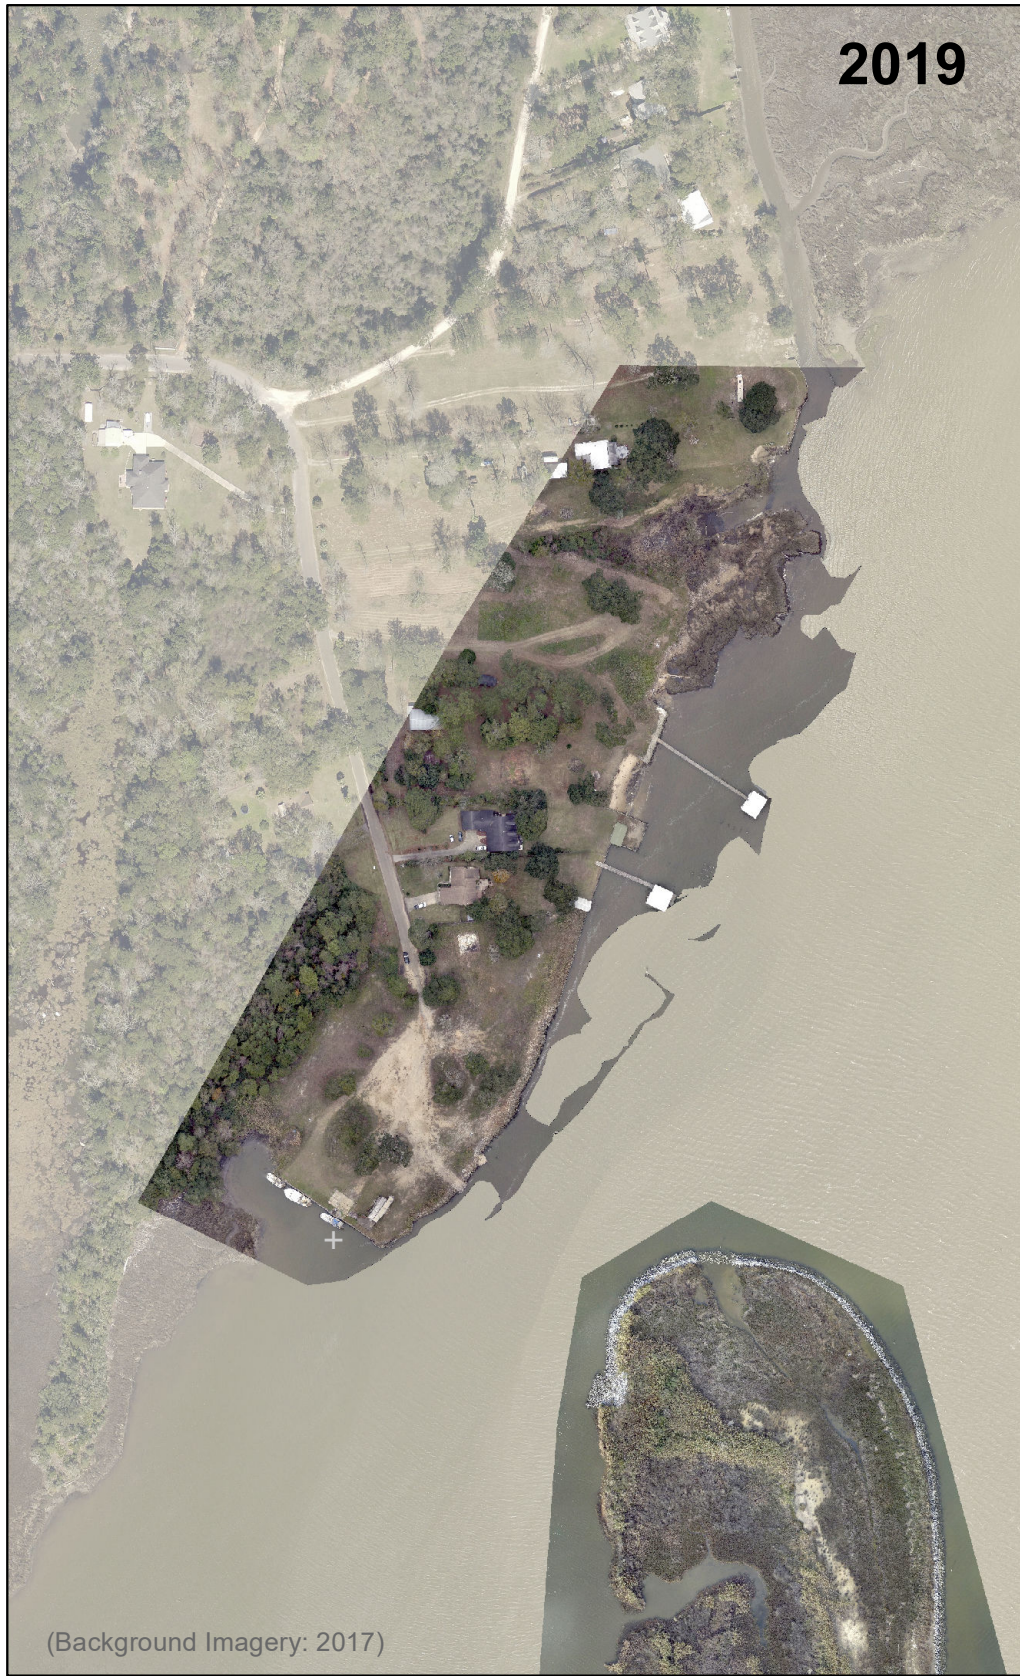
NORTH OF FOWL RIVER COMPARISON AERIALS

A review of the Fowl River segment, as shown on the *North of Fowl River Comparison Aerials* in Appendix A, shows that there is no discernable shoreline change from pre-construction in 2016 to both post-construction images dated 2017 and 2019. The shoreline south of the rock breakwater on MLI was assessed by reviewing the *South of Project Comparison Aerials* in Appendix A. The aerials show what appears to be a rock or rip/rap structure installed by a private individual on one of the properties south of the project. However, there is no discernable evidence of shoreline change for this segment as a result of the restoration at the tip of MLI.

2016 NAIP Imagery - 1Meter Resolution
2017 Mobile County Imagery - 1 Foot Resolution
2019 Thompson Engineering UAV Orthomosaic (Dec.)

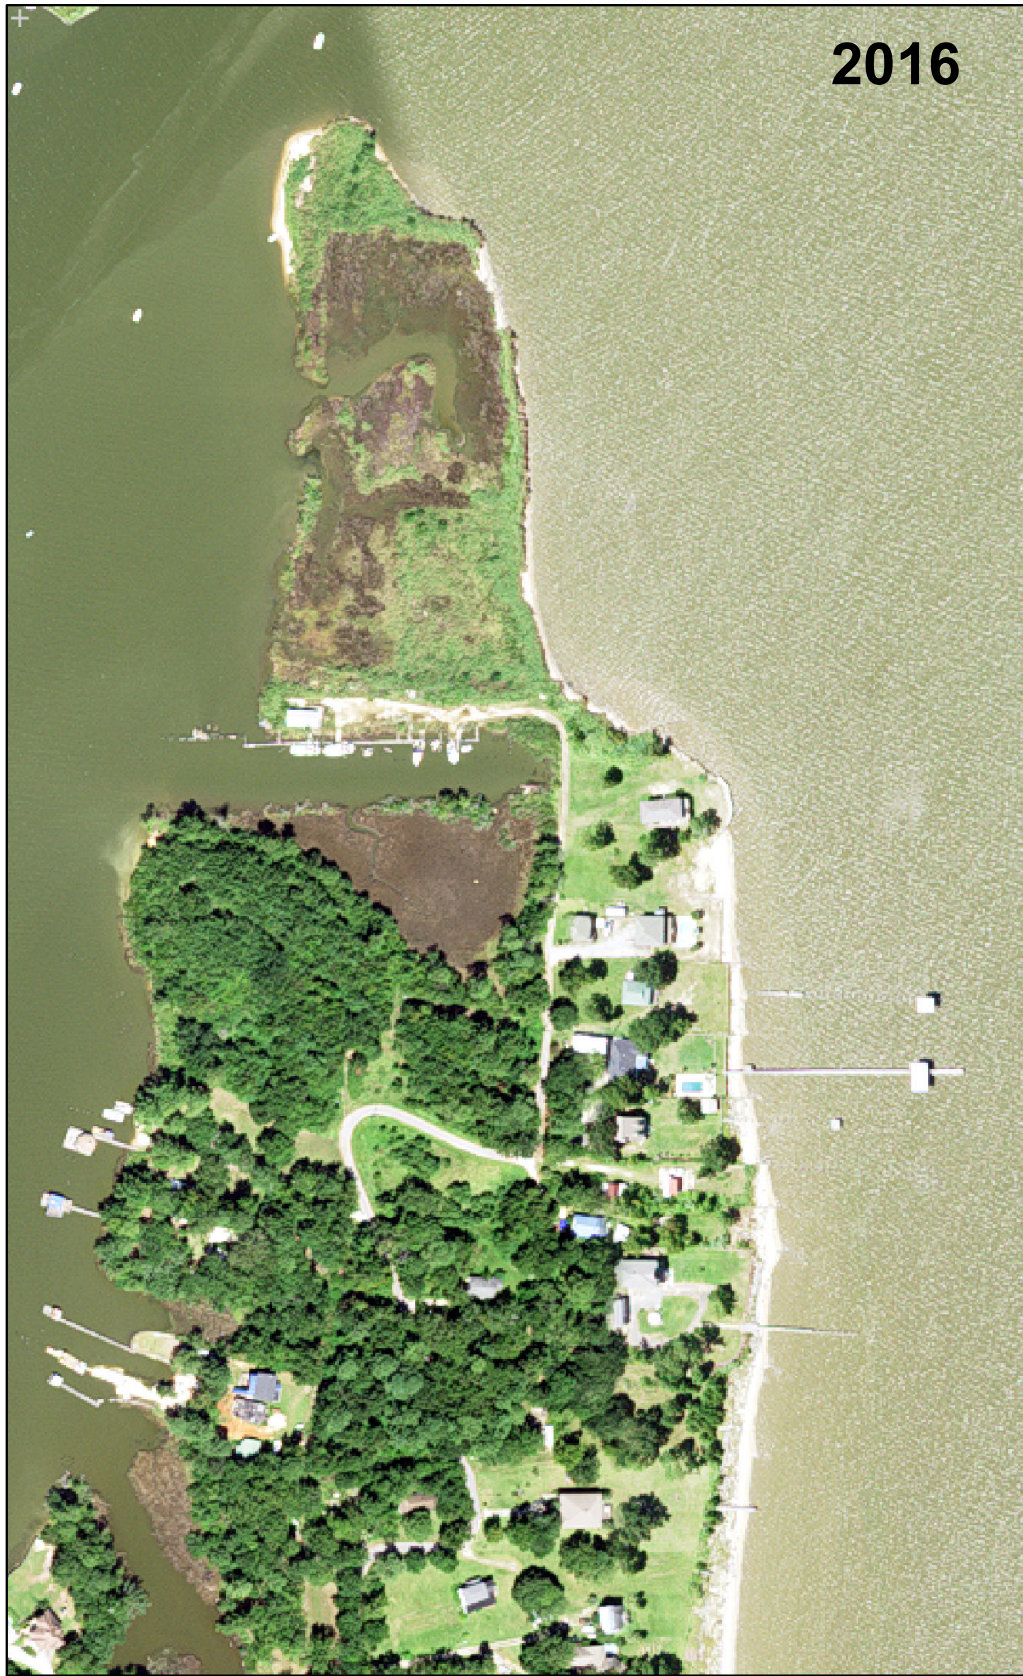
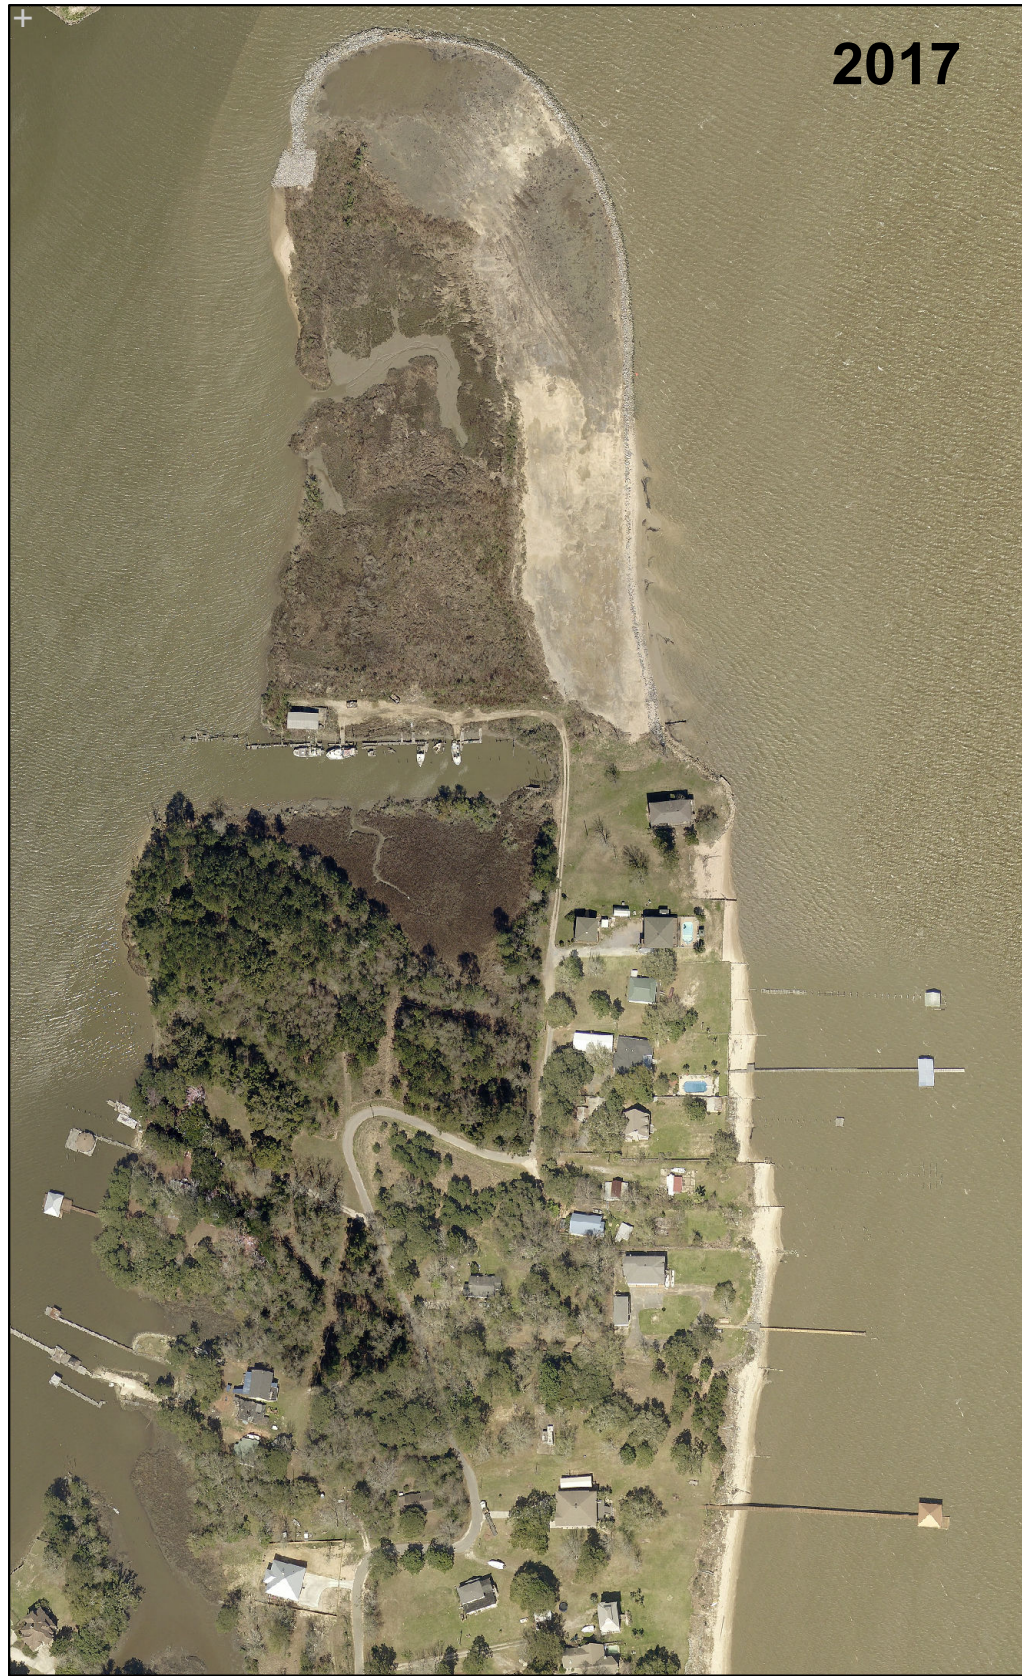
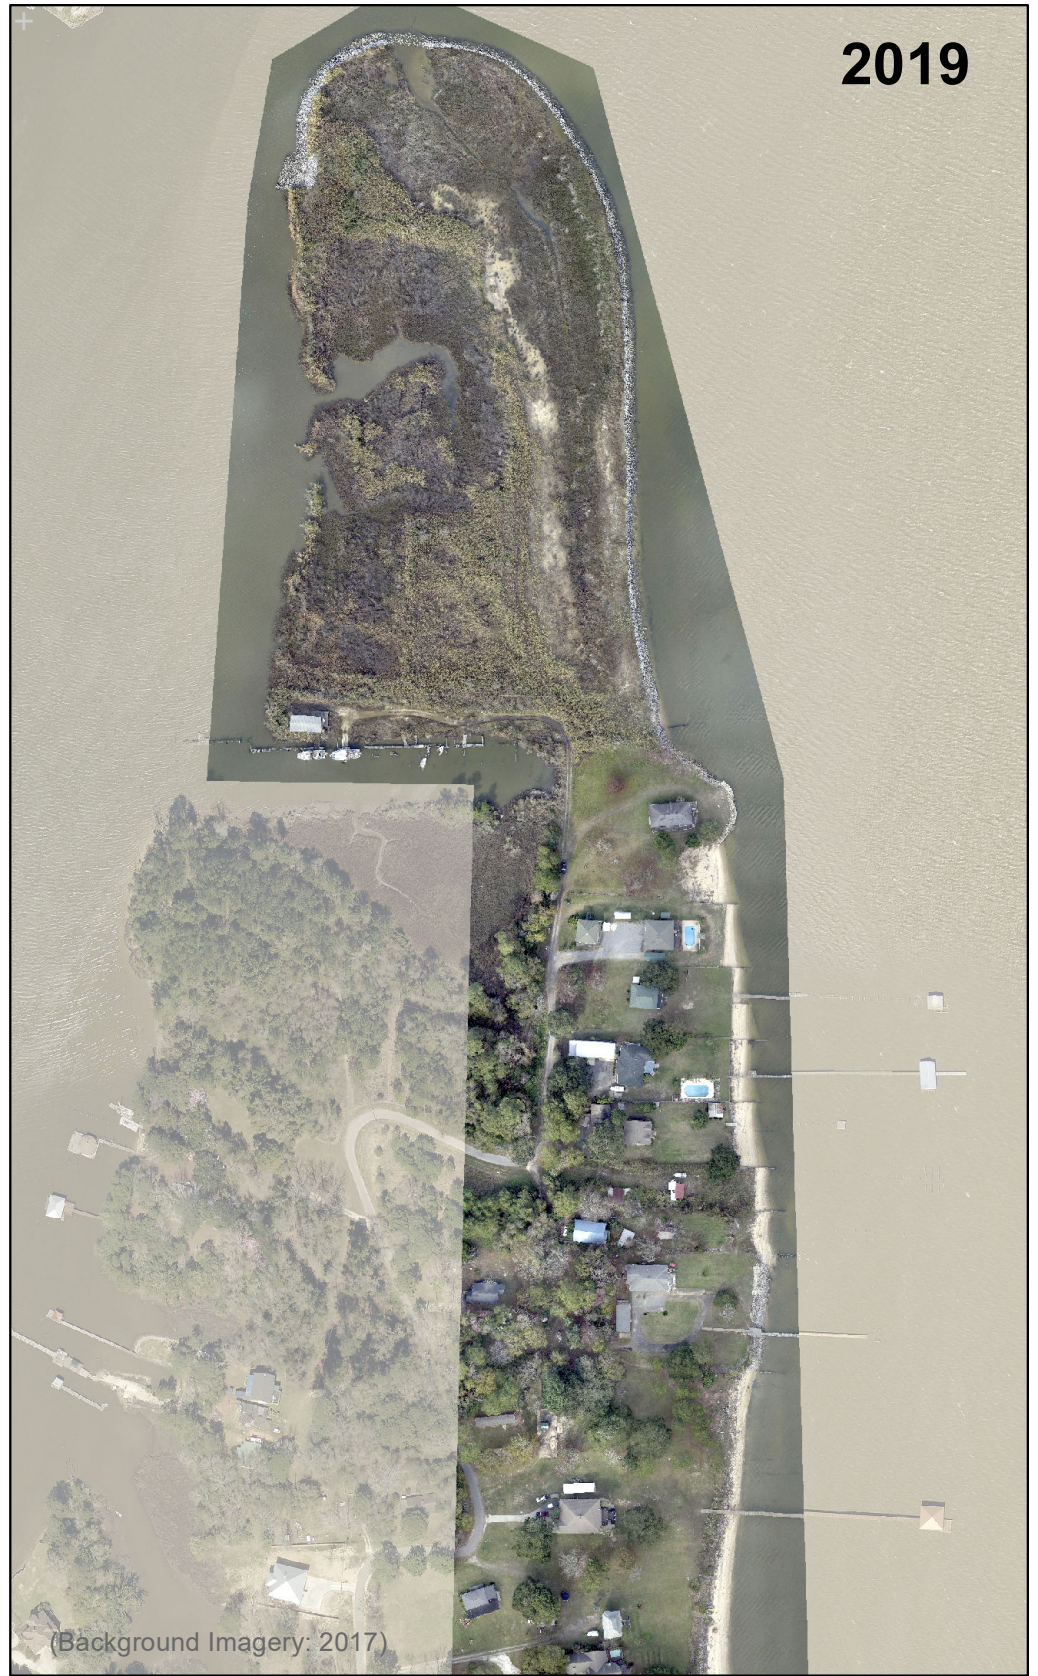
SOUTH OF PROJECT COMPARISON AERIALS

2016 NAIP Imagery - 1Meter Resolution
2017 Mobile County Imagery - 1 Foot Resolution
2019 Thompson Engineering UAV Orthomosaic (Dec.)
