Watershed Management Plan for the D'Olive Creek, Tiawasee Creek, and Joe's Branch Watersheds Daphne, Spanish Fort, and Baldwin County, Alabama

Final - August 2010

Thompson Engineering Project No.: 09-2116-0071

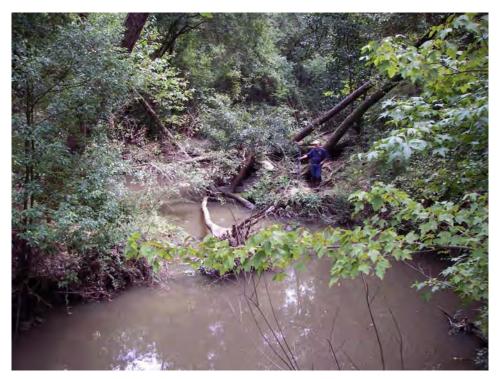
Figure 2-8. Head-cut through Less Erosion Resistant Materials on Tributary TC Showing Effects of Mass-Wasting of Streambanks and Collapse of Trees into Channel

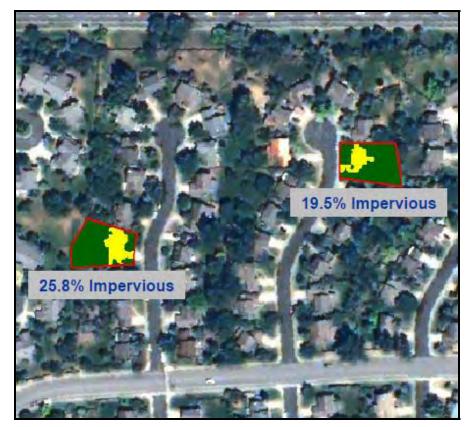
is usually reported as the percentage of impervious cover occurring within a specific area, which can range in size from an individual lot to an entire watershed. Figure 2-33 illustrates the impervious cover as measured for two individual residential lots.

Figure 2-33. Measured Percent Impervious Cover for Individual Residential Lots

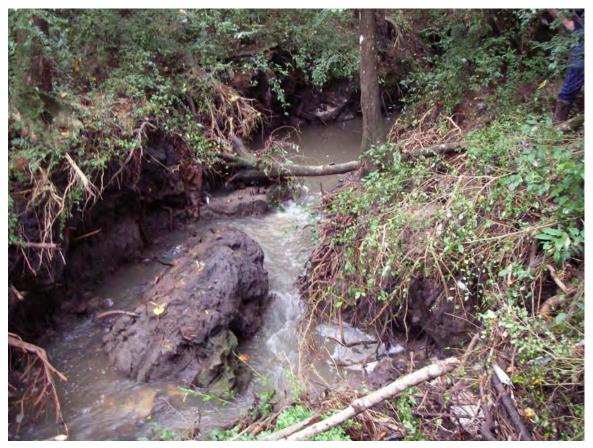
Figure 4-10. Head-cut on Tributary TC to Tiawasee Creek

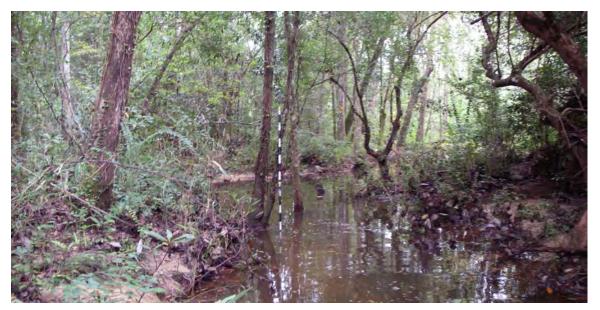
Figure 4-12. Tiawasee Creek Upstream of Existing Head-Cut

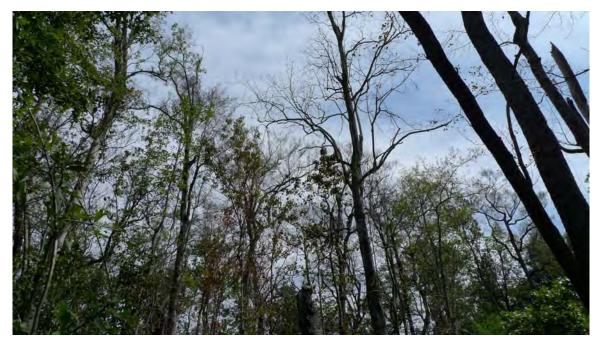
Figure 4-13. Large Openings in Forested Wetland Tree Canopy Along Lower Joe's Branch Caused by Tree Death and Defoliation Due to Stress of Sedimentation.

Wetlands adjacent to the reach of Joe's Branch between Bass Pro Drive and Town Center Avenue have been severely impacted by sedimentation. Approximately 50% of the mature, native canopy trees are dead or dying (see Figure 4-13) and the understory is dominated by exotic species (see Figure 4-14). The sediment deposits are over 12 inches deep across much of the wetland, and the upland buffer has been cleared.

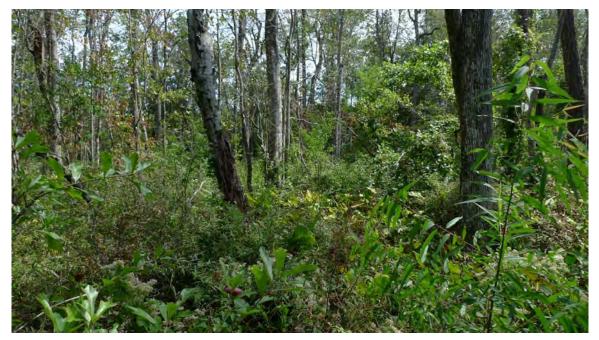
Figure 4-14. Open Tree Canopy along Lower Joe's Branch Caused by Sedimentation Stresses Allows Increased Light Penetration and Invasion of Exotic Plants

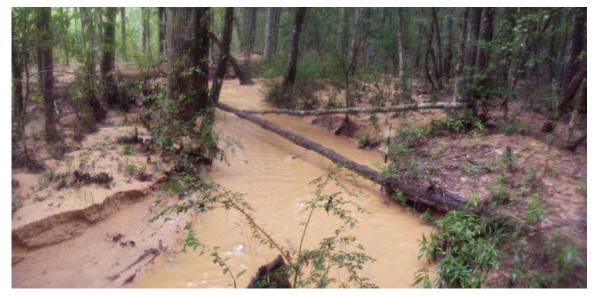
Figure 4-15. Sedimentation in Wetlands of Tributary JB to Joe's Branch Upstream of Town Center Avenue

The sources of the sediments are not known, but appear to be coming from areas upstream of the Spanish Fort Town Center. Although the recently constructed Spanish Fort Town Center cannot be excluded as a possible source of some of the sediments in this reach of Joe's Branch, it appears that the most significant sources have originated from upstream of the Town Center (see Figures 4-15 and 4-16).

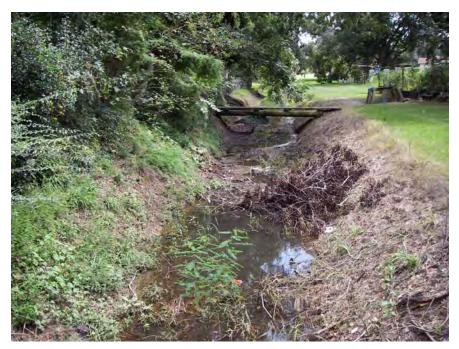
Figure 4-17. Limited Wetland Habitat along Tributary TCC to Tiawasee Creek

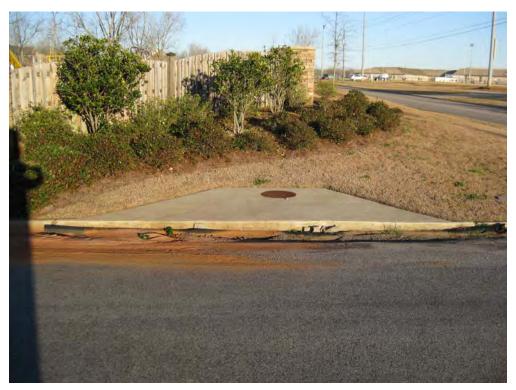
Figure 4-19. Sediments from Construction Sites Entering Drain Outlet

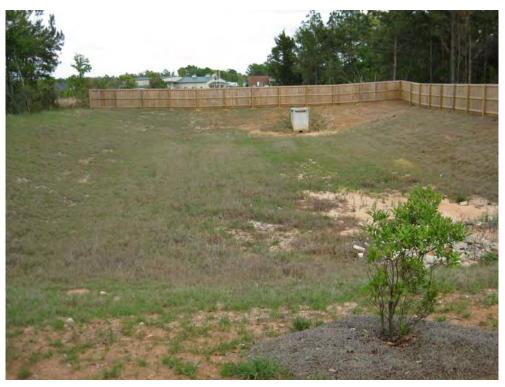
Figure 6-13. Detention Pond at Caroline Woods Subdivision

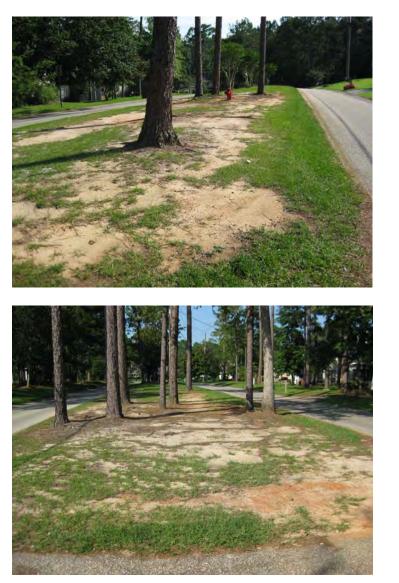
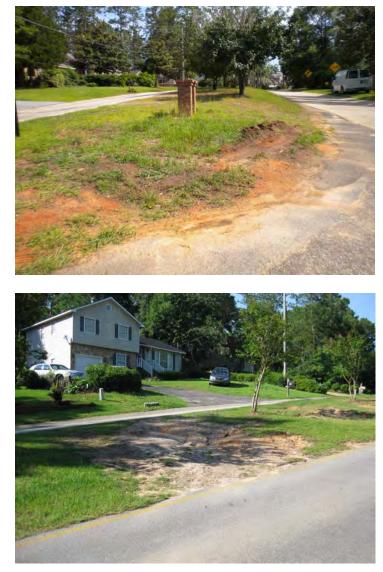
Figure 6-28. Examples of Erosion Problems Affecting the Road Medians of the Lake Forest Subdivision

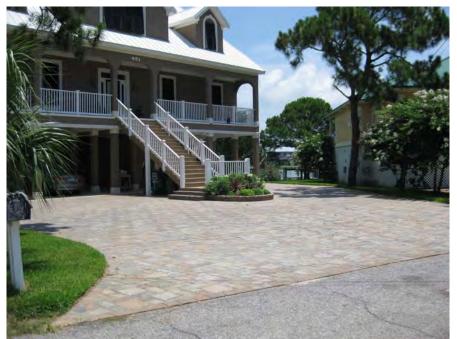
Figure 6-34. Example Application of Pavers in a Residential Driveway

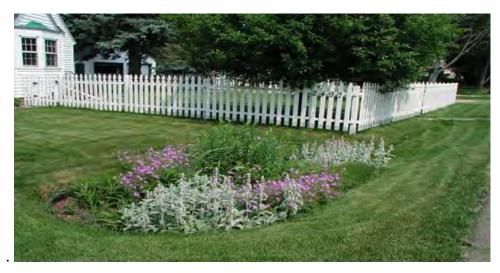
Figure 6-37. Example of Depressional Rain Garden.

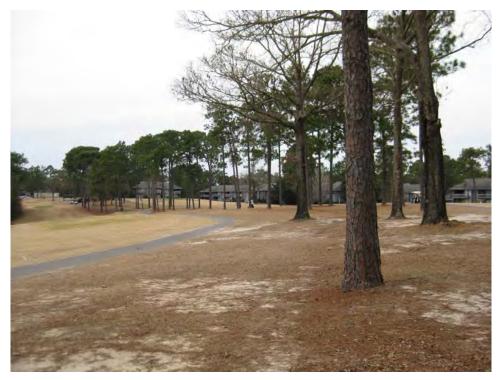
Figure 6-45. Example of Aged Remnant Forest at Lake Forest Golf Course Separating Fairways showing Absence of Understory and Bare Soils

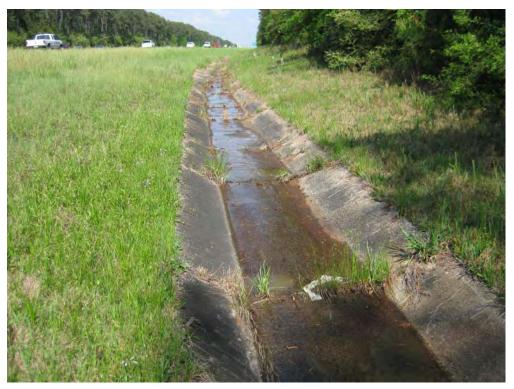
Figure 6-53. Existing Concrete-Line Drainage Ditch Along I-10

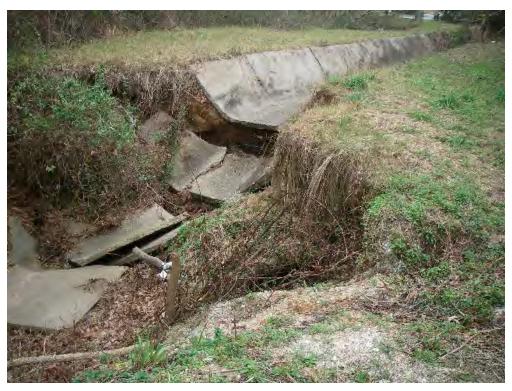
Figure 6-54. Example of Erosion Caused Damage

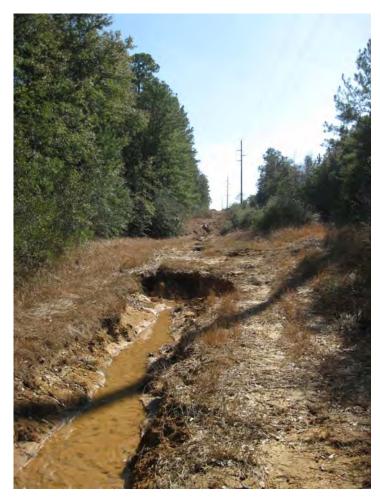
Figure 6-55. Typical Erosion Associated with Power Line Right-of-Ways

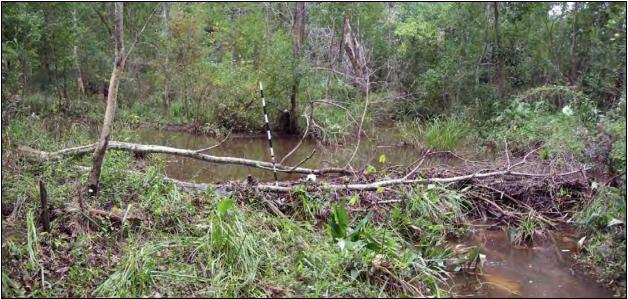
Figure 4-2. Beaver Dam on Tiawasee Creek. Site T32.

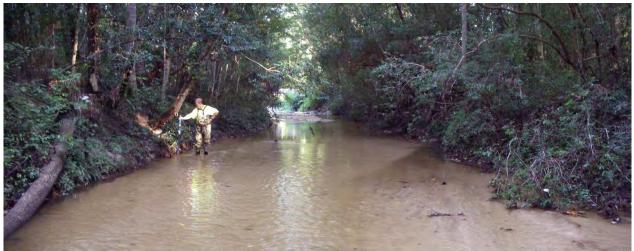
Figure 4-4. Exceptionally straight reach of Tiawasee Creek choked with sediment. Site T7.

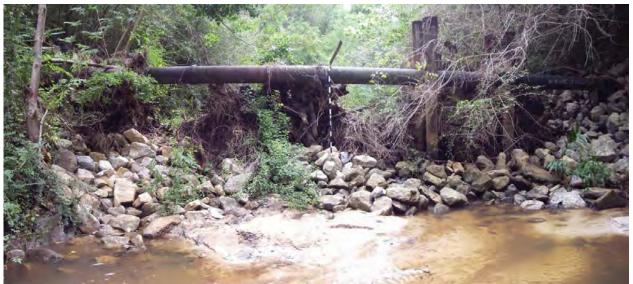
Figure 4-6. Woody debris jam formed on sewage pipeline crossing. Site T18.

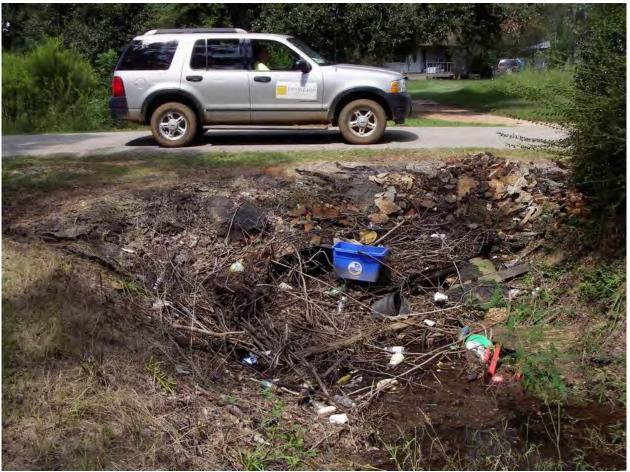
Figure 4-7. Culvert blocked by debris. Site TCC1.

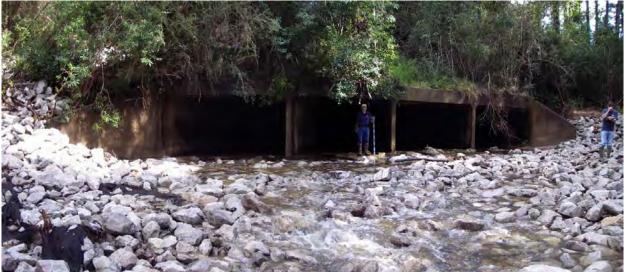
Figure 4-8. Scour repair below I-10 crossing of D'Olive Creek. Site D7.

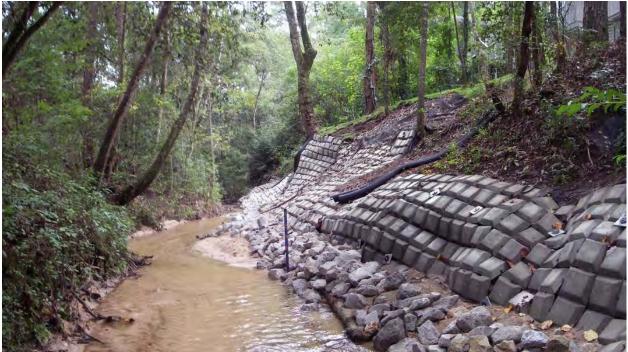
Figure 4-10. Bank protection along an incised reach of trib DA. Site DA9.

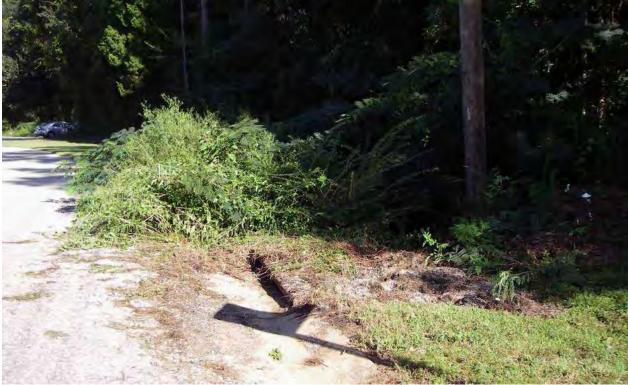
Figure 4-11. Four meter deep gully within 5 meters of road is totally obscured by vegetation. Site U37.

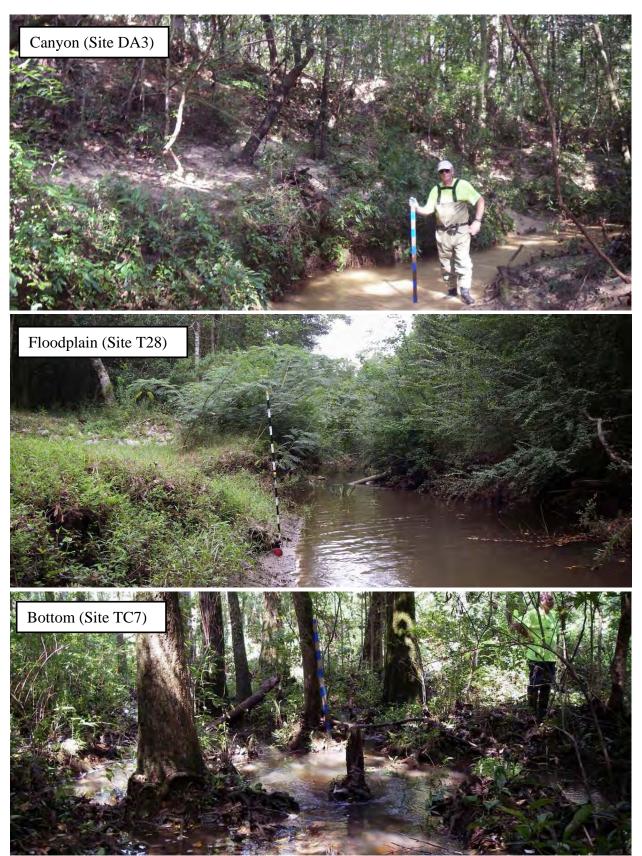
Figure 4-14. Channel forms typical of the "canyon," "floodplain," and "bottom" type stream reaches.

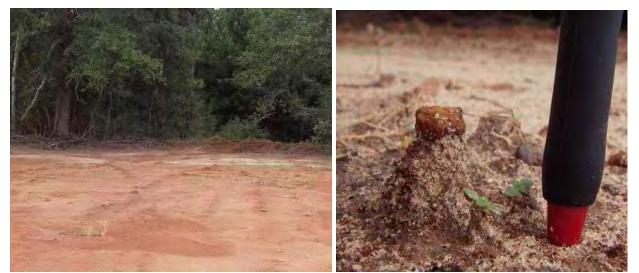
Figure 4-15. Construction site. Note ½ inch of soil loss marked by pedistalled pebble. Site U13.

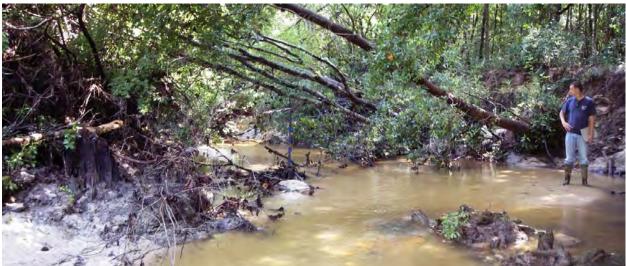
Figure 5-2. Trees recruited to channel by bank mass wasting. Site D5.

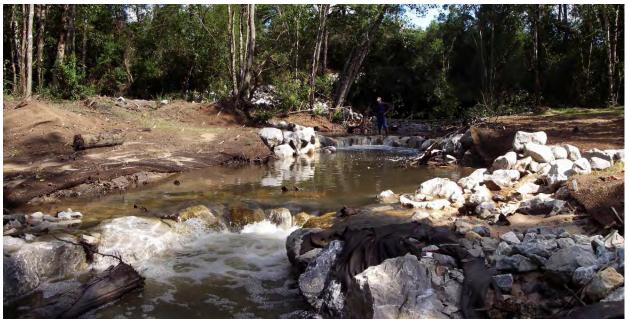
Figure 5-3. Restabilized reach below I-10. Site D6.

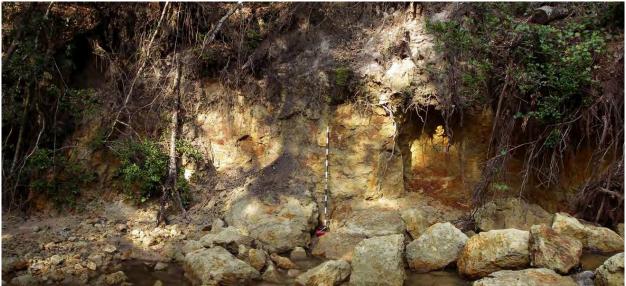
Figure 5-7. Erosion by block failure observed at DA22 and DA34. Site DA22

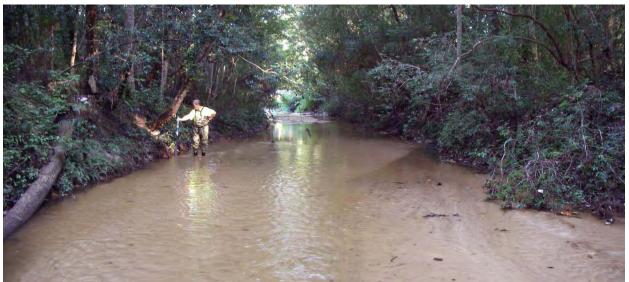
Figure 5-14. Heavy sand deposits on Tiawasee Creek below Bay View Drive. Site T7.

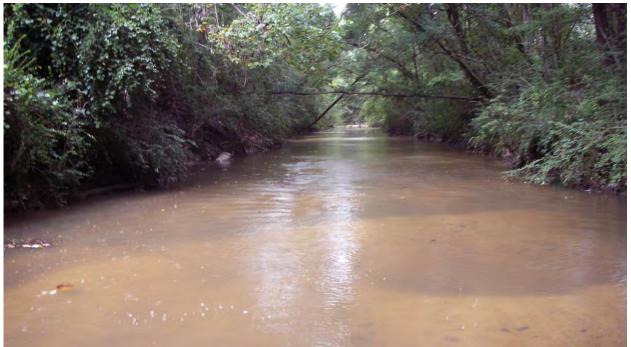
Figure 5-15. Heavy sand load in the form of dunes on the bed of Tiawasee Creek. Site T11.

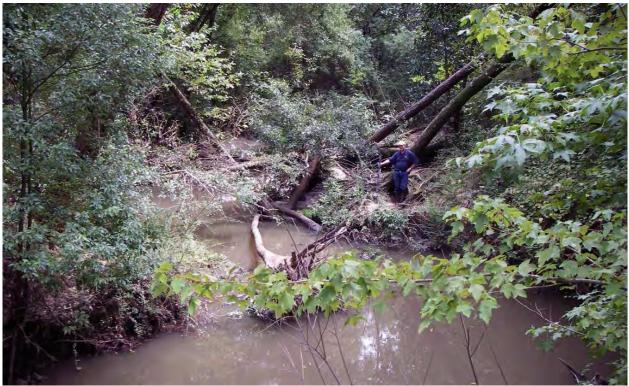
Figure 5-19. Person standing on rotational failure of high streambank with trees. Site TC2.

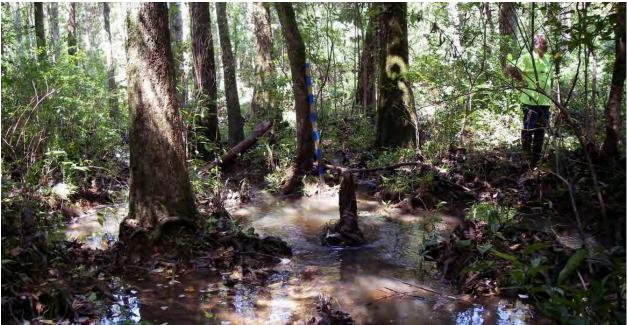
Figure 5-20. Multi-threaded low sediment load valley bottom type channel. Site TC7.

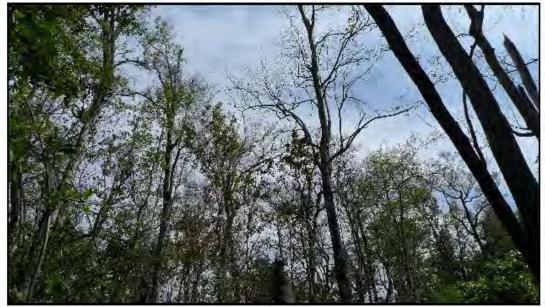
PHOTO 4: Taken from the same location as Photo 3, this angle shows the large openings in the canopy caused by tree death and/or defoliation.

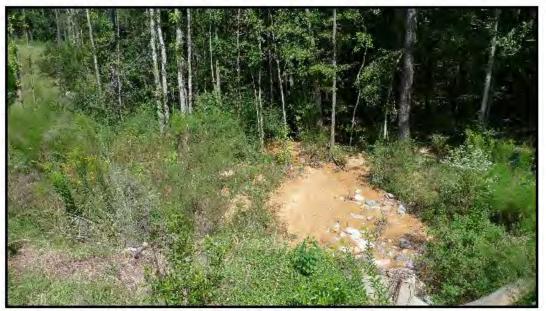
PHOTO 5: Site JB 1W looking north. Most significant impact to this area was the heavy sediment deposit and resulting stress in some canopy trees.

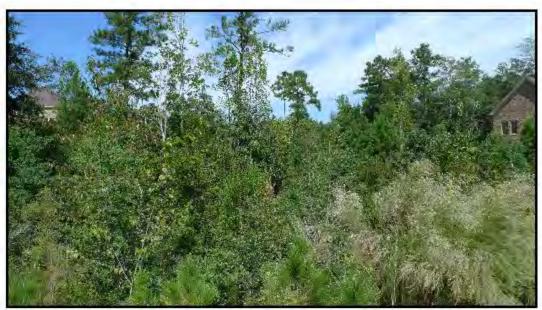
PHOTO 9: Site DC1W looking north. This view shows more clearly the damage done to the canopy of this wetland. The houses in the photo are located in the Timber Creek subdivision.

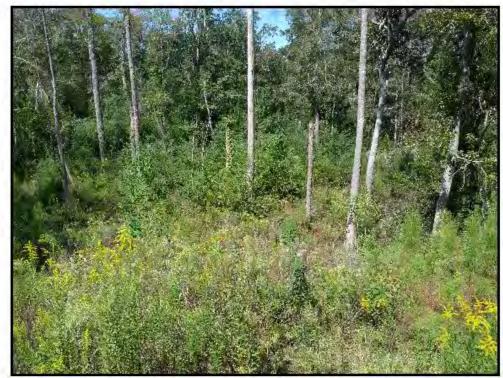
PHOTO 10: Site D6W looking north. A gain, sedimentation has severely stressed the canopy and eliminated much of the native understory vegetation in this section of D'Olive Creek.
