**PRE-RESTORATION ANALYSIS OF DISCHARGE,  
SEDIMENT TRANSPORT RATES, WATER QUALITY,  
AND LAND-USE IMPACTS IN WATERSHEDS ALONG THE  
EASTERN SHORE OF MOBILE BAY, BALDWIN COUNTY,  
ALABAMA**

Marlon R. Cook,  
Barry A. Vittor and Associates, Inc.

Funding for this project was provided by the  
Mobile Bay National Estuary Program

March, 2021

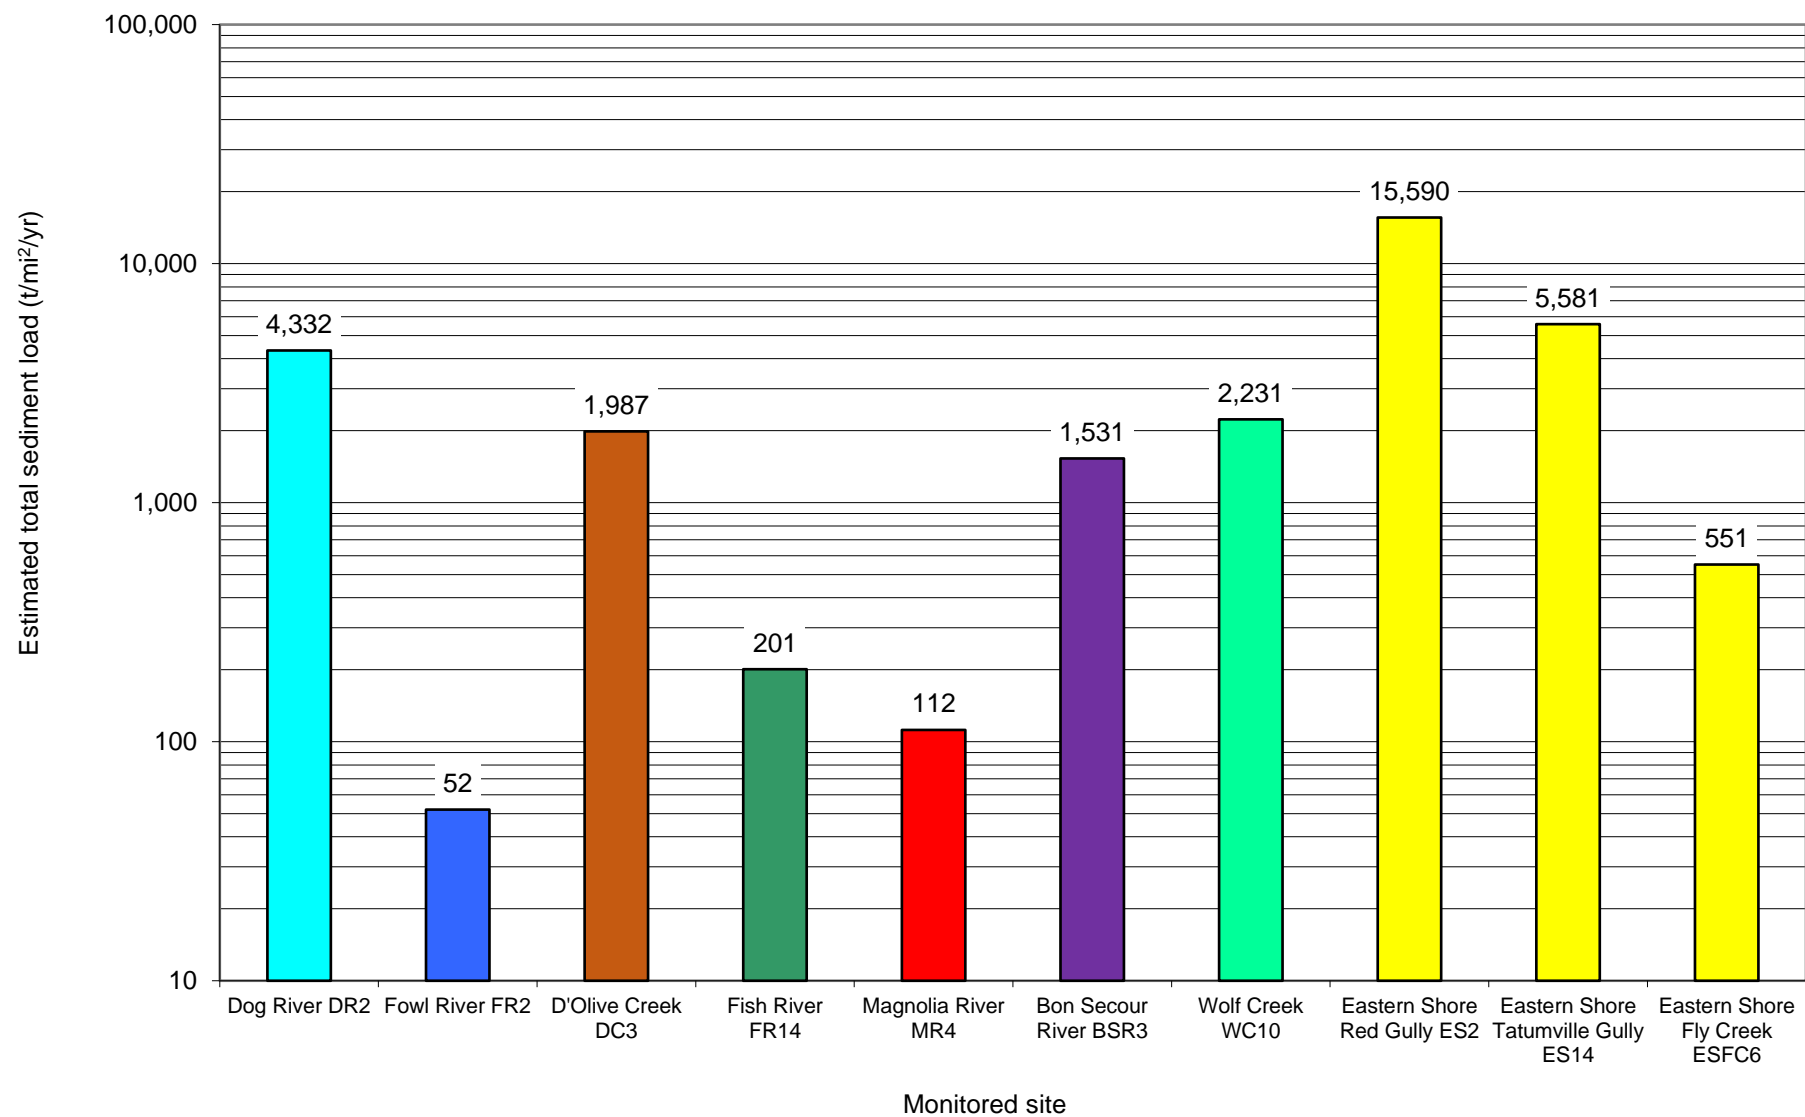
Figure 16.—Comparisons of estimated normalized total sediment loads for monitored watersheds in Mobile and Baldwin Counties.

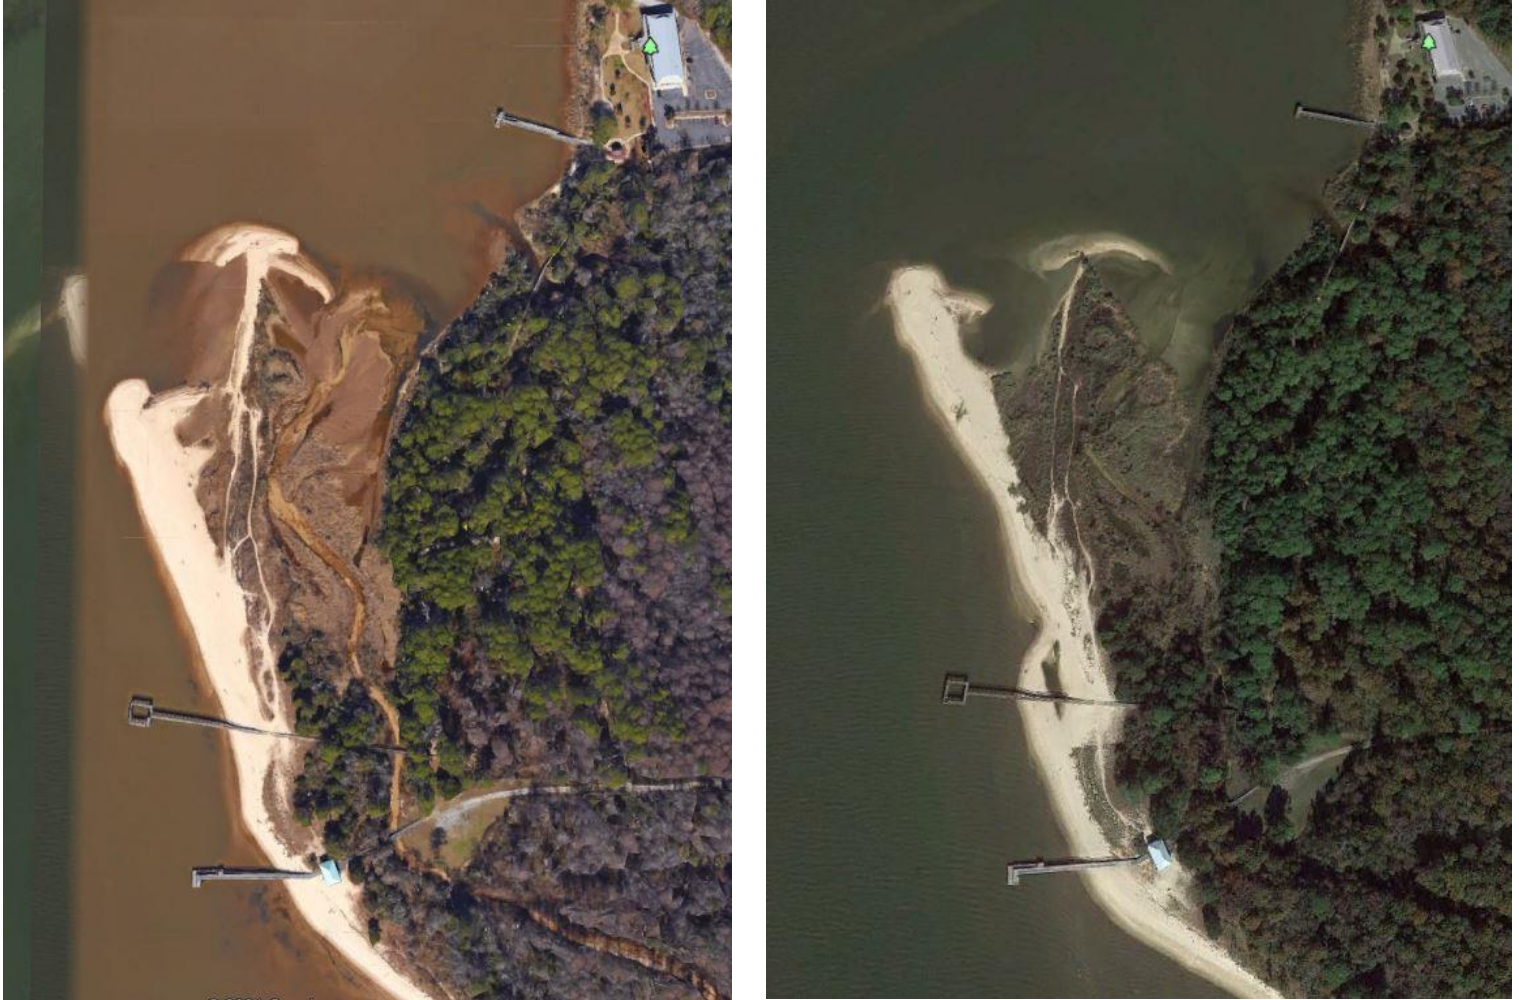
Figure 17.—Sediment deposition into D'Olive Bay at the mouth of Yancey Branch in 1985(left) and 2019 (right) (Google Earth, 2020).

Yancey Branch. Figure 17 (left) is 1985 imagery showing an alluvial fan about 900 ft long and 600 ft wide, extending into D'Olive Bay from the mouth of Yancey Branch. Figure 17 (right) is a November 2019 image showing that deposition of new sediment is significantly less than in 1985. Vegetation has established on the alluvial fan and the spit on the west side of the fan has narrowed and extended about 300 ft northwestward.

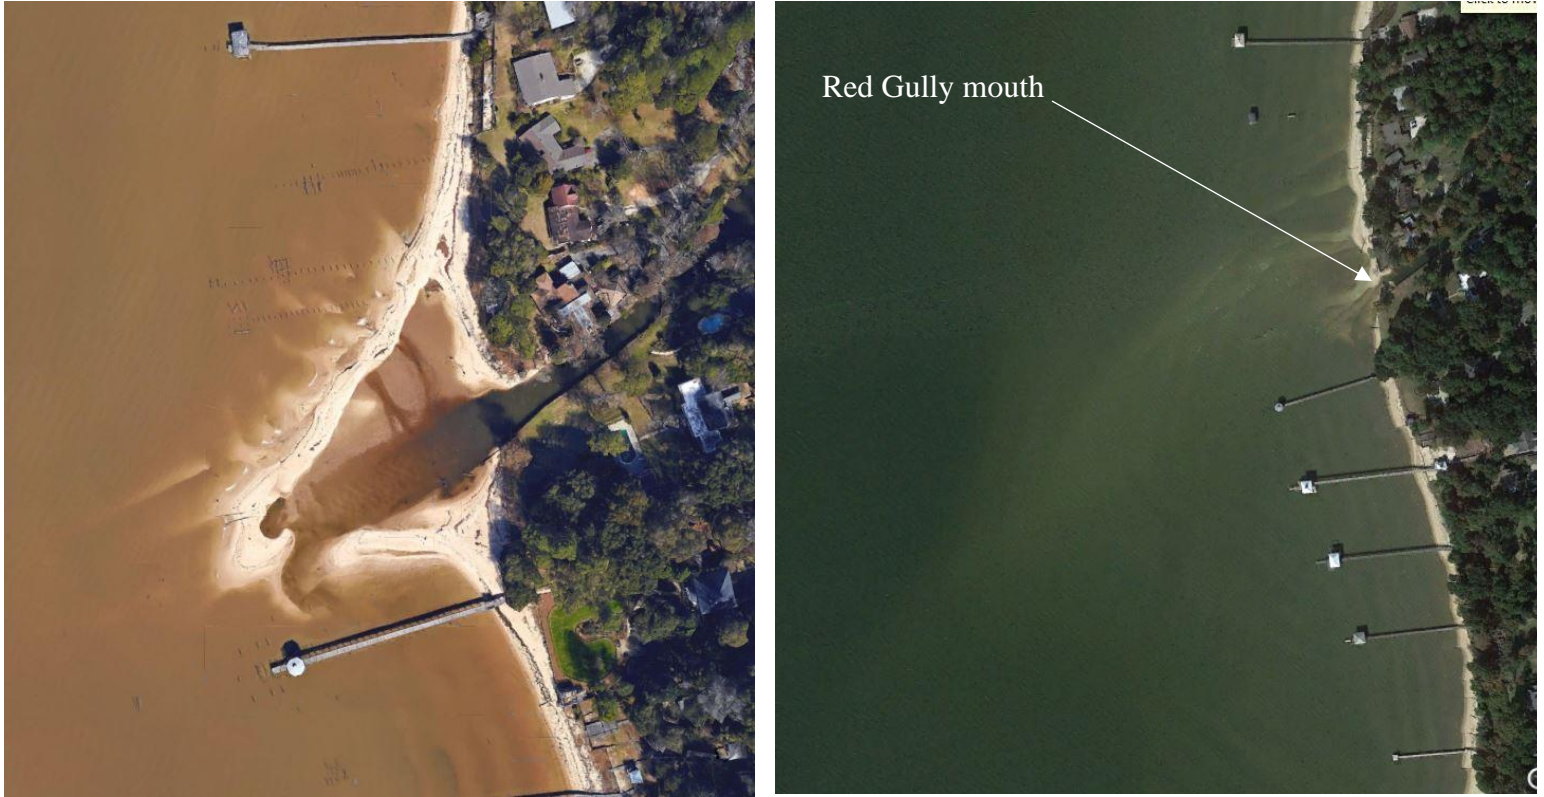
Figure 18.—Sediment deposition into Mobile Bay at the mouth of Red Gully in 1985 (left) and 2019 (right) (Google Earth, 2020).

Red Gully discharge along with its sediment load (12,472 t/yr or about 23,000 (yd<sup>3</sup>/yr) empties into Mobile Bay just south of the Daphne city limits. Reworking of this sediment by Mobile Bay currents along the eastern shore in 1985 formed a triangular-shaped alluvial fan about 500 ft long and 500 ft wide. November 2019 imagery shows that the alluvial fan has been removed by Mobile Bay currents. However, plumes of

turbidity can be seen flowing southwestward into Mobile Bay. USGS topobathymetric mapping in 2013 shows that Mobile Bay water depths at the mouth of Red Gully are 0 to 1.3 ft (USGS, 2013) (fig. 18).

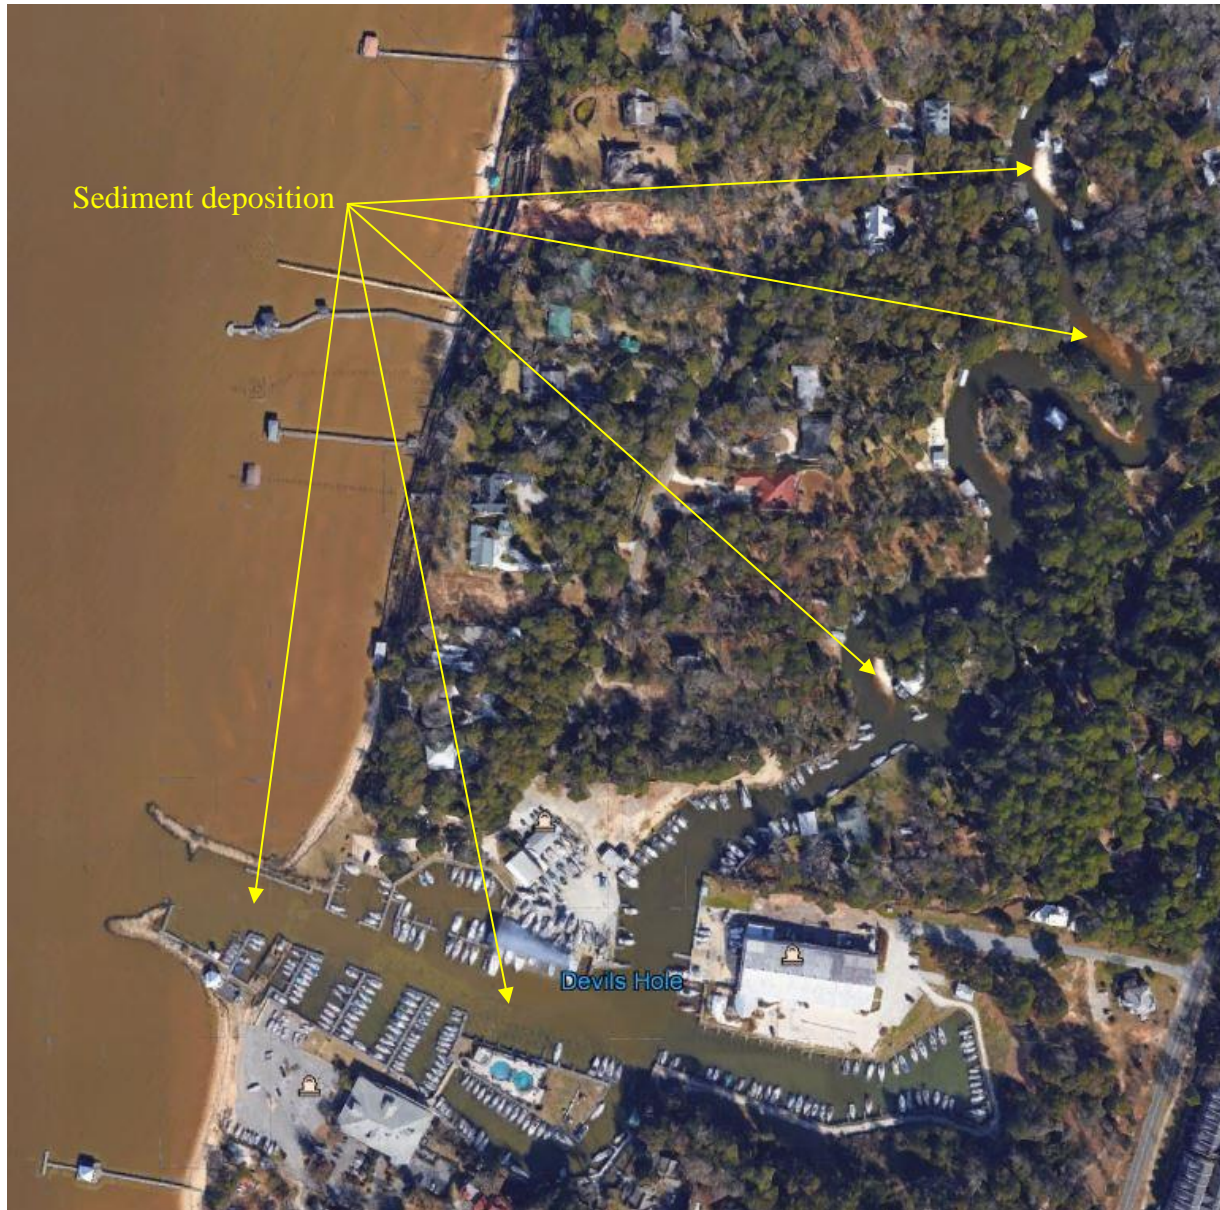
Figure 19.—Sediment deposition in the tidally influenced reach and yacht basin of Fly Creek in 1985 (Google Earth, 2020).

Fly Creek has long been the subject of observations concerning excessive sediment transport. Erosion from major construction projects in the watershed contributed large amounts of sediment that were transported downstream and deposited in the tidal reach and at the mouth of the stream. Figure 19 shows sediment in lower Fly Creek, deposited as point bars and channel fill in the lower part of the stream, in the yacht basin, and at the mouth. Fly Creek currently transports an estimated 3,965 t/yr (7,343 yd<sup>3</sup>/yr) of silt and sand. However, little evidence of sediment deposition is seen on 2019 imagery (fig. 20).

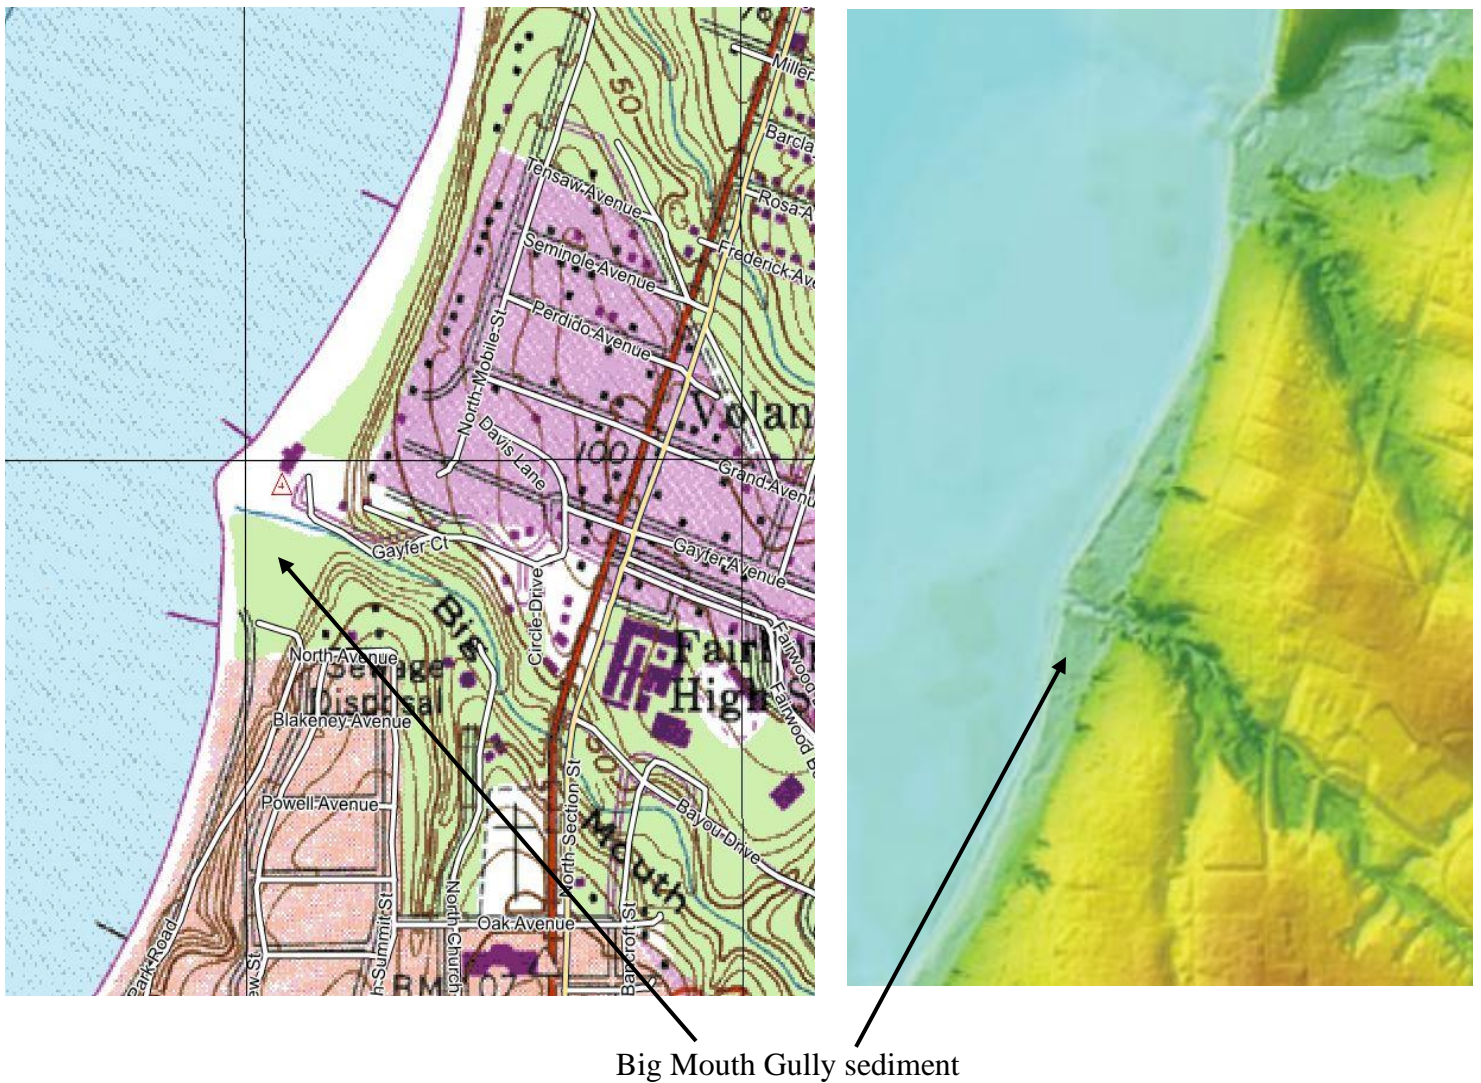
Figure 21.—USGS topographic and topobathymetric maps, showing sediment deposition at the mouth of Big Mouth Gully.

Big Mouth Gully currently transports an estimated 472 t/yr (874 yd<sup>3</sup>/yr) of sediment, which is deposited into Mobile bay at its mouth just north of downtown Fairhope. However, sediment deposition rates were much higher in the past, as evidenced

by USGS topographic maps (USGS, 1953 and 1982) and topobathymetric mapping (USGS, 2013), which show that about 35 acres of additional land mass was created by sediment deposition from Big Mouth Gully (fig. 21). As previously discussed, current sediment transport rates are limited by detention areas on the east side of North section Street.

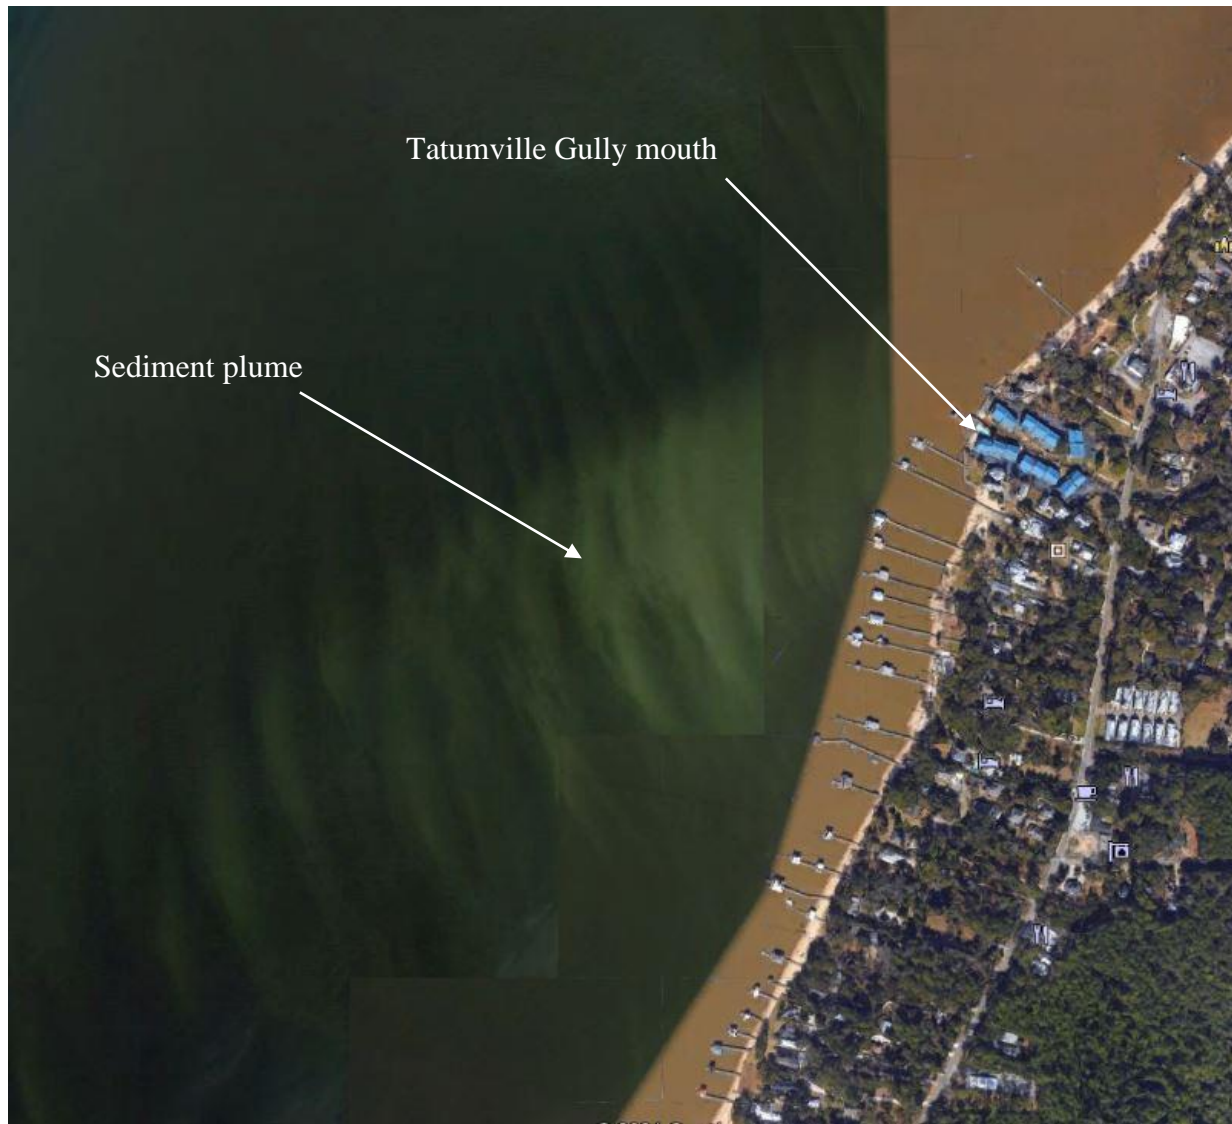
Figure 22.—Sediment plume shown on 1985 satellite imagery, extending southwestward into Mobile Bay from the mouth of Tatumville Gully (Google Earth, 2020).

Tatumville Gully has an estimated sediment transport rate of 7,255 t/yr, which is deposited into Mobile Bay just south of downtown Fairhope. Satellite imagery from 1985 shows a sediment/turbidity plume extending southwestward into Mobile Bay from the Tatumville Gully mouth (fig. 22). USGS topobathymetric mapping shows that an alluvial fan has developed into Mobile Bay, covering about 30 acres (fig. 23). Water depths at the Tatumville Gully mouth range from 0 to 3 ft. (USGS, 2013). Satellite imagery from 2019 continues to show a sediment plume extending into Mobile Bay from the mouth of Tatumville Gully (fig. 24). Figure 25 is a 2019 satellite image showing sediment/turbidity plumes extending into Mobile Bay from the mouths of Rock Creek, Big Mouth Gully and Tatumville Gully along with discharge from Fly Creek that is less turbid than Mobile Bay.

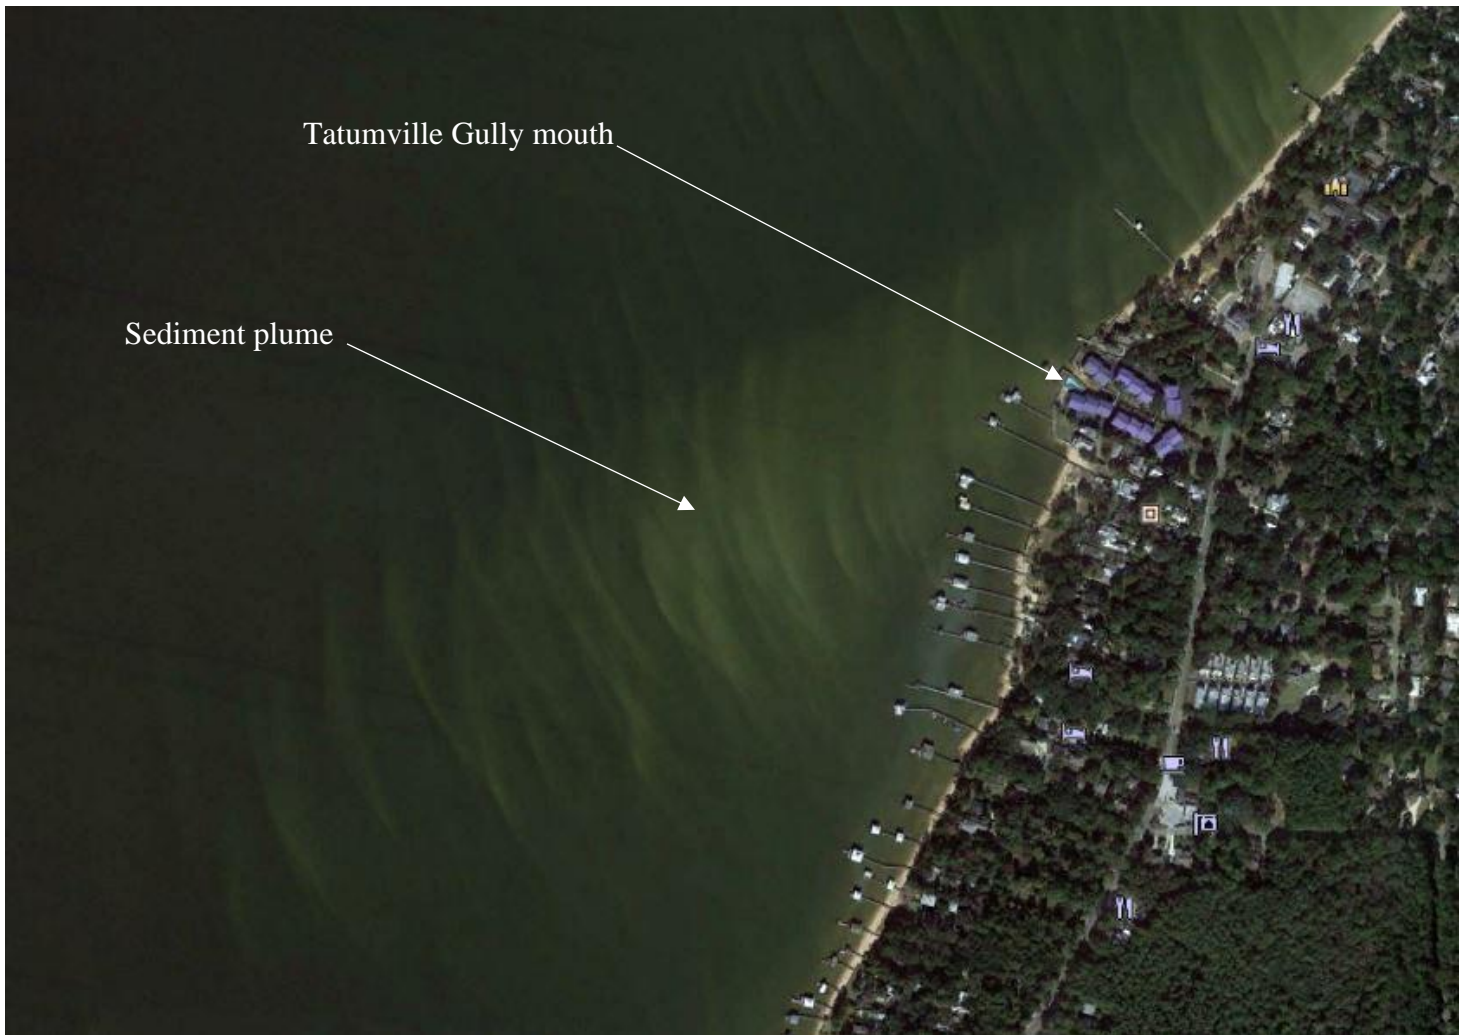
Figure 24.—Sediment plume from the mouth of Tatumville Gully shown on 2019 satellite imagery (Google Earth, 2020).
