PHASE II POST-RESTORATION ANALYSIS OF DISCHARGE, SEDIMENT TRANSPORT RATES, AND WATER QUALITY IN TRIBUTARIES OF JOES BRANCH IN SPANISH FORT, BALDWIN COUNTY, ALABAMA

GEOLOGICAL SURVEY OF ALABAMA

PHASE II POST-RESTORATION ANALYSIS OF DISCHARGE AND SEDIMENT TRANSPORT RATES IN TRIBUTARIES OF JOES BRANCH IN SPANISH FORT, BALDWIN COUNTY, ALABAMA

OPEN FILE REPORT 1408

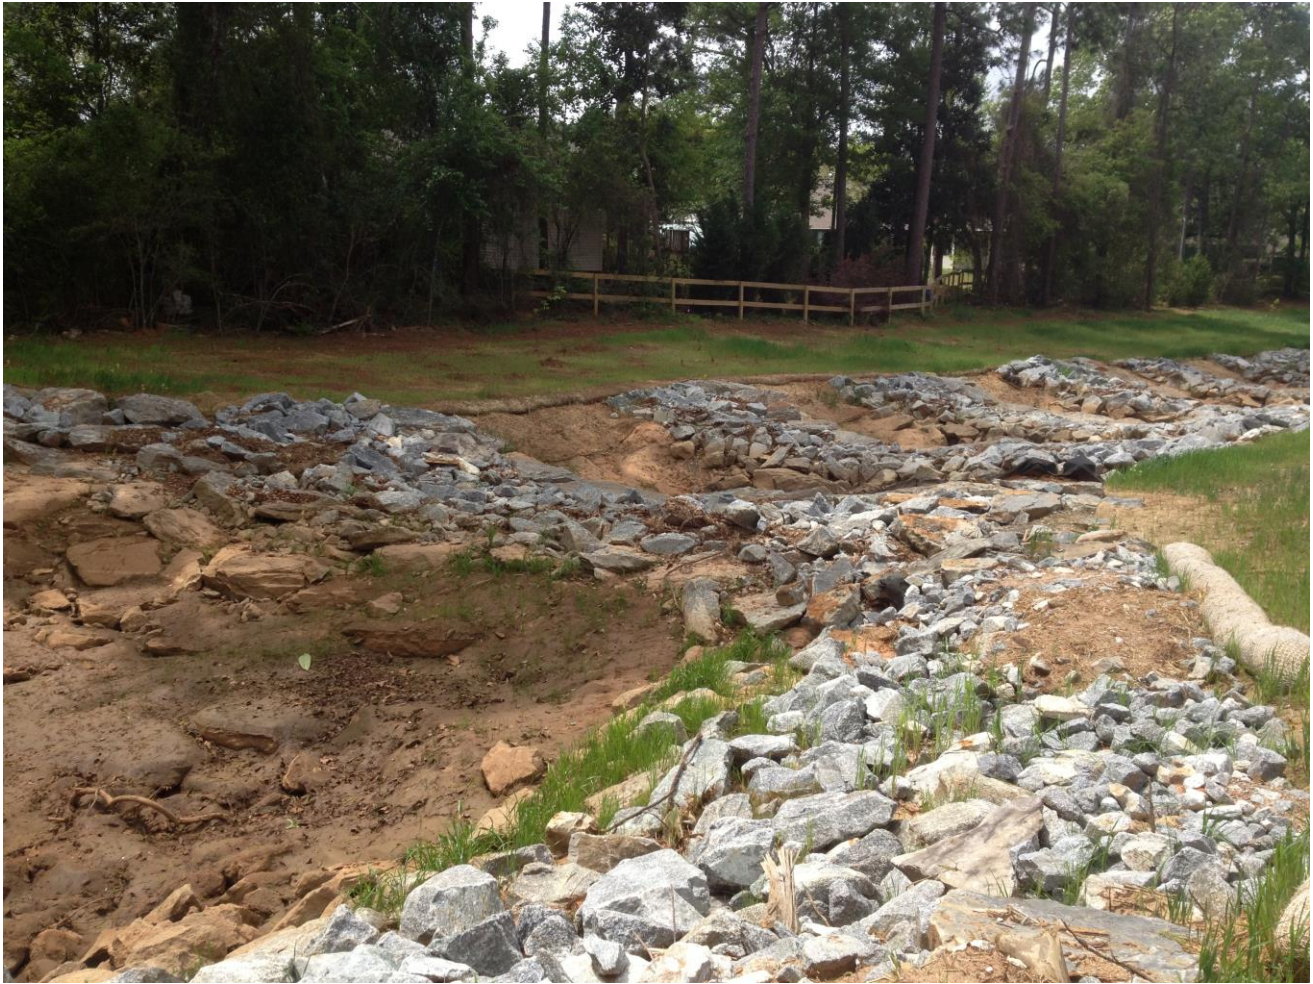
Figure. 1—Step pool conveyance system constructed in the unnamed tributary of Joes Branch in Spanish Fort.

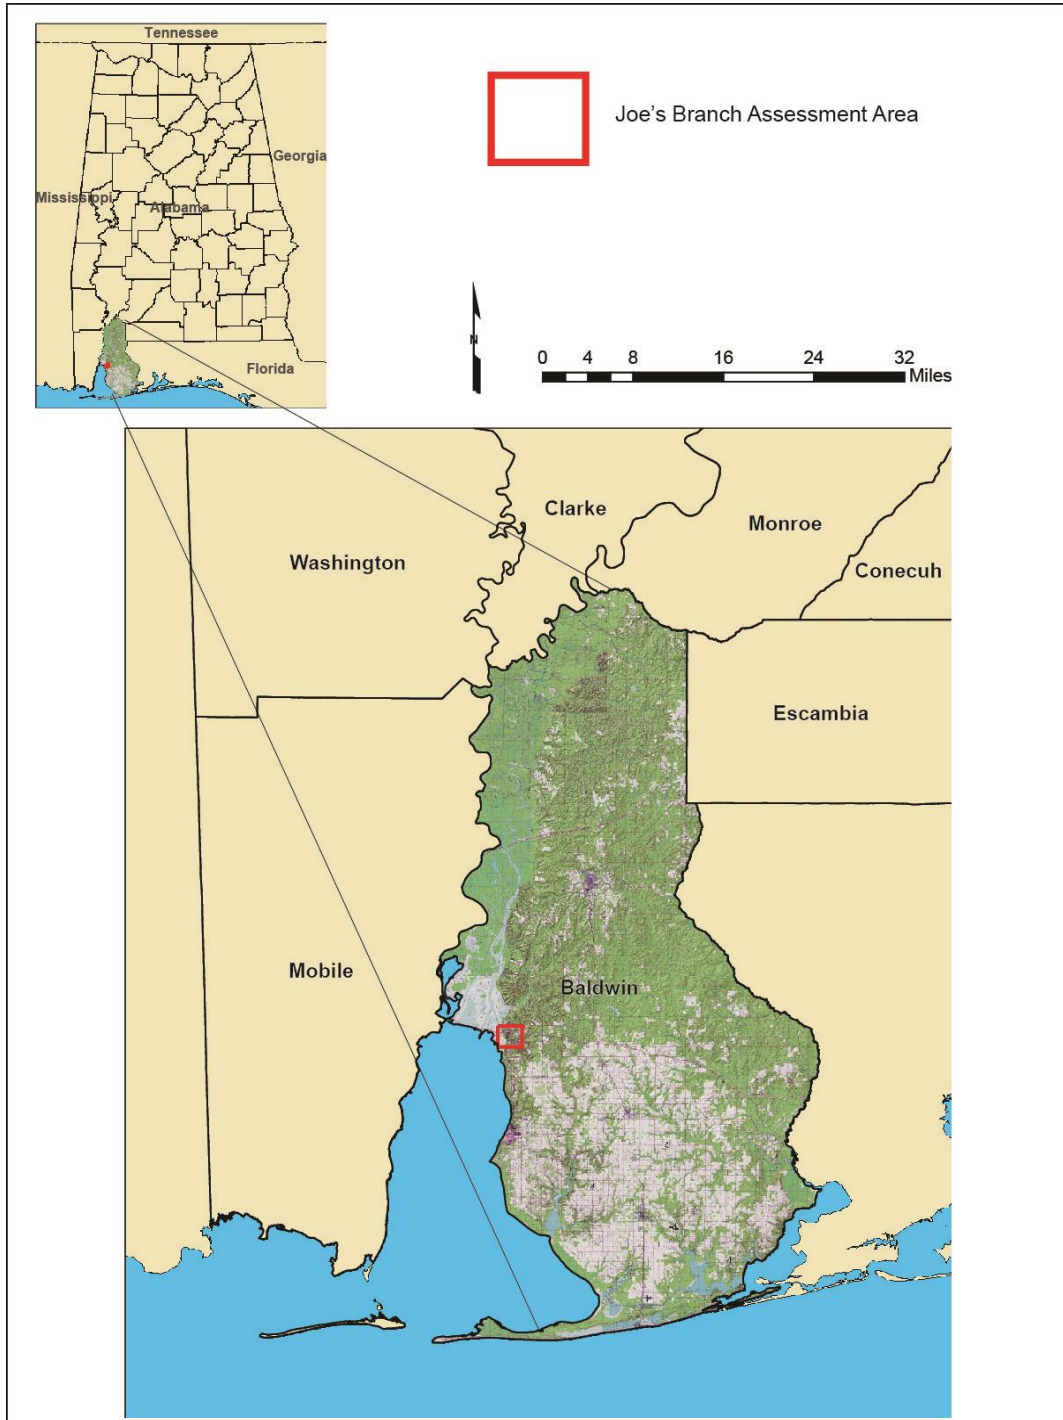
Figure 2.—Joes Branch project area in west-central Baldwin County.

The Joes Branch project is in the city of Spanish Fort in west-central Baldwin County (fig. 2). The project consists of monitoring sites on two unnamed tributaries that

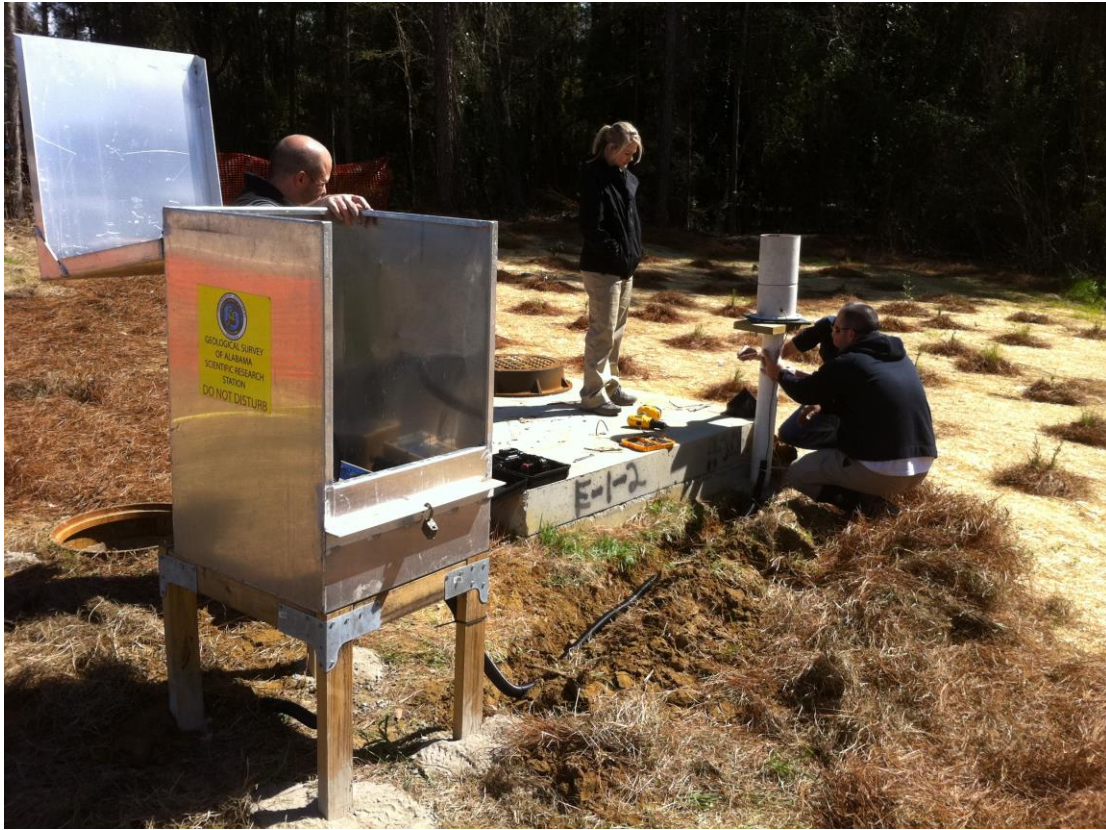
Figure 3.—Installation of discharge and precipitation monitoring and sample collection equipment at Joes Branch site JB1.

Sites JB1 and JB6 each were outfitted with an American Sigma 900 Max automated sampler and data logger. The site JB1 American Sigma 900 Max also had a tipping bucket rain gauge (fig. 3). The 900 Max units measured water level and were programed to collect water samples based on specified water levels resulting from storm events. Both sites were rated for discharge so that stream water levels in inches and discharge in cubic feet per second (cfs) were recorded at 15-minute intervals. One of the design characteristics of the step pool conveyance system is to slow runoff velocities. During the pre-restoration period, the average stream flow velocity increased from 1.0 foot per second (ft/s) at site JB1 to 3.0 ft/s at site JB6. Discharge data collected during the post-restoration period, after installation of the step pool conveyance system, indicates that the average stream flow velocity decreased from 4.8 (ft/s) at site JB1 to 1.4 ft/s at site JB6. Average stream flow velocity at site JB7 was 1.1 ft/s during the pre-restoration

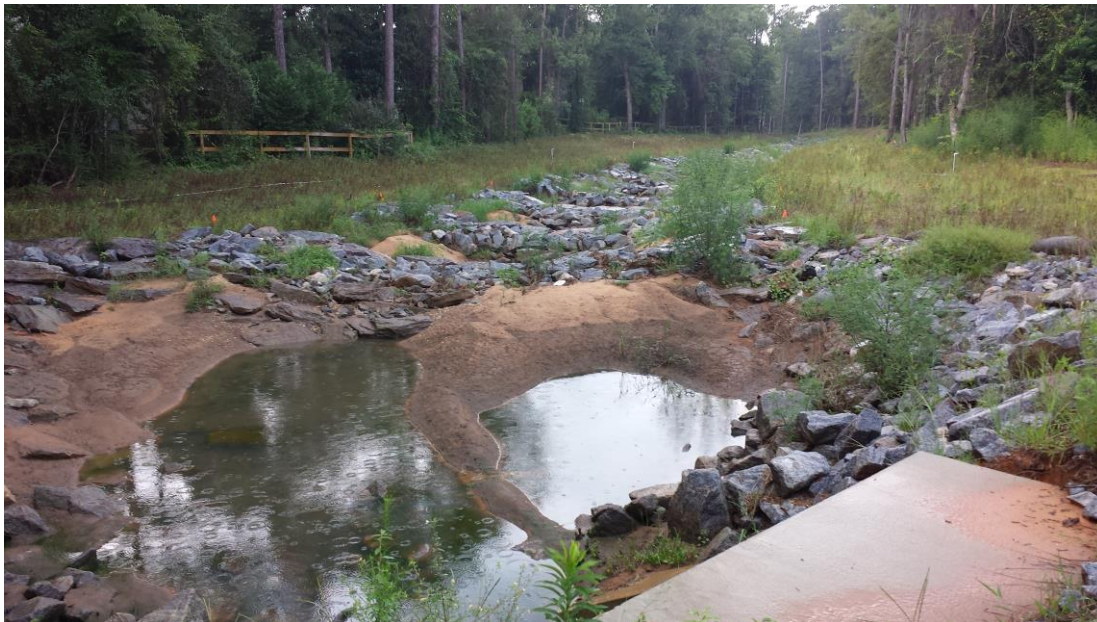
Figure 4.—Sediment deposition in step pool conveyance system cells as a result of land disturbance upstream from site JB1.

Turbidity values measured in stream at site JB1 shows that utility excavation upstream from the site during the post-restoration monitoring period caused increased turbidity during high flow events. Figure 4 shows impacts of sediment deposition in the step pool conveyance system cells. Except for this disturbance it was expected that turbidity values for the pre- and post-restoration monitoring periods would be similar (fig. 5). Values at site JB6 indicate decreased turbidities of more than an order of magnitude, demonstrating the effectiveness of the step pool conveyance system in preventing erosion and sediment transport in the area between sites JB1 and JB6 (fig. 6). Values at site JB7 also indicate a major reduction in turbidity during the post-restoration monitoring period (fig. 7).

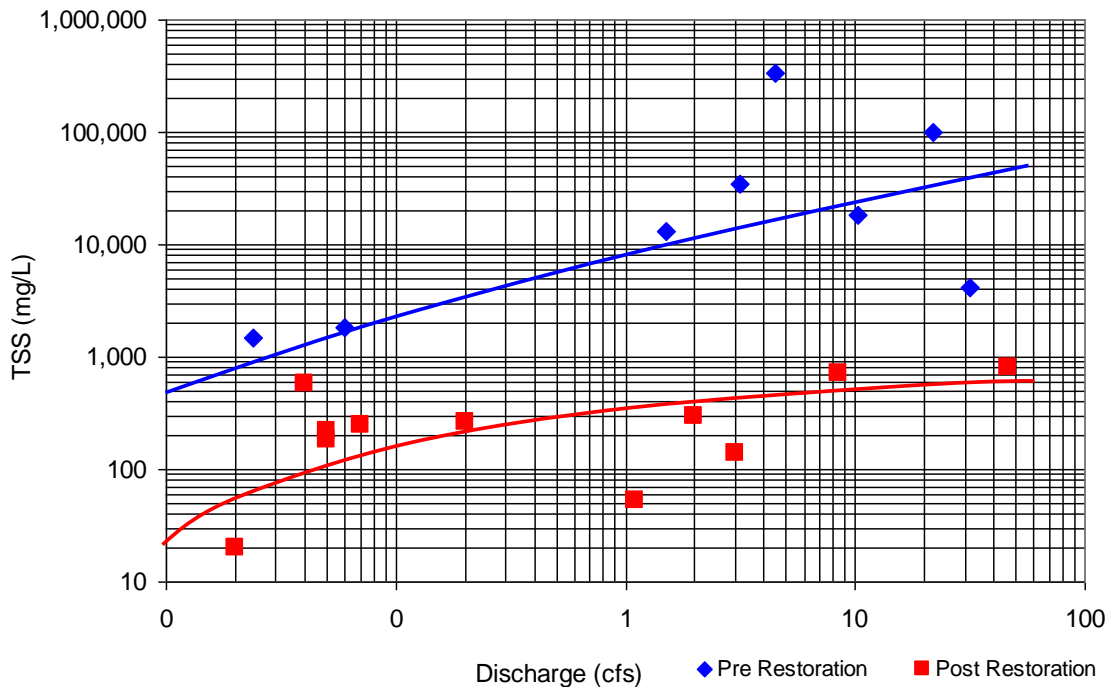
Figure 9.—Measured total suspended solids and stream discharge during the pre- and post-restoration monitoring period at Joes Branch site JB6.

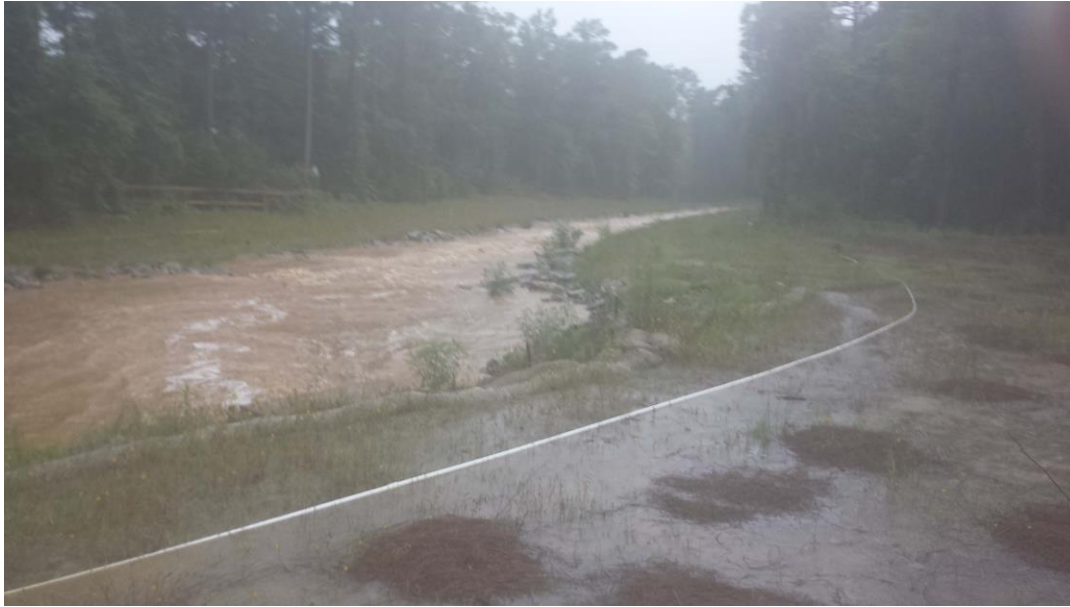
Figure 11.—The step pool conveyance system after an intense storm event with discharge of about 43 cfs on July 11, 2013.

site JB6 during the pre-restoration monitoring period (table 2). Figure 11 is a photograph of the step pool conveyance system with a 43 cfs flow on July 11, 2013.

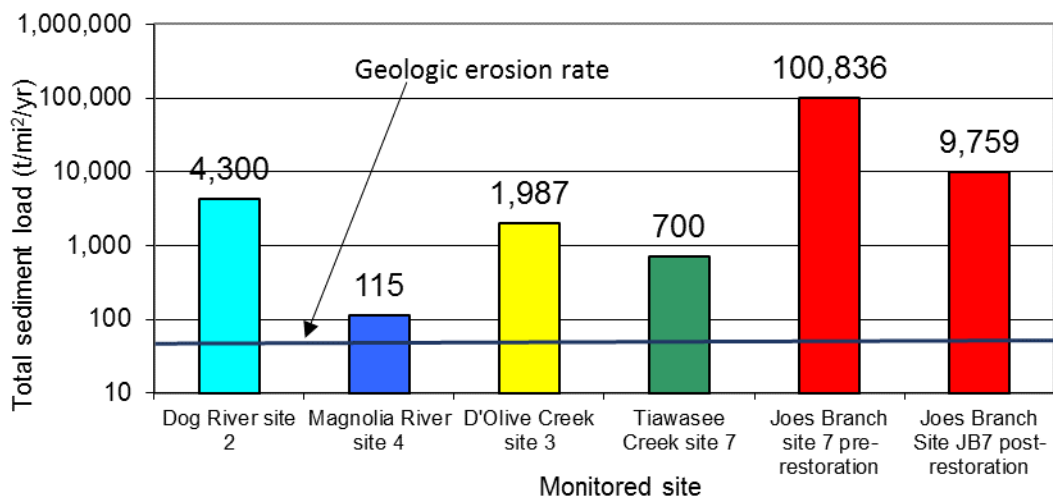
Figure 13.—Comparisons of estimated normalized total sediment loads from selected Baldwin County streams.
