GEOLOGIC INVESTIGATIONS PROGRAM

**COMPREHENSIVE SHORELINE MAPPING,  
BALDWIN AND MOBILE COUNTIES, ALABAMA:  
PHASE II**

**OPEN FILE REPORT 1106**

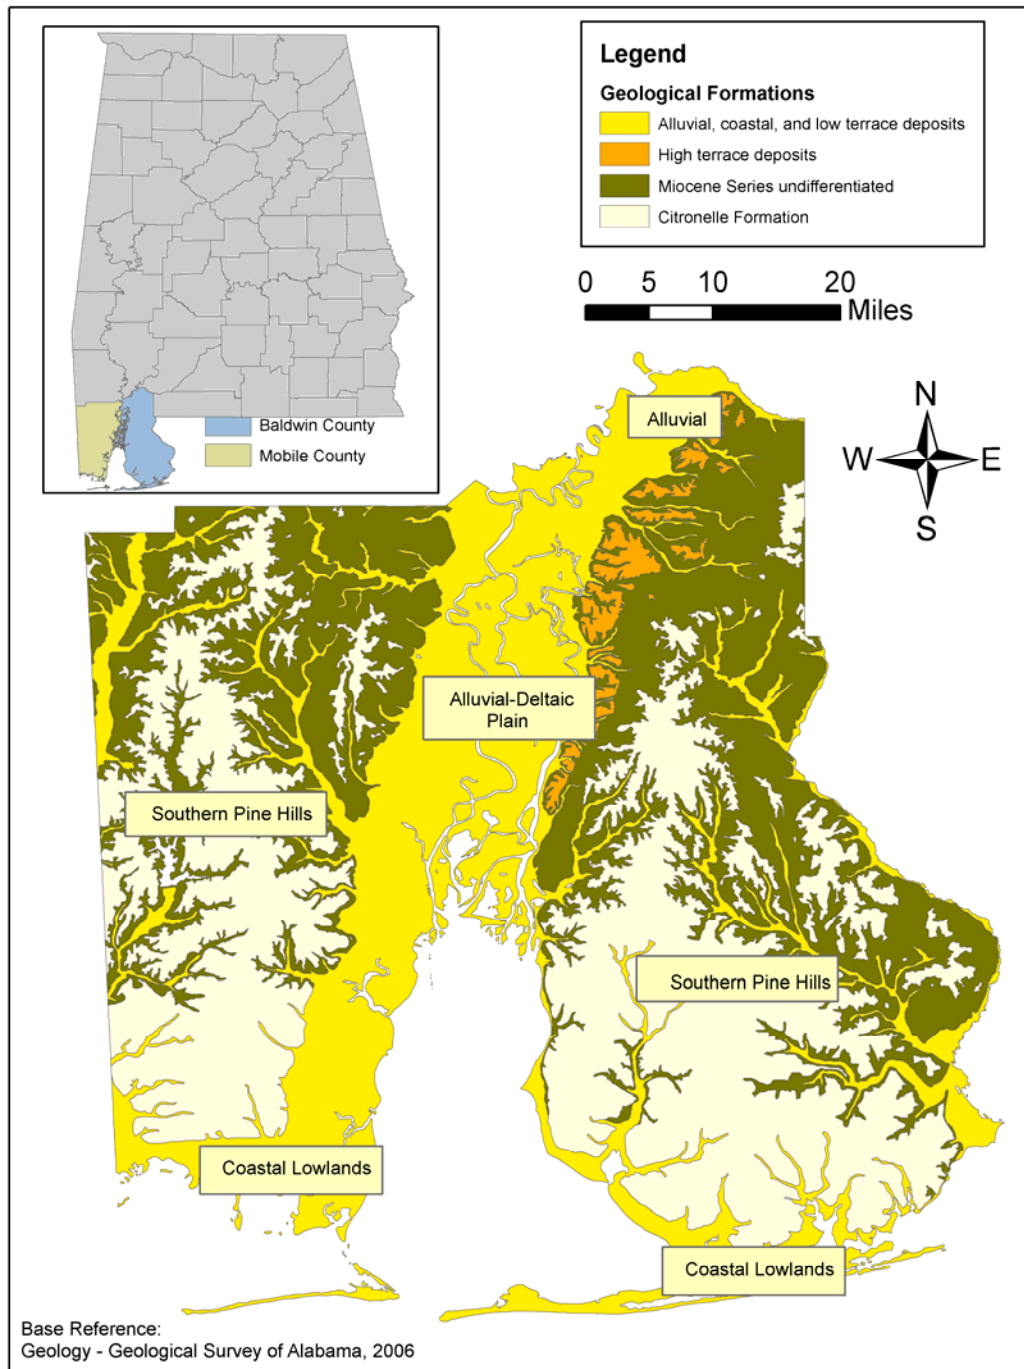
Figure 1.--Generalized geology and physiography in Baldwin and Mobile Counties, Alabama

These counties lie within two physiographic districts: the Southern Pine Hills and the Coastal Lowlands (Sapp and Emplainscourt, 1975) (fig. 1). The Southern Pine Hills district is characterized by broad, rounded hills of low relief with segregated flat upland areas. As the number of incised channels increase with distance from the broad alluvium deposits, a dendritic drainage pattern is evident with well defined stream channels, narrow riparian buffers, and occasional steep stream banks. The Coastal Lowlands district is of very low relief and is characterized by abundant sand which allows for broad floodplains and wide riparian wetlands. The area is underlain by the Miocene series undifferentiated and the Citronelle Formation of Pliocene and Pleistocene age (fig. 1).

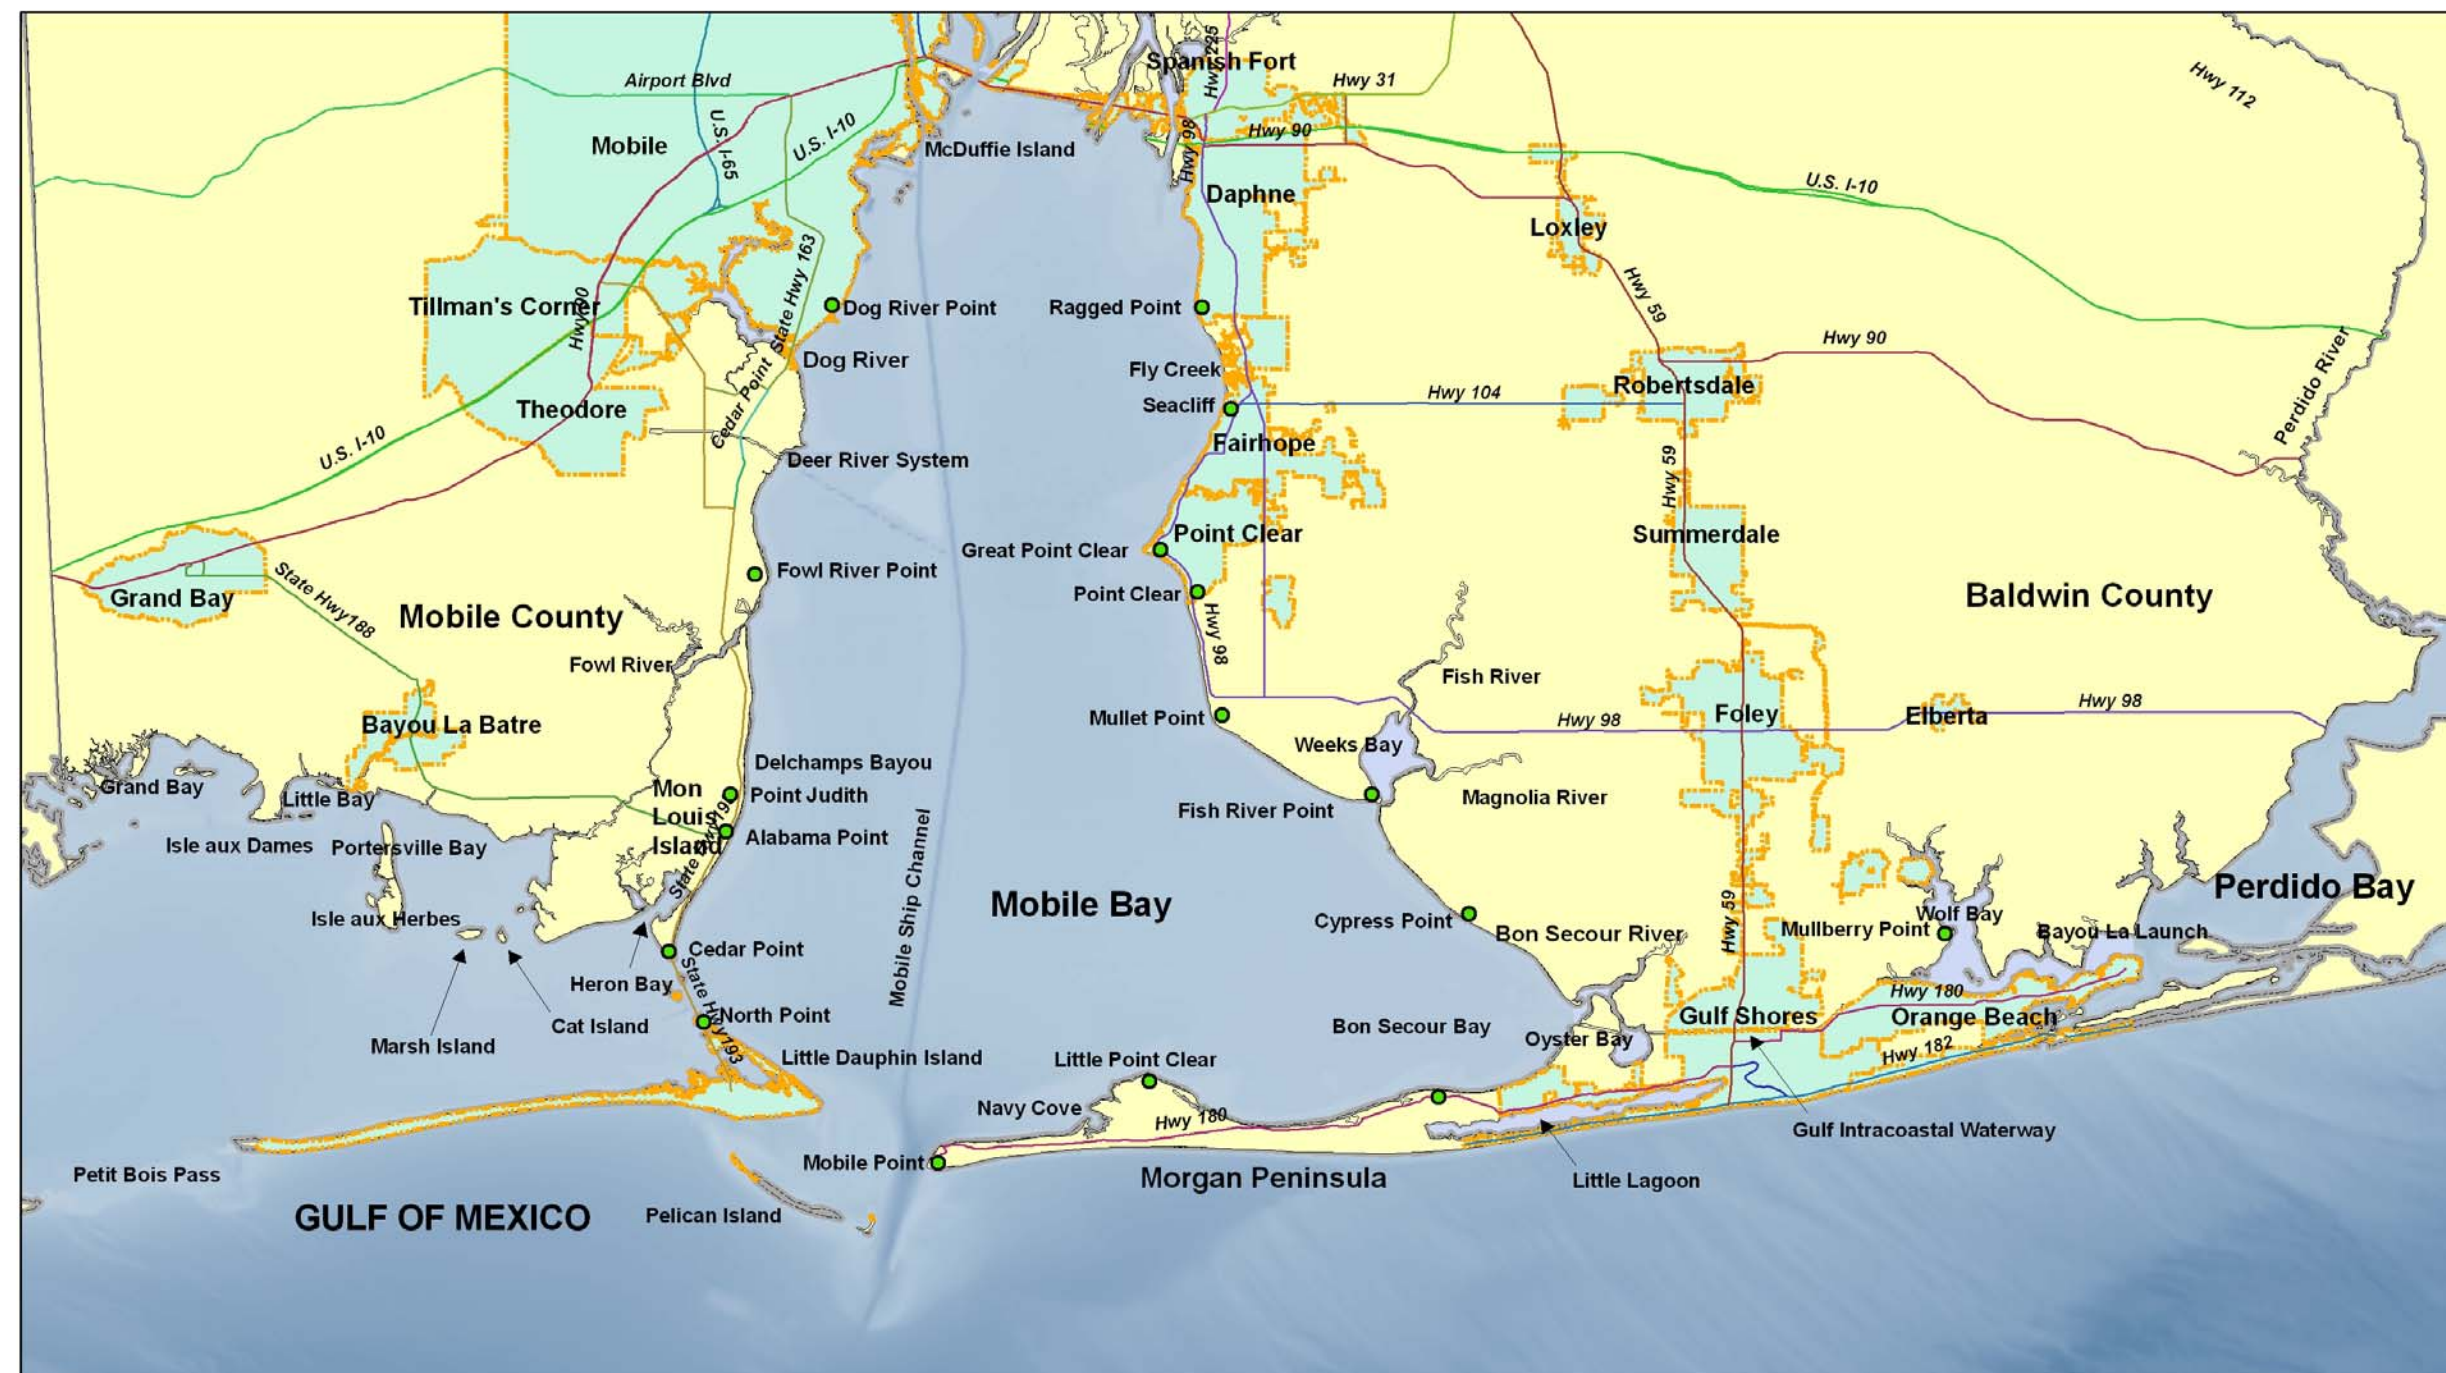
Figure 2.--Study area map.

The study areas for Phase II and described herein are Little Lagoon, the Alabama segment of the Gulf Intracoastal Waterway, Oyster Bay (includes Bear Creek), Wolf Bay, and Bon Secour River (including Boggy Branch and Brights Creek) in Baldwin County and Dog River and adjoining tributaries in Mobile County (fig. 2). For convenience, the “Dog River System” and its adjoining tributaries Alligator Bayou, Moore Creek, Robinsons Bayou, Perch Creek, Rabbit Creek, Rattlesnake Bayou, and Halls Mill Creek have been combined and are referred to hereafter as the Dog River System.

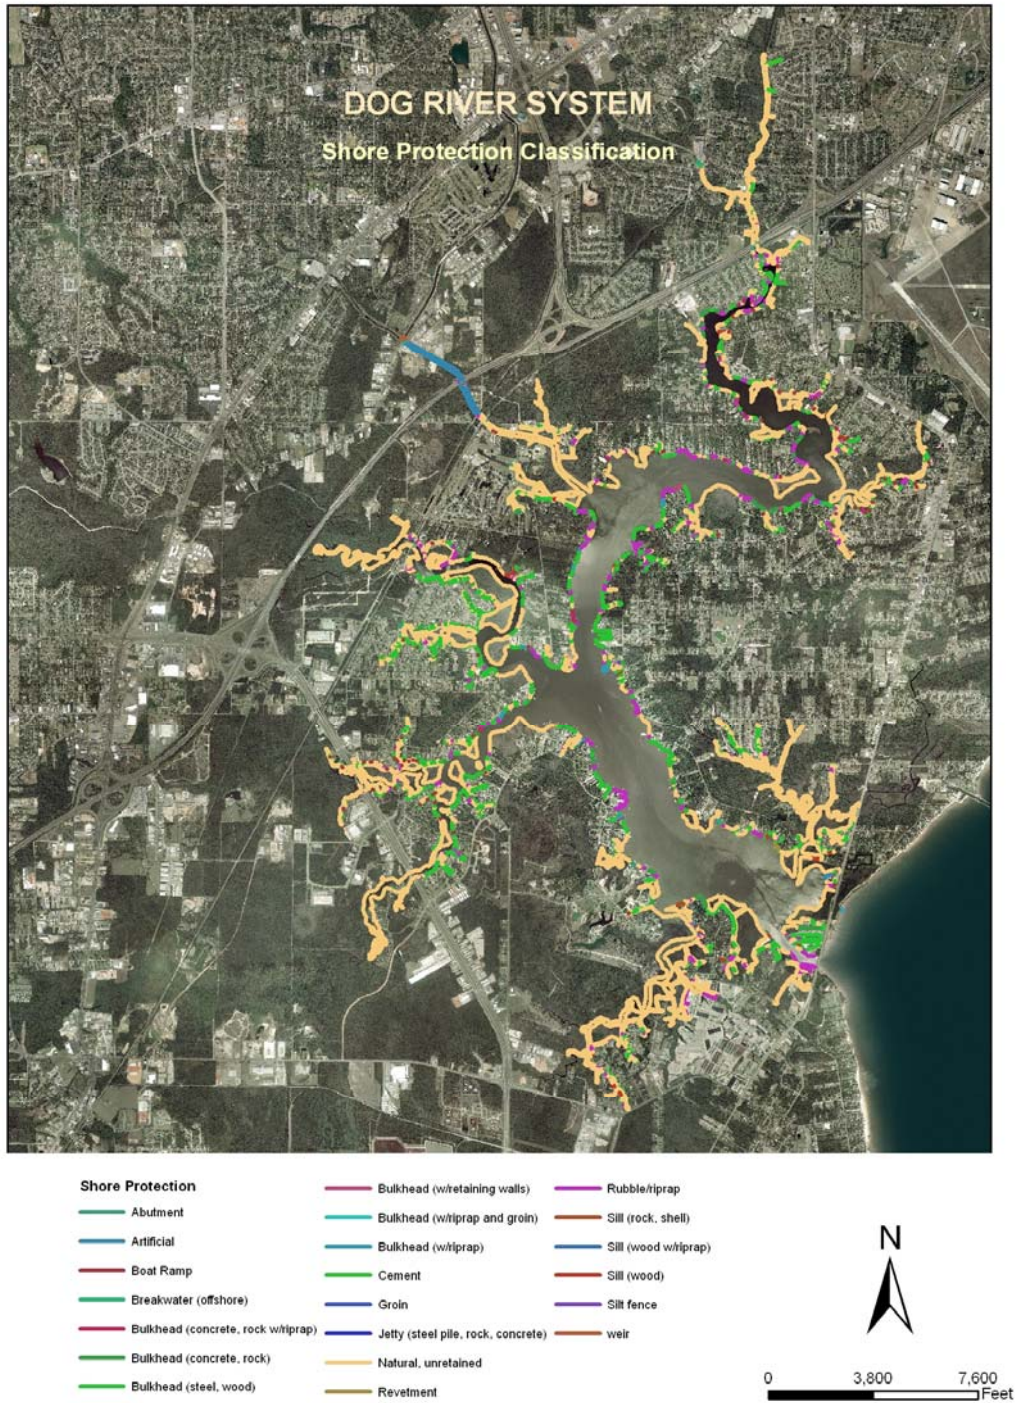
Figure 3.--Shore protection map of the Dog River System.

Figure 3 illustrates the distribution of shore protection in the Dog River System. About 457,451 feet (86.6 miles) or about 68.3 percent of the shoreline mapped is natural, unretained. About 40.2 miles or 31.7 percent was mapped with hard shore protection. Bulkhead shore protection makes up about 144,896 feet (27.4 miles) or about 21.6 percent of the total. Bulkhead (steel, wood) shore protection, the longest of the five subtypes mapped, makes up about 125,804 feet (23.8 miles) or about 18.8 percent of the total. Rubble/riprap, the second longest hard shoreline classification mapped, makes up about 44,682 feet (8.5 miles) or about 6.7 percent of the total shore protection. The remaining protection, about 41,462 feet, is mainly artificial, bulkhead, and sill (table 5). There were 178 private boat ramps and 6 public boat ramps encountered in the Dog River System making up about 3,315 feet or about 0.5 percent of the total shore protection in the Dog River System (fig. 4).

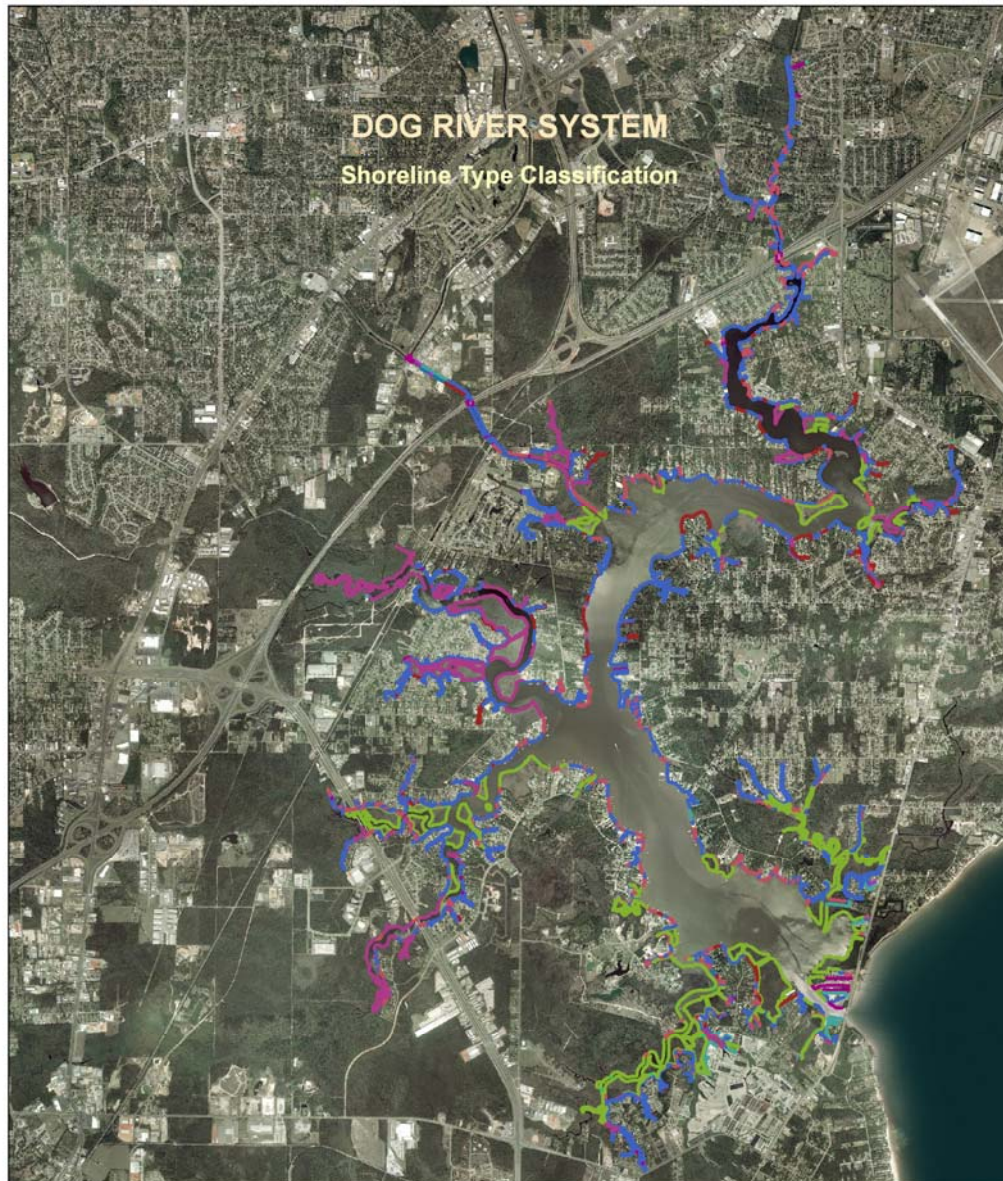
Figure 5.--Shoreline type map of the Dog River System.

up 668,979 feet or about 126.7 miles encountered in the Dog River System. Figure 5 illustrates the distribution of the shoreline types in the Dog River System.

Organic shoreline type makes up about 325,065 feet (61.6 miles) or about 48.6 percent of the total. Vegetated bank shoreline type makes up about 317,408 feet (53.9 miles) or about 47.4 percent of the total. Sediment bank shoreline type makes up about 12,800 feet (2.4 miles) or about 1.9 percent of the total in the Dog River System. Artificial and pocket beach shoreline types makes up about 10,572 feet (2.0 miles) or about 1.6 percent and about 213 feet or less than 0.1 percent of the total shoreline type in the Dog River System, respectively. There were 129 inlets identified.

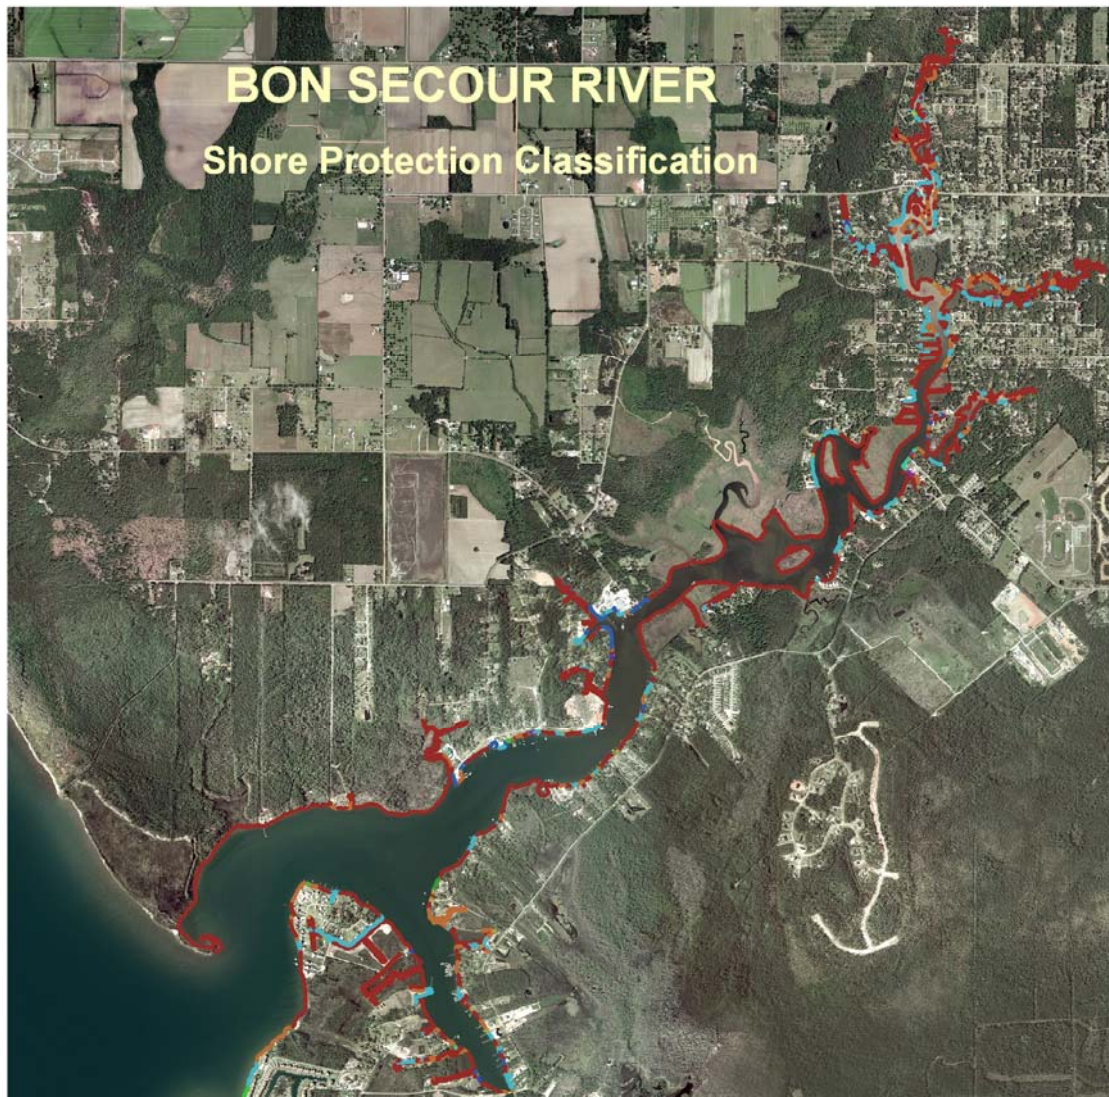
Figure 6.--Shore protection map of Bon Secour River.

Fifteen different types of shore protection were mapped in the Bon Secour River which were classified as follows: boat ramp, bulkhead (concrete, rock), bulkhead (steel, wood), bulkhead (w/groin), bulkhead (w/riprap and groin), bulkhead (w/riprap and sill), bulkhead (w/riprap), bulkhead (w/sill), groin, natural, unretained, revetment, rubble/riprap, rubble/riprap (w/groin) and sill (wood). The detailed shore protection values for the Bon Secour River are listed in table 7. These shore protection types make up 184,841 feet or about 35 miles of shore protection that were mapped in the Bon Secour River (fig. 6). The Bon Secour River consists mainly of natural, unretained shoreline having about 131,570 feet (24.9 miles) or about 71.2 percent of the total with 28.8 percent armored. Bulkhead (steel, wood) shore protection, longest of the five bulkhead subtypes observed, makes up about 27,548 feet (5.2 miles) or about 14.9 percent of the total. Rubble/riprap shore protection makes up about 17,512 feet (3.3 miles) or about 9.5 percent of the total shore protection in the Bon Secour River. There were 54 private boat ramps and 4 public boat ramps encountered on Bon Secour River (fig. 7). The remaining 4.4 percent of the shoreline is armored through various methods listed above and tabulated in table 7.

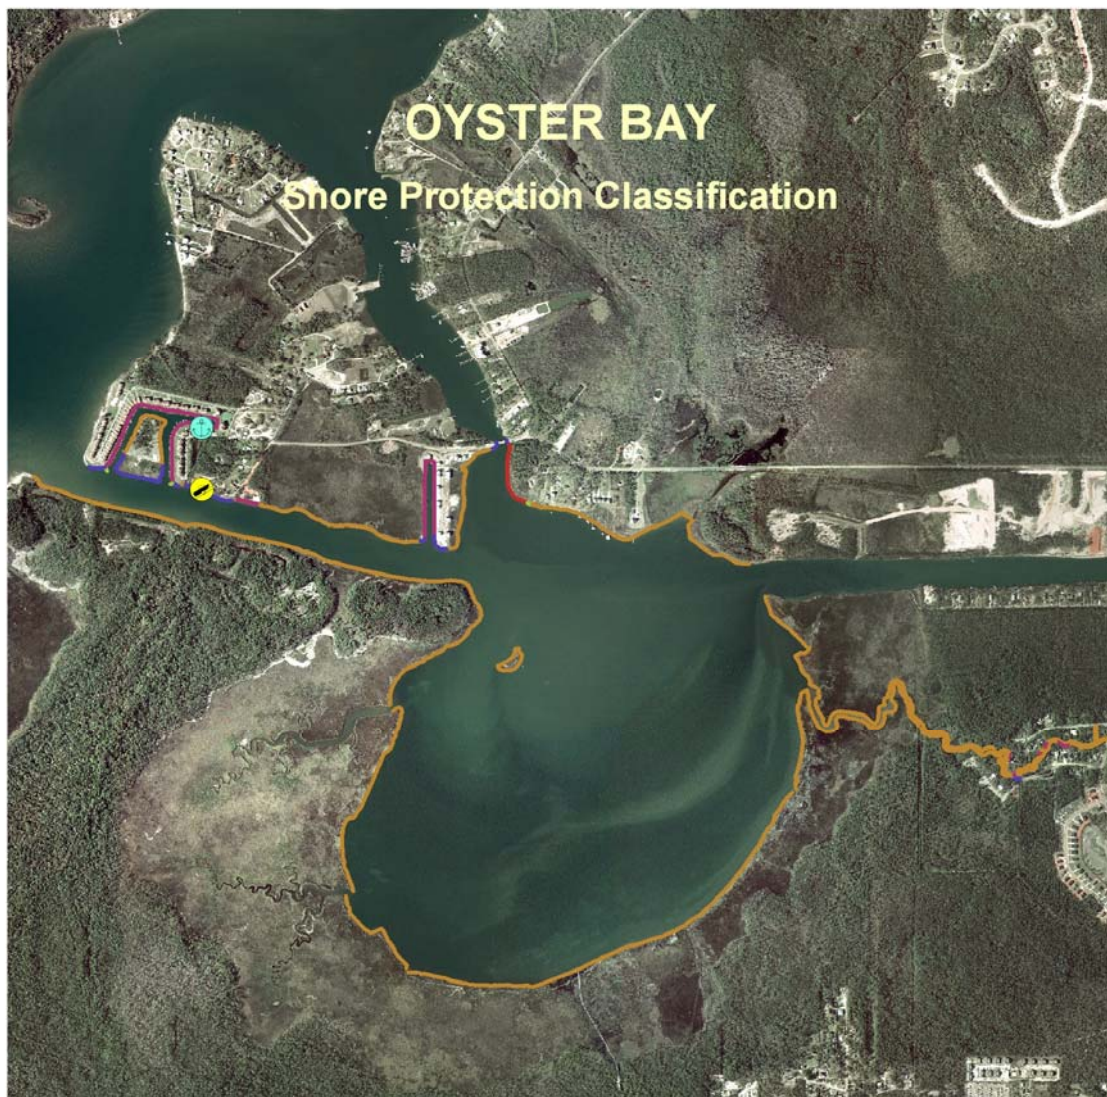
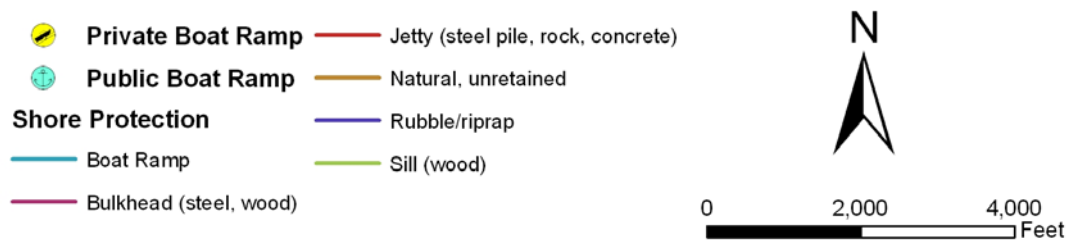
Figure 9.--Shore protection map of Oyster Bay.

The longest class of the Oyster Bay shoreline is natural, unretained having about 45,010 feet (8.5 miles) or about 81.6 percent of the total. Bulkhead (steel, wood) makes up about 6,124 feet (1.2 miles) or about 11.1 percent of the total 18.43 percent armored. Rubble/riprap makes up about 2,949 feet or about 5.3 percent of the total shore protection in Oyster Bay. There were two private boat ramps observed.

Field mapping of about 10.5 miles of shoreline in Oyster Bay determined that 81.6 percent of the total was natural, unretained. Bulkhead (steel, wood) makes up about 1.2 miles (11.1 percent) of the total 18.43 percent armored. About 7 miles (68.5 percent) of shoreline type is organic; vegetated bank makes up about 2.8 miles (26.9 percent). Two boat ramps were observed.

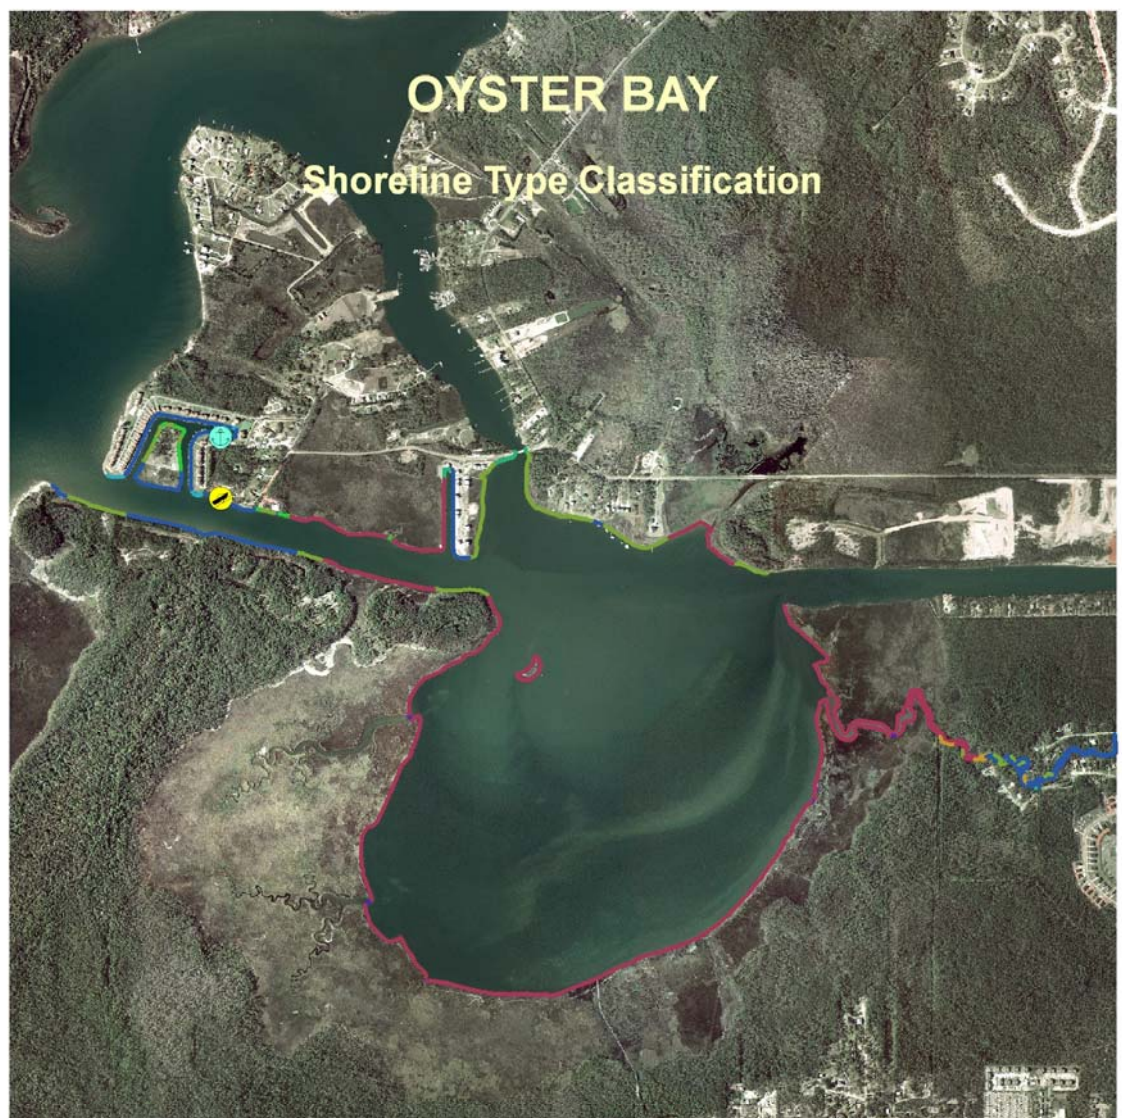
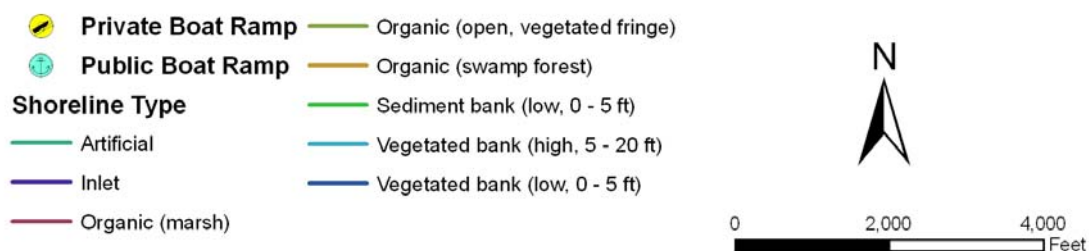
Figure 10.--Shoreline type map of Oyster Bay.

Illustrated on figure 10, there were eight general shoreline types identified in Oyster Bay which were classified as artificial, inlet, organic subtypes, sediment bank (low), vegetated bank (high) and vegetated bank (low) (table 10). Organic types make up about 37,168 feet (7.0 miles) or about 68.5 percent of the total. Vegetated bank shoreline types make up about 14,622 feet (2.8 miles) or about 26.9 percent. There were 22 inlets encountered in Oyster Bay.

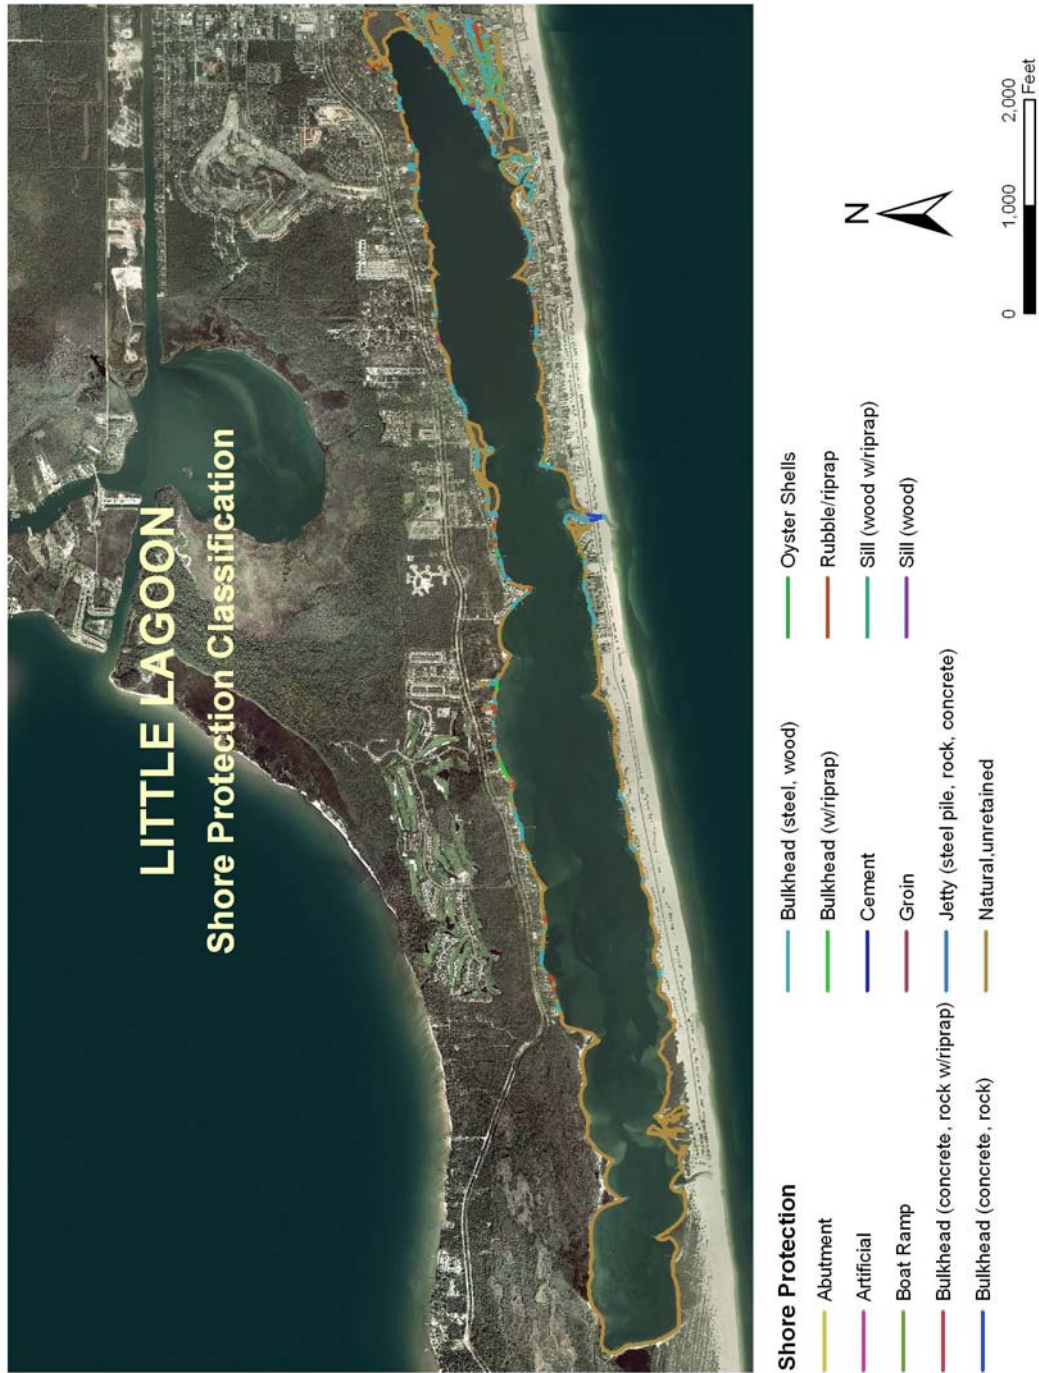
Figure 11.--Shore protection map of Little Lagoon.

Shore protection classifications in Little Lagoon are numerous. Fourteen different classification types were observed, including abutment, boat ramp, bulkhead subtypes, cement, groin, jetty (steel pile, rock, concrete), oyster shells, rubble/riprap, sill (wood w/riprap), and sill (wood). Detailed shore protection data for Little Lagoon are provided in table 11 where about 174,449 feet (33 miles) of shoreline were mapped. Figure 11 illustrates the distribution of shore protection as mapped in Little Lagoon.

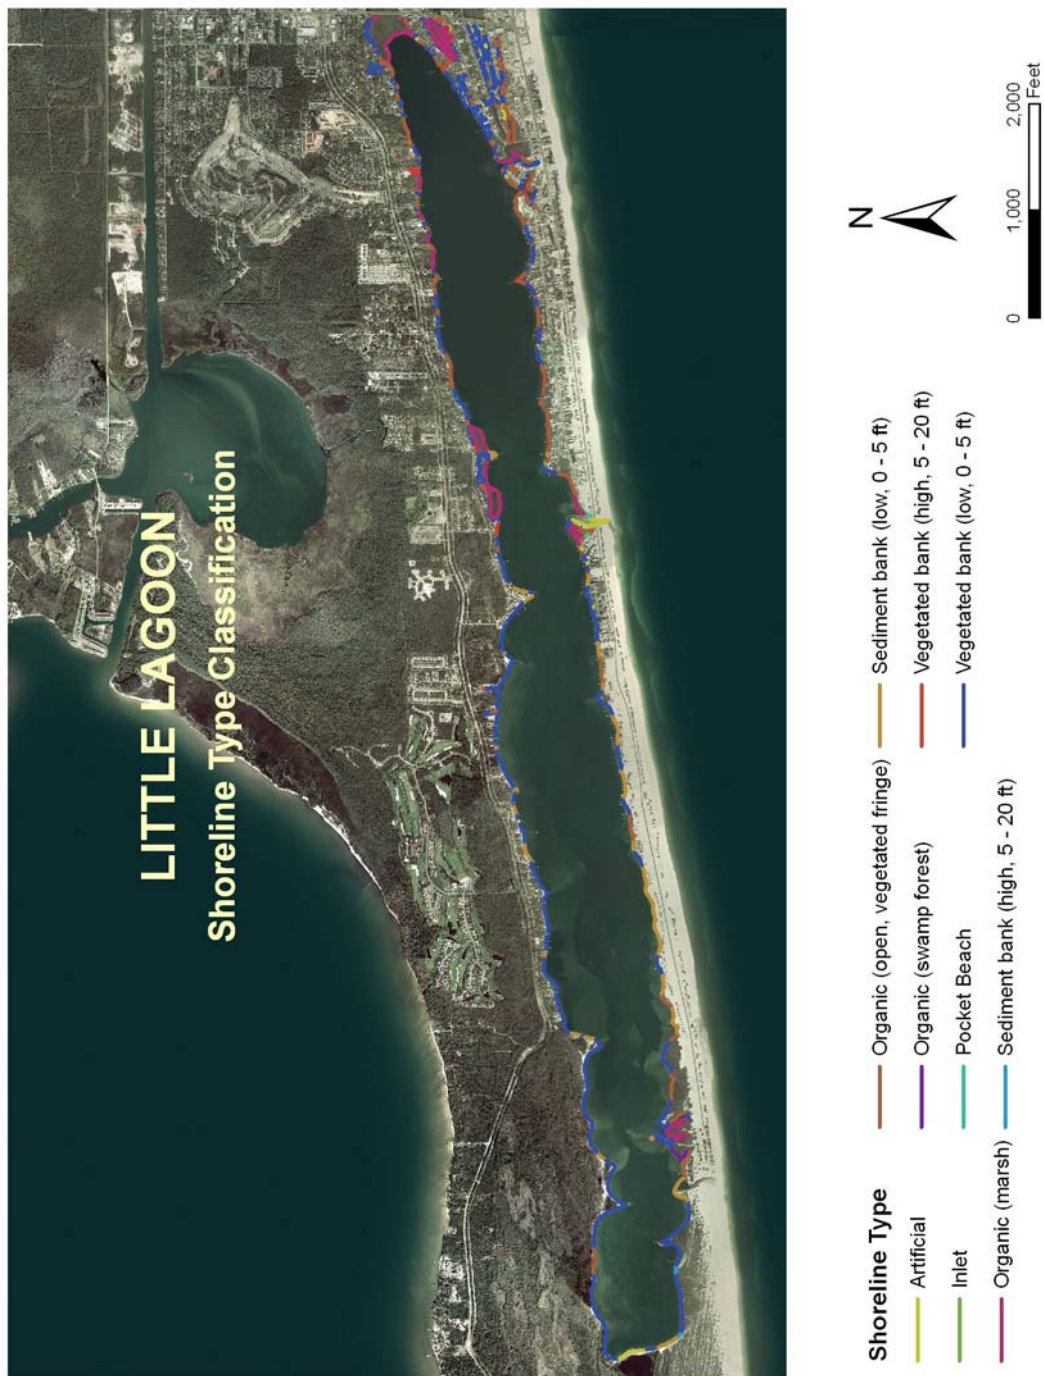
Figure 13.--Shoreline type map of Little Lagoon.

The dominant shoreline type in Little Lagoon is vegetated bank making up about 91,155 feet (17.3 miles) or about 53 percent of the total which is predominantly vegetated low bank (52 percent). Organic shoreline type makes up about 59,358 feet (11.2 miles) or about 34.5 percent of the total. Although high subtype is minimal, the sediment bank shoreline types make up about 15,008 feet (2.8 miles) or about 8.7 percent. Lesser classifications with specifics are tabulated in table 12. There were ten inlets identified in Little Lagoon.

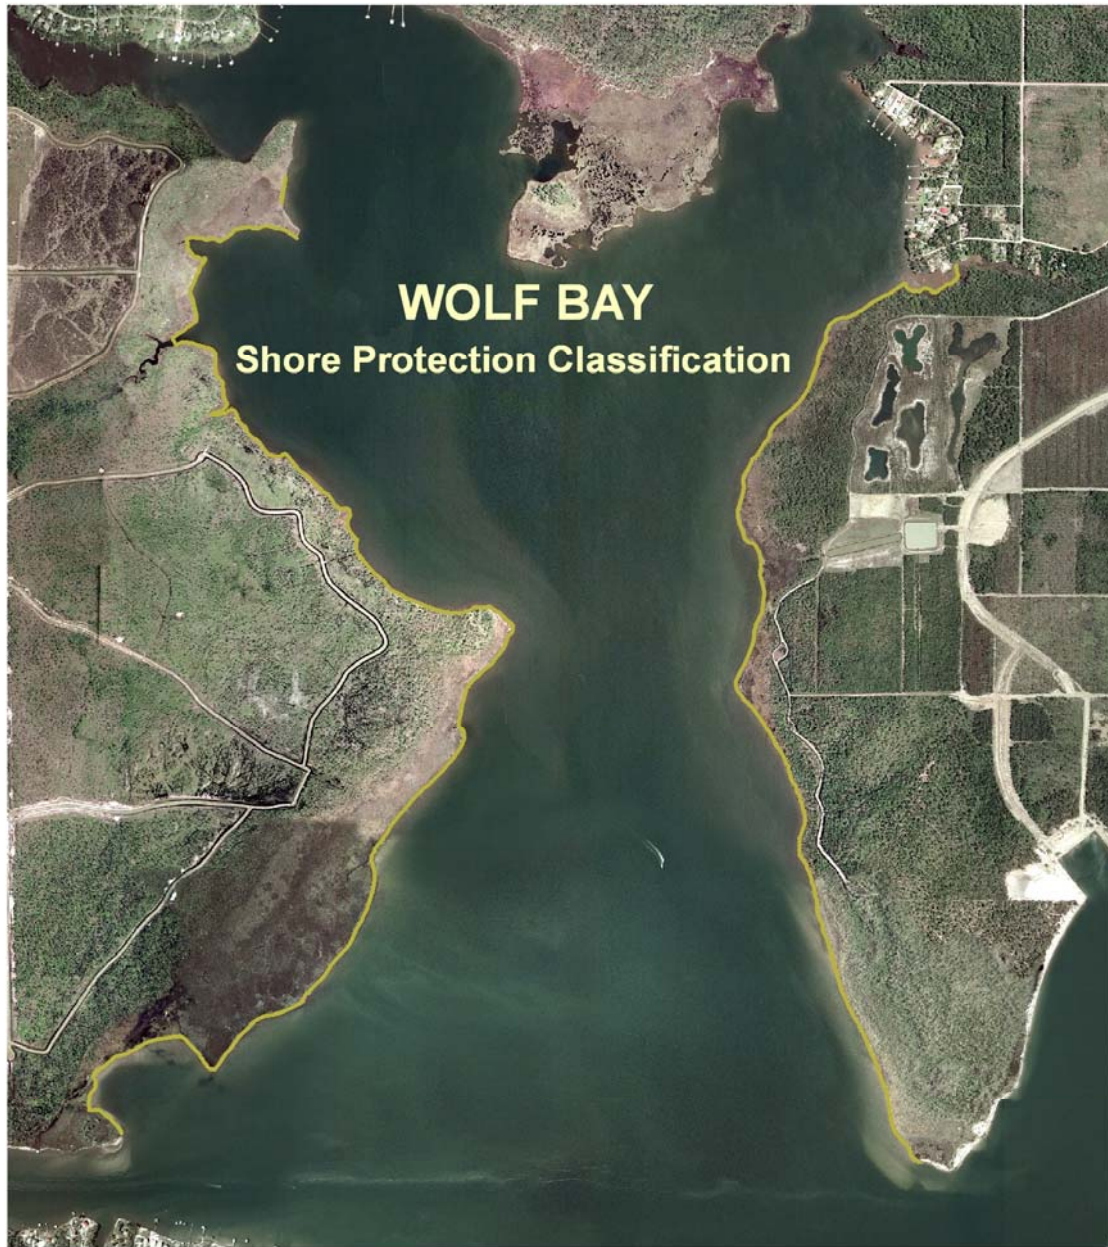
Natural, unretained shoreline was the only type of shore protection encountered along the western and eastern shorelines of Wolf Bay (fig. 16). Mapped were 35,187 feet (6.7 miles) of shoreline.

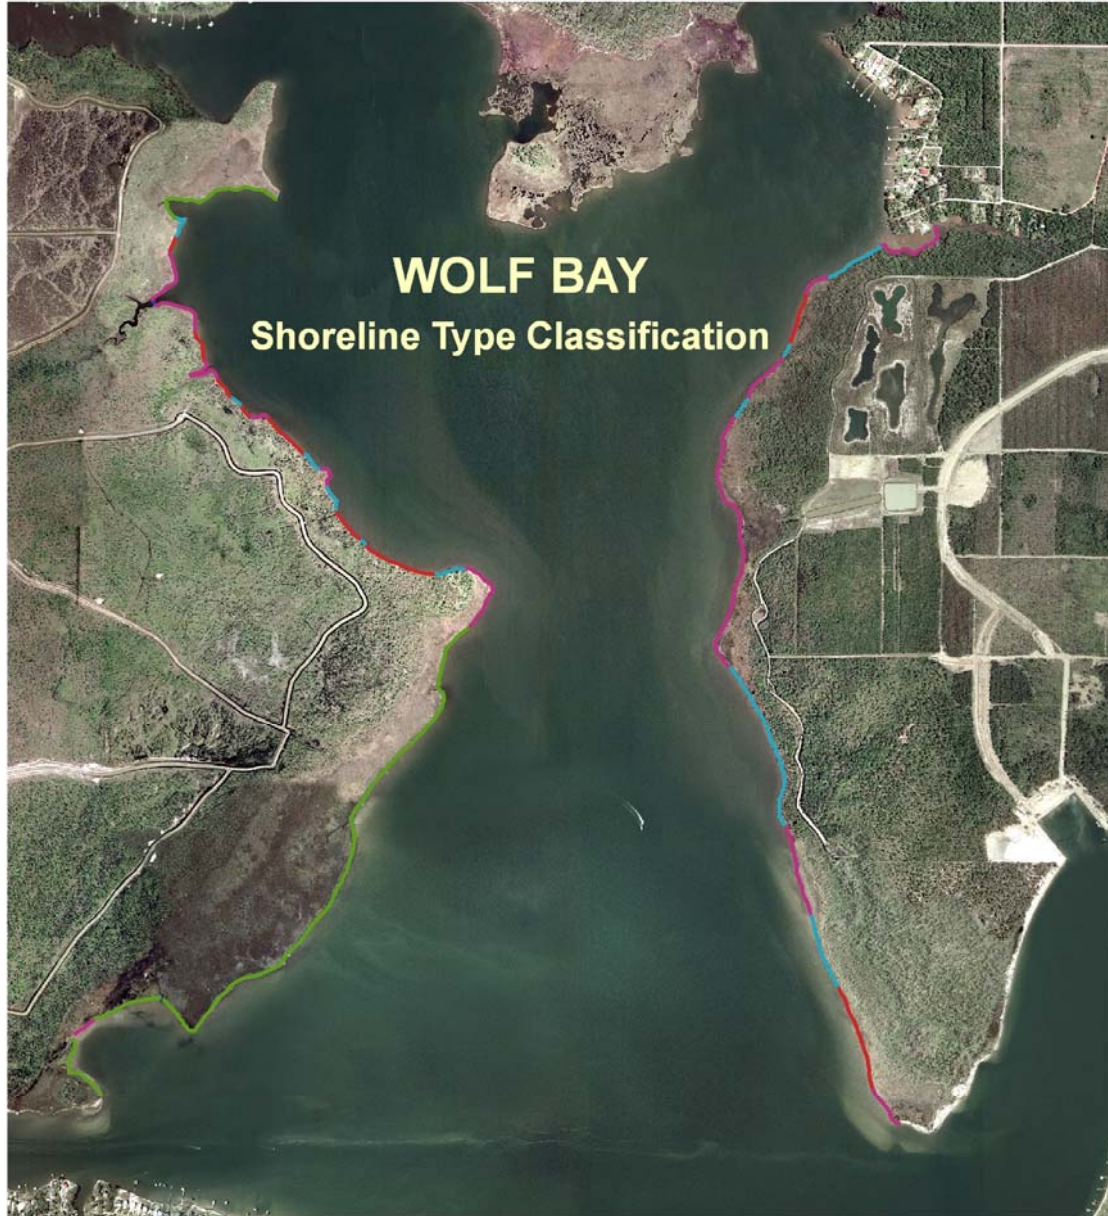
- Shoreline Type**
- Inlet
  - Organic (marsh)
  - Organic (open, vegetated fringe)
  - Sediment bank (low, 0 - 5 ft)
  - Vegetated bank (low, 0 - 5 ft)

Table 15.--Wolf Bay shoreline type classification lengths and percentages.

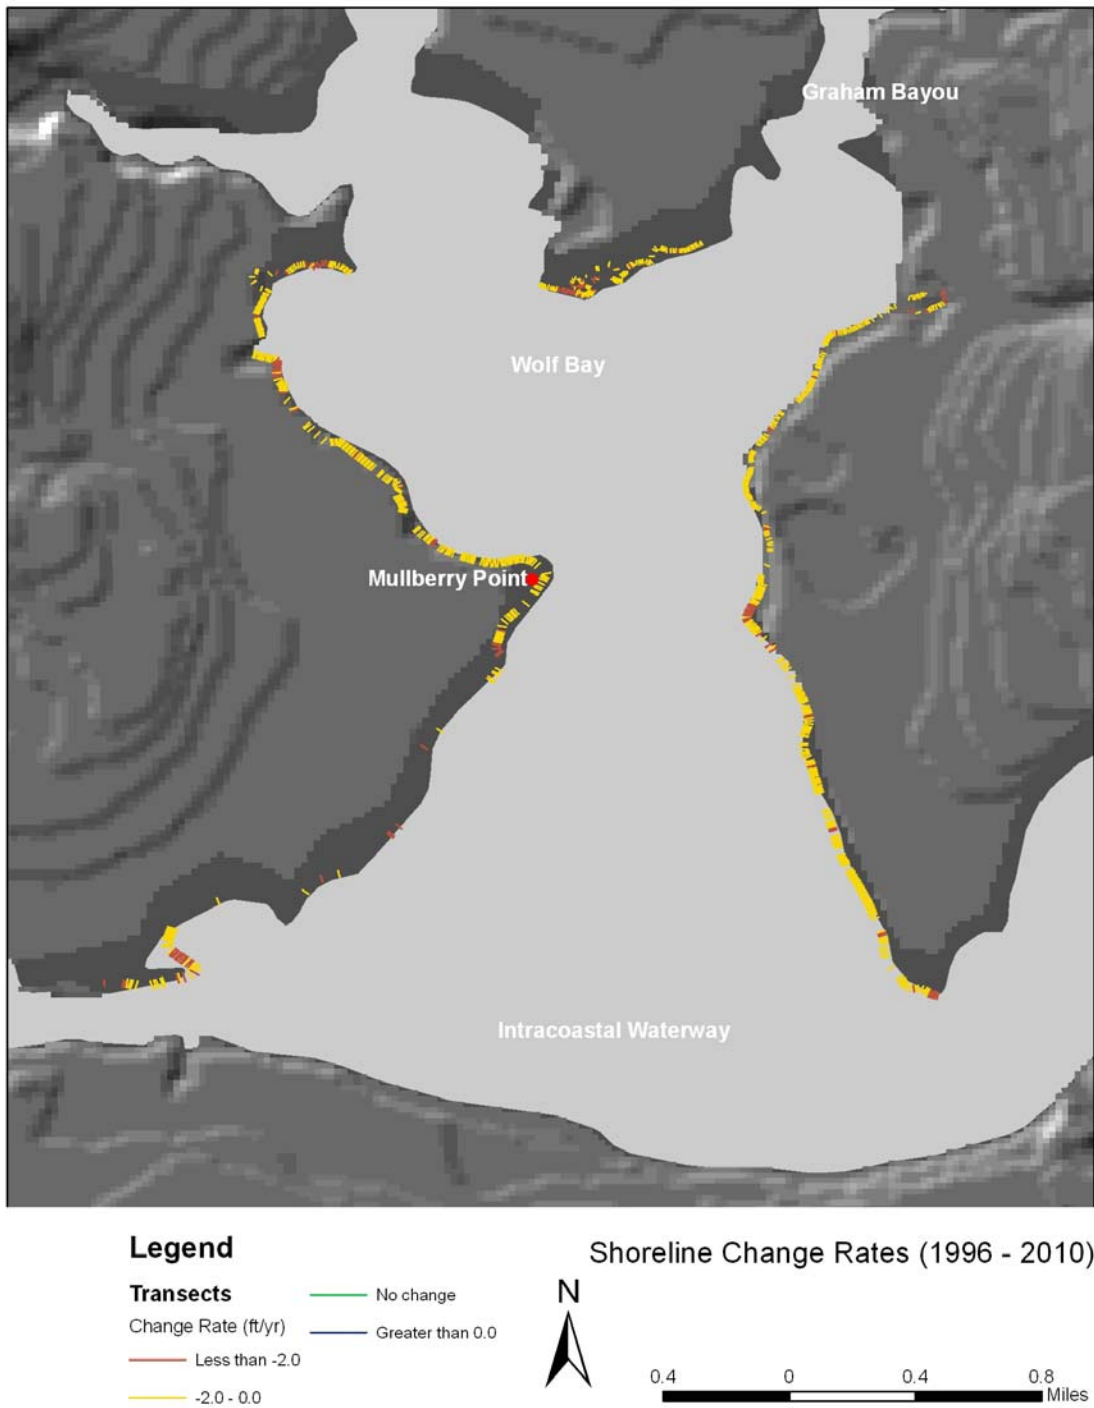
Figure 18.—Wolf Bay results from Digital Shoreline Analysis System (1996 through 2010).

Table 16.--Tabulated results from Phase II Digital Shoreline Analysis System modeling.
