Riparian Habitat Health Evaluation Following Stream Restoration

A thesis submitted to the Department of Earth and Environmental Sciences

Master of Science

2017

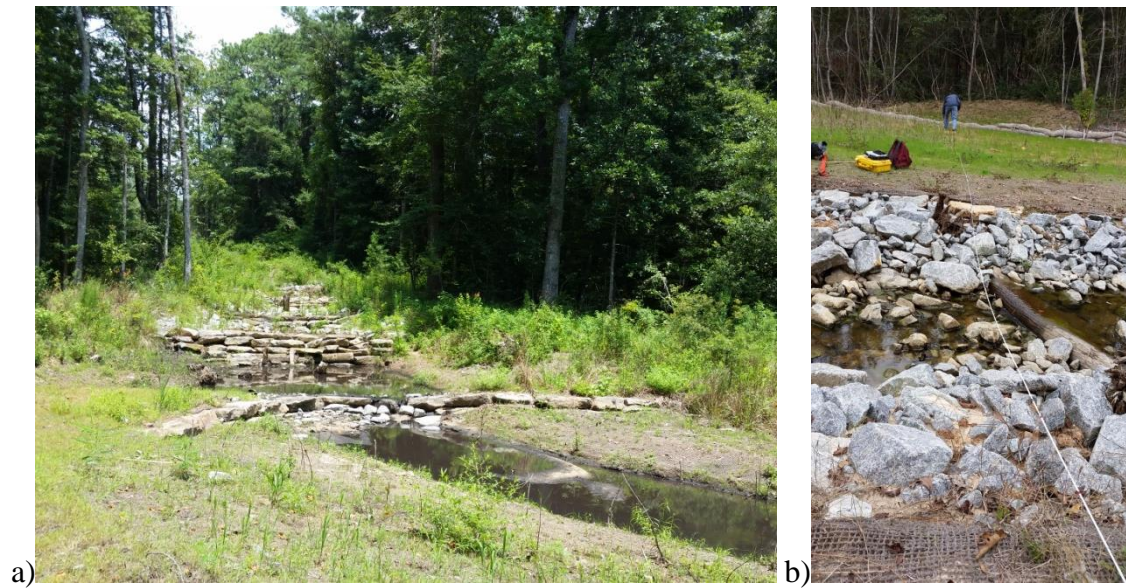
Figure 3: Examples of hard stabilization techniques used in the study area at a) Joe's Branch step pool conveyance (completed 2013) and b) JB1R (completed 2015).

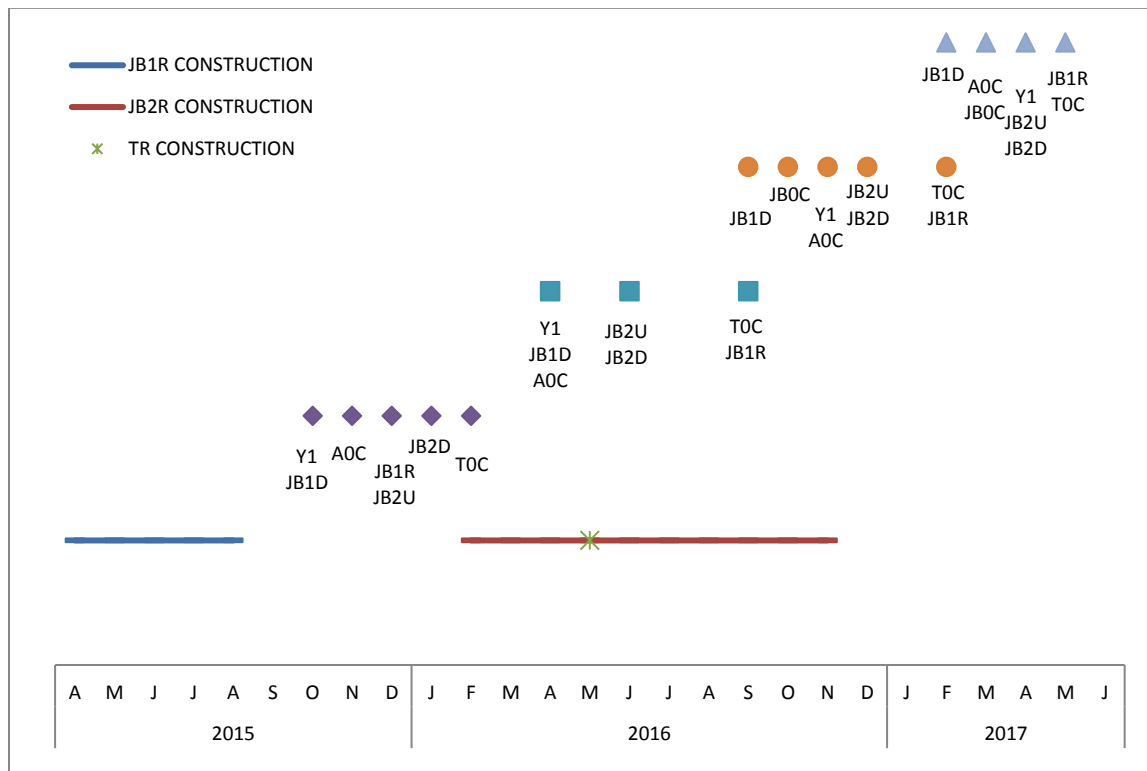
Figure 7: Timeline of restoration construction and data collection.

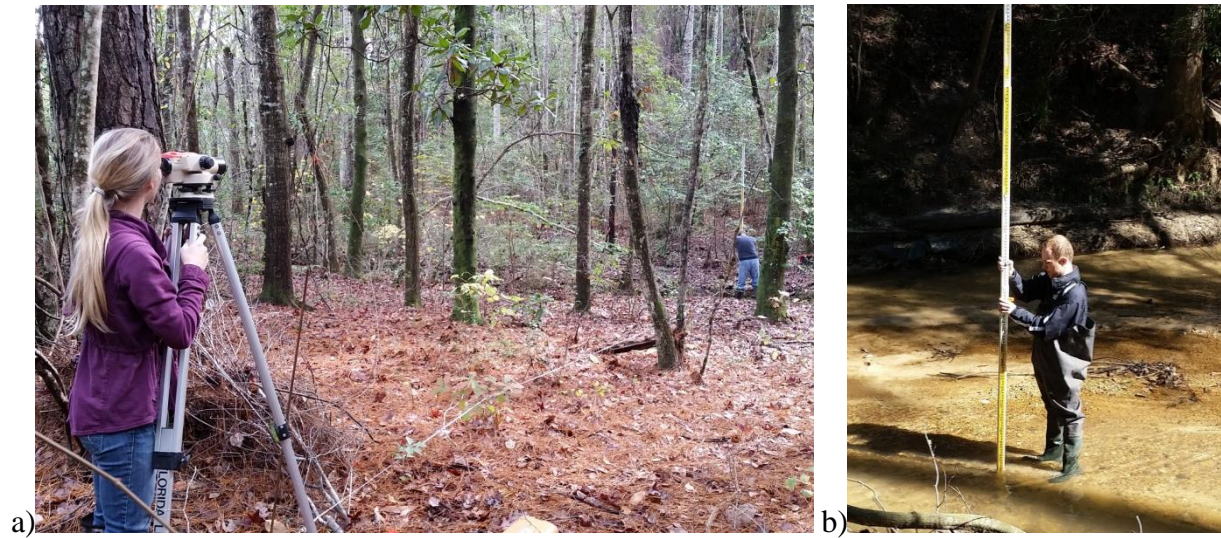
Figure 9: Riffle cross section setup at a) JB2U Dec 2015 and b) T0C Feb 2016.

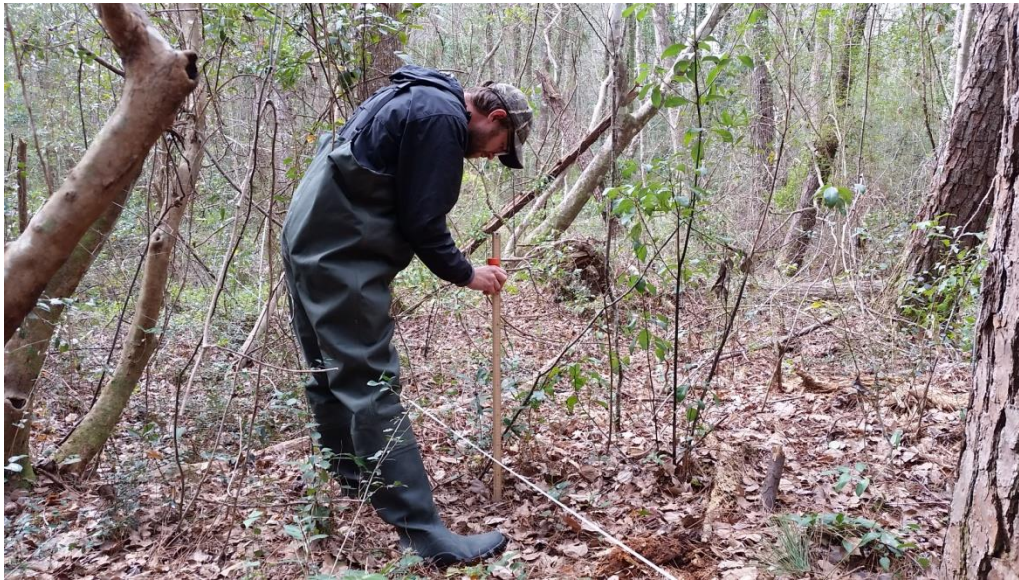
Figure 11: Understory survey point intercept method along the vegetation cross sections at T0C in February 2017.

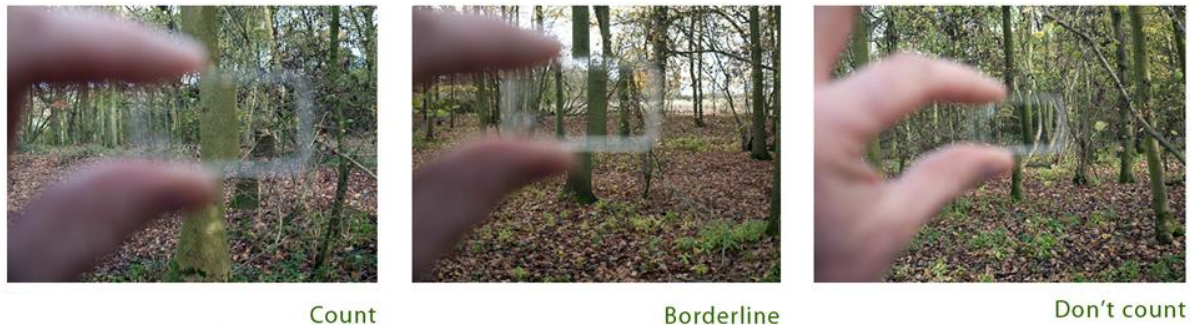
Figure 12: Image showing the difference between in, borderline, and out trees for use within the non-fixed radius vegetation plots (Hemery, 2011)

genus, and compositional structure. All of the “in” trees and half the borderline trees were measured. See 12 to differentiate between “in”, “out”, and “borderline” trees.

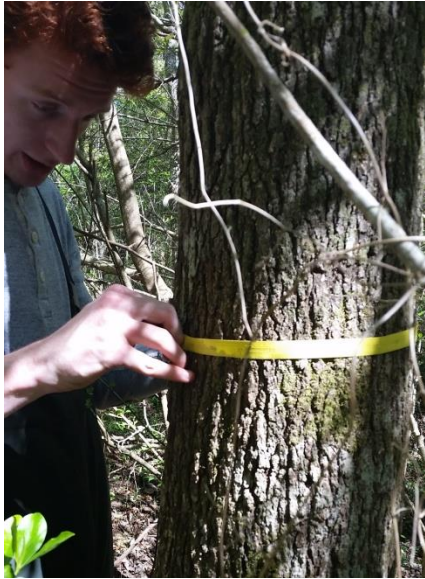
Figure 13: Volunteer using the DBH tape at A0C in April 2017.

Diameter at breast height (DBH) was measured at a height of 1.37 m using a diameter tape (Figure 13). The trees were identified to genus using reference materials. The trees were categorized into emergent, canopy, subcanopy, and midstory. At each plot the canopy cover was measured using a densiometer (Figure 14). The data was analyzed to determine percent nativity, genus diversity and abundance.

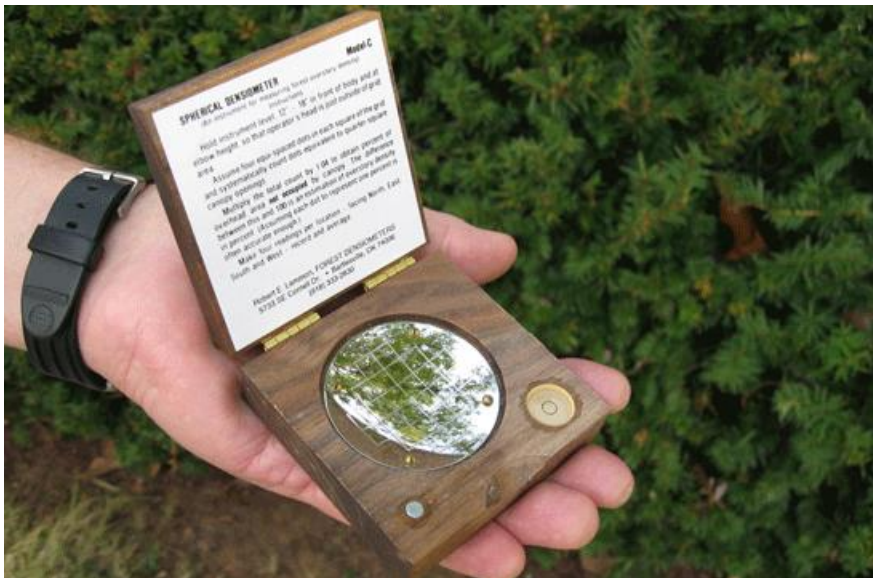
Figure 14: Image of the densiometer instrument. Canopy cover is determined using the gridded mirror and presence/ absence within the grid.ⁱⁱ

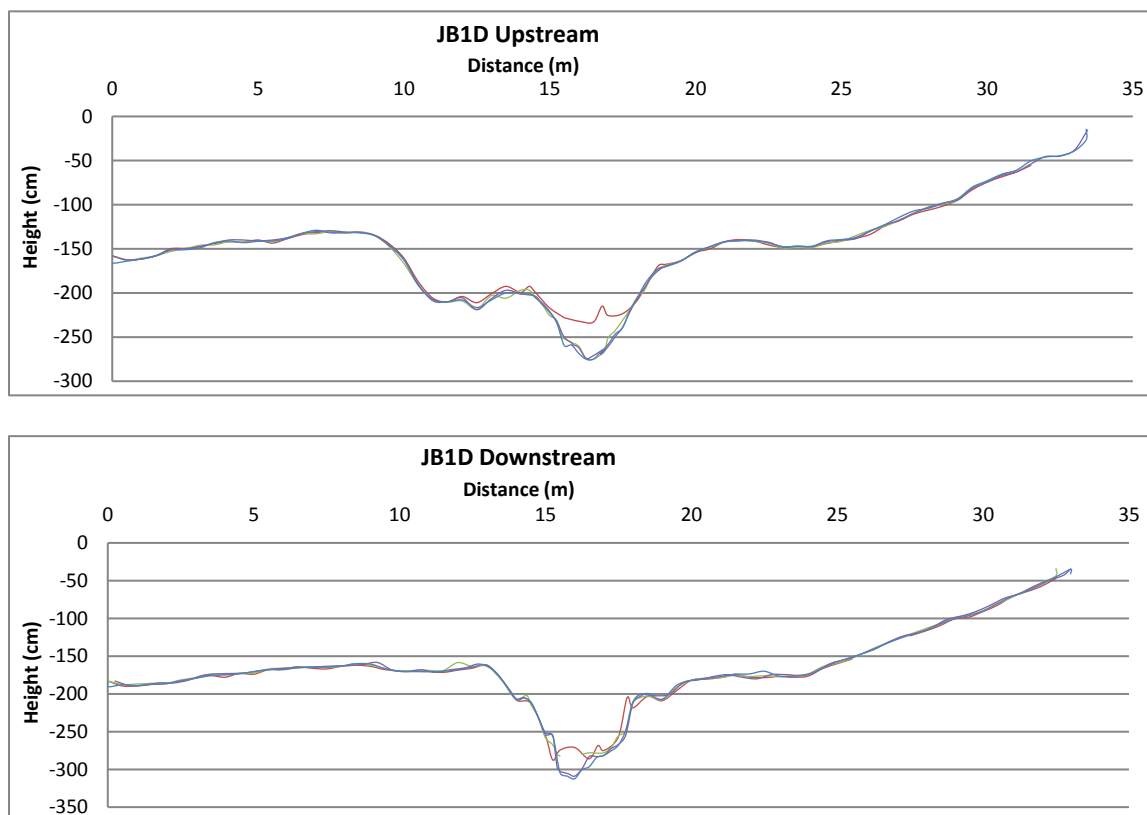
Figure 15: JB1D Riffle Cross Section profile. Visits in chronological order are colored: red (October 2015), green (April 2016), purple (September 2016), and blue (February 2017).

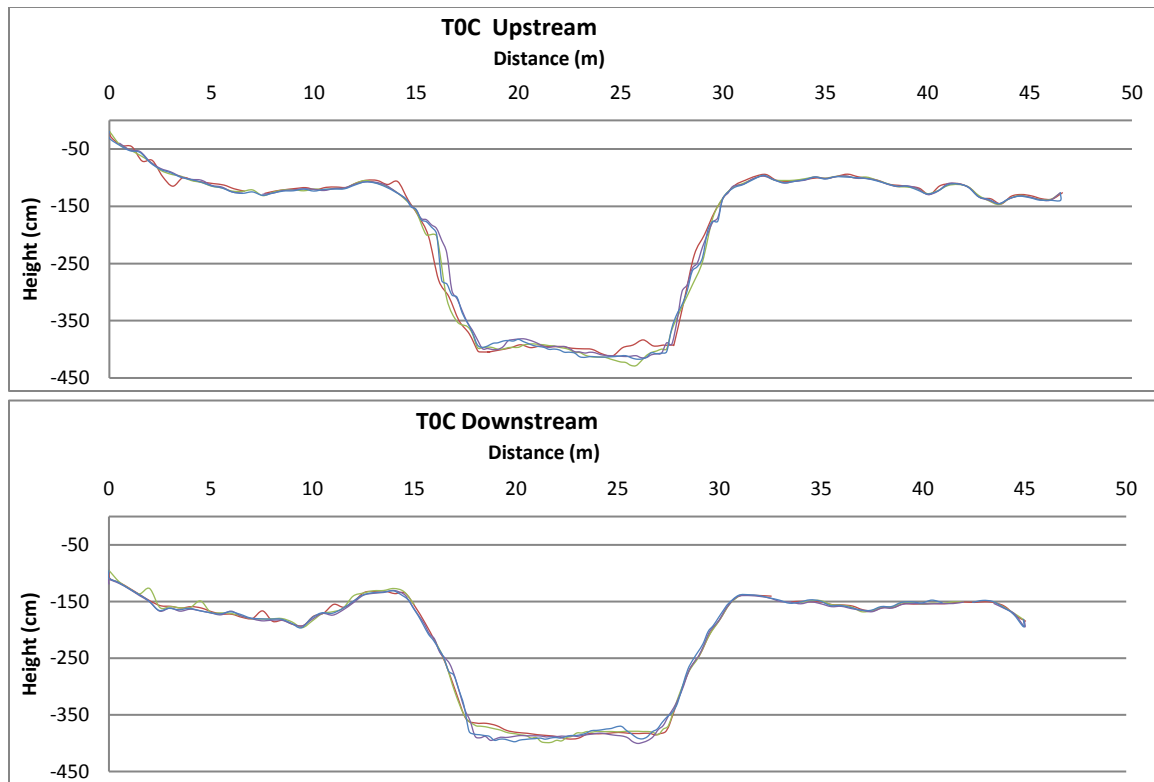
Figure 16: T0C Riffle Cross Section profile. Visits in chronological order are colored: red (February 2016), green (September 2016), purple (February 2016), and blue (May 2017).

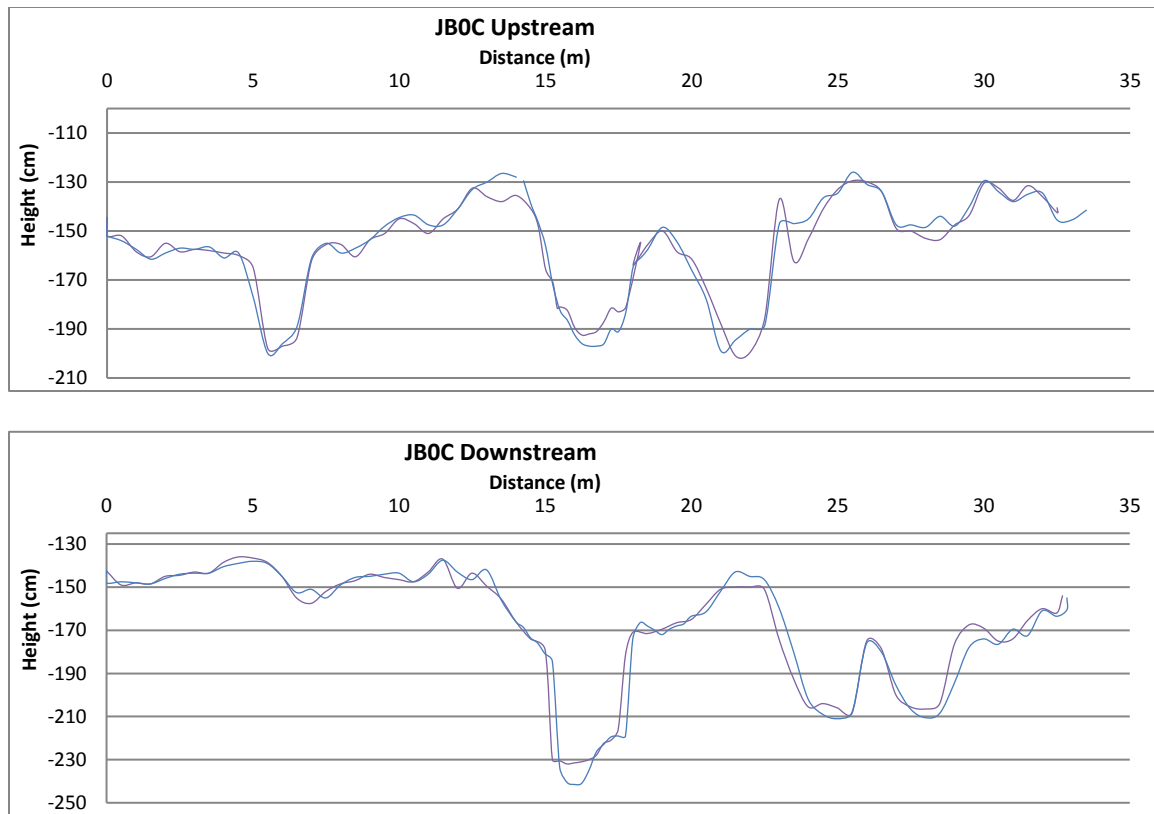
Figure 17: JB0C Riffle Cross Section profile. Visits in chronological order are colored: purple (October 2016), and blue (March 2017).

Figure 17: JB0C, Figure 18: A0C, Figure 19: JB2U). JB2D is a special case that shows more major changes (Figure 20), sometimes an increase up to seven centimeters, between visits. This site specifically was primarily sandy deposition resulting from large gully erosion upstream (at the restoration site). The restoration occurred during the second sampling period (June 2016) and was completed just one month prior to the third sampling period, which may have continually contributed construction materials to the downstream floodplain. JB2D shows deepening in both the floodplain and channel after the start of the JB2 restoration construction in February 2016 (Figure 20). This site does show response to the restoration activity upstream, not only in the floodplain, but also in the changing channel morphology.

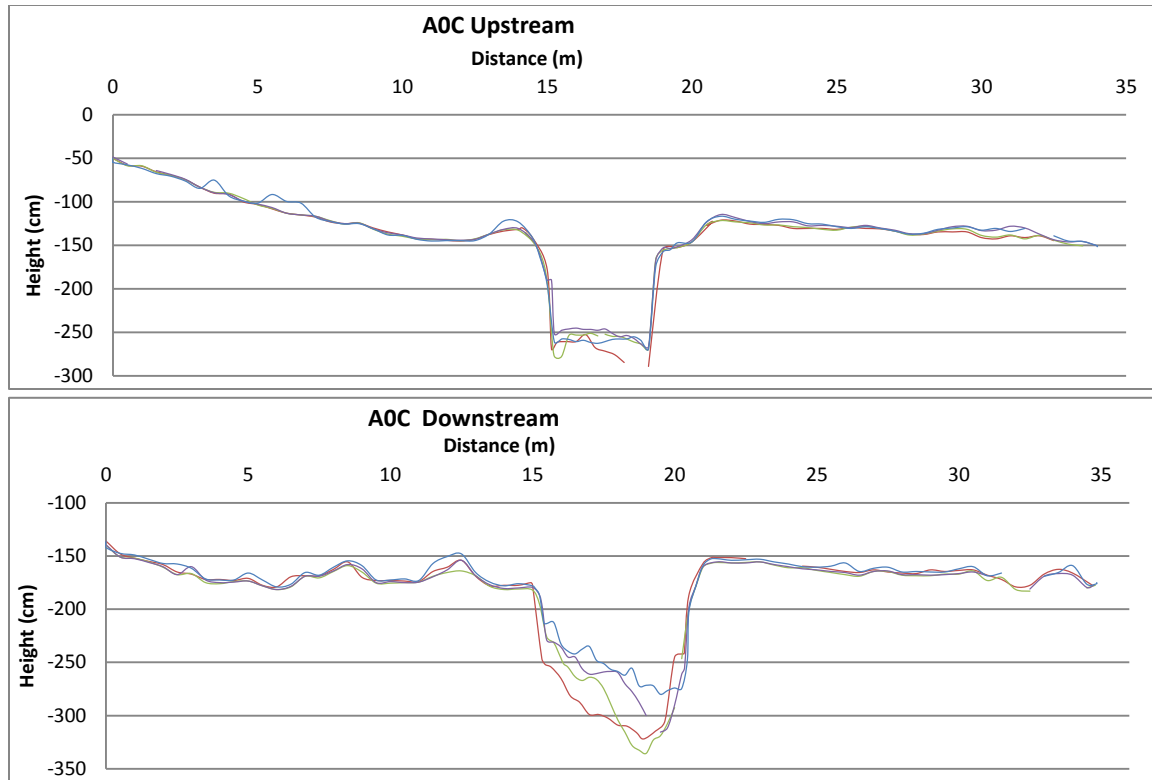
Figure 18: AOC Riffle cross section profile. Visits in chronological order are colored: red (November 2015), green (April 2016), purple (November 2016), and blue (March 2017). Erroneous data is noted as a break in the line series.

A0C is another site that showed major changes in channel elevation, although more extreme at the downstream riffle cross section (Figure 18). However, unlike the prior sites, A0C showed major filling of the channel by up to 18.6cm at the upstream transect and up to an average of 47cm at the downstream transect (Figure 18). While this could indicate that the sediment from the channel bottom is not being deposited into Mobile Bay but rather in the stream before reaching the bay, this site is within 150m of the mouth of the stream and tidal influences are more likely a cause of the changing channel bed. While tides have not changed significantly throughout the 2 year study period, of all the sites, A0C is the only site with tidal oscillations each day.

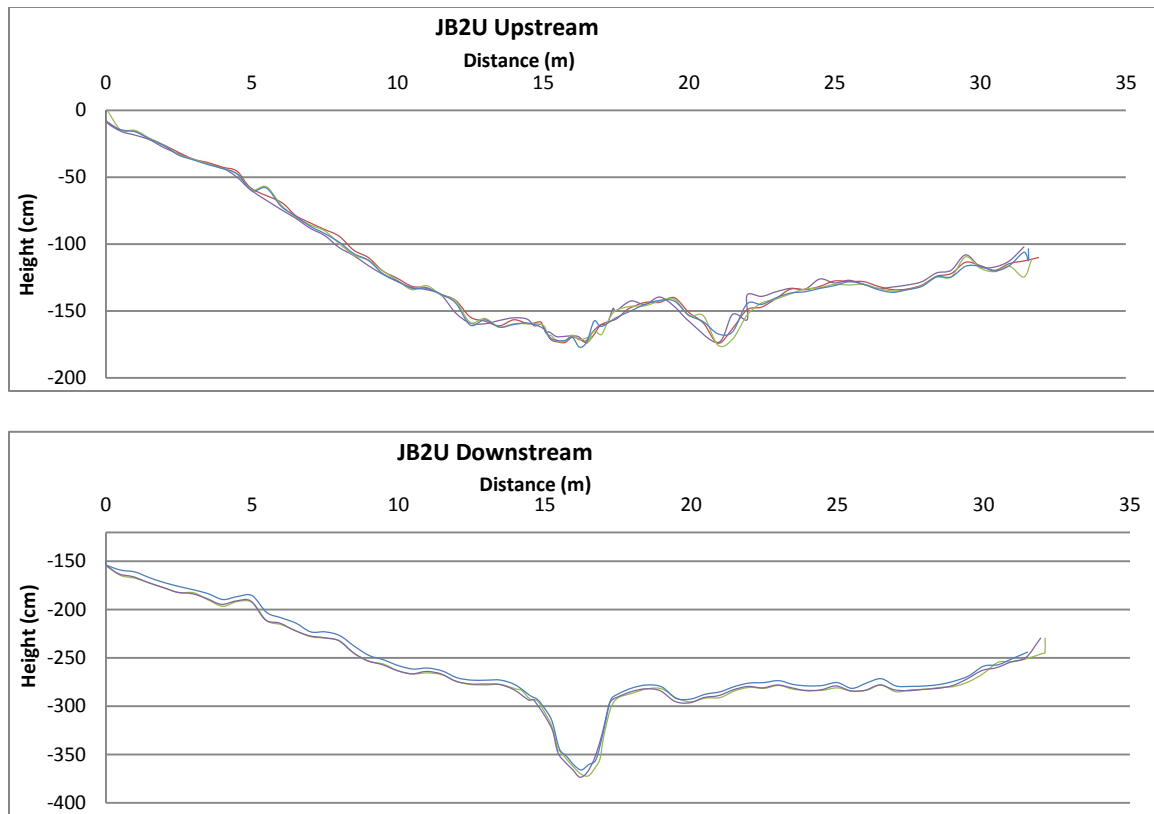
Figure 19: JB2U Riffle Cross Section profile. Visits in chronological order are colored: red (Jan 2016), green (June 2016), purple (December 2016), and blue (April 2017).

Unlike the other sites, JB2U (Figure 19) has minor fluctuations throughout the entire transect, including the channel bottom. This site does not exhibit any major incision or filling which is to be expected from a site upstream of the restoration construction. JB2D has major changes in morphology through both the floodplain and the stream channel (Figure 20 and Figure 21). The channel bottom at the upstream transect was mostly consistent with a deepening just after the restoration construction (December 2016) that was filled in by the final sampling period (April 2017) (Figure 20). The downstream transect showed a continually deepening channel, which although channel is deepening, is not incised.

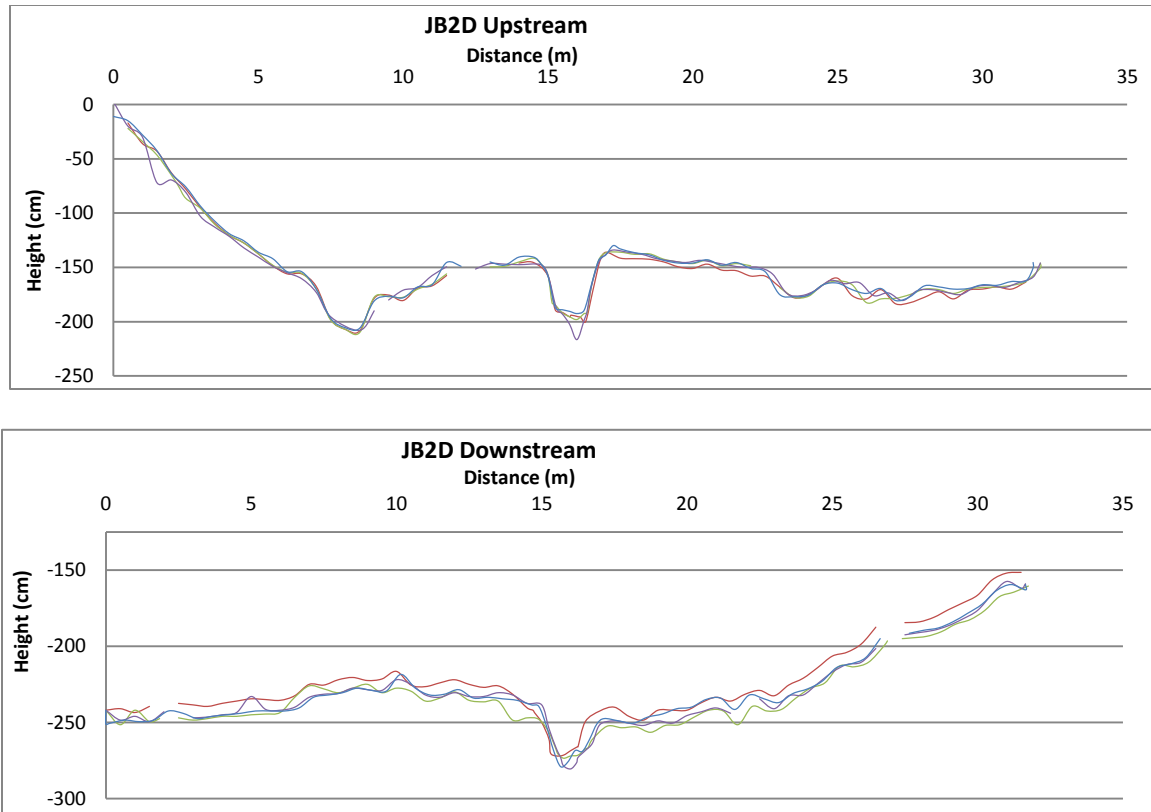
Figure 20: JB2D Riffle Cross Section profile. Visits in chronological order are colored: red (December 2015), green (June 2016), purple (December 2016), and blue (April 2017).

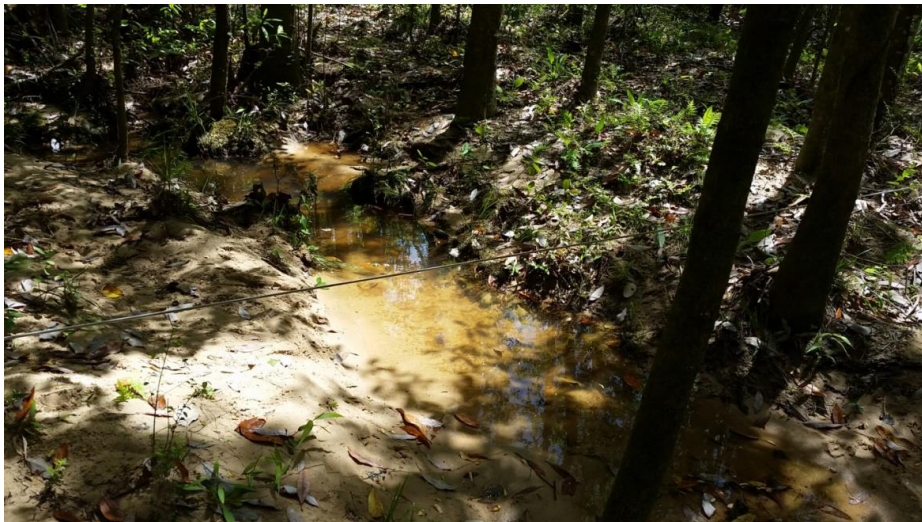
Figure 21: Image showing the sandy deposition at the downstream riffle-cross section at JB2D in April 2017.

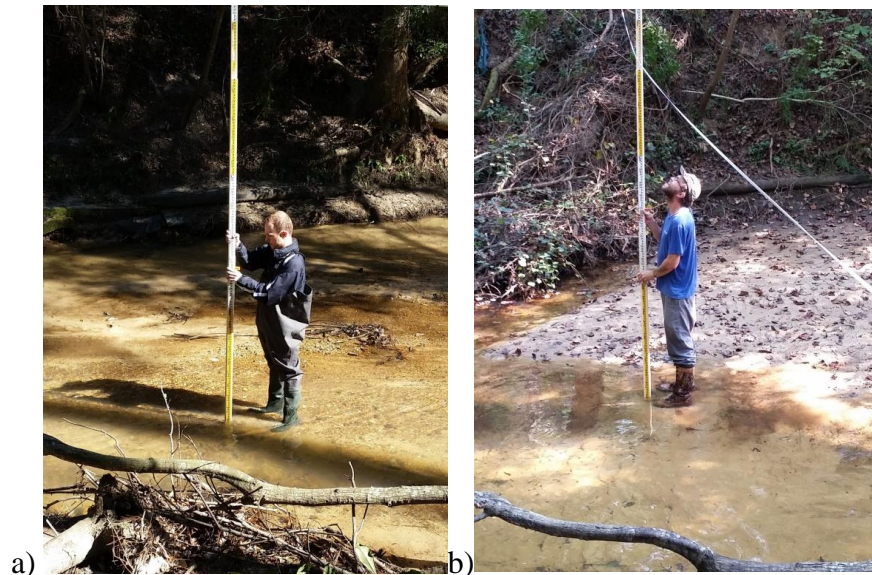
Figure 22: T0C water level was consistently shallower than boot height in a) February 2016 and b) September 2016.

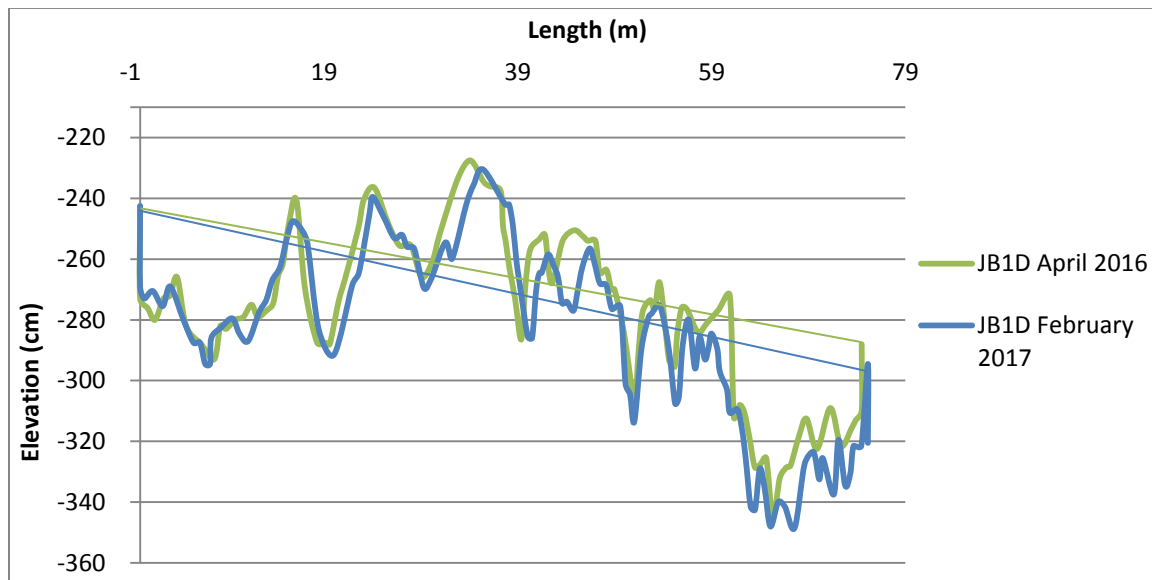
Figure 23: Longitudinal profile of JB1D showing thalweg of the measured stream in April 2016 and February 2017. Change in gradient is illustrated with straight line segments.

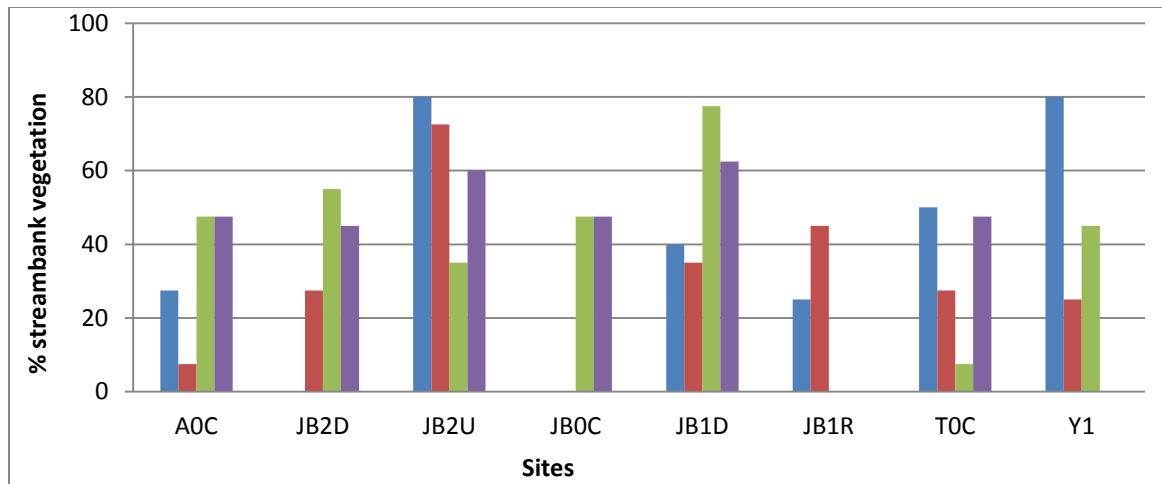
Figure 25: Streambank vegetation cover at each site per site sampling period. Sampling period 1 Fall/Winter (red), SP2 Spring/Summer (green), SP3 Fall/Winter (purple), and SP4 Spring/Summer (blue).

The streambank vegetation cover also shows variability between sampling periods. It was expected there would be increased vegetation during the sampling periods that occurred in late spring and early fall but the results show that the vegetation coverage did not consistently change with seasonal variation (Figure 25). External factors can influence stream bank vegetation including fallen trees (as occurred at T0C), rapid sedimentation (such is the case at JB2D where the channel and floodplain continually changed between each sampling period Figure 20) and tidal influence (as seen in A0C). Rapid sedimentation could be caused by increased suspended sediment caused by erosion or even stream restoration.

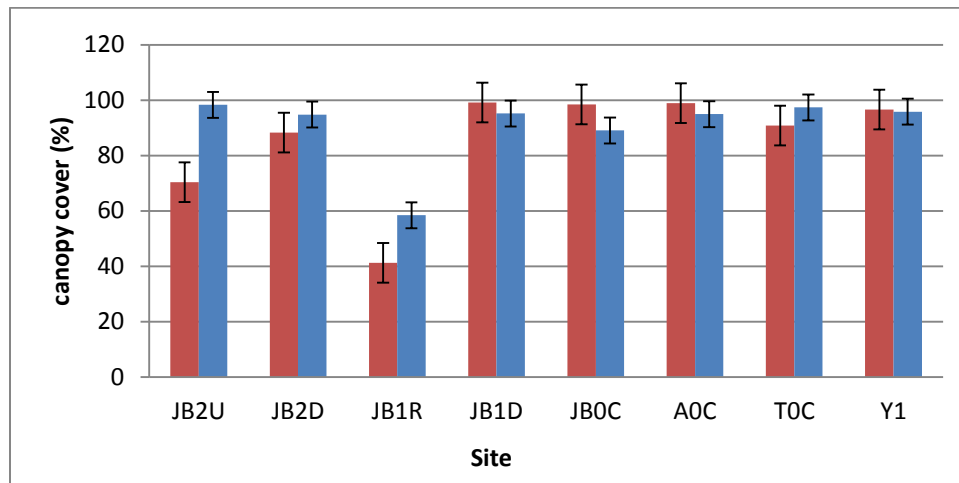
Figure 26: Changes in percent canopy cover between sampling period 1 (red) and sampling period 4 (blue) with standard error.

December 2016: 30%; April 2017: 37%) (Figure 26 and Figure 29). At the site just upstream of the JB2R restoration, JB2U, the LL average remained similar to the initial sampling period (December 2015:86%; December 2016; 83%), although the LL increased from June 2016 (66%) to December 2016 (83%). This change at JB2U reflects seasonal biomass changes due to senescence. JB0C also shows vegetation decrease just following restoration activity from both JB1 (April 2015) and JB2 (November 2016), however, the change occurs between sampling period 3 (October 2016: 51%) and sampling period 4 (March 2017: 36%) where an increase in vegetation is expected from seasonal biomass changes. This indicates that the restoration activity may have an impact on riparian vegetation by decreasing understory biomass. JB1D, unlike the other two downstream sites, showed minimal fluctuation in vegetation cover between sampling period 1: 30; SP 2:25; SP 3: 21; and SP 4: 28. Since this decline in vegetation was not systematically observed at every downstream site following restoration activity, the decline is most likely due to external factors and is not conclusive.

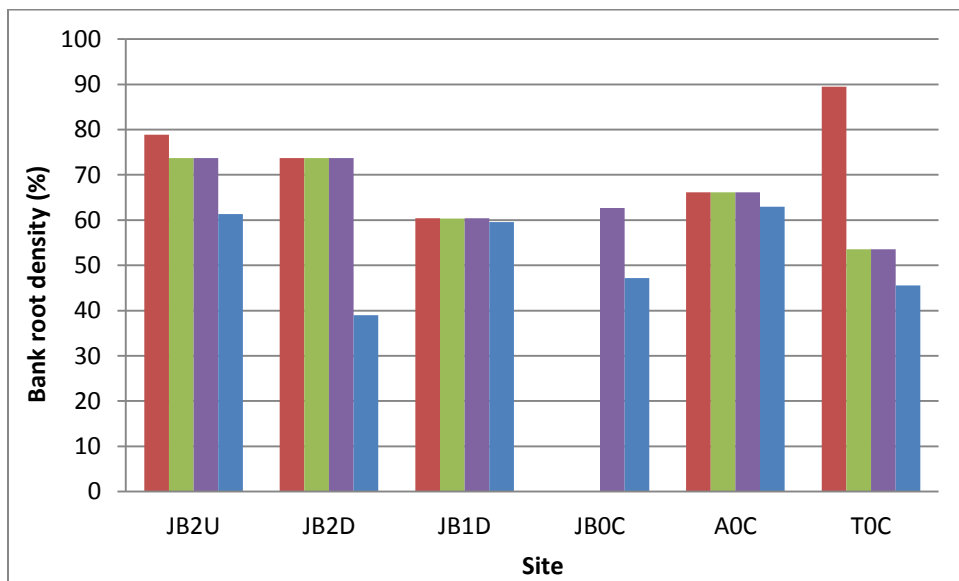
Figure 28: Changes in bank root density between sampling period 1 (red), sampling period 3 (purple) and sampling period 4 (blue). Bank root density was not consistently measured during sampling period 2 so the data is excluded.

JB2D with its consistently changing floodplains and channel as noted by the riffle cross section data showed less root density at sampling period 4, perhaps due to changing streambanks (Figure 20). JB2U also showed a decrease in bank root density which suggests that there may external factors (perhaps different flow regimes) impacting the bank root density. The literature reports that root structure is closely related to the ability to obtain moisture in times of drought, waterlogging, and scouring (Richardson et al., 2007). It is possible that this change in root density is a biological response to altered hydrology during the study period. Many of the channels were diverted and several pools infilled, thus altering the amount of water moving through the system.

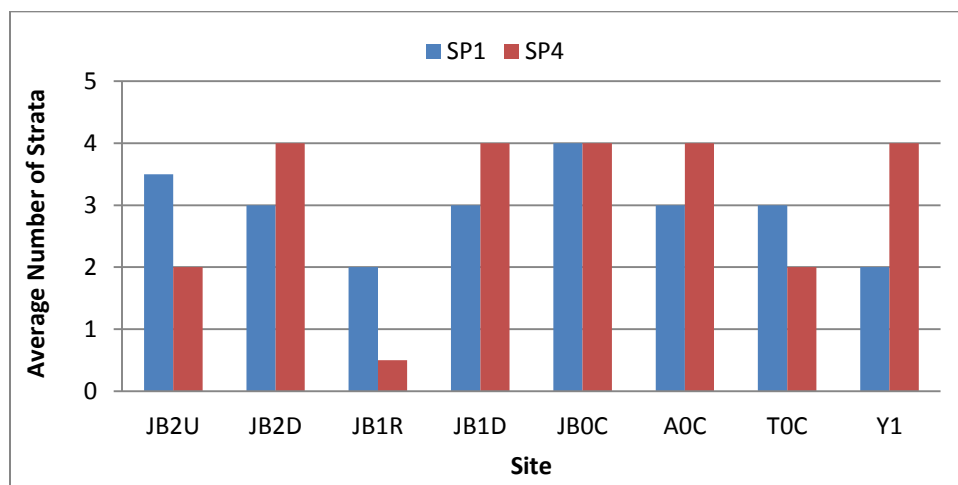
Figure 30: Average number of strata at each site.

The structural complexity was not sensitive to changes at the majority of the sites (Figure 30). The strata increased at JB2D, JB1D, Y1, A0C but decreased at T0C, JB2U and JB1R (likely due to seasonal changes in understory vegetation along the vegetation transect). The changes in the reference site (Y1) suggest that external factors contributed to the changes in strata recorded over the study period. This variable will be most useful in monitoring severely disturbed sites, such as the actual restoration sites where the overstory is removed and the strata will develop during the monitoring period. To remedy this change, the data should be collected during the same season on an annual, rather than semi-annual basis.

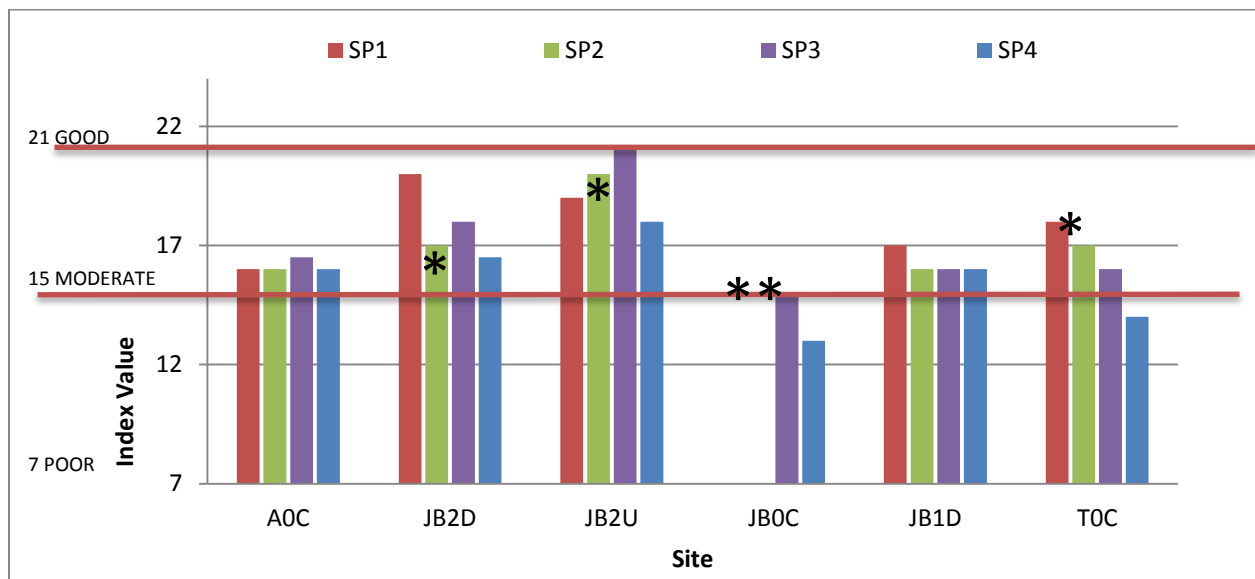
Figure 33: Riparian Habitat Level Evaluation (RipHLE) method where scores > 21 are good, 15-21 moderate, and ≤15 poor. The asterisks indicate the timing of the corresponding restorations (to the left meaning before, on top meaning during and between two bars indicating in between visits).

This decline in habitat level is shown primarily through the habitat metrics used within the RipHLE since the floodplain is inactive according to the riffle cross section data. Both JB0C measures were taken following the JB restoration construction but the Fall 2016 visit (sampling period 3) occurred during the active restoration of JB2R, so the Spring 2017 visit (sampling period 4) which shows a poor RipHLE value occurred after both restorations occurred. T0C was first visited before the restoration (sampling period 1), and then the three following sampling periods occurred after the restoration by at least four months. The two final sampling periods occurred at least 8 months after the restoration of Tiawasee Creek, and show declining RipHLE values. Along Tiawasee creek, there are many man-made culverts (Figure 34) and historical restorations disrupting stream flow from the TCR restoration which may interfere with RipHLE values.

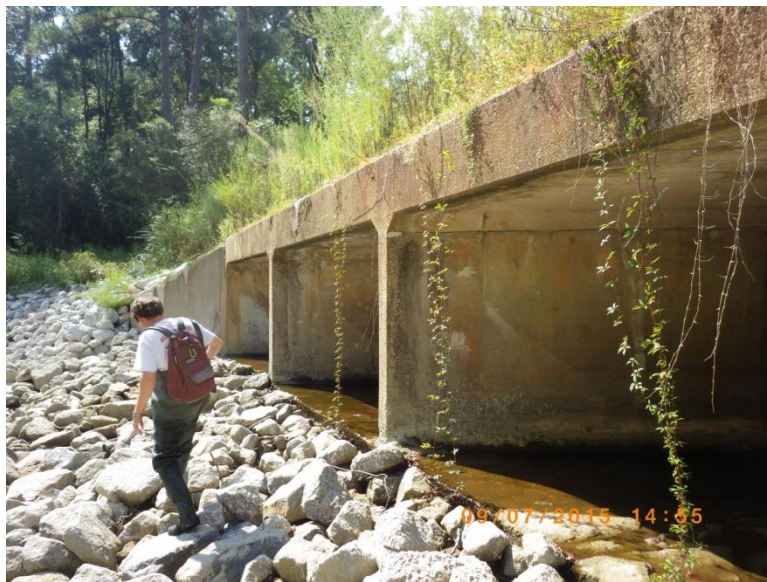
Figure 34: An example of the culvert and rip rap upstream from T0C in September 2015.
