**EVALUATION OF PRE- AND POST-RESTORATION SEDIMENT
LOADS IN JOES BRANCH,
SPANISH FORT, BALDWIN COUNTY, ALABAMA**

Marlon R. Cook,
Poly, Inc.

2019

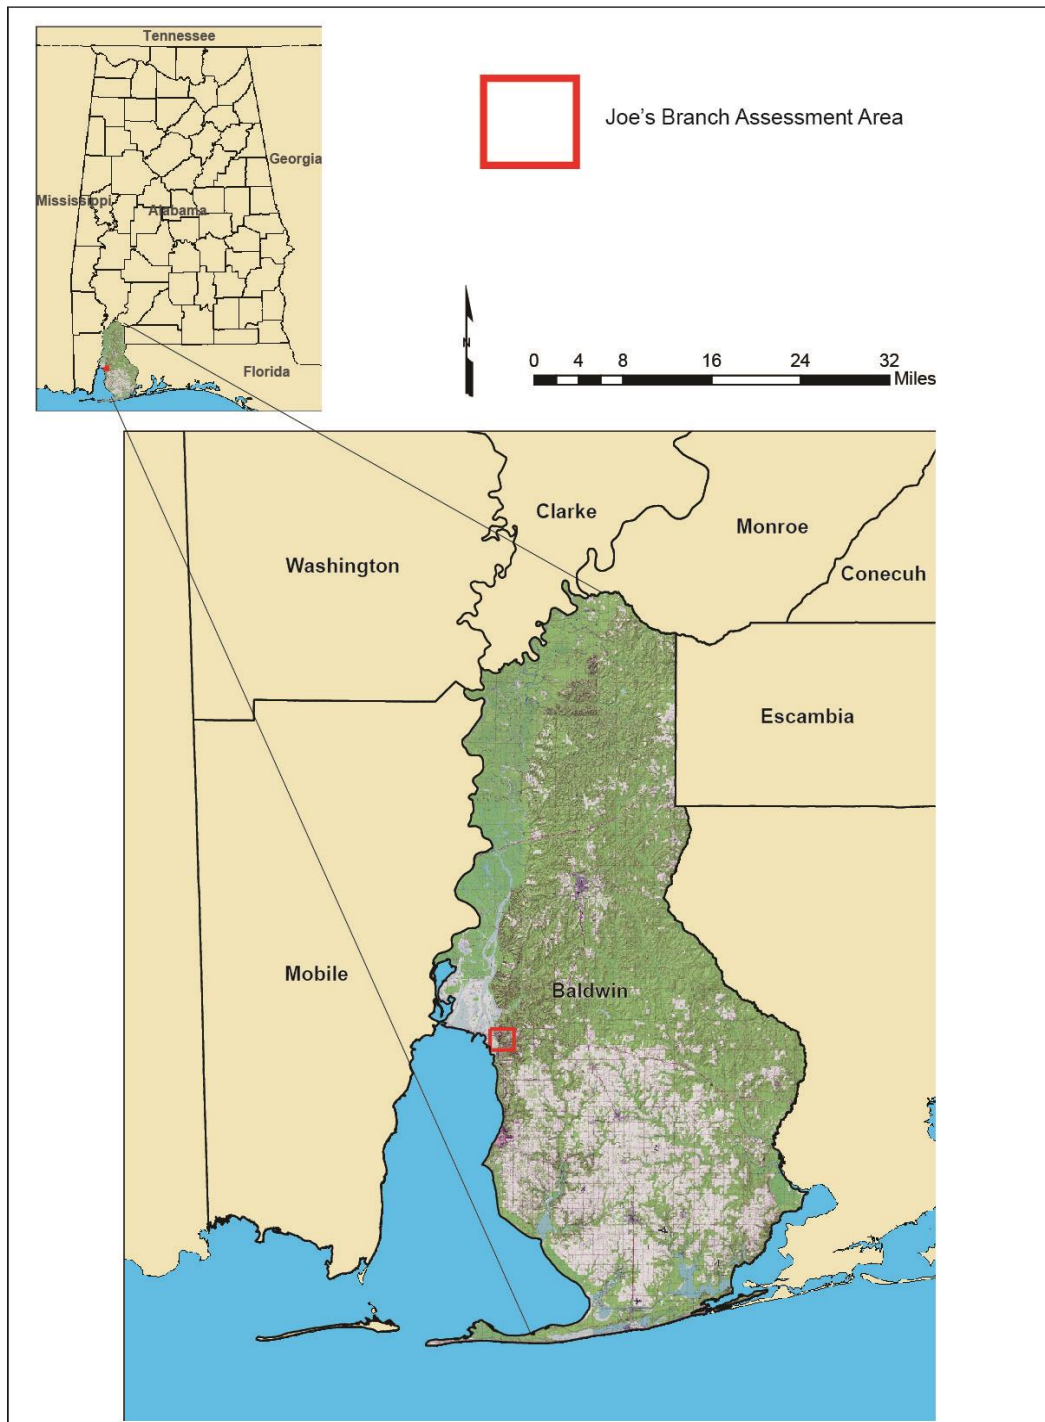
Figure 1.—Joes Branch watershed area in west-central Baldwin County.

Joes Branch is a tributary of D'Olive Creek, with headwaters in Spanish Fort, west-central Baldwin County (fig. 1). The watershed contains about 0.9 square miles (mi²) of drainage area, drains the western part of the city of Spanish Fort, and flows southwestward underneath Interstate Highway 10 where it joins D'Olive Creek immediately upstream from Mobile Bay.

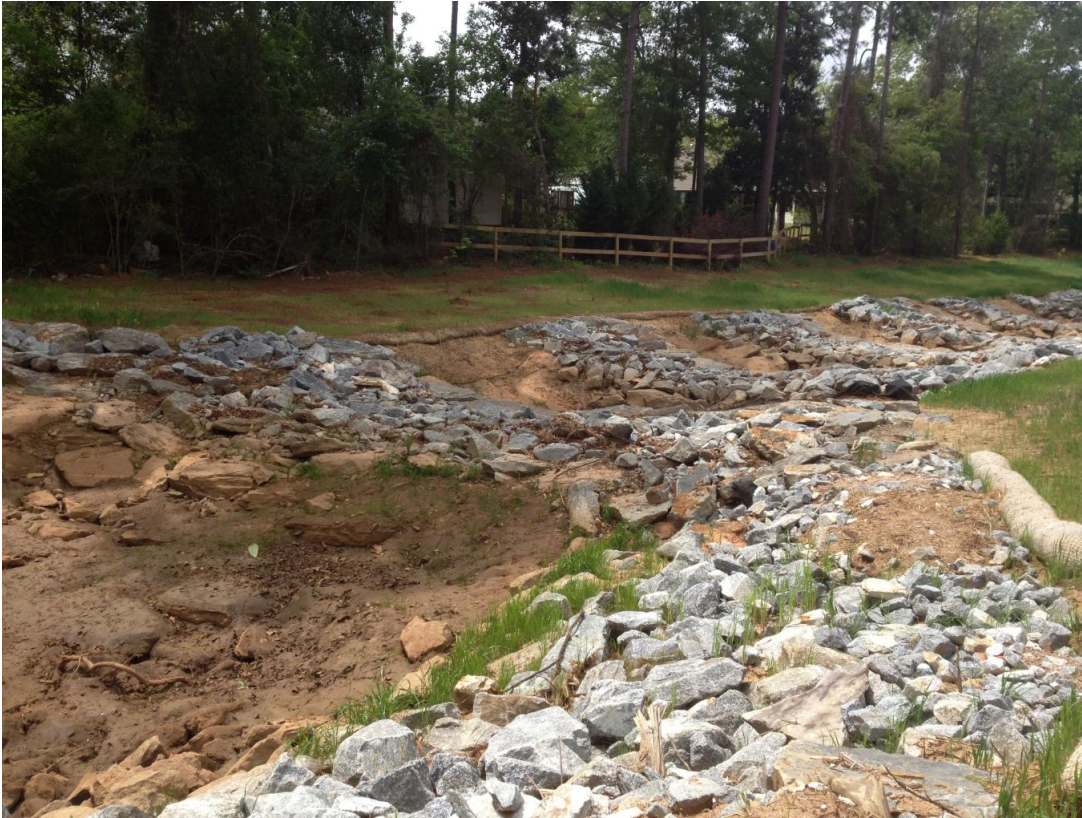
Figure. 3—Step pool conveyance system constructed in the unnamed tributary of Joes Branch in Spanish Fort.

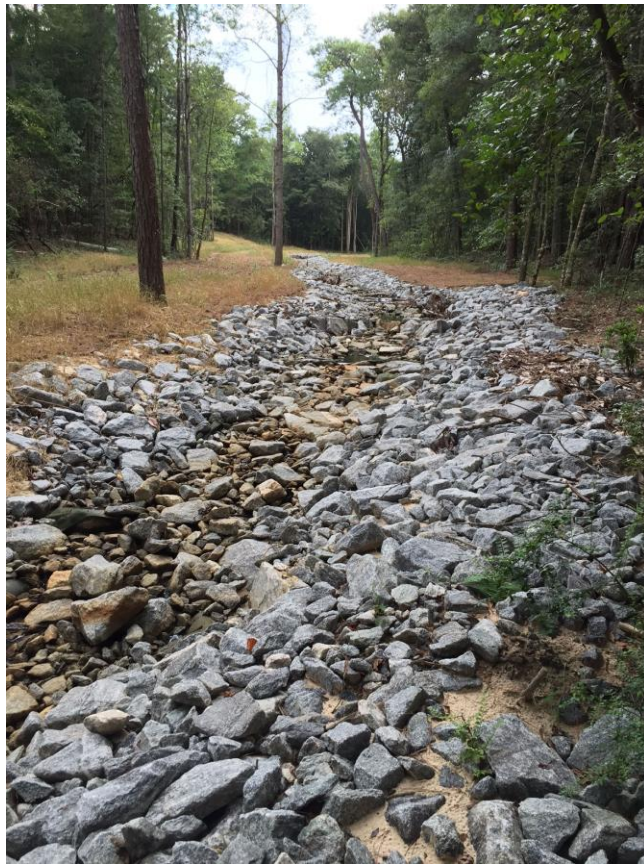
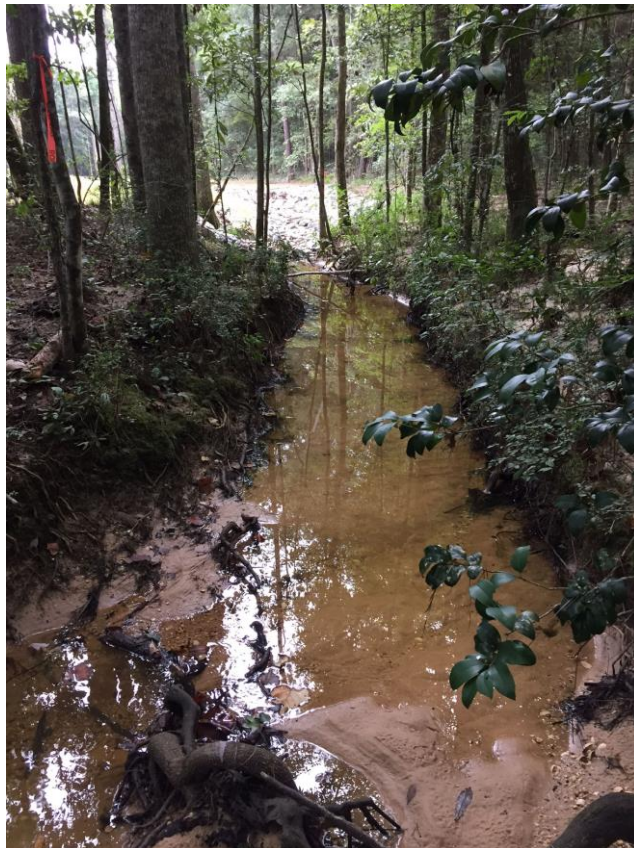
Figure 4.—Phase II reconstruction downstream from the step pool conveyance (upper photo) and stream channel in 2015 immediately upstream from site JB9 (lower photo).

caused by the headcut. This work was completed in August 2015 (fig. 4). A stormwater retention structure was also added on the north side of US Highway 31. Post-construction monitoring of the first phase of restoration was ongoing at site JB9, at the time of the second headcut. Therefore, monitoring continued during and after construction of the second phase of restoration.

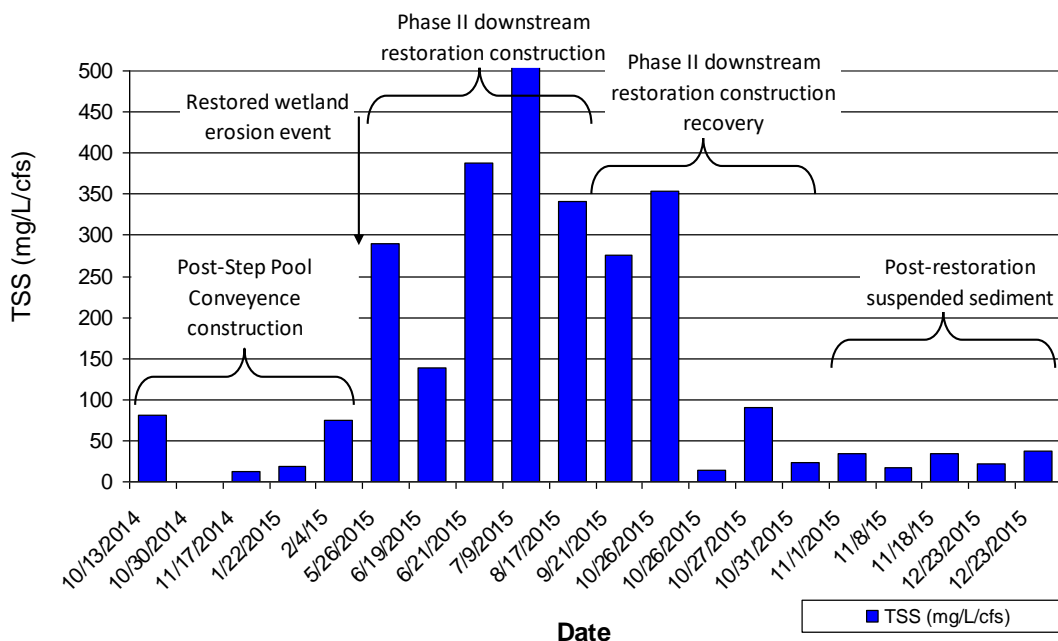
Figure 10.—Site JB9 showing the temporal context of restoration activities and corresponding normalized TSS values.
