EIGHT MILE CREEK/GUM TREE BRANCH MONITORING PROGRAM SUMMARY REPORT

April 2006

Prepared by:
Steven G. Summersell
Alabama Department of Environmental Management
2204 Perimeter Road
Mobile, Alabama 36615

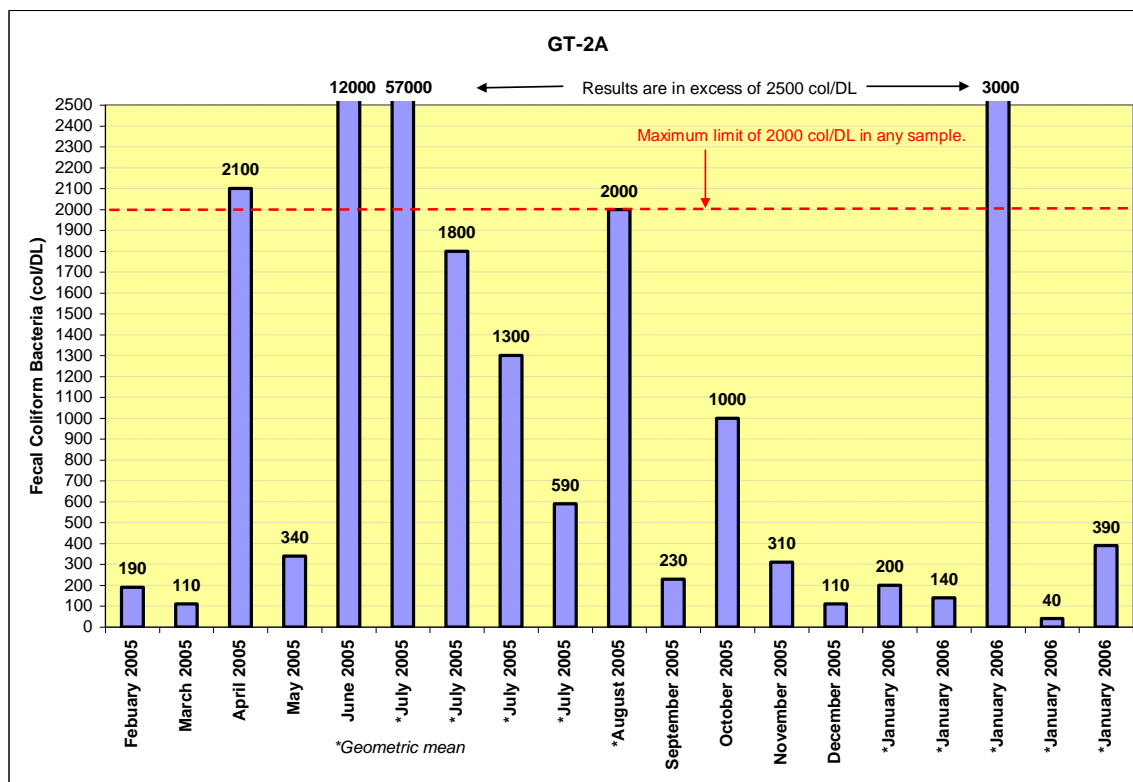
Figure 2. Fecal coliform results for GT-2A.

GT-2A. This station is on Gum Tree Branch near the bridge on Wasson Ave. in Prichard, Alabama. Figure 2 is a summary of results for fecal coliform bacteria for GT-2A. Figure 3 is upstream of GT-2A. Note the shallow depth when compared to the downstream view in Figure 4.

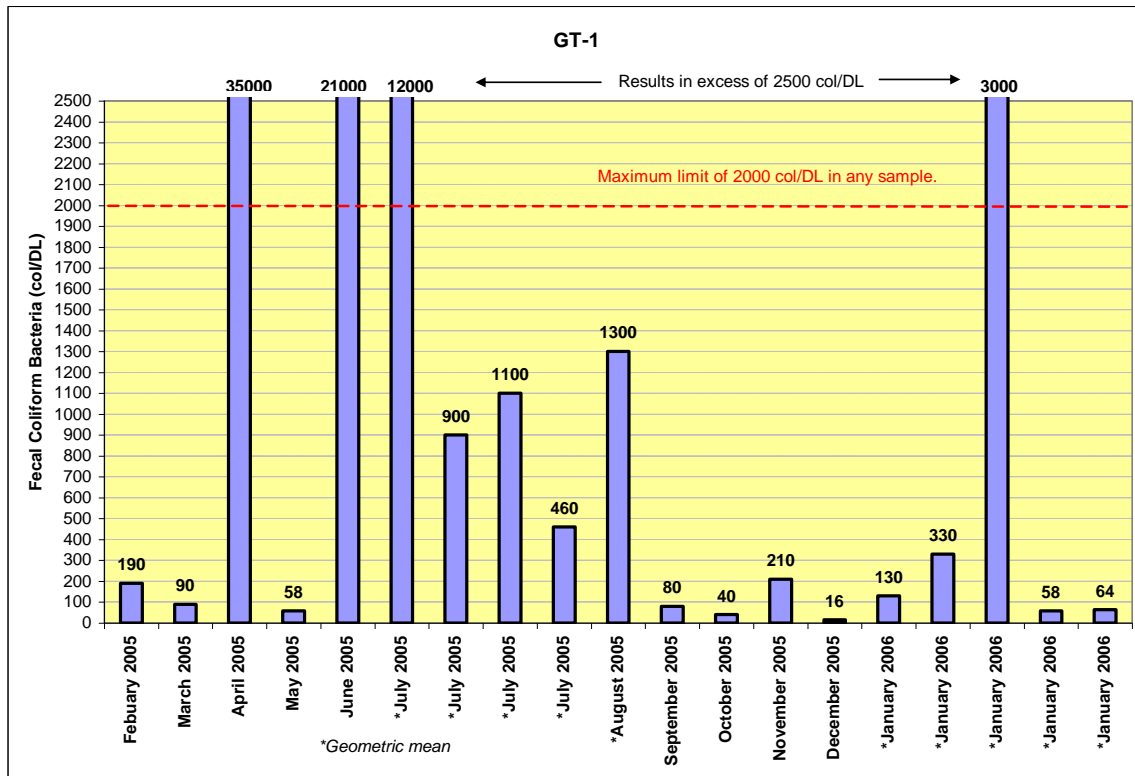
Figure 5. Fecal coliform results for GT-1.

GT-1. This station is located on Gum Tree Branch near the confluence with Eight Mile Creek (EM-1). Figure 5 is a summary of results for fecal coliform bacteria for GT-1. Figure 6 is an Upstream view of GT-1 and Figure 7 is a Downstream view of GT-1 (also a view of the confluence of Gum Tree Branch and Eight Mile Creek).

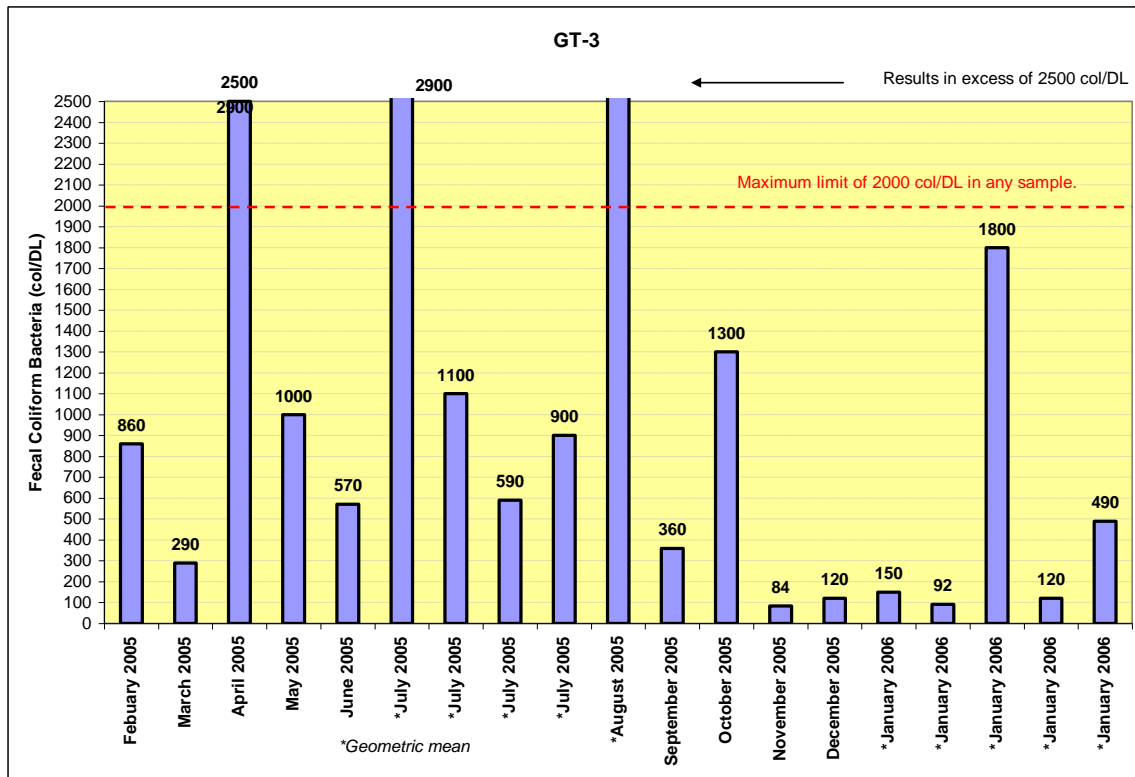
Figure 8. Fecal coliform results for GT-3.

GT-3. This station is located on an unnamed tributary to Gum Tree Branch at Culvert Street. Figure 8 is a summary of results for fecal coliform bacteria for GT-3. Figure 9 is an Upstream view of GT-3 and Figure 10 is a Downstream view of GT-3.

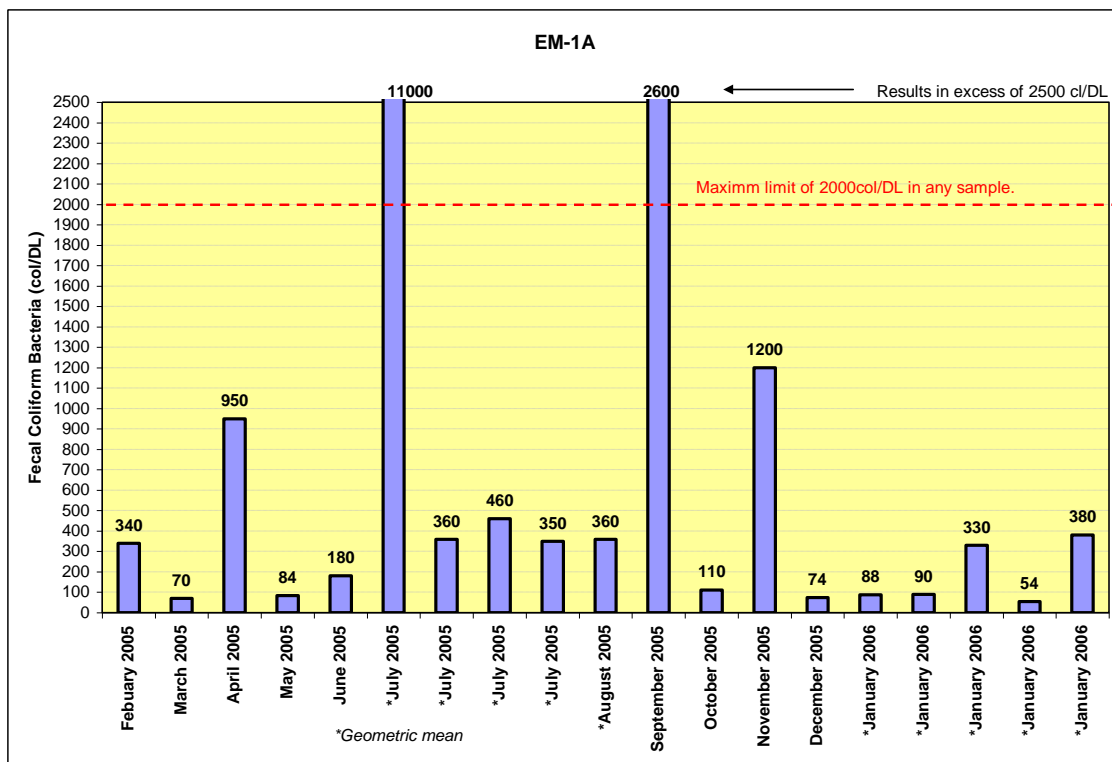
Figure 11. Fecal coliform results for EM-1A.

EM-1A. This station is located near the confluence with Chickasaw Creek. Figure 11 is a summary of results for fecal coliform bacteria for EM-1A. Figure 12 is an aerial view of EM-1A.

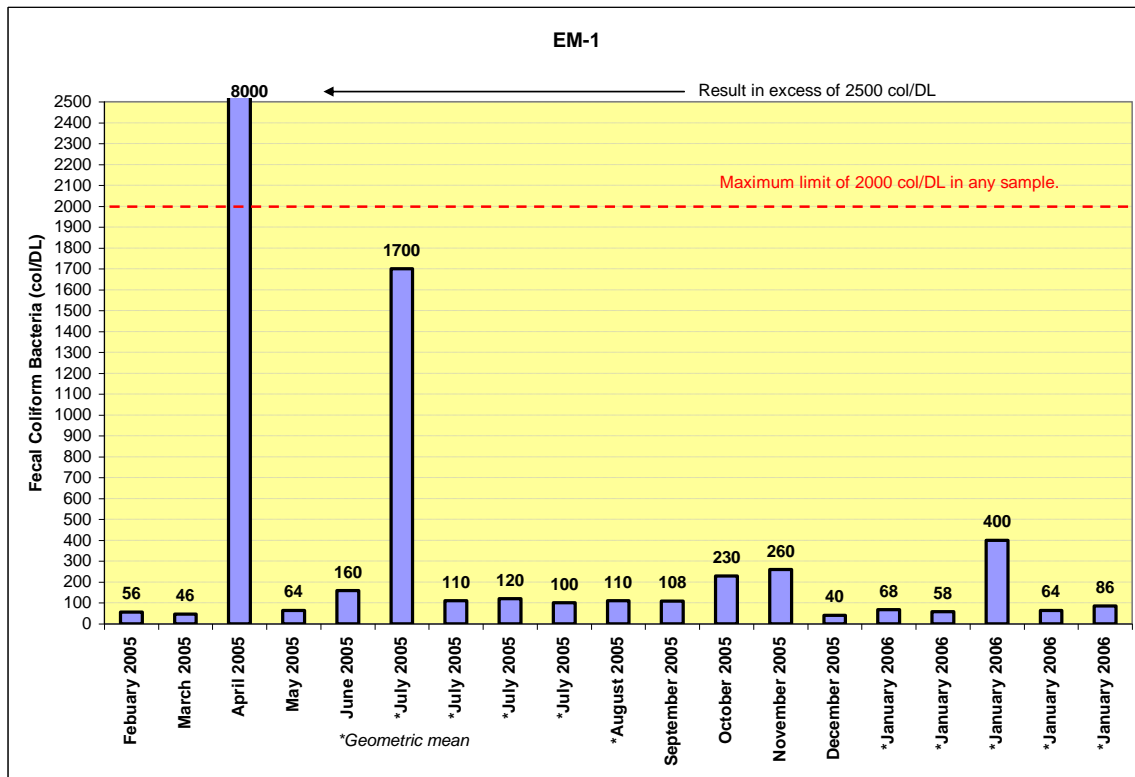
Figure 13. Fecal coliform results for EM-1.

EM-1. This station is located near the confluence with Gum Tree Branch (GT-1). Figure 13 is a summary of results for fecal coliform bacteria for EM-1. Figure 14 is an Upstream view of EM-1 and Figure 15 is a Downstream view of EM-1.

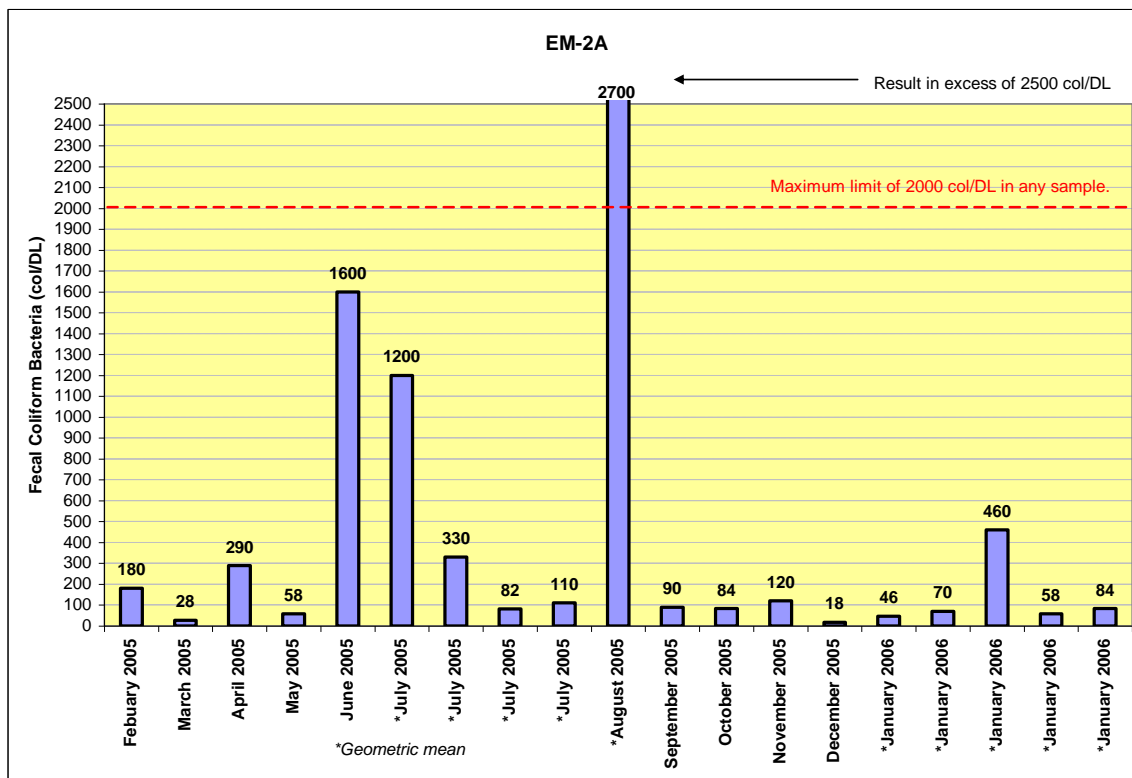
Figure 16. Fecal coliform results for EM-2A.

EM-2A. This station is located near Hwy 45 on Winchester Street. Figure 16 is a summary of results for fecal coliform bacteria for EM-2A. Figure 17 is an Upstream view of EM-2A and Figure 18 is a Downstream view of EM-2A.

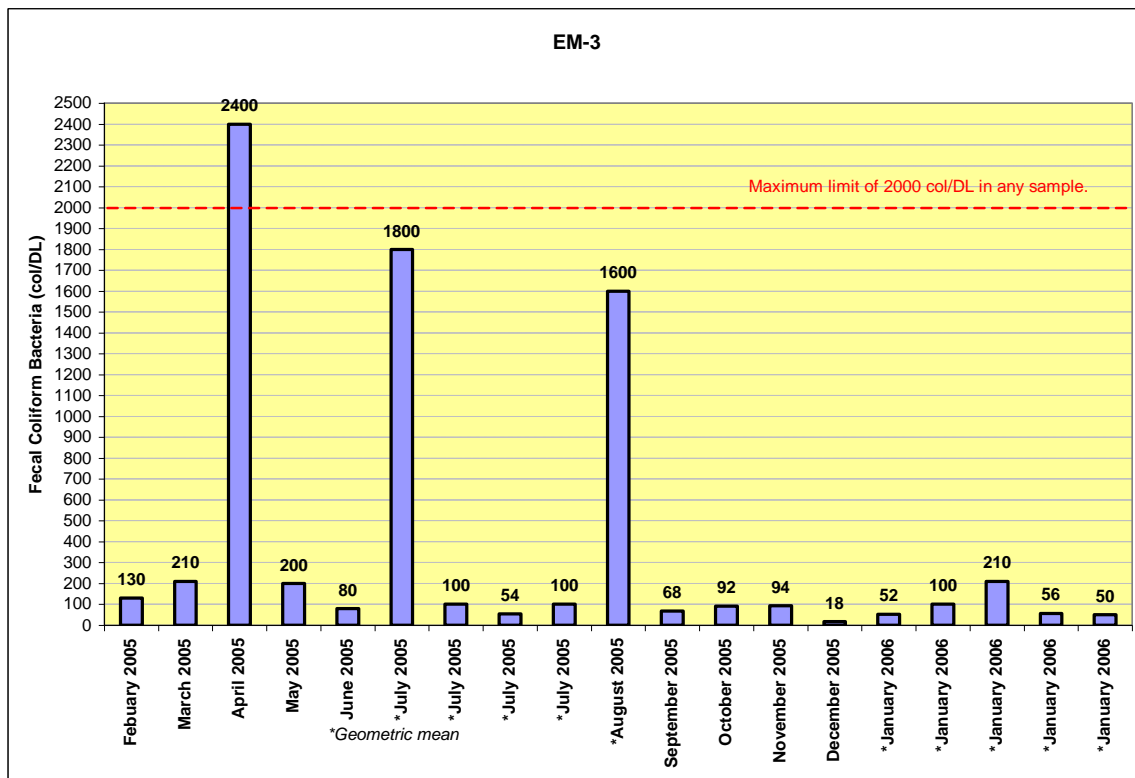
Figure 19. Fecal coliform results for EM-3.

EM-3. This station is located on Highpoint Blvd. Figure 19 is a summary of results for fecal coliform bacteria for EM-3. Figure 20 is an Upstream view of EM-3 and Figure 21 is a Downstream view of EM-3.

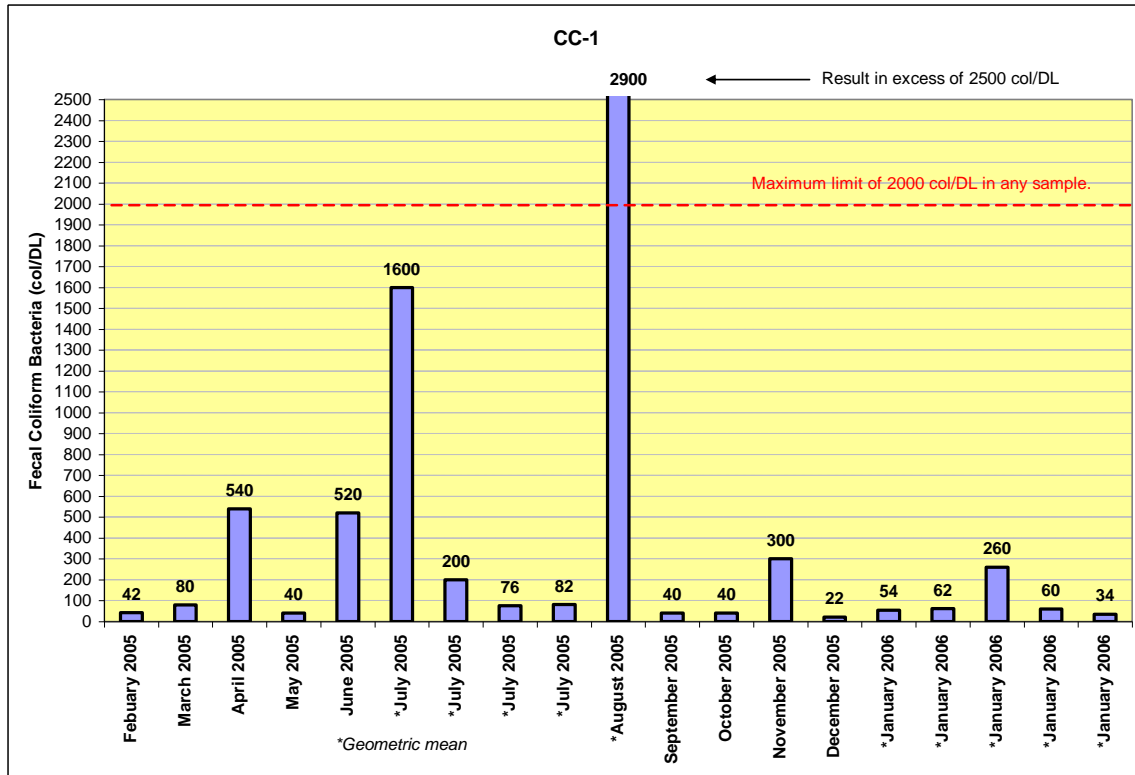
Figure 22. Fecal coliform results for CC-1.

CC-1. This station is located on Hwy 98. Figure 22 is a summary of results for fecal coliform bacteria for CC-1. Figure 23 is an Upstream view of CC-1 and Figure 24 is a Downstream view of CC-1.

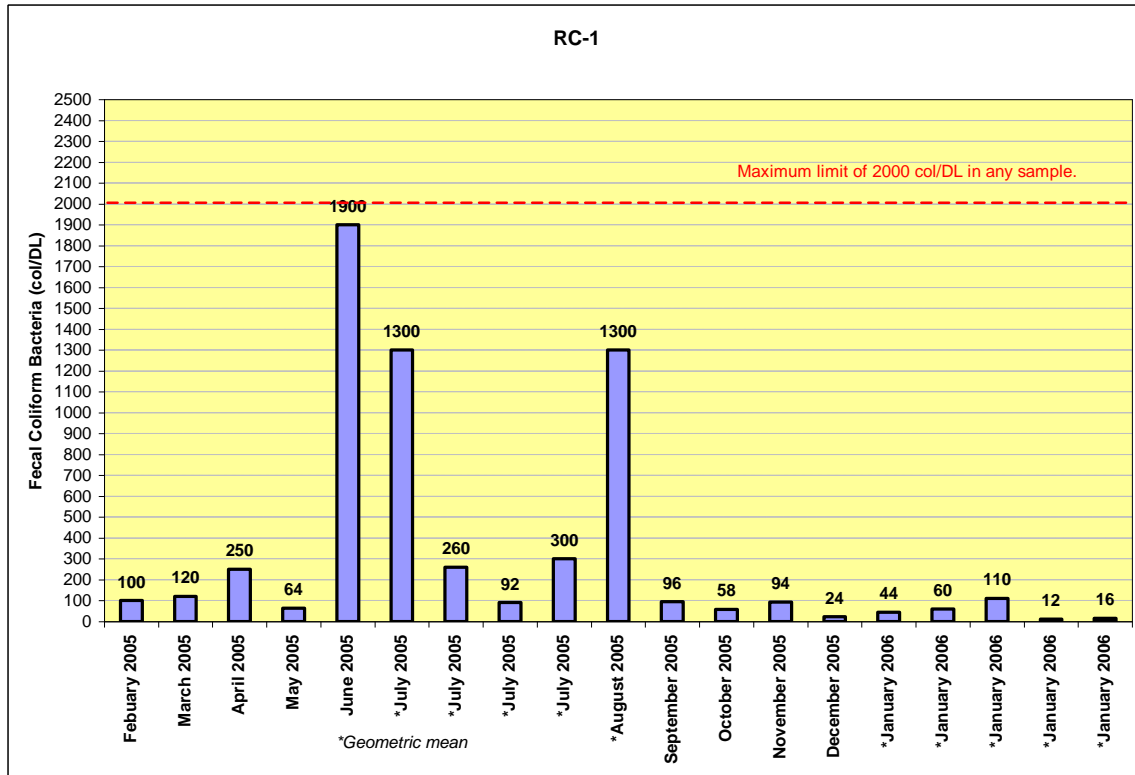
Figure 25. Fecal coliform results for RC-1.

RC-1. This station is located on Bearfork Road. Figure 25 is a summary of results for fecal coliform bacteria for RC-1. Figure 26 is an Upstream view of RC-1 and Figure 27 is a Downstream view of RC-1.

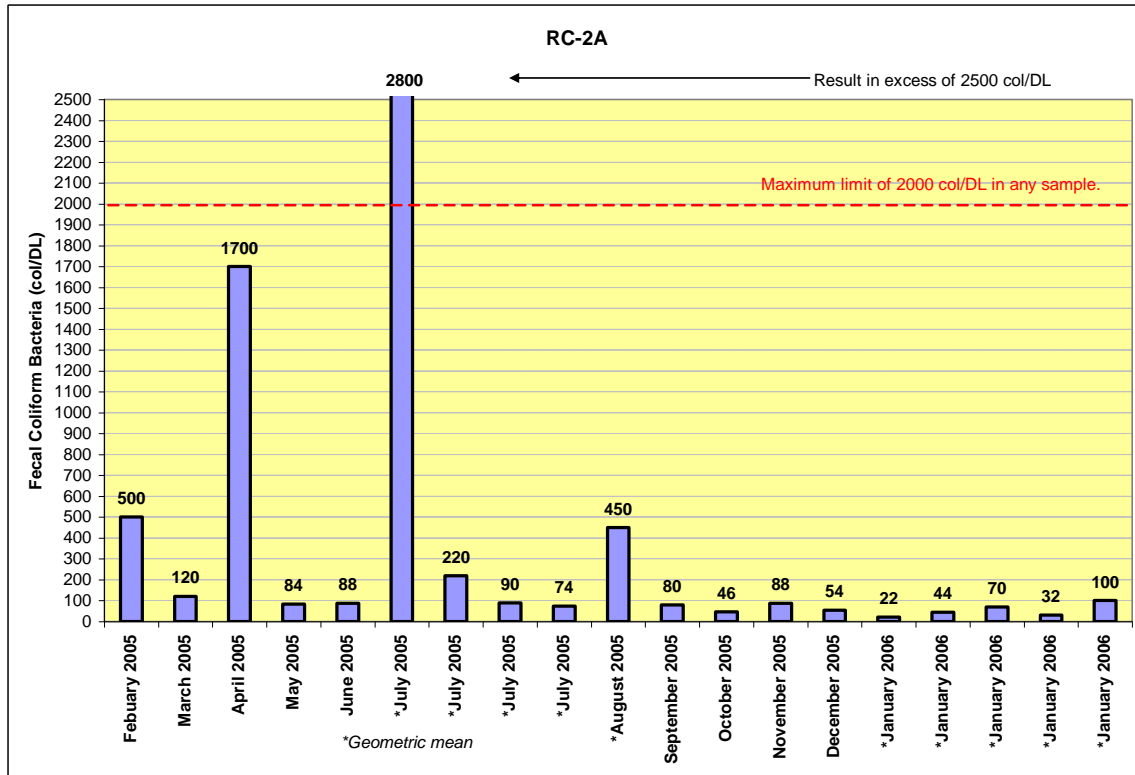
Figure 28. Fecal coliform results for RC-2A.

RC-2A. This station is located on Shillingers Road. Figure 28 is a summary of results for fecal coliform bacteria for RC-2A. Figure 29 is an Upstream view of RC-2A and Figure 30 is a Downstream view of RC-2A.

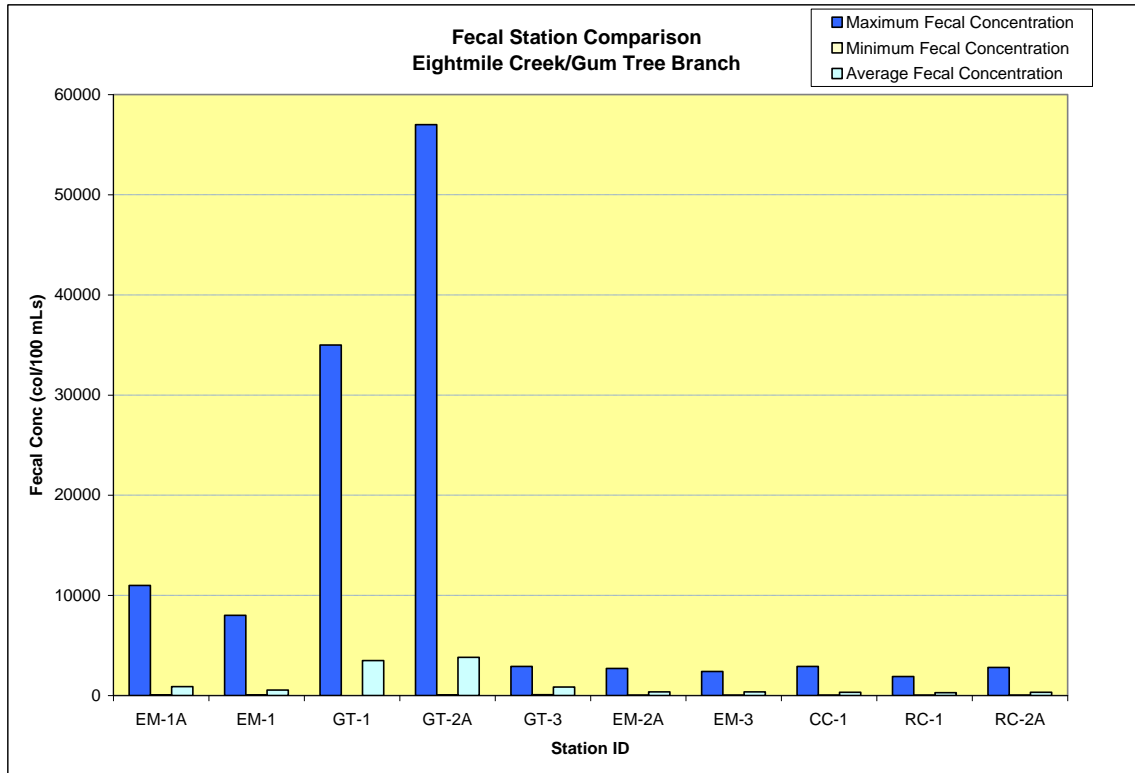
Figure 31. Comparison of Maximum, Minimum, and Average Fecal Results.

Table 3 depicts the maximum, minimum, and average of fecal results. Figure 31 is a graph of those results.

Station	# of Sampling Events	Maximum Fecal Concentration	Minimum Fecal Concentration	Average Fecal Concentration
EM-1A	22	11000	54	894
EM-1	22	8000	40	545
GT-1	22	35000	10	3479
GT-2A	22	57000	40	3803
GT-3	22	2900	78	842
EM-2A	22	2700	18	356
EM-3	21	2400	18	357
CC-1	22	2900	22	324
RC-1	22	1900	12	287
RC-2A	21	2800	18	313
