# Ocean & Coastal Management

## Marshes with and without sills protect estuarine shorelines from erosion better than bulkheads during a Category 1 hurricane

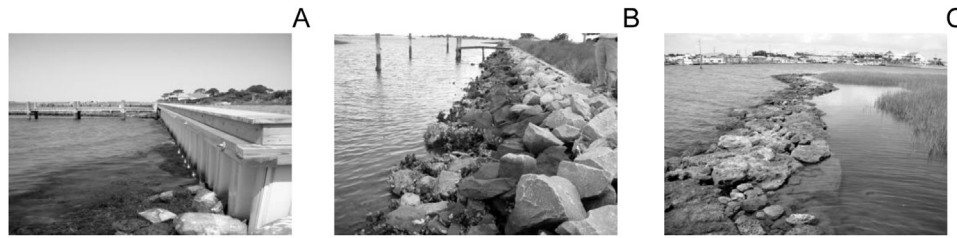
**Fig. 1.** Photographs of shoreline types: A) a bulkhead: a vertical structure typically constructed of vinyl composite, concrete, asbestos, or treated wood placed at or above the observed high water mark; B) a riprap revetment: a sloped structure typically constructed of granite, marl, or concrete placed at or above OHWM; and C) a sill: a structure typically constructed of granite, marl, or oyster shell, seaward of marsh.

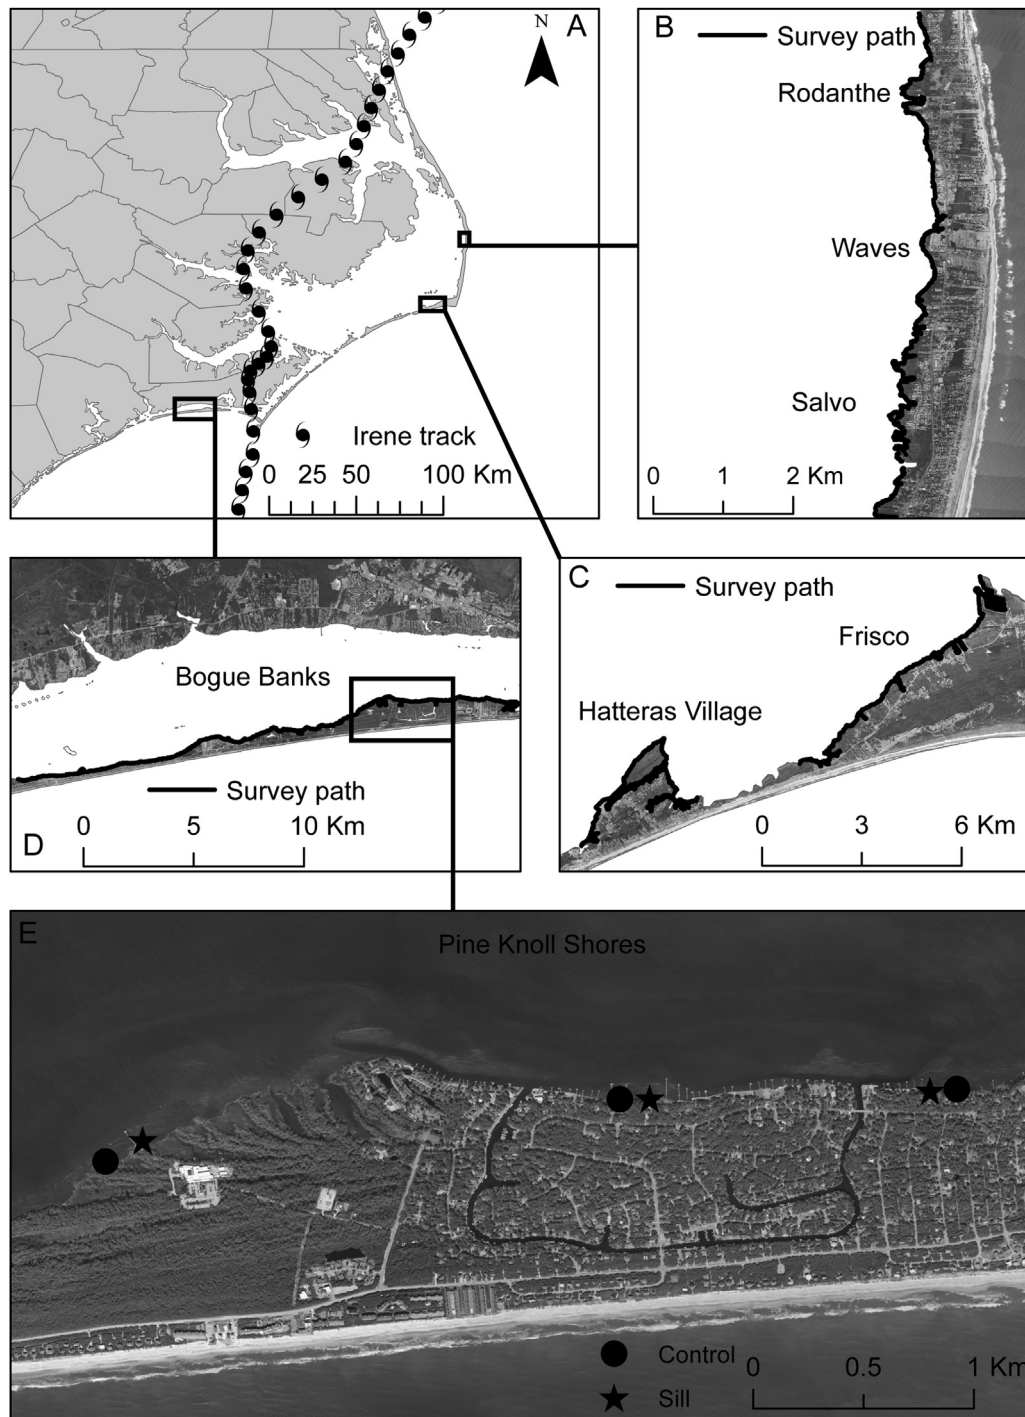
**Fig. 2.** A map of: A) the study areas relative to the path of Hurricane Irene (made landfall in NC at 34.7°N, 76.6°W; B) survey path for damage classifications on Rodanthe, Waves, and Salvo, NC; C) survey path for damage classifications on Frisco and Hatteras Island, NC; D) survey path for damage classifications on Bogue Banks, NC; and E) zoom-in to the sill sites and unmodified marsh sites that were surveyed along Bogue Banks, NC. The Hurricane Irene track and rate of movement is depicted at 30-min intervals by the location symbol.

Visually apparent damage to bulkheads, riprap revetments, and marshes with sills was recorded within one month of landfall of Hurricane Irene in North Carolina (Fig. 2A). Landfall occurred at Cape Lookout, NC, on August 27, 2011 as a Category 1 Hurricane, with a sustained wind-speed of 38 m/s. The strongest winds were primarily to the east of the eye over Pamlico Sound and the Outer Banks (Avila and Cangialosi, 2011). Approximately 14 km of back-barrier shoreline on the Outer Banks were surveyed within the towns of Rodanthe, Waves, and Salvo on the north end of Hatteras Island (Fig. 2B), as well as approximately 38 km of shoreline within Frisco and Hatteras Village on the southern end of Hatteras Island, NC (Fig. 2C, D). Hatteras Island is a barrier island approximately 320 km in length, bordered by Pamlico Sound to the west and the Atlantic Ocean to the east. Approximately 25 km of back-barrier estuarine shoreline on Bogue Banks (Fig. 2E) were also surveyed. Bogue Banks is a south-facing barrier island approximately 34 km in length, bordered by Bogue Sound to the north and the Atlantic Ocean to the south and the surveyed shoreline on Bogue Banks is situated within 25 km of the Irene landfall.

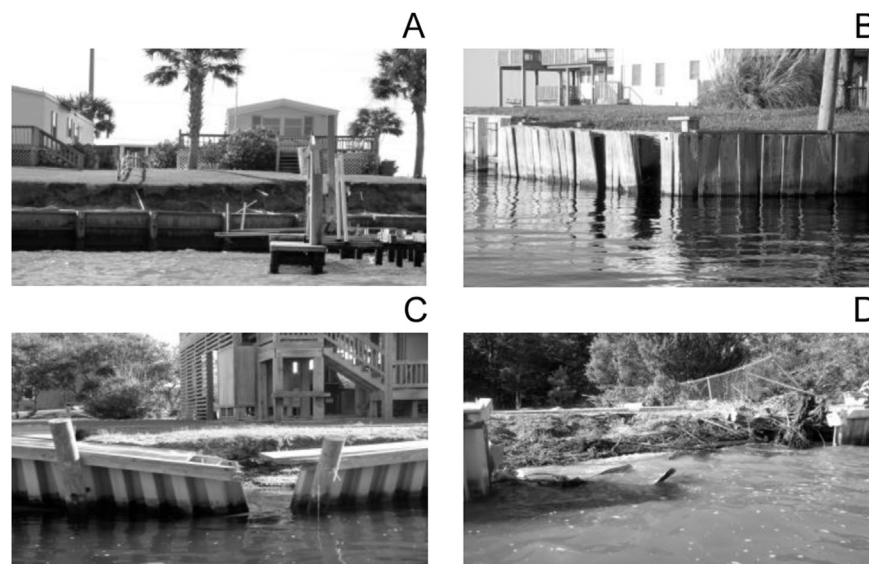
Fig. 3. Bulkhead damage classifications: A) Landward erosion; B) Structural damage; C) Breach; and D) Collapse.

erosion of the shoreline landward of the structure (Fig. 3A). Structural damage was defined as warping or evident damage to the structure without breach or collapse (Fig. 3B). A breach was defined as a gap or hole visible in the structure that allowed landward sediment to escape (Fig. 3C), while a collapse was defined as complete loss of the integrity of the structure so that it was no longer effectively retaining any sediment landward (Fig. 3D). Photographs were taken of each shoreline protection type (e.g., bulkhead, riprap revetment, sill) and each instance of damage to a shoreline protection structure. GPS data were imported into ArcGIS as shapefiles. Shapefiles were overlaid on 2010 aerial orthoimagery (North Carolina One Map, 2013) and digitized shorelines of Bogue Banks and the Outer Banks (NC DCM, 2012). NC DCM classified NC shorelines using 2007 aerial orthoimagery for Dare and Hyde counties and 2010 aerial orthoimagery for Carteret County (where Bogue Banks is located), producing ArcGIS continuous line shapefiles that include the shoreline type (marsh, beach, modified with structure [hardened]) and shoreline structure type (boat ramp, bulkhead, bulkhead and riprap combined, breakwater, groin/jetty, sill, riprap revetment).

Of the 1.86 km of bulkheads surveyed in Rodanthe, Waves, and Salvo (Fig. 4A), 76% (1.41 km) was damaged after the Hurricane (Fig. 4B), with damage ranging from landward soil erosion (Fig. 3A) to complete bulkhead collapse (Fig. 3D). In contrast, only 4% (0.26 km) of the 7 km of bulkheads surveyed in Frisco, 9% (0.83 km) of the 9 km of bulkheads in Hatteras Village, and 12% (1.14 km) of the 9.77 km of bulkheads on Bogue Banks (Fig. 4A) was damaged (Fig. 4B). No visible damage (structural failure, landward soil erosion) was detected to sill, riprap revetment, or hybrid shoreline structures surveyed within the study regions.

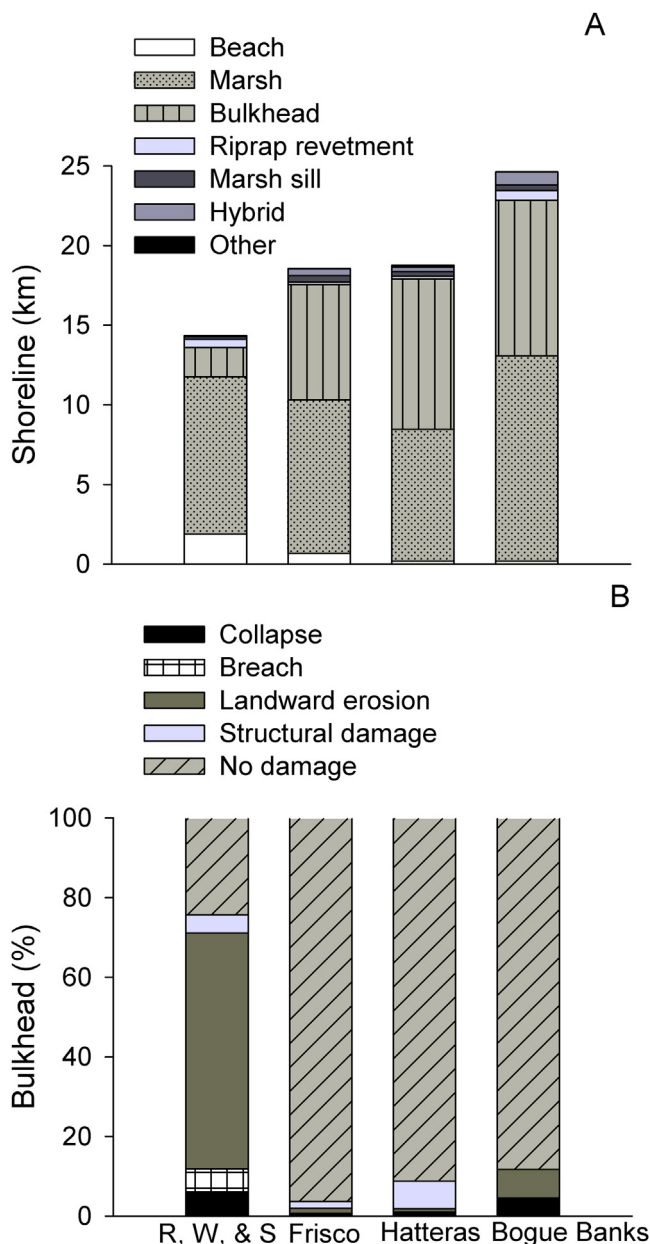
**Fig. 4.** A) Shoreline classification by type (km) for Rodanthe, Waves, and Salvo; Frisco; Hatteras Village; and Bogue Banks, NC. See Fig. 1 for descriptions and photographs of a bulkhead, riprap revetment, and marsh with a sill. Hybrid is a combination of bulkhead and riprap and beach is unvegetated shoreline. B) Bulkhead damage classification by type (%) for Rodanthe, Waves, and Salvo (R, W, & S); Frisco; Hatteras Village; and Bogue Banks, NC. See Fig. 3 for photographs of damage classifications.

Of the 76 km of shoreline surveyed along the back-barriers of Hatteras Island and Bogue Banks, 28 km (37%) of the shoreline was protected by bulkheads. Riprap revetments, sills, and hybrid methods were less common than bulkheads, making up only 1.9%, 1.6%, and 2% of the shoreline, respectively, while the remaining shoreline was marsh (53%) or beach (3%) (see Fig. 4A for km of shoreline protection types by survey region).

Bulkheads were the only type of shoreline protection structure that showed visible damage after the hurricane (Fig. 4A). Thieler and Young (1991) also found greater damage to bulkheads when compared to riprap revetments along barrier island shorelines in South Carolina after Hurricane Hugo. They attributed the high rate of damage to bulkheads (58% of 6.1 km of bulkheading destroyed) and riprap revetments (24% of 7.1 km destroyed) to overtopping by the storm surge (Thieler and Young, 1991). Most of the bulkhead failures observed in our study were probably also a consequence of overtopping of bulkheads by waves and storm surge (Table 2). Bulkheads retain landward sediment at an elevation 1–2 m higher than the natural shoreline. This large difference in elevation, when compared to typically lower-sloped marsh, riprap revetments, or sills, can result in a large and rapid loss of sediment if the stabilizing structure (the bulkhead) collapses or is breached (Fig. 3D). This process was evident from the large amount of sediment lost at all collapsed bulkheads surveyed throughout the NC coast (Fig. 4B). Damage to bulkheads was frequently observed directly adjacent or close to shorelines stabilized with riprap revetments, hybrid structures, and sills that were not damaged (R.K. Gittman, *personal observation*), even along the Rodanthe, Waves, and Salvo shorelines. One of the sill sites surveyed on Bogue Banks was located approximately 100 m from a collapsed bulkhead and experienced no change in overall marsh elevation in 2011 (Figs. 3D and 5A).

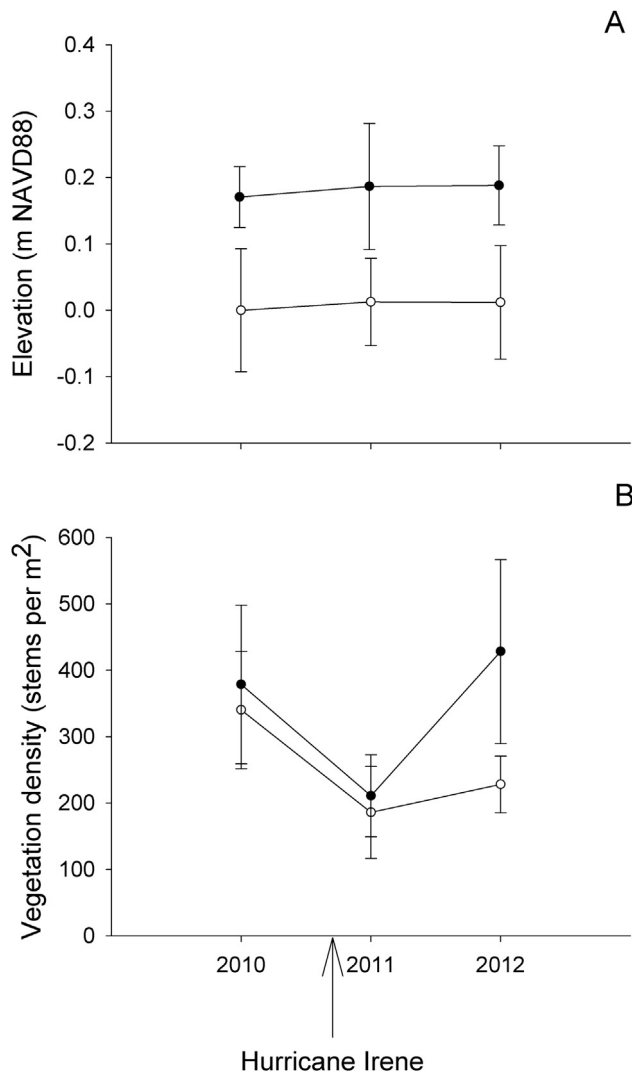
**Fig. 5.** The effects of Hurricane Irene on: (A) average marsh surface elevation (m, NAVD88); and (B) average vegetation density per m<sup>2</sup> at marsh sites with (closed circles) and without (open circles) sills. Error bars represent  $\pm 1SE$  ( $n = 9$  to 21 per site).

Mean marsh surface elevations were significantly higher at sites with sills than at marsh sites without sills across all years ( $P = 0.001$ , Table 1, Fig. 5A). Elevation increased with increasing distance from the lower marsh edge, with the change in elevation being greater from the edge to the upland marsh at sites without sills than at sites with sills ( $P < 0.001$ ). However, a significant change in marsh surface elevation was not detected from August 2010 (before Hurricane Irene) to October 2011 (one month after Hurricane Irene) at marshes with or without sills nor was a significant change detected in marsh surface elevation from October 2011 (immediately after Hurricane Irene) to October 2012 (13 months after Hurricane Irene) ( $P = 0.930$ , Fig. 5A). There were no significant interactions between treatment and year or treatment, year, and distance from marsh edge ( $P > 0.05$ ).

Vegetation density did not vary between marshes with sills and marshes without sills ( $P = 0.078$ , Table 1, Fig. 5A), but did increase with increasing distance from the marsh edge ( $P = 0.007$ ). From August 2010 (before Hurricane Irene) to October 2011 (after Hurricane Irene), vegetation density decreased by  $167 \pm 86$  stems  $m^{-2}$  within marshes with sills and by  $154 \pm 73$  stems  $m^{-2}$  within marshes without sills respectively, ( $P < 0.05$ , Tukey's post hoc tests, Fig. 5B). Increases of  $218 \pm 98$  macrophyte stems  $m^{-2}$  within marshes with sills and  $42 \pm 59$  macrophyte stems within marshes without sills, respectively, occurred from October 2011 (immediately after Hurricane Irene) to October 2012 (13 months after Hurricane Irene) ( $P < 0.05$ , Tukey's post hoc tests, Fig. 5B). In 2010 and 2012, vegetation density was not significantly different across sites ( $P > 0.05$ , Tukey's post hoc tests, Fig. 5B). However, while vegetation within marshes with sills in 2012 appeared to have recovered to 2010 levels, within marshes without sills, the marsh did not appear to recover to the same vegetation density over this time period, although this difference in recovery was not statistically significant ( $P = 0.289$ , Fig. 5B). There were no significant interactions between treatment and year or treatment, year, and distance from marsh edge ( $P > 0.05$ ).
