Toulmins Spring Branch Watershed Stormwater Management

DATE: 11/20/2014

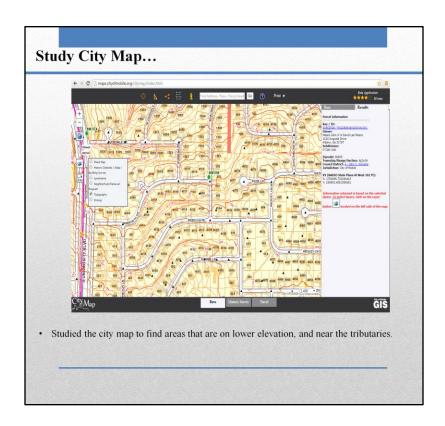
Notes: In addition to that project, in order to locate the spots that are vulnerable to flooding, we studied the city map to find areas that are on lower elevation, and near the tributaries. This map shows the contour lines. This map helped us to identify areas that are on lower elevation, near the tributaries and vulnerable to flooding.

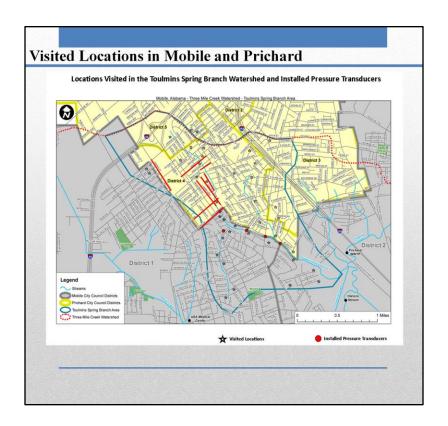
Notes: Then we started visiting the locations. The star signs in the map show the places that we have visited in last few months. You can see on the map that the locations are mostly near the creek. We interviewed people who are living in those places.
