Erosion Activity Assessment of the D'Olive Creek Watershed

Erosion Activity Assessment of the D'Olive Creek Watershed. Daphne, Alabama.

Tetra Tech, Inc.
2110 Powers Ferry Rd.,
Suite 202
Atlanta, GA 30339

Thompson Engineering, Inc.
2970 Cottage Hill Road, Suite 190
Mobile, AL 36606

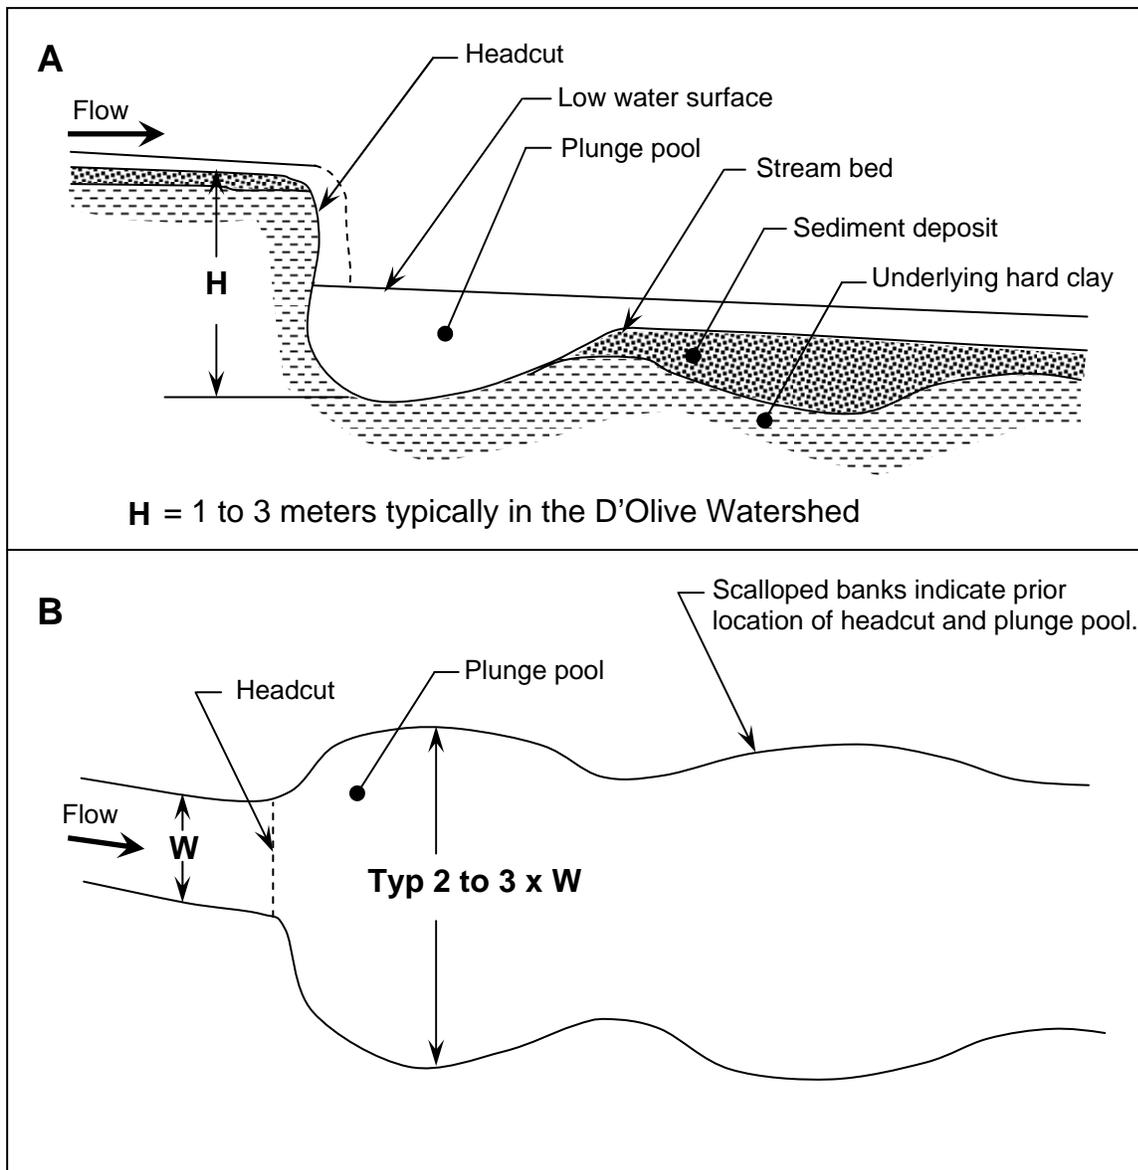
With long-term sea level fluctuations (1000 to 100,000 year scale) the stream channels cycle through phases of incision and deposition to match the base level controlled by the prevailing sea level. Stream channels in the incision phase are often marked by one or more "headcuts" which are a natural process (Figure 4-1) but can be initiated, accelerated, and/or slowed by human activities that alter channel gradient (straightening, weirs, etc) or alter runoff (increasing impervious land use, increasing stormwater detention, etc). Headcuts in the D'Olive Watershed streams have likely been propagating upstream for thousands of years. However, the change in hydrology brought on by recent land use change since the 1960s throughout the Watershed has accelerated the rate of headcutting with a corresponding increase in sediment load to Lake Forest Lake and D'Olive Bay. Essentially every tributary in the Watershed has at least one headcut. Some are actively advancing upstream, while the advance of others has been prevented by grade control structures installed at road and pipeline crossings. The nature of specific headcuts will be discussed in the reach descriptions provided in Section 5.0.

Figure 4-1. (A) Profile and (B) Plan View of a headcut typical to the D'Olive Watershed.

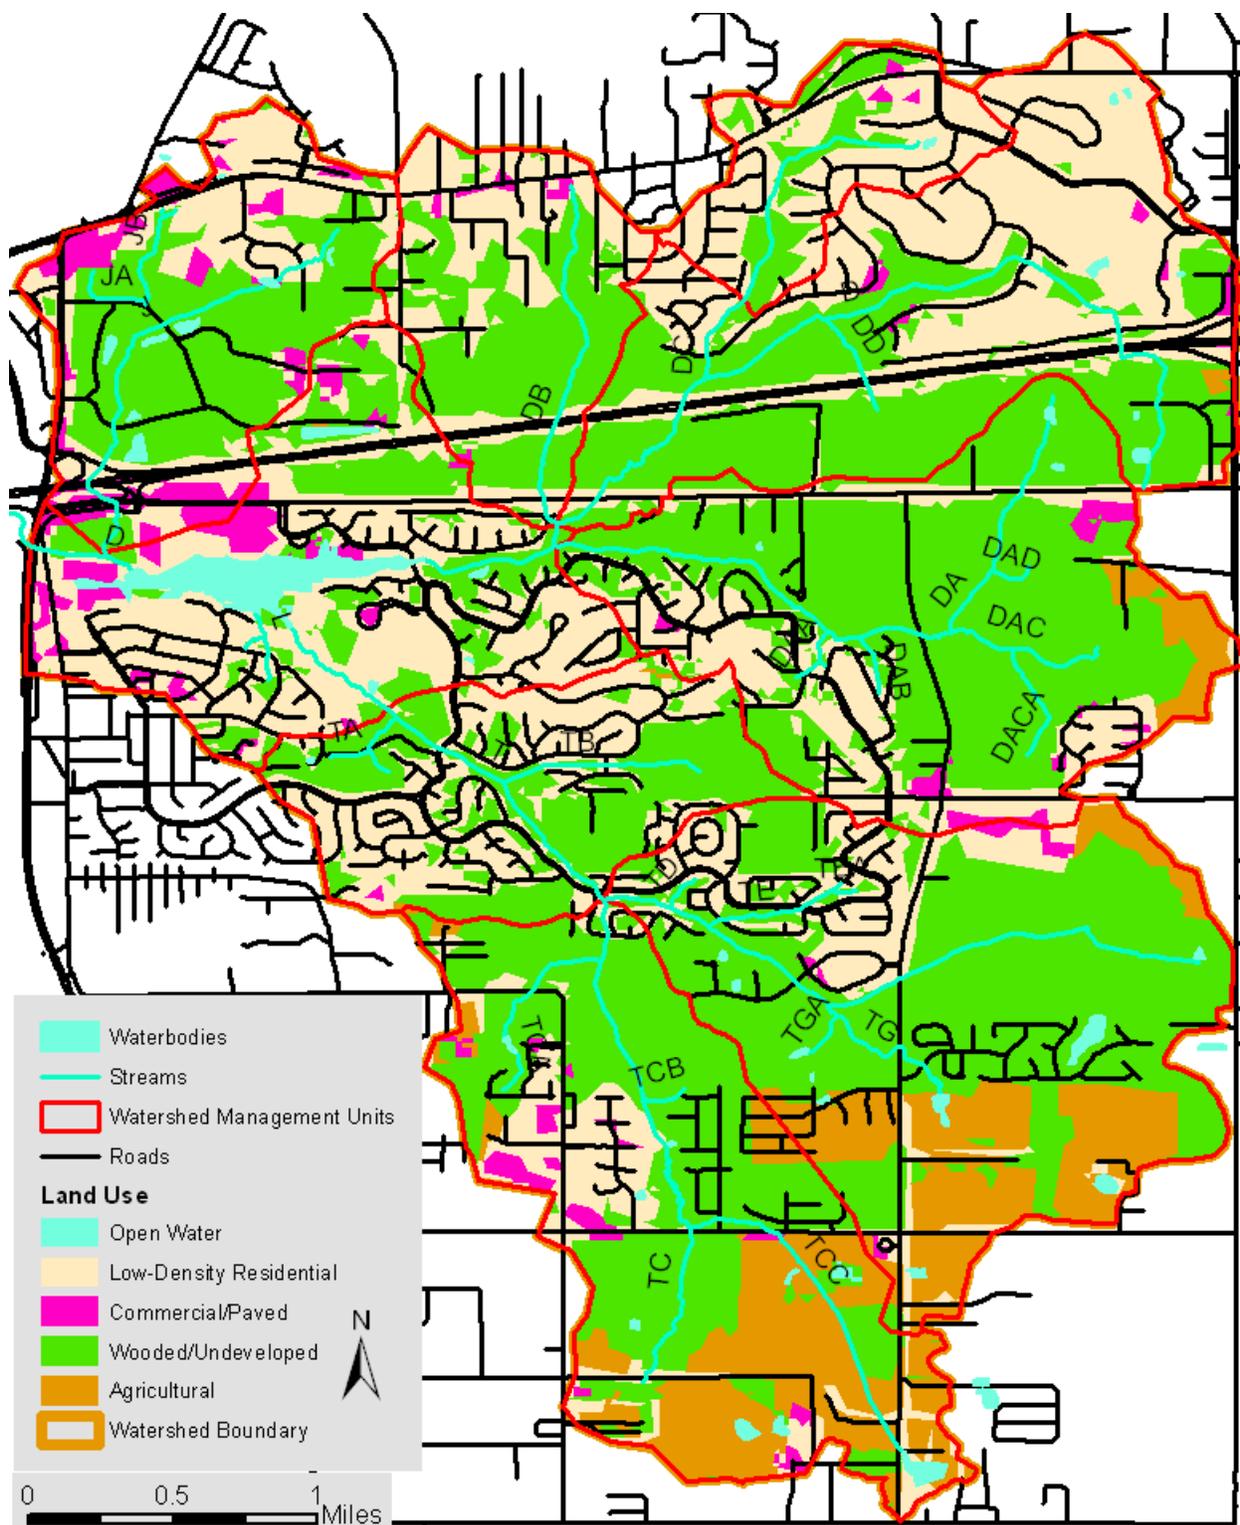
The D'Olive Watershed has been developed into primarily four different types: commercial, low-density residential, agricultural, and undeveloped. (Figure 4-5). Figure 4-5, which is based on the 2001 National Land Cover Database, does not include the following recently commercially developed areas: (1) the Spanish Fort Town Center plaza located northeast of the I-10 and US98 junction; and (2) the Lowe's Plaza and automobile dealerships located southwest of the I-10 and CR27 junction. Recently developed residential areas include the Estates of Tiawasee and the French Settlement, both located west of CR13. Note that there may be other areas that have undergone or are presently undergoing development.

Figure 4-5. Land Use in the D'Olive Creek Watershed (Adapted from the 2001 NLCD).

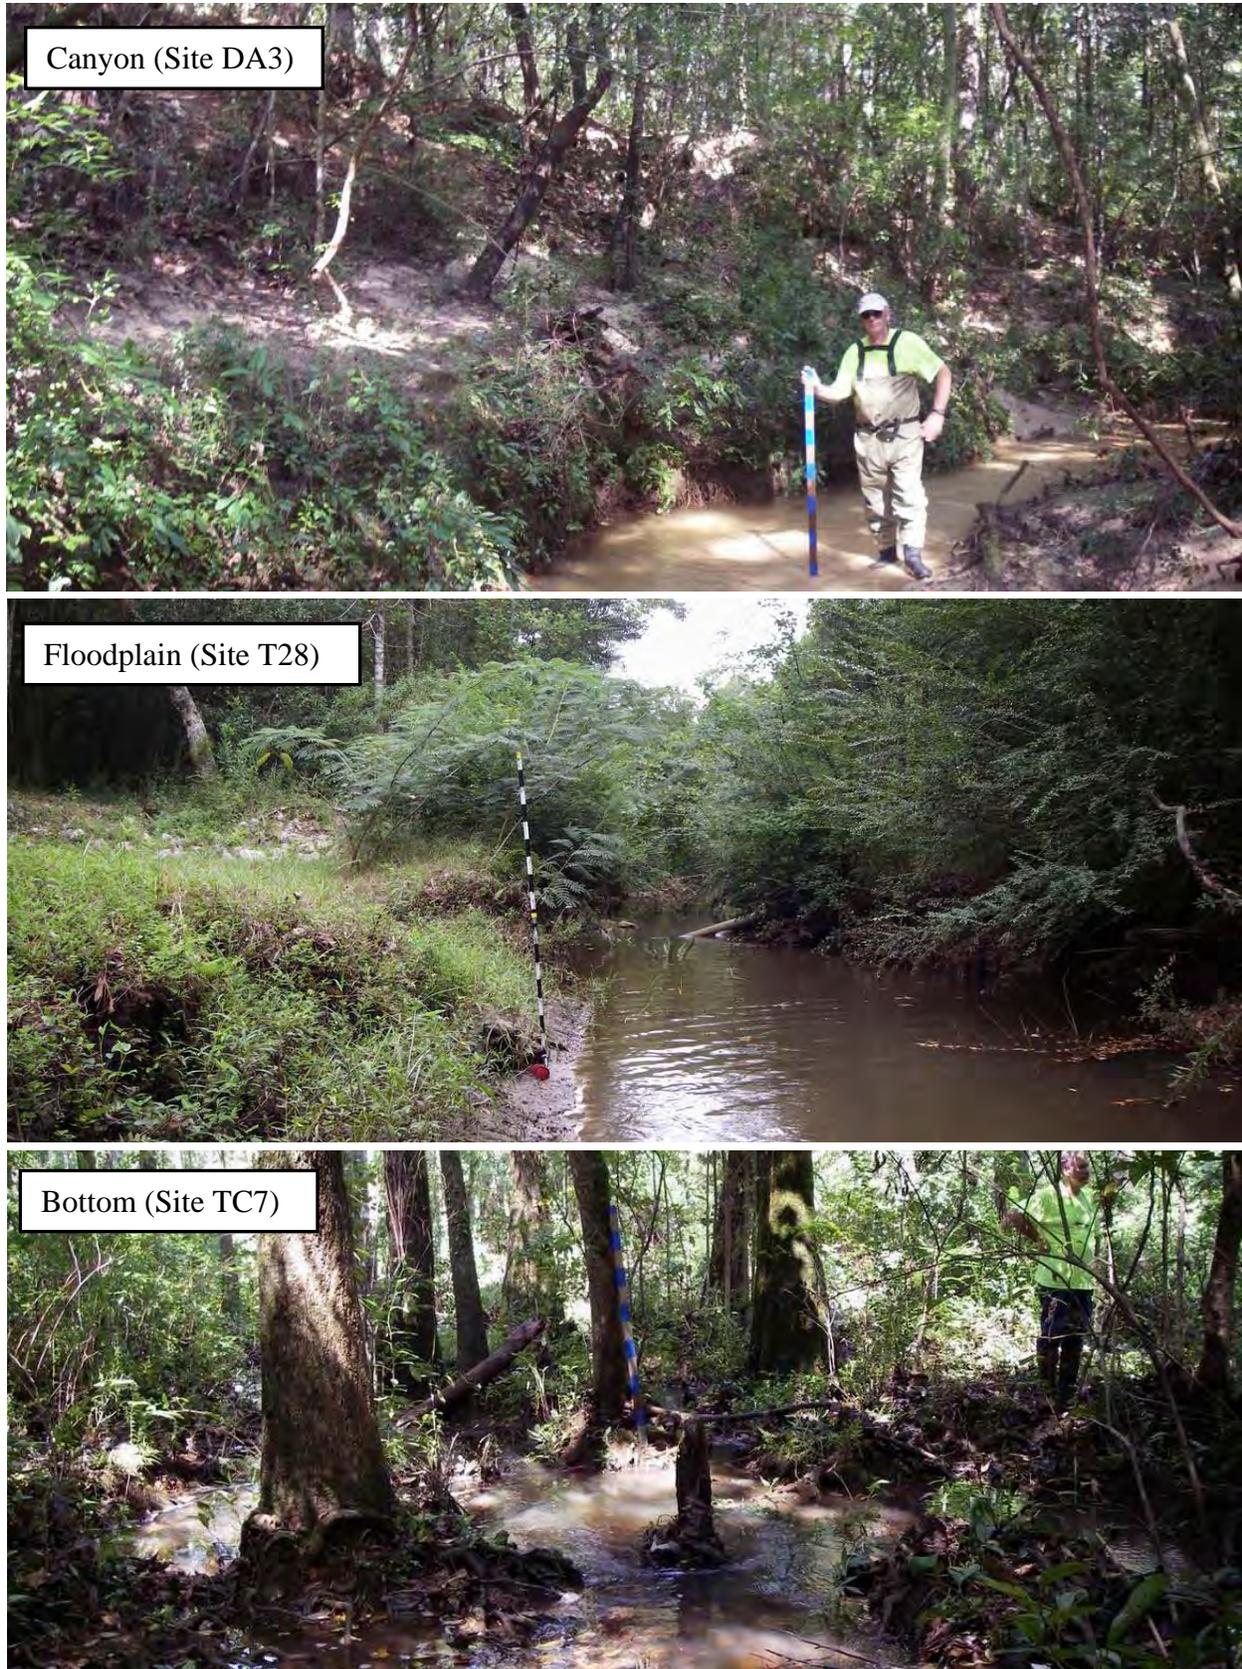
The prevalent landowner practices appear to be dictated by the valley form of each stream. The valley forms can be divided into three classes: (1) canyons, (2) floodplains, and (3) bottoms (Figure 4-14).

Figure 4-14. Channel forms typical of the “canyon,” “floodplain,” and “bottom” type stream reaches.

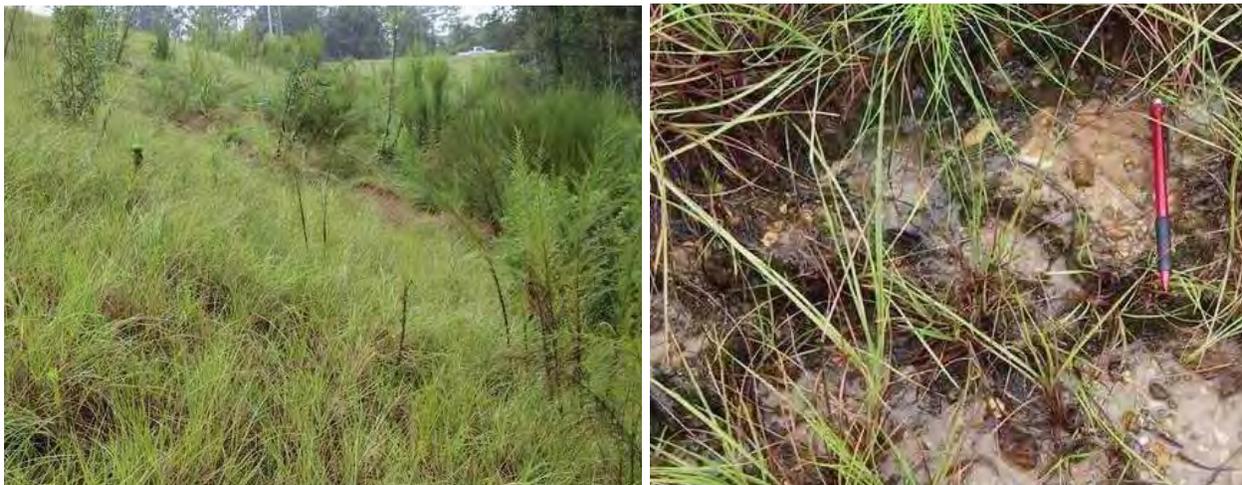
Figure 4-16. Not fully established grass protection. Note pooling runoff. Site U1.

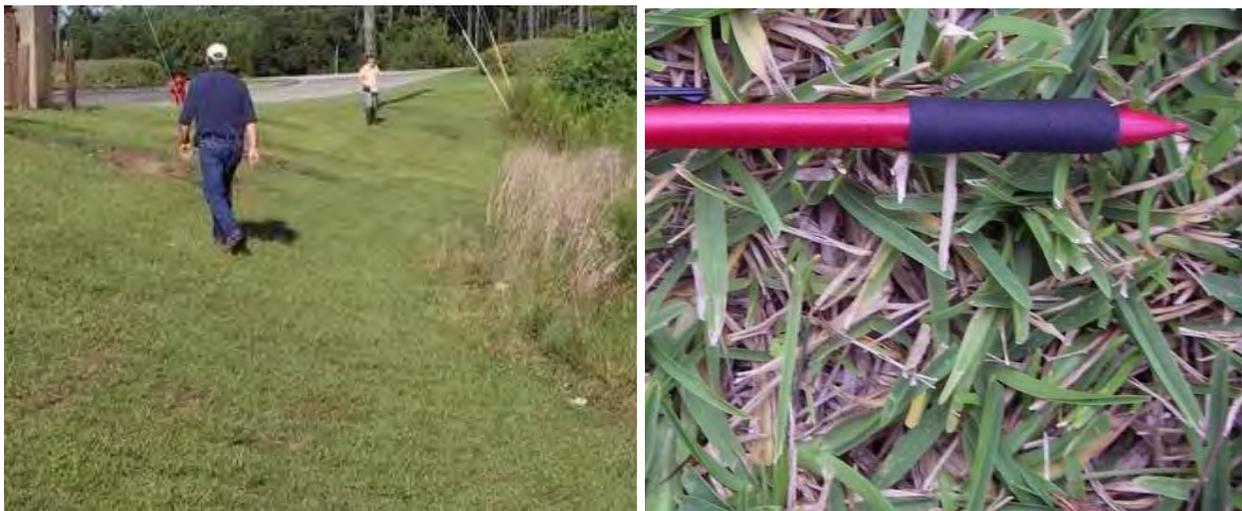
Figure 4-17. Well established grass vegetative protection. Sites U2 and U22.

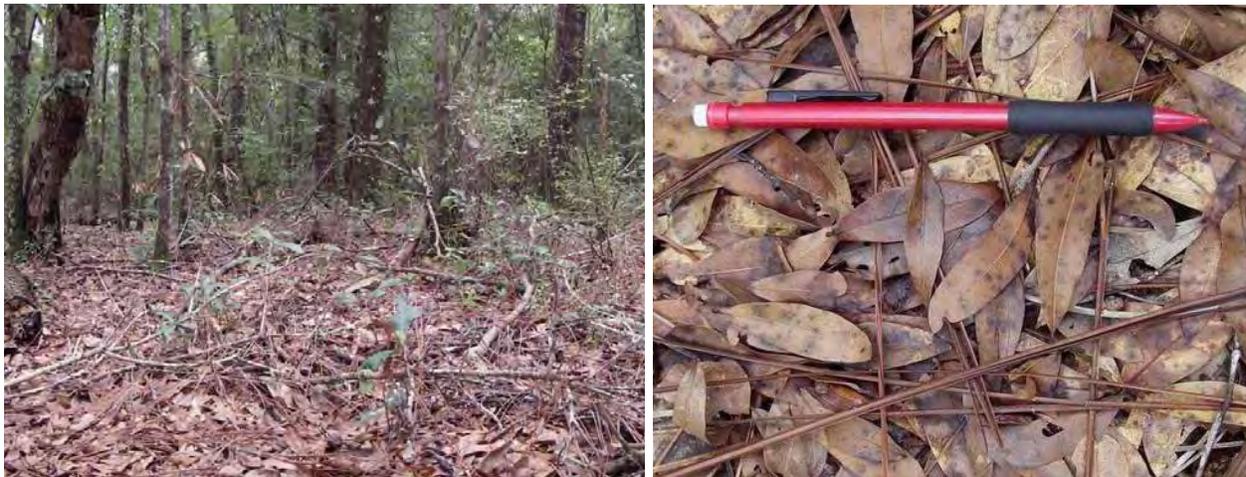
Figure 4-18. Leaf litter layer over forest soil. Site U16.

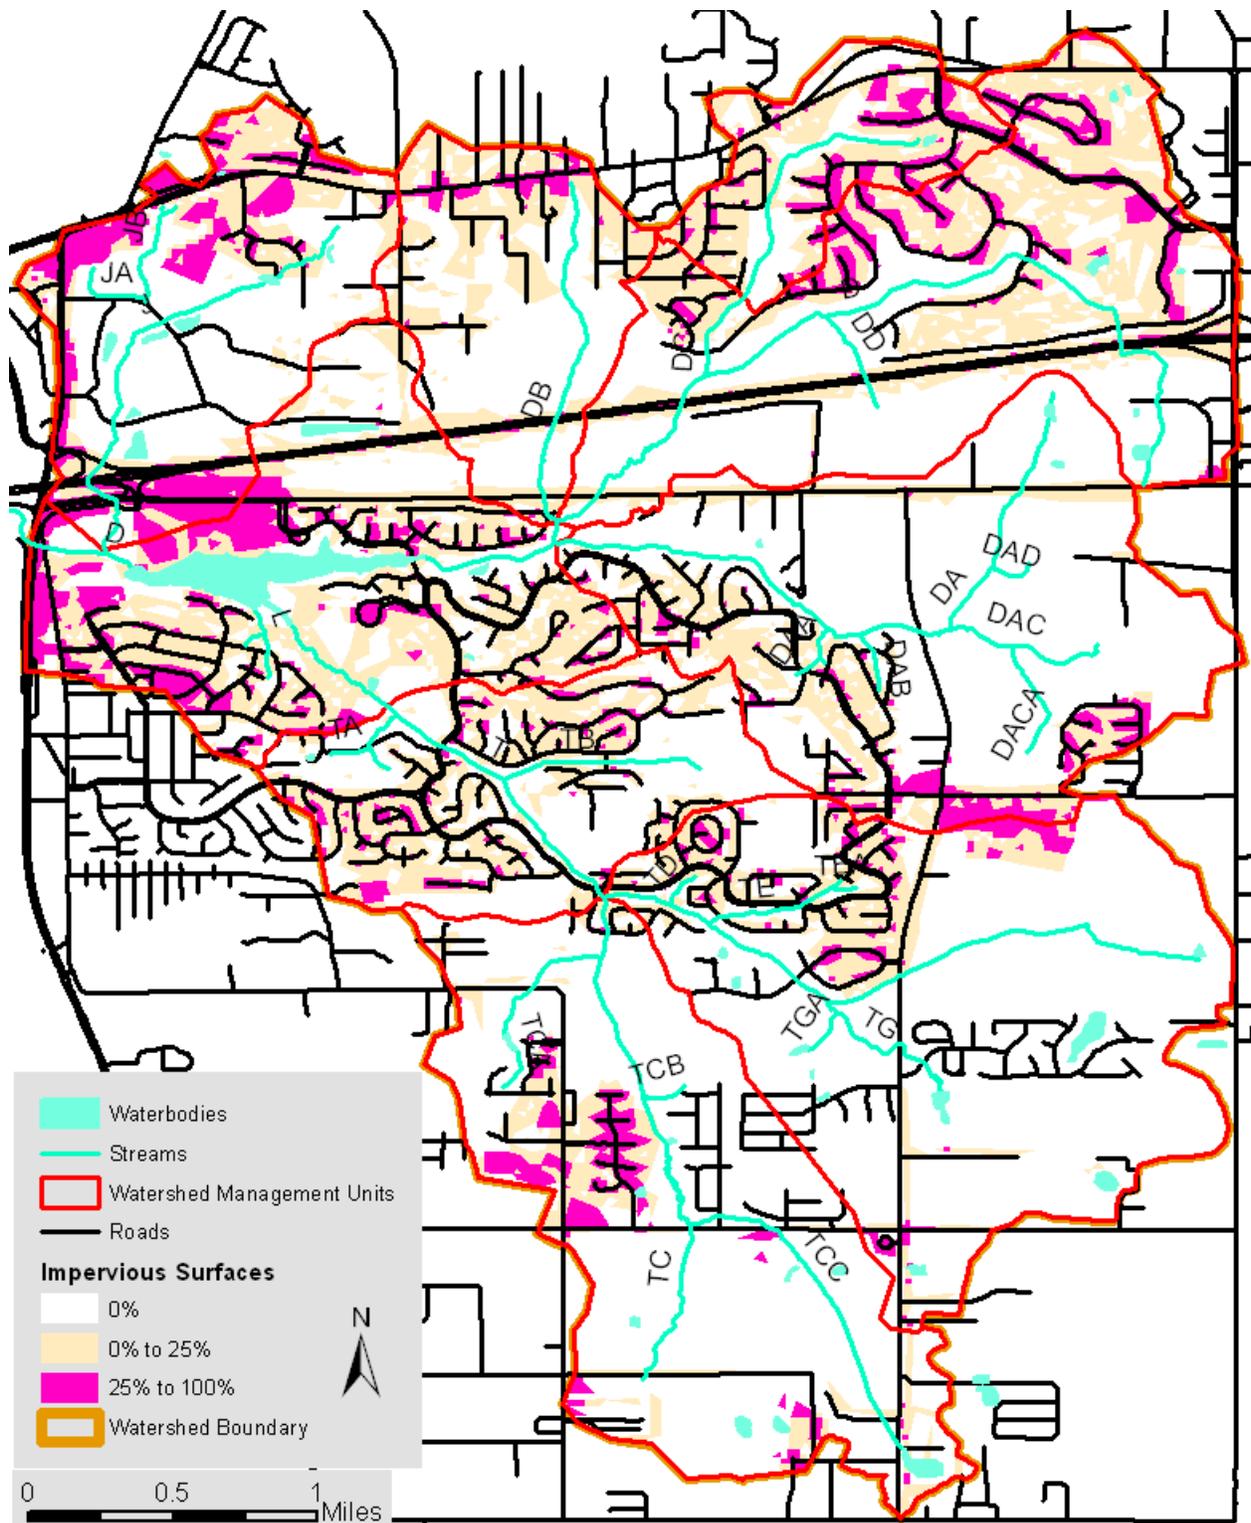
Figure 4-19. Impervious surfaces in the D'Olive Creek Watershed (Adapted from the 2001 NLCD).

channel erosion rates has resulted in a major portion of the observed downstream sediment load and sediment deposition in Lake Forest Lake and in D'Olive Bay. The spatial distribution of impervious surfaces within the Watershed is shown in Figure 4-19. Areas developed since 2001 are not included.
