**D'OLIVE WATERSHED MONITORING STUDY
AND
DEVELOPMENT OF A WATERSHED CONDITION FRAMEWORK**

Prepared for

Mobile Bay National Estuary Program
118 North Royal Street #601
Mobile, Alabama 36602

July 24, 2019

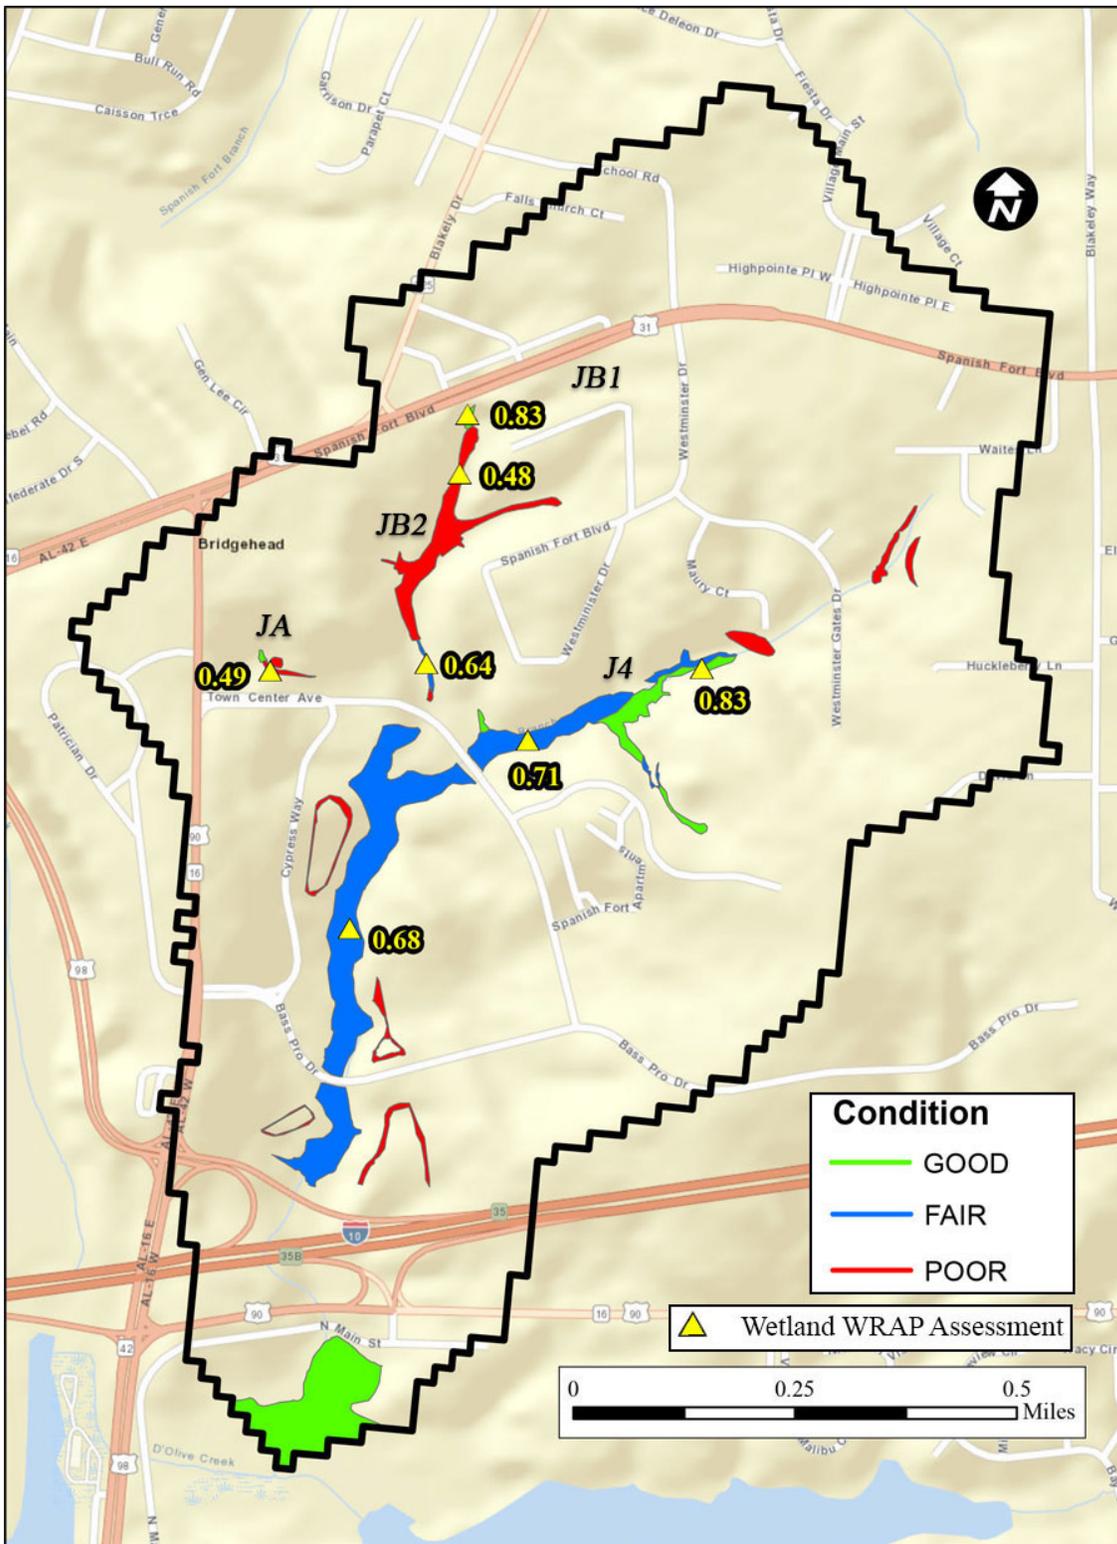
Figure 4-1. Wetland quality and WRAP scores in the Joes Branch sub-watershed.

Sampling Station	2019 WRAP Score	Condition
JA-Restoration	0.49	Poor
JB-Upstream	0.83	Good
JB-Restoration	0.48	Poor
JB-Downstream	0.64	Fair
J4-Upstream	0.83	Good
J4-Downstream	0.71	Fair
JB-Bass Pro Shop	0.68	Fair

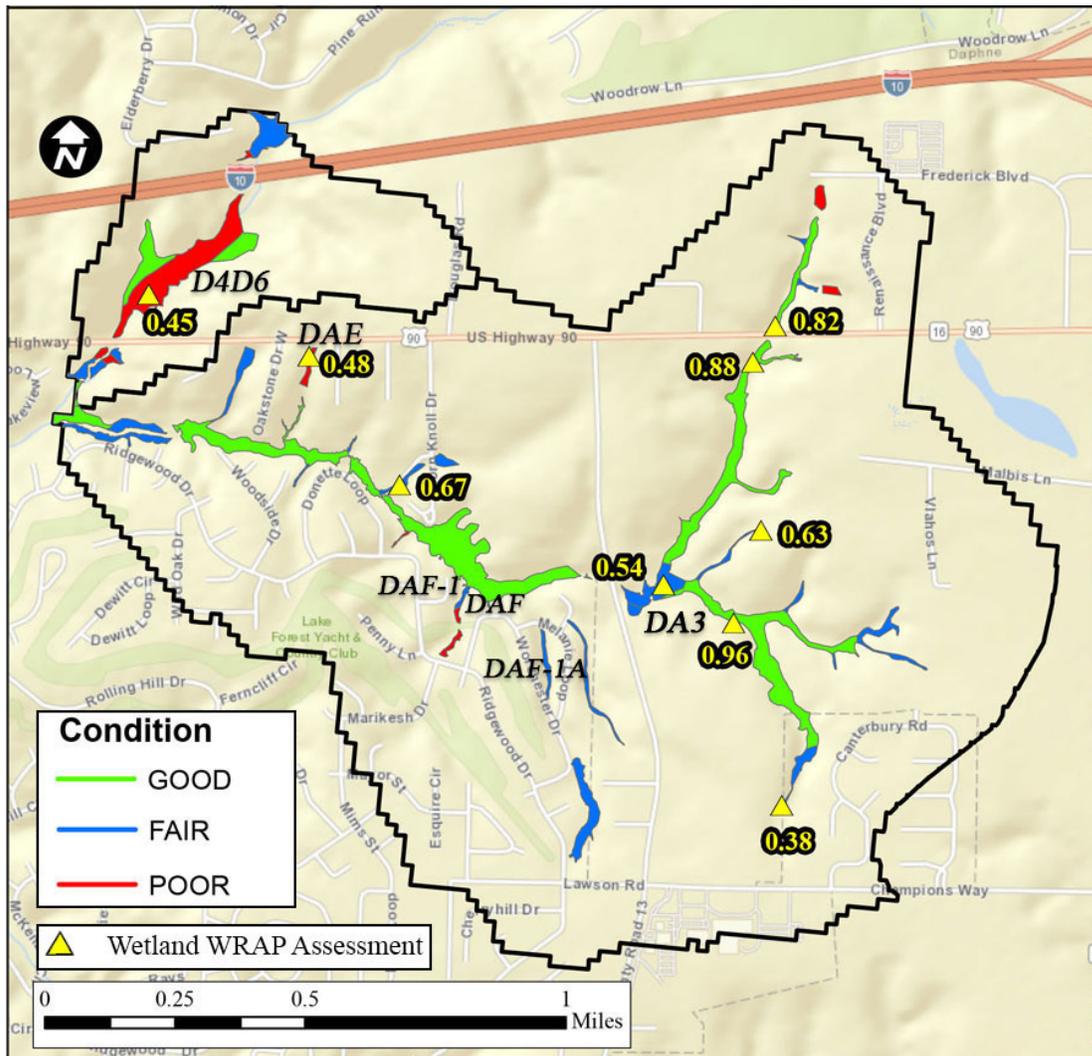
Figure 4-2. Wetland quality and WRAP scores in the D'Olive Creek sub-watersheds.

Downstream at Acorn Knoll and Deciduous Court, fair quality wetlands occur at a drainageway leading to the DA tributary of D'Olive Creek. These wetlands scored high for wetland canopy and ground cover, and field hydrology. Human disturbance, vehicle traffic and barriers such as silt fence negatively affect wildlife utilization. A large portion of its drainage area has been removed by residential development, and has a low score for water quality input and treatment.

Restoration sites DAE and D4D6 have poor quality wetlands, though only marginally, with WRAP scores of 0.48 and 0.45, respectively. While both sites have little to no canopy cover, the planted trees at D4D6 have good potential for future condition improvement. D4D6 has a low functional value for ground cover, whereas DAE has a moderate ground cover score. With continued maturation, ground cover values at D4D6 are expected to improve. Both DAE and D4D6 have moderate scores for field

Sampling Station	2019 WRAP Score	Condition
D4D6-Restoration	0.45	Poor
DAE-Restoration	0.48	Poor
DA3-Restoration	0.54	Fair
Acorn Knoll at Deciduous Ct	0.67	Fair
MP-WRAP 6	0.88	Good
MP-WRAP 4	0.82	Good
MP-WRAP 3	0.63	Fair
MP-WRAP 1	0.96	Good
MP-WRAP 2	0.38	Poor

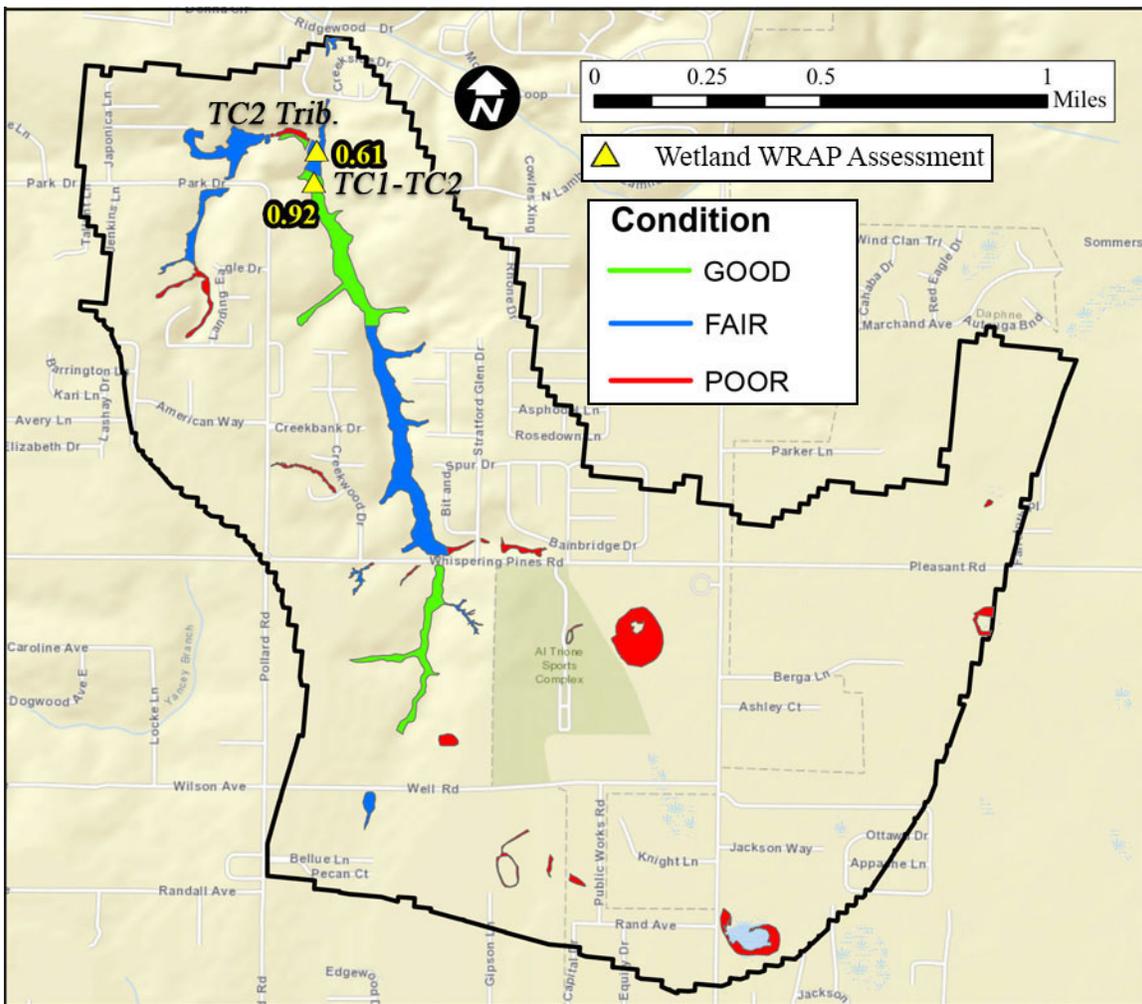
Figure 4-3. Wetland quality and WRAP scores in the Tiawasse Creek sub-watershed.

Restoration site TC1-TC2 wetlands are classified as Fair (0.61), and scored highest for upland buffer quality and water quality input and treatment. Wildlife habitat is marginal due to limited canopy cover, and wetland ground cover is sparse compared to high quality wetlands. With continued maturation, canopy and ground cover values at TC1-TC2 are expected to improve. The wetlands immediately upstream of TC1-TC2 are high quality, scoring high in all six WRAP functional values. The TC2-Tributary restoration site was inspected and its associated wetlands determined to have Poor condition.

Sampling Station	2019 WRAP Score	Condition
TC1-TC2-Restoration	0.61	Fair
TC1-TC2-Upstream	0.92	Good
TC2 Tributary-Restoration	N/A	Poor

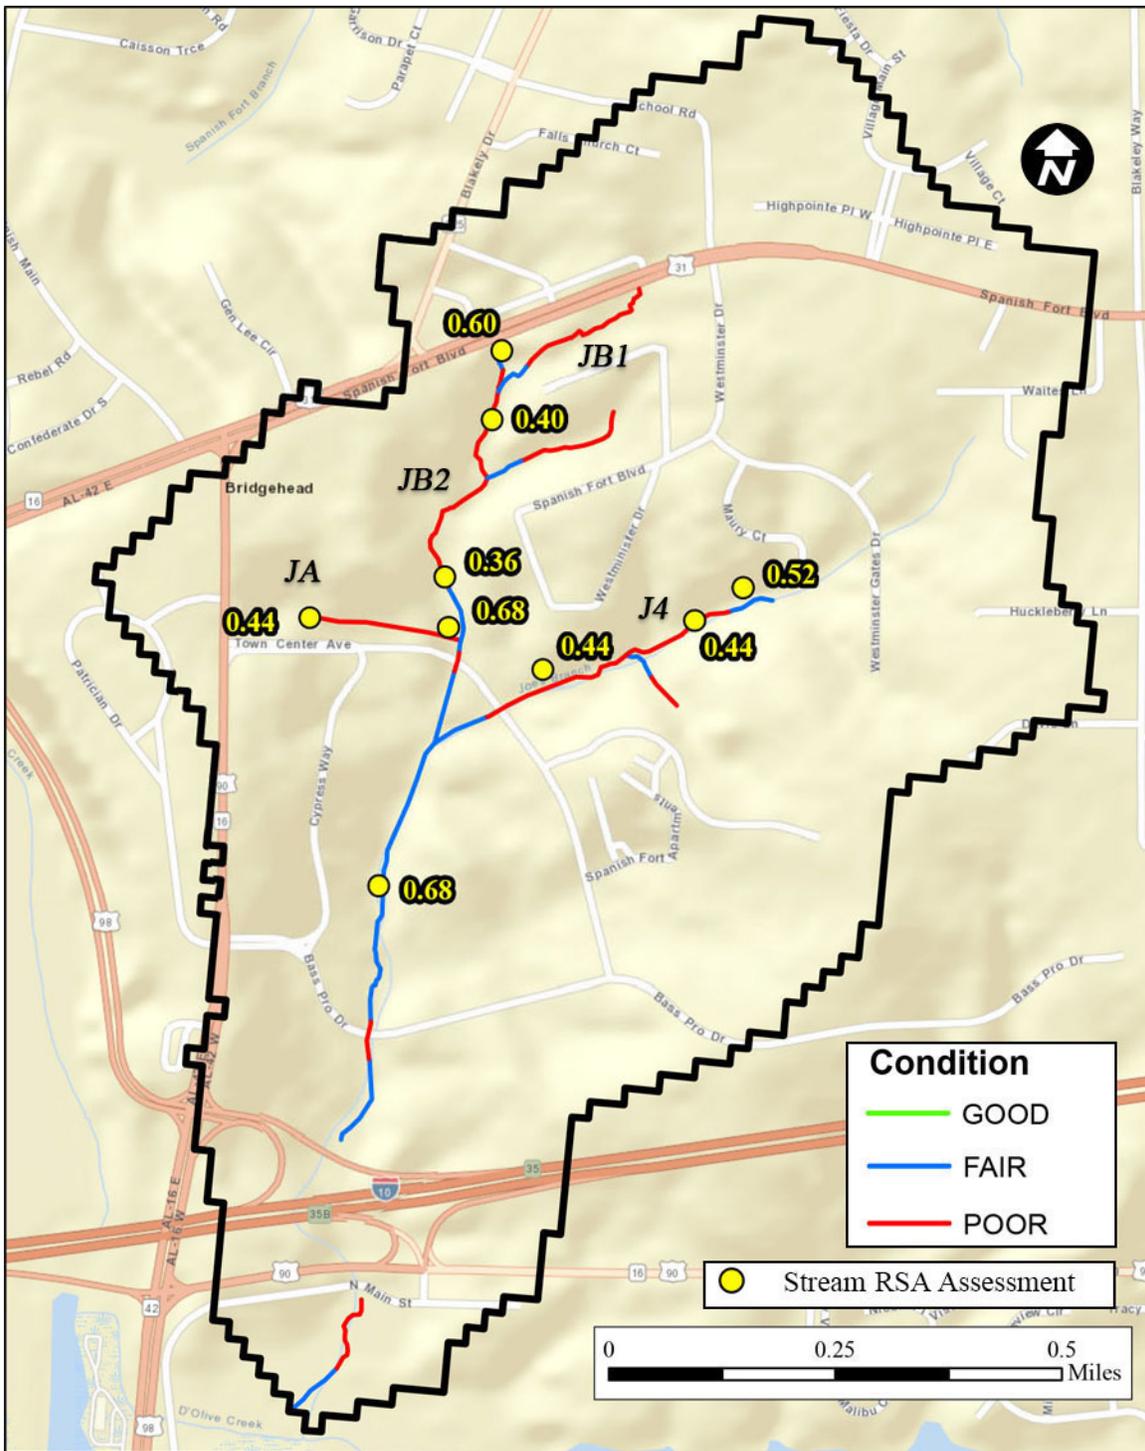
Figure 4-4. Stream quality and RSA scores at sites in the Joes Branch sub-watershed.

Table 4-4. Stream RSA scores at sites in the Joes Branch sub-watershed.		
Sampling Station	2019 RSA Score	Condition
JB1-Upstream	0.60	Fair
JB1-Restoration	0.40	Poor
JB2-Downstream	0.68	Fair
JB2-Restoration	0.36	Poor
JA-Downstream	0.44	Poor
JB-Bass Pro Shop	0.68	Fair
J4-Upstream	0.52	Fair
J4-Restoration	0.44	Poor
J4-Downstream	0.44	Poor

The restoration sites in the Joes Branch sub-watershed had Poor stream conditions, including at JB1 (RSA=0.40), JB2 (0.36), and J4 (0.44). All three sites had “poor” scores for canopy cover and riparian zone width. The JB2 site had “poor” scores for channel alteration and sinuosity, whereas JB1 and JB4 had “moderate” scores for these two metrics. All three sites had “moderate” scores for sediment deposition and habitat smothering. The JA Downstream site is essentially a drainage ditch with good riparian buffer width and canopy cover, but received “poor” scores for channel sinuosity, habitat availability and smothering, and sediment deposition. Two upstream sites in Joes Branch, at JB1 and J4, are in Fair condition, with RSA scores of 0.60 and 0.52, respectively.

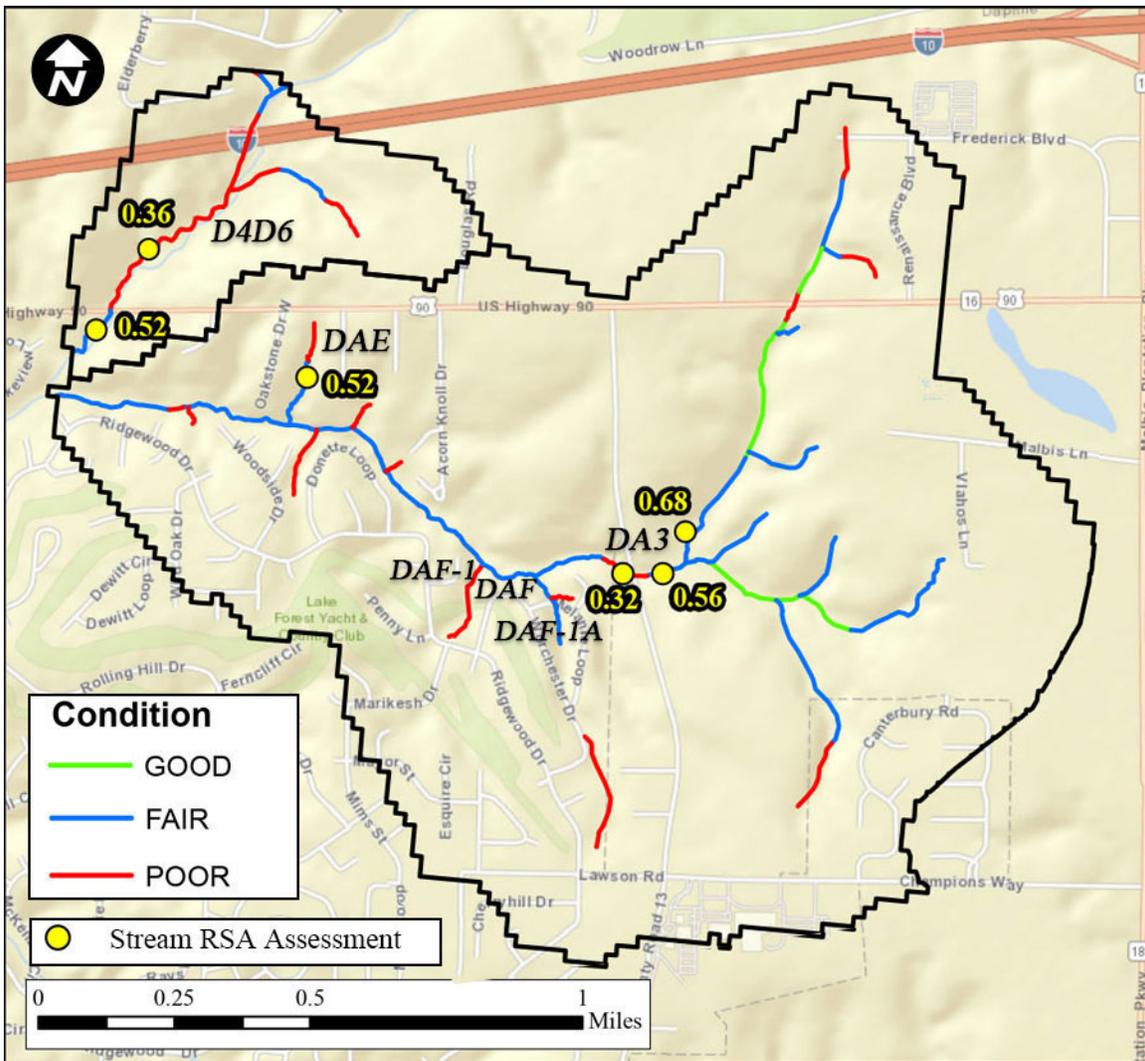
Figure 4-5. Stream quality and RSA scores at sites in the D'Olive Creek sub-watersheds.

In the D'Olive Creek DA Tributary sub-watershed, highest quality streams are associated with Malbis Plantation property upstream from restoration site DA3. The DA3 Upstream location scored “good” for riparian zone width, vegetative quality, canopy cover, channel alteration, and habitat smothering (Table B).

The D4D6 restoration site has poor stream quality, with “poor” conditions for bank vegetative protection, canopy cover, and riparian zone width, reflecting the recent construction of the site. D4D6 is rated “good” for stream bank stability, and receives “moderate” scores for channel sinuosity, channel alteration, bank vegetative protection, habitat availability, and habitat smothering.

Restoration Sites DAF, DAF-1, AND DAF-1A were not field-inspected. Stream condition is predicted to be Fair at DAF and DAF-1A (Melanie Loop). DAF-1 is assigned a condition of Poor.

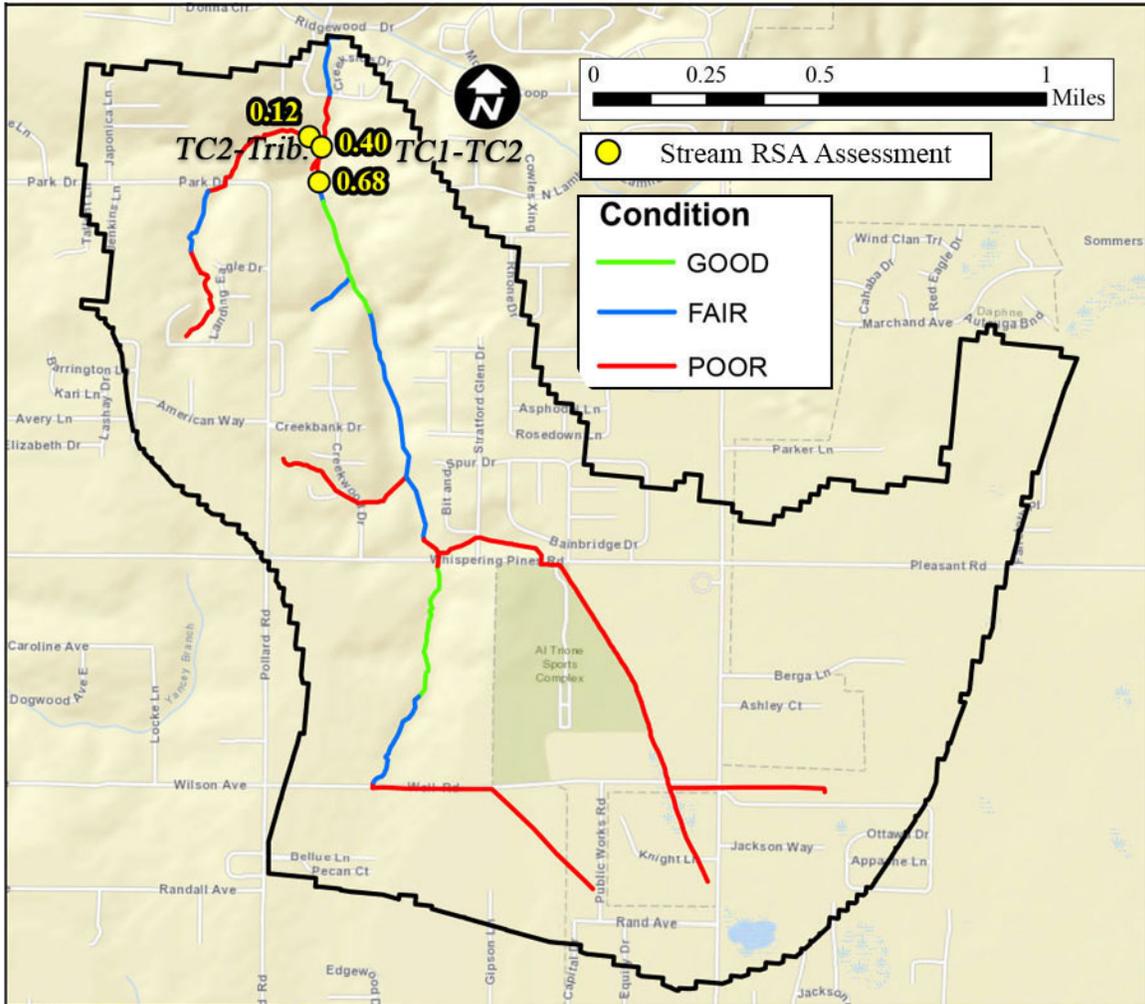
Figure 4-6. Stream quality and RSA scores at sites in the Tiawasse Creek sub-watersheds.

The TC1-TC2 restoration site is classified as Poor (0.40), primarily due to “poor” scores for riparian zone width, canopy cover, and channel alteration. The site receives a “good” score for bank stability, and “moderate” scores for sediment deposition, habitat smothering, habitat availability, channel sinuosity, and bank vegetative protection. The reach upstream of TC1-TC2 is classified as Fair quality (0.68), scoring high for riparian zone width, canopy cover, and macroinvertebrate taxa.

The TC2-Tributary restoration site scored lowest of all stream assessment locations in 2019, largely due to poor bank stability, bank vegetative protection, habitat availability, sediment deposition, and habitat smothering.

Sampling Station	2019 RSA Score	Condition
TC1-TC2 -Upstream	0.68	Fair
TC1-TC2 -Restoration	0.40	Poor
TC2-Tributary Restoration	0.12	Poor

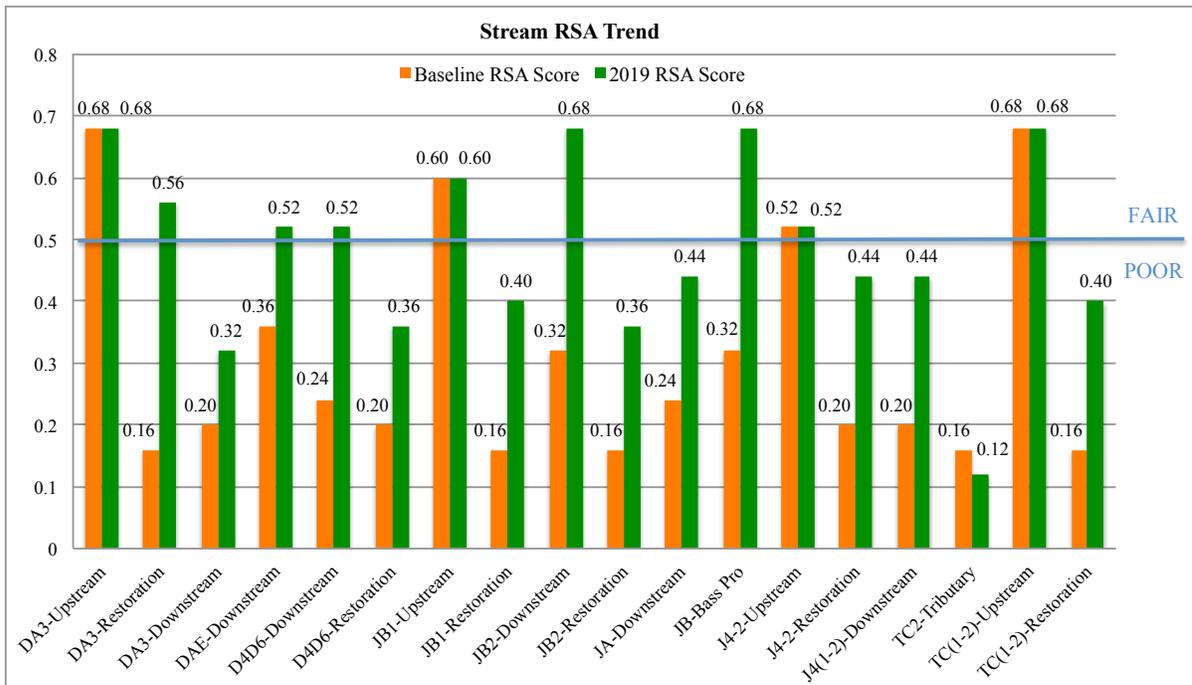
Figure 4-7. Comparison of baseline and 2019 RSA scores.

Figure 4-7 presents the baseline RSA and 2019 RSA scores for the assessed stream reaches. Appendix B includes the complete per-category breakdown for the RSA scores. Compared to the 2019 RSA, baseline conditions for the restoration sites were generally given higher scores for riparian buffer zone width and canopy cover, but low for local watershed erosion, sediment deposition, habitat availability, habitat smothering, bank stability and bank vegetative protection. Baseline scores for the restoration sites averaged 12 points (ranging from 8 to 20 points) below the 2019 site scores.

One restoration site (DA3), two downstream reaches in Joes Branch (JB2, Bass Pro) and two downstream reaches in the D'Olive subwatersheds (DAE, D4D6), are improved from baseline Poor to restored Fair classification. Site DA3 had the greatest overall increase in condition. The increase in stream reach quality at these sites suggests that restoration activities have resulted in measurable decreases in sediment loads being transported downstream, with corresponding improvements in habitat condition.
