**1<sup>st</sup> ANNUAL POST-CONSTRUCTION MONITORING REPORT**

**POST-CONSTRUCTION BATHYMETRY, SHORELINE, AND  
STRUCTURAL MONITORING**

**MON LOUIS ISLAND RESTORATION PROJECT  
USACE FINAL PERMIT# SAM-2014-01046-LET**

**AUGUST 24, 2018**

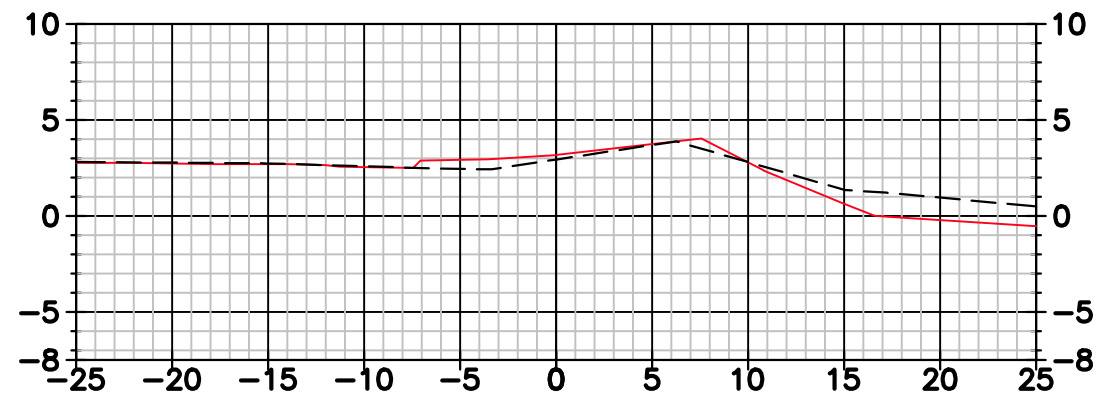
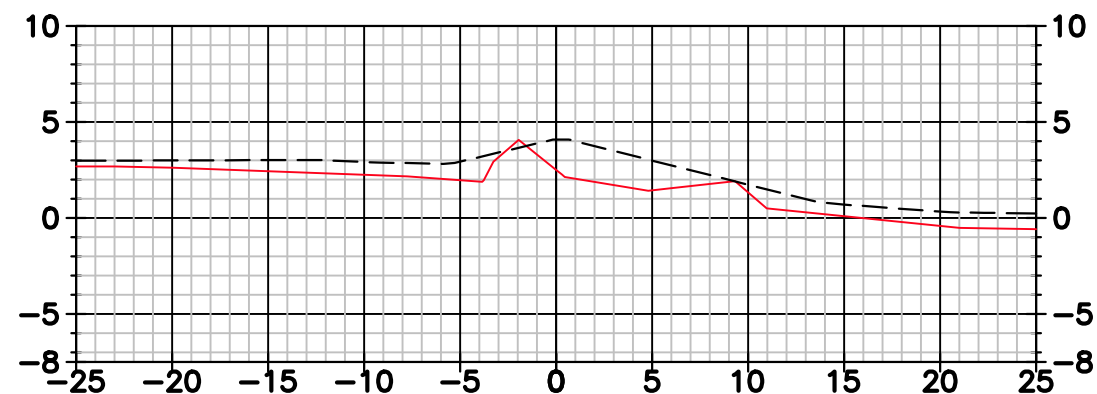
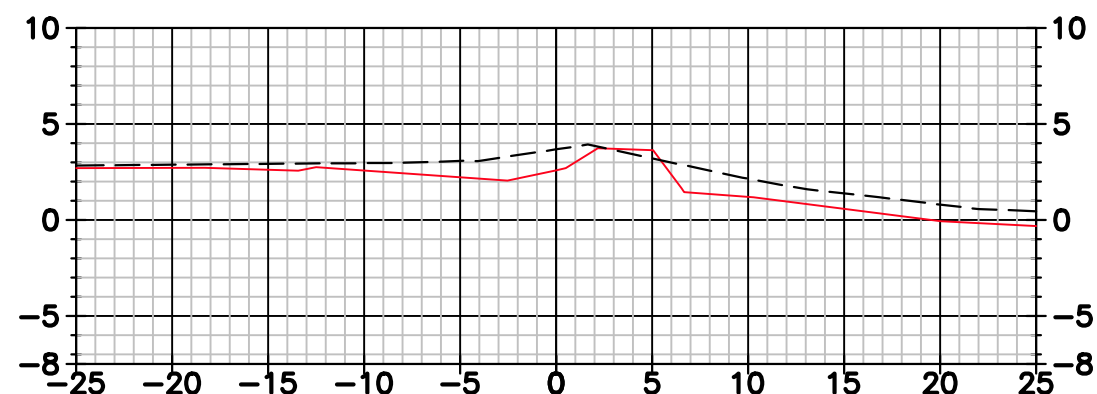
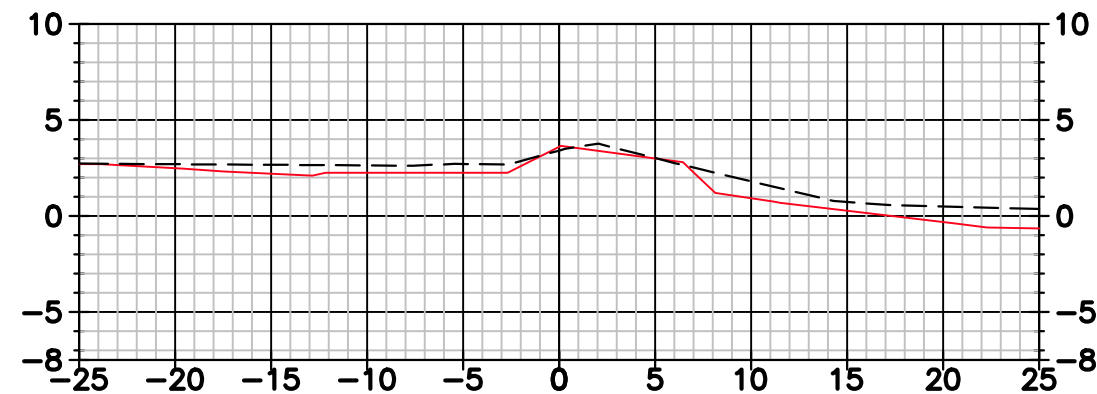
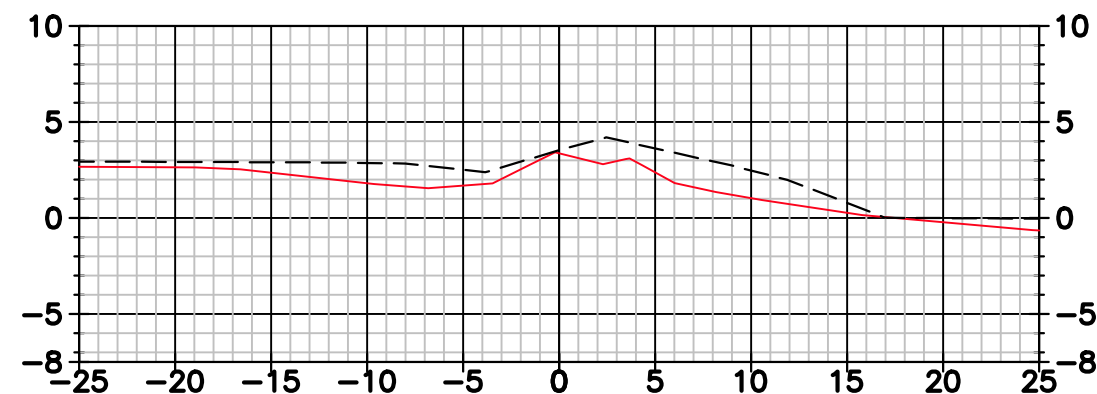
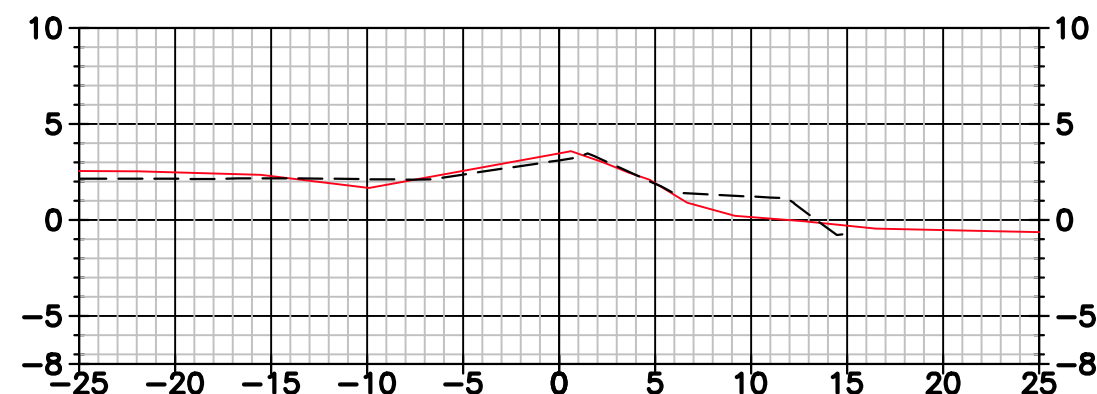
A review of the comparative transects indicate that some of the June 2018 transects are slightly lower than some of the December 2016 transects. This may indicate some slight settlement at these areas. Potential sources of vertical error to consider include, relative positioning of comparative cross section survey lines, GPS error, and the large rock size. Because some of the rip rap pieces are three to four feet in diameter, the specific spot that a cross section elevation shot is taken may result in different transect line shapes. Field observations do not indicate any

displacement or fracturing of rip rap, nor do they indicate any changes on overall cross section. Figures 2 and 3 provide a representative view of the rubble mound breakwater. These photographs were taken on August 9, 2018.
