2nd ANNUAL POST-CONSTRUCTION MONITORING REPORT

POST-CONSTRUCTION BATHYMETRY, SHORELINE, AND STRUCTURAL MONITORING

**MON LOUIS ISLAND RESTORATION PROJECT
USACE FINAL PERMIT# SAM-2014-01046-LET**

October 25, 2019

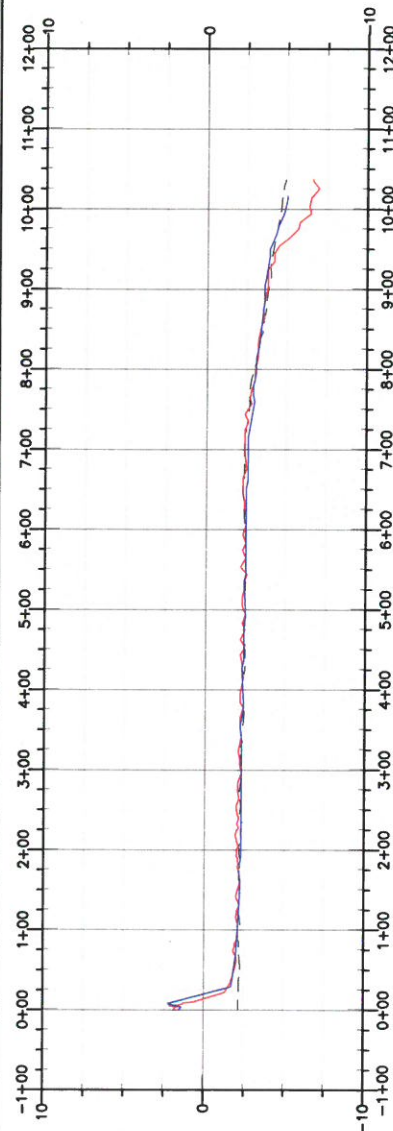
LN1 PROFILE
 HORIZ. SCALE: 1"=150'
 VERT. SCALE: 1"=7.5'

A review of the transects (June 2016, June 2018, and October 2019) adjacent to and south of the marsh restoration construction indicates no discernable bottom changes were observed (Appendix A).
