Report of Findings

Prichard Drainage Study Toulmin Springs Branch and Gum Tree Branch

For
**Mobile Bay National Estuary Program
Mobile County Commission
Project No. MCP-101-15**

May 2016

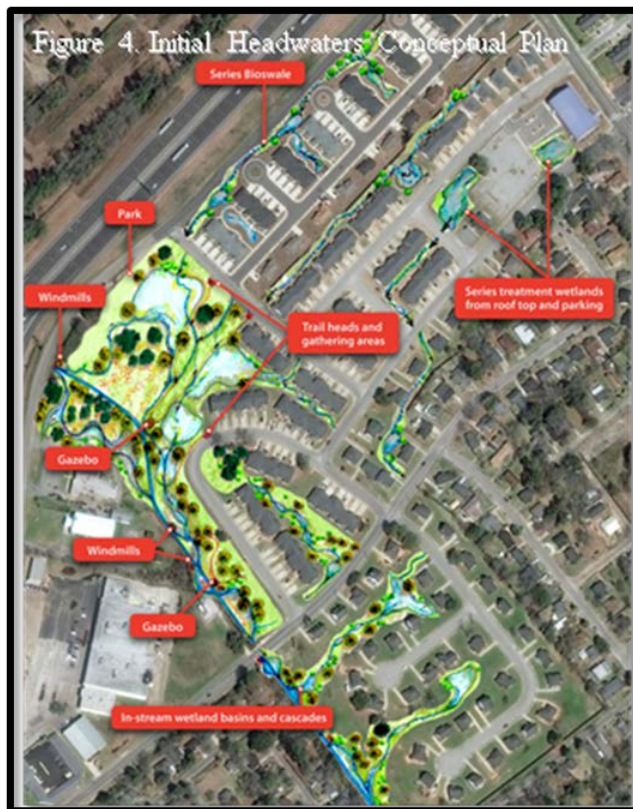
Figure 1.5.1 – Toulmin Springs Branch headwaters conceptual wetland creation plan (taken from Three Mile Creek Watershed Management Plan)

The Three Mile Creek Watershed Management Plan identifies impairments to headwaters located at Toulmin Springs Branch as sanitary sewer leaks, illicit discharges, and trash as primary sources of nutrients and pathogens. By addressing these issues with appropriate LID improvements within the project area, the overall quality of life and safety of public spaces in adjacent residential neighborhoods is expected to improve as well. An initial conceptual plan for the Toulmin Springs Branch headwaters has been drafted (Figure 1.5.1), and extending these concepts throughout the project area is an effective way to establish the City's multiple goals. By linking the initial conceptual wetland creation plan at the stream's headwaters with NSI's recommendations, Toulmin Springs Branch could greatly improve its water quality, flow rate, and downstream drainage.

LID should be considered for use in the development of Best Management Practices (BMPs) for the maintenance of the two branches. Heavy maintenance is required throughout both branches to include removal of invasive vegetation species as well as overgrown and problematic vegetation which serves as debris collection points, slowing stormwater drainage. Routine maintenance along both branches should include trash and debris collection, the installation of Gross Pollutant Removal Structures (GPRS) on outfall pipes and inlets, and the removal of sediment to restore natural water depth and volume. Sandy sediments and revegetation of freshwater wetland plants and submerged aquatic vegetation (SAV) may improve water quality in these two systems by filtration and removal of heavy metals and nutrient loads. In areas where traditional concrete structures would be placed, or in areas where damaged concrete should be replaced, a series of open channel stormwater conveyances through rock and sand bottomed step pools could be placed to convert some surface water flow to shallow groundwater flow. This will allow for water quantity and quality treatment as well as providing habitat for wetland species. Another important component to solving drainage problems in this area is public outreach and education. Partnerships are strongly encouraged within community churches, schools, and other groups to achieve intense education and outreach programs that encourage area residents and adjoining property owners within these two watersheds to assist in keeping them clean from litter and debris. Installation of educational signs throughout the watersheds could encourage the surrounding community to take pride in keeping their streams clean.

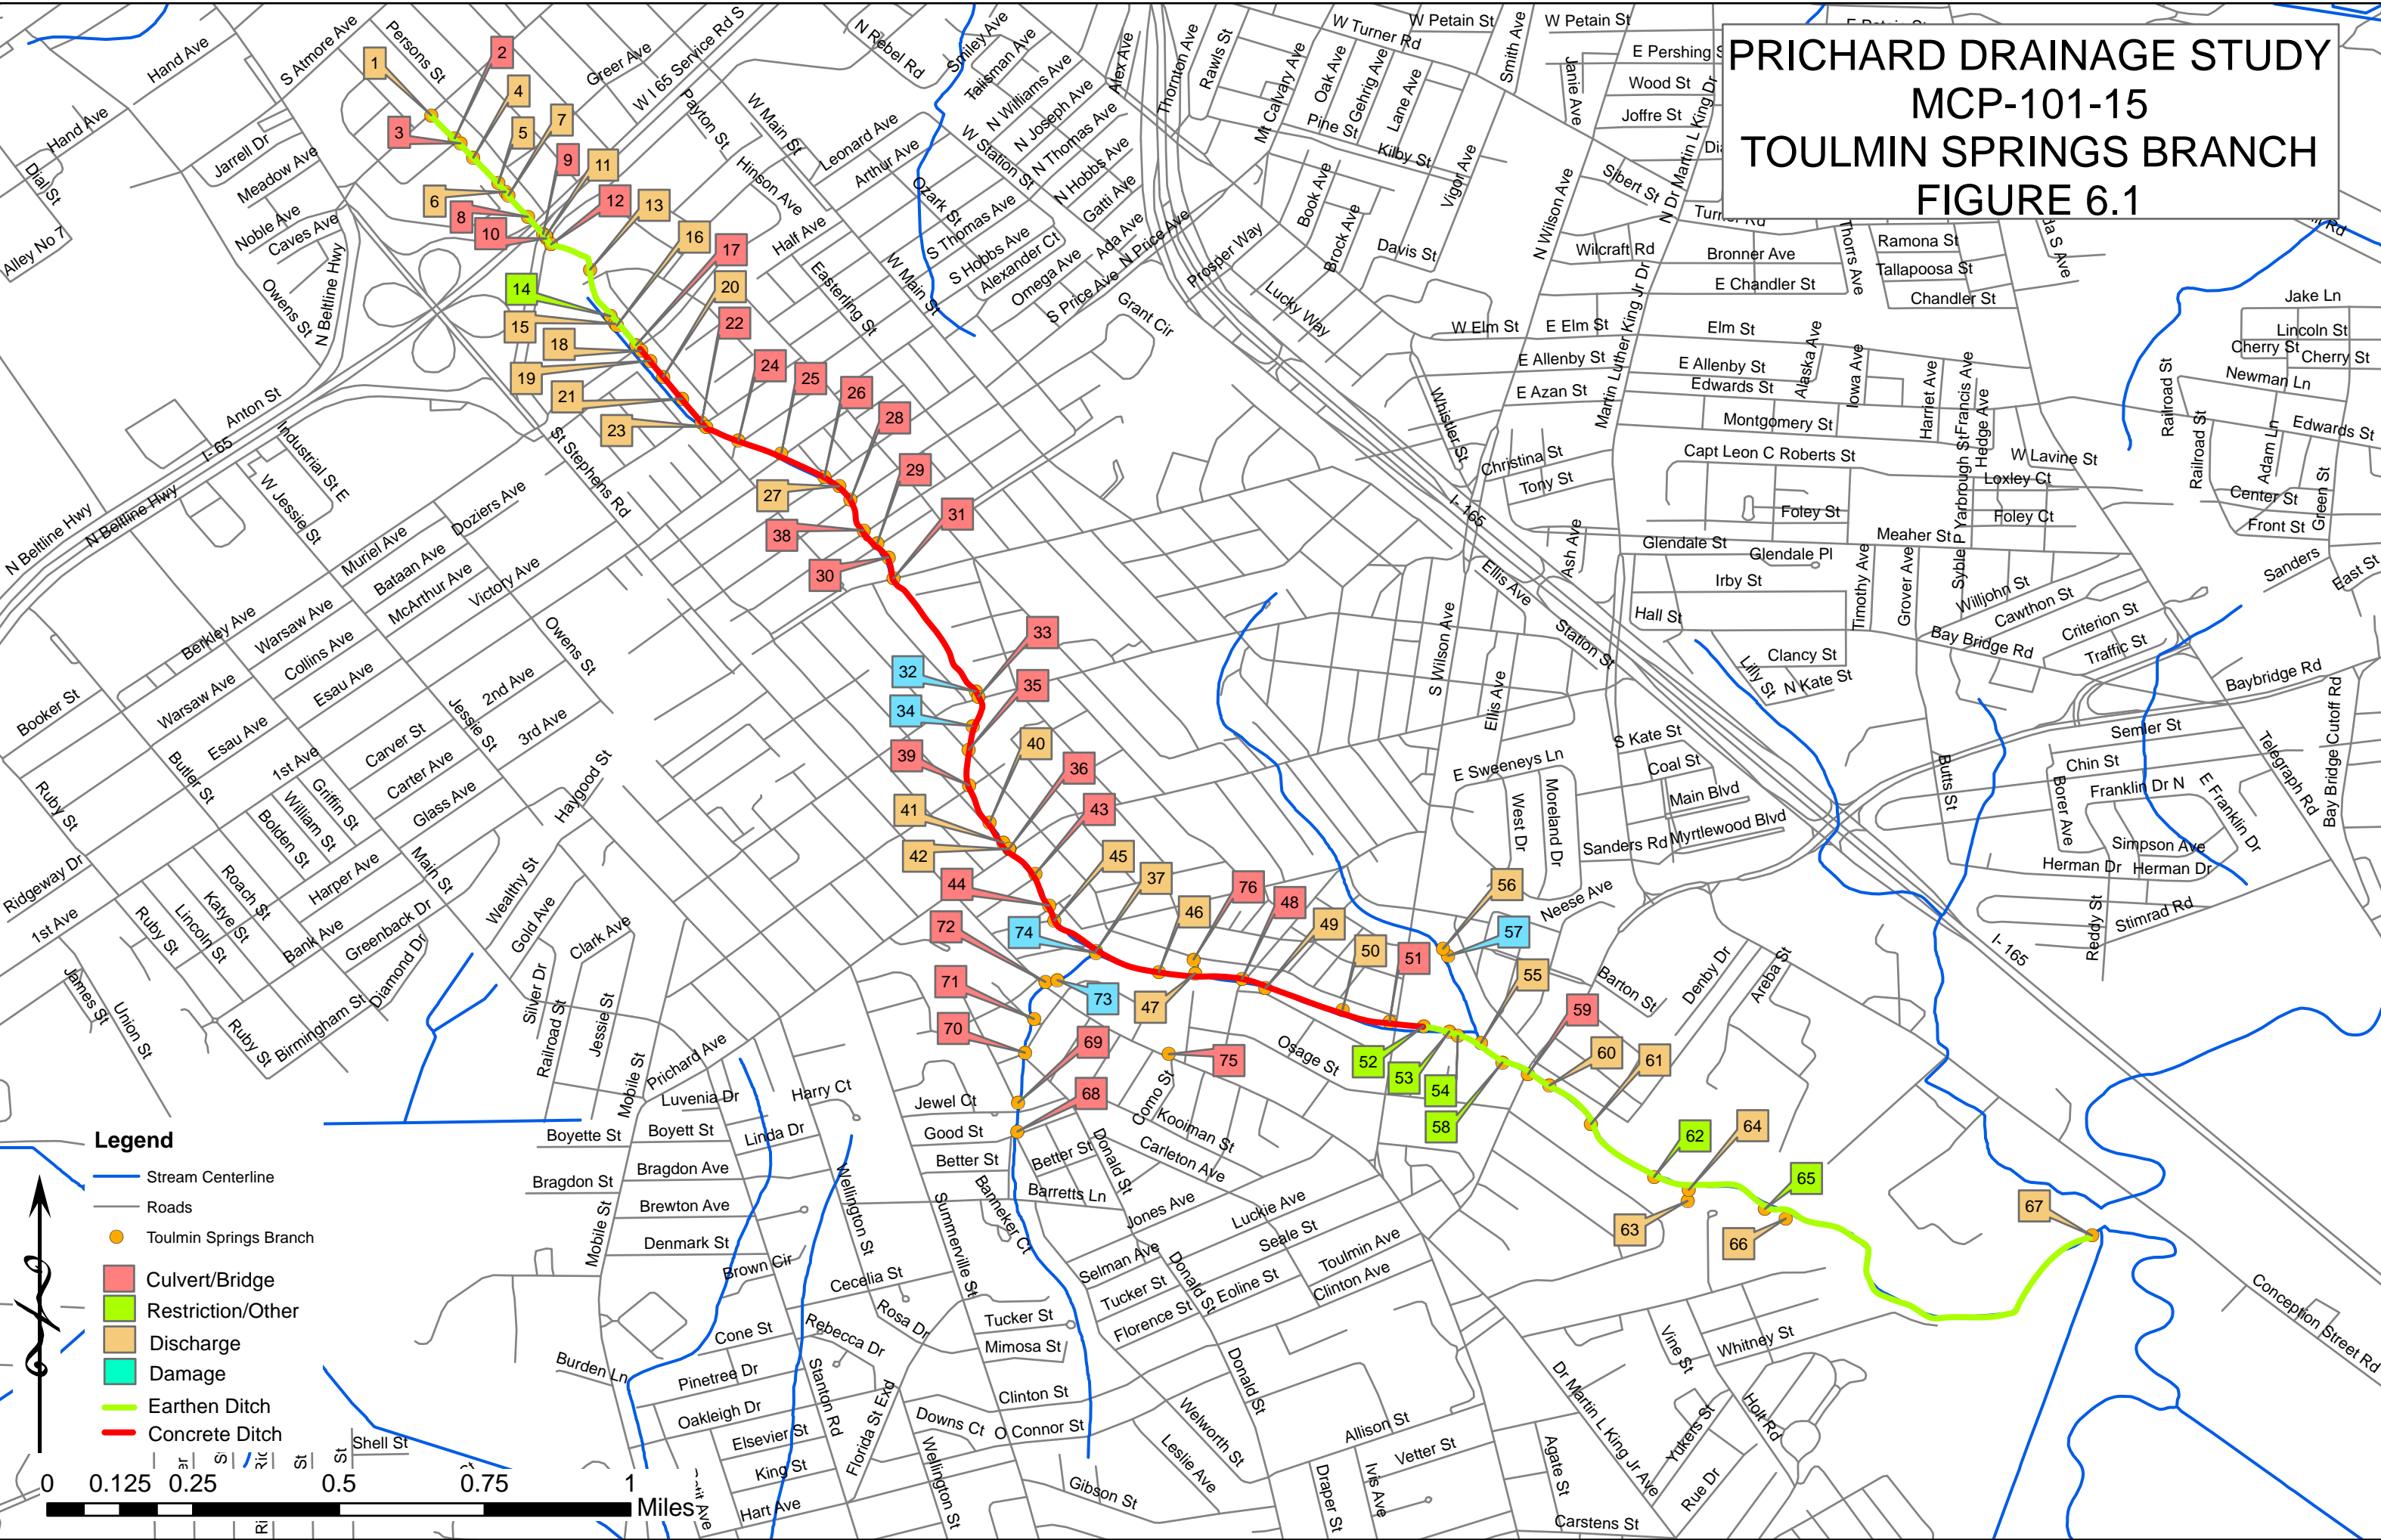
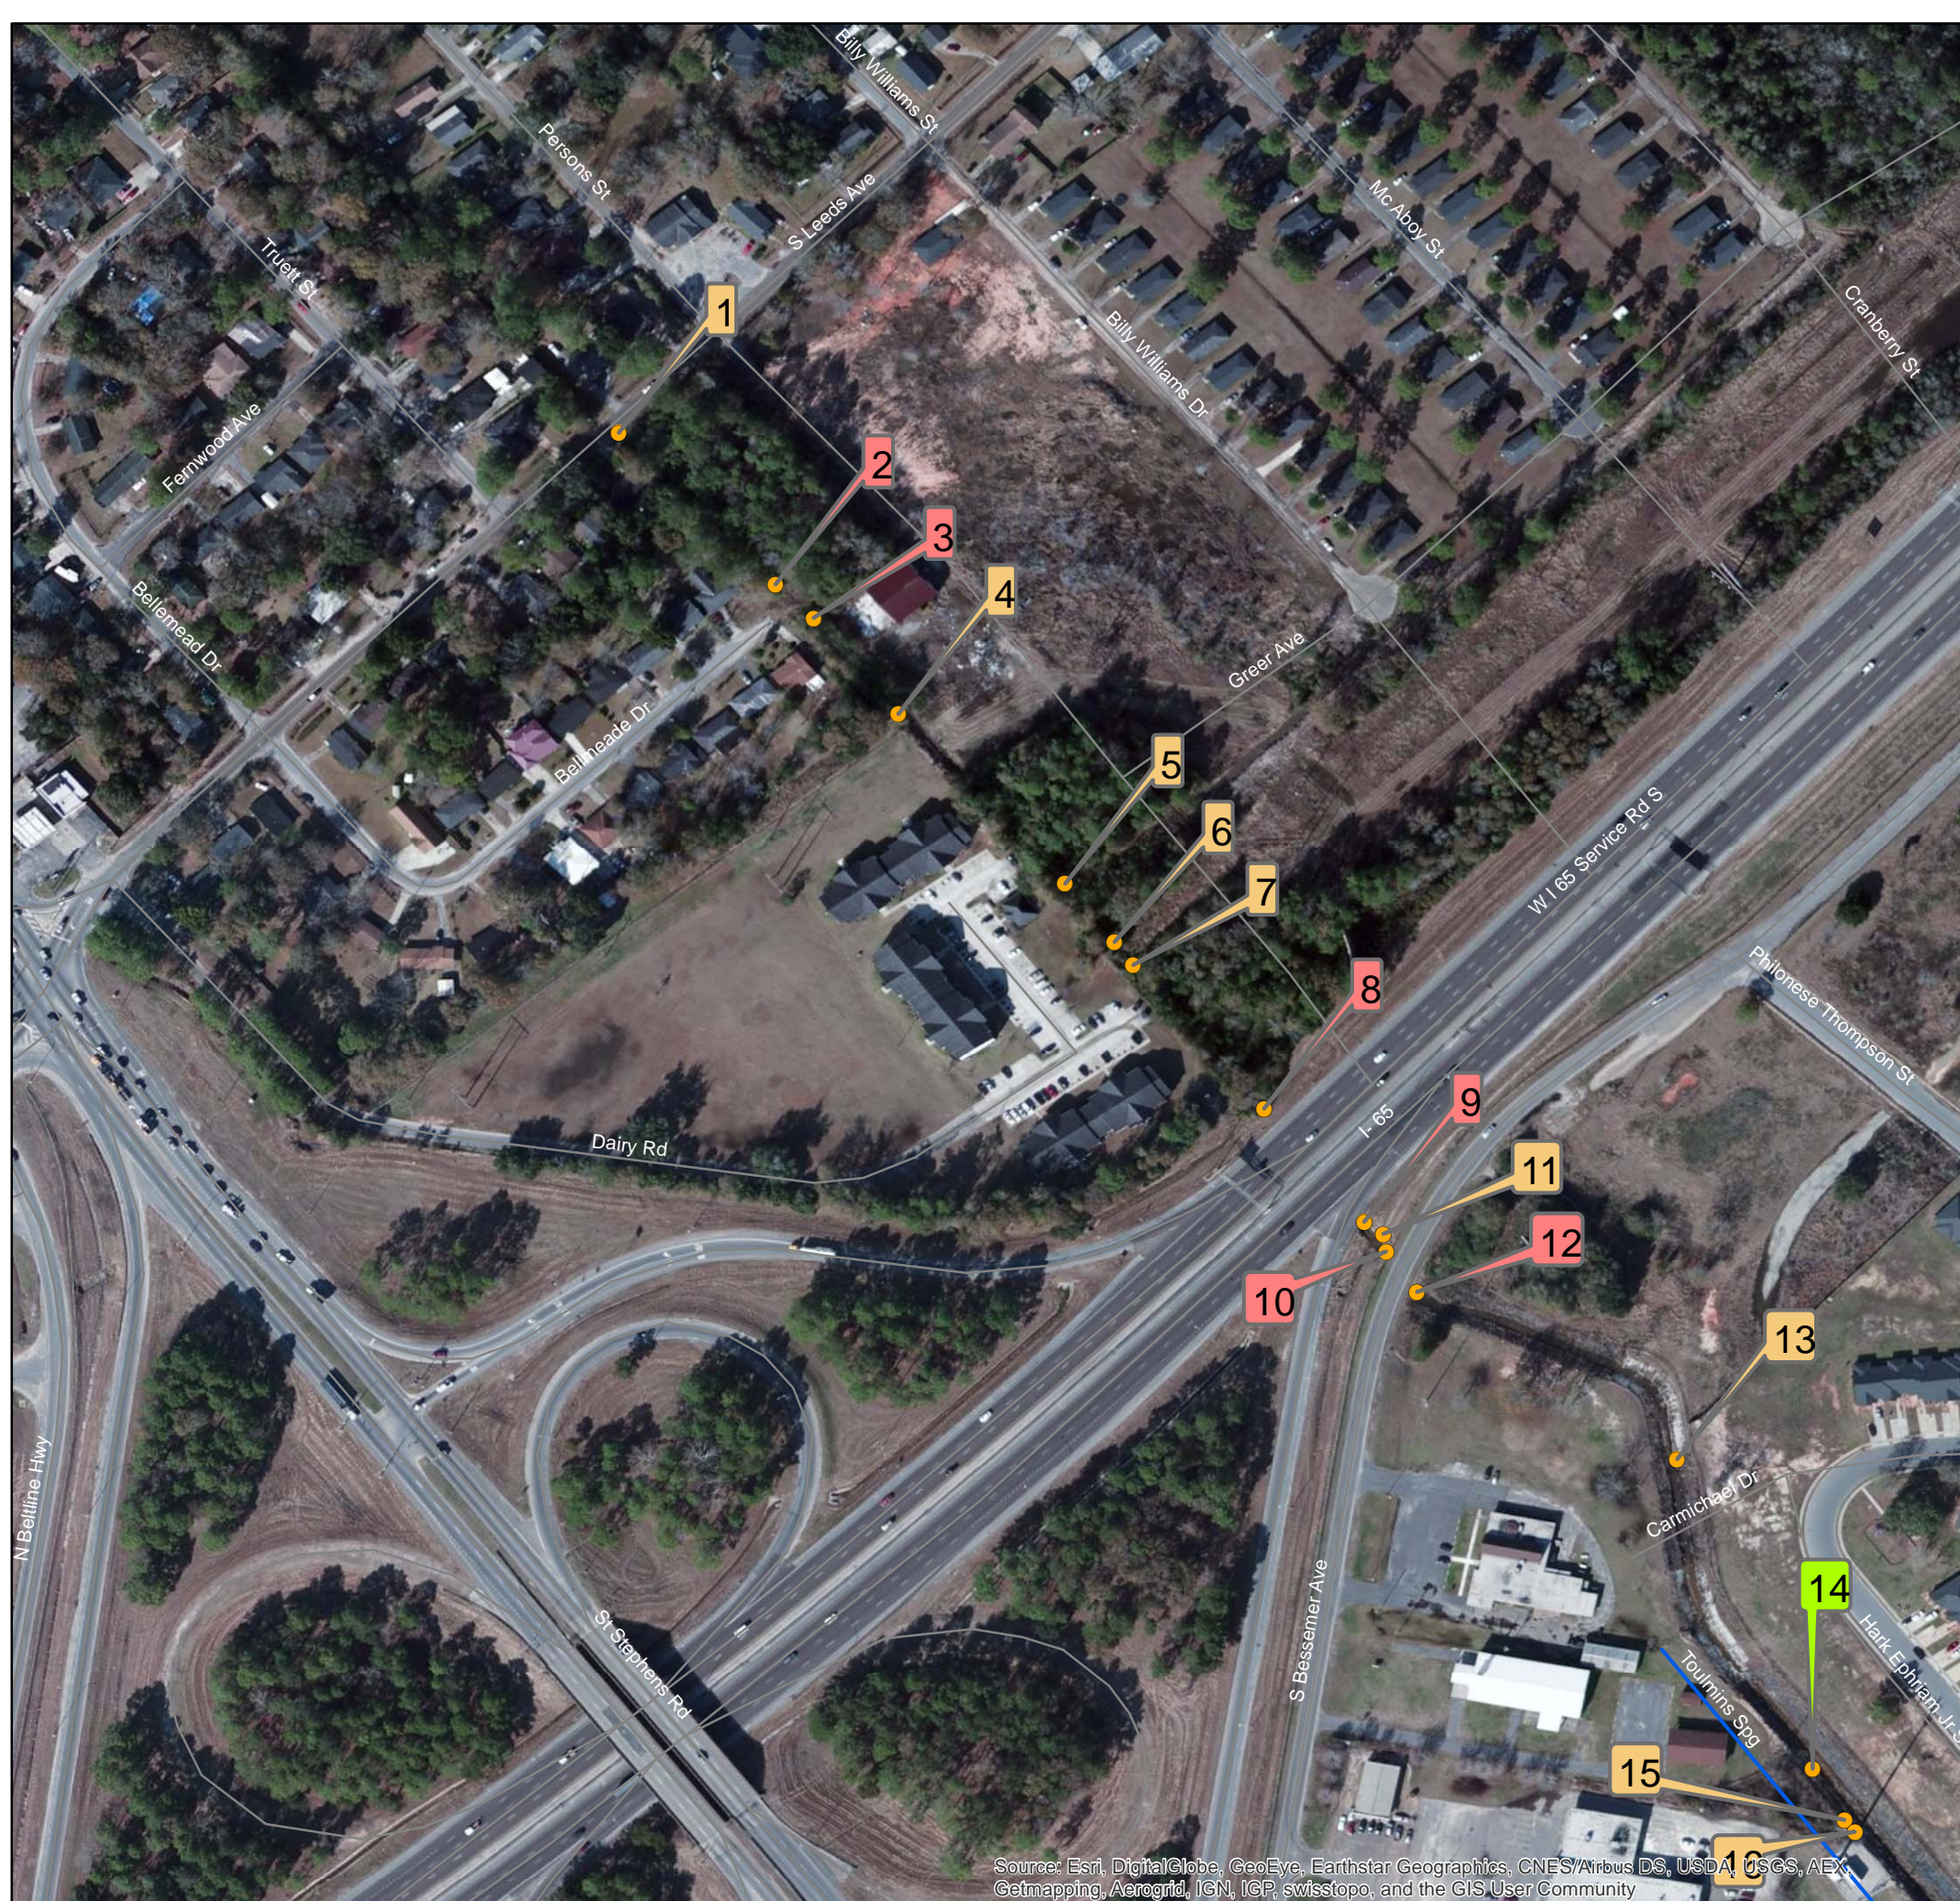
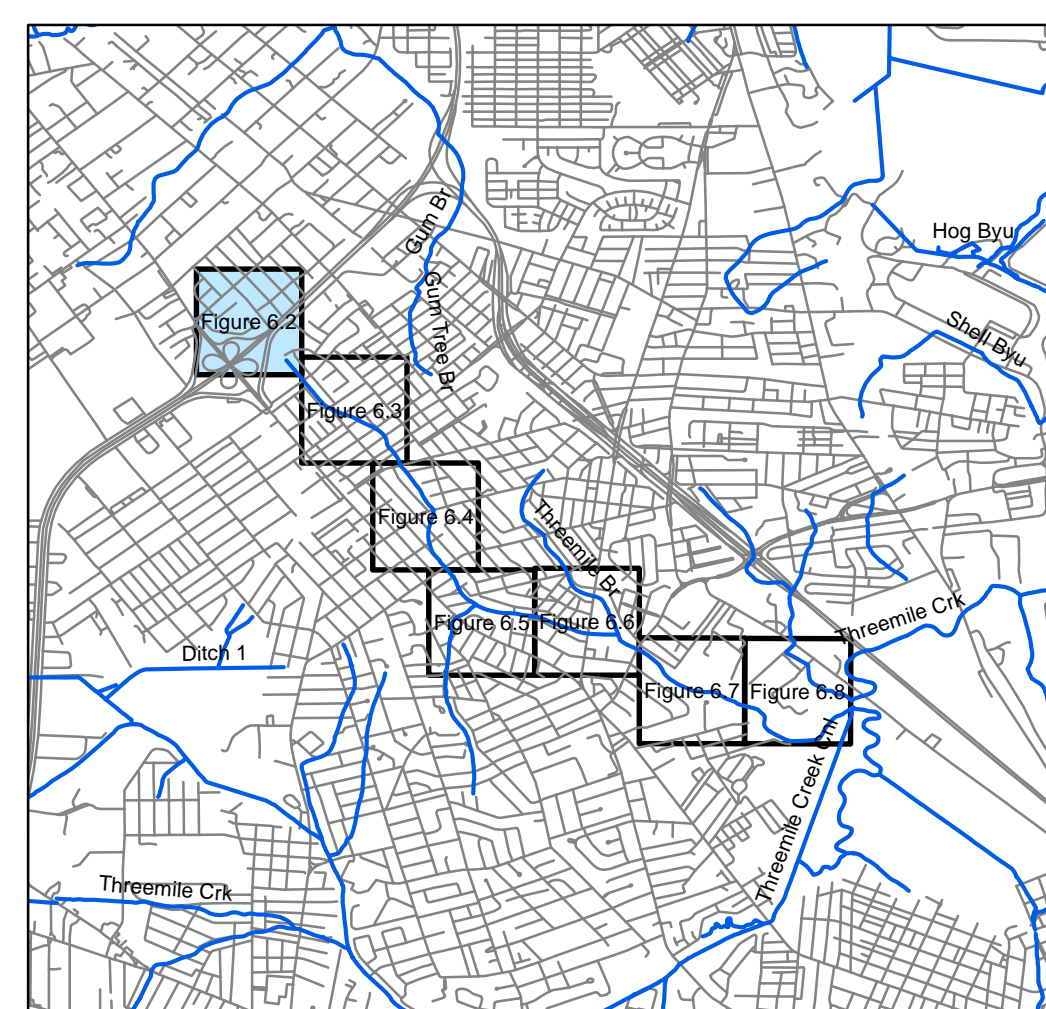
PRICHARD DRAINAGE STUDY
MCP-101-15
TOULMIN SPRINGS BRANCH
FIGURE 6.1

Toulmin Springs Branch has several concentrated areas of concern. The section between South Leeds Avenue and I-65 is heavily vegetated. Field investigators observed ponded water upstream due to sediment and debris traps downstream, and possible grading issues. Based on aerial photography, the section between I-65 and Hinson Avenue appears to have been a sloped concrete channel (or similar material) in the past, but heavy vegetation growth has narrowed its footprint preventing proper drainage through this section.

Figures 6.1 through 6.8 provide maps of problem locations outlined in this report, and Tables A.1 through A.4 (Appendix A) prioritize action items at each location.

To simplify analysis and understanding of the Toulmin Springs Branch *project* area, it has been divided into three sections (Figures 6.1-6.8). The northern section is an earthen channel from South Leeds Avenue to Hinson Avenue. This section is classified by heavy vegetation that constricts flow with the potential to cause upstream flooding northwest of I-65. The channel is partially defined through this section, but could alter without regular maintenance. This section would highly benefit from short-term improvements that include removal of all overgrown vegetation and sediment accumulation. All invasive vegetation species, such as Chinese Tallow (*Triadica sebifera*), should be removed along this section as well.

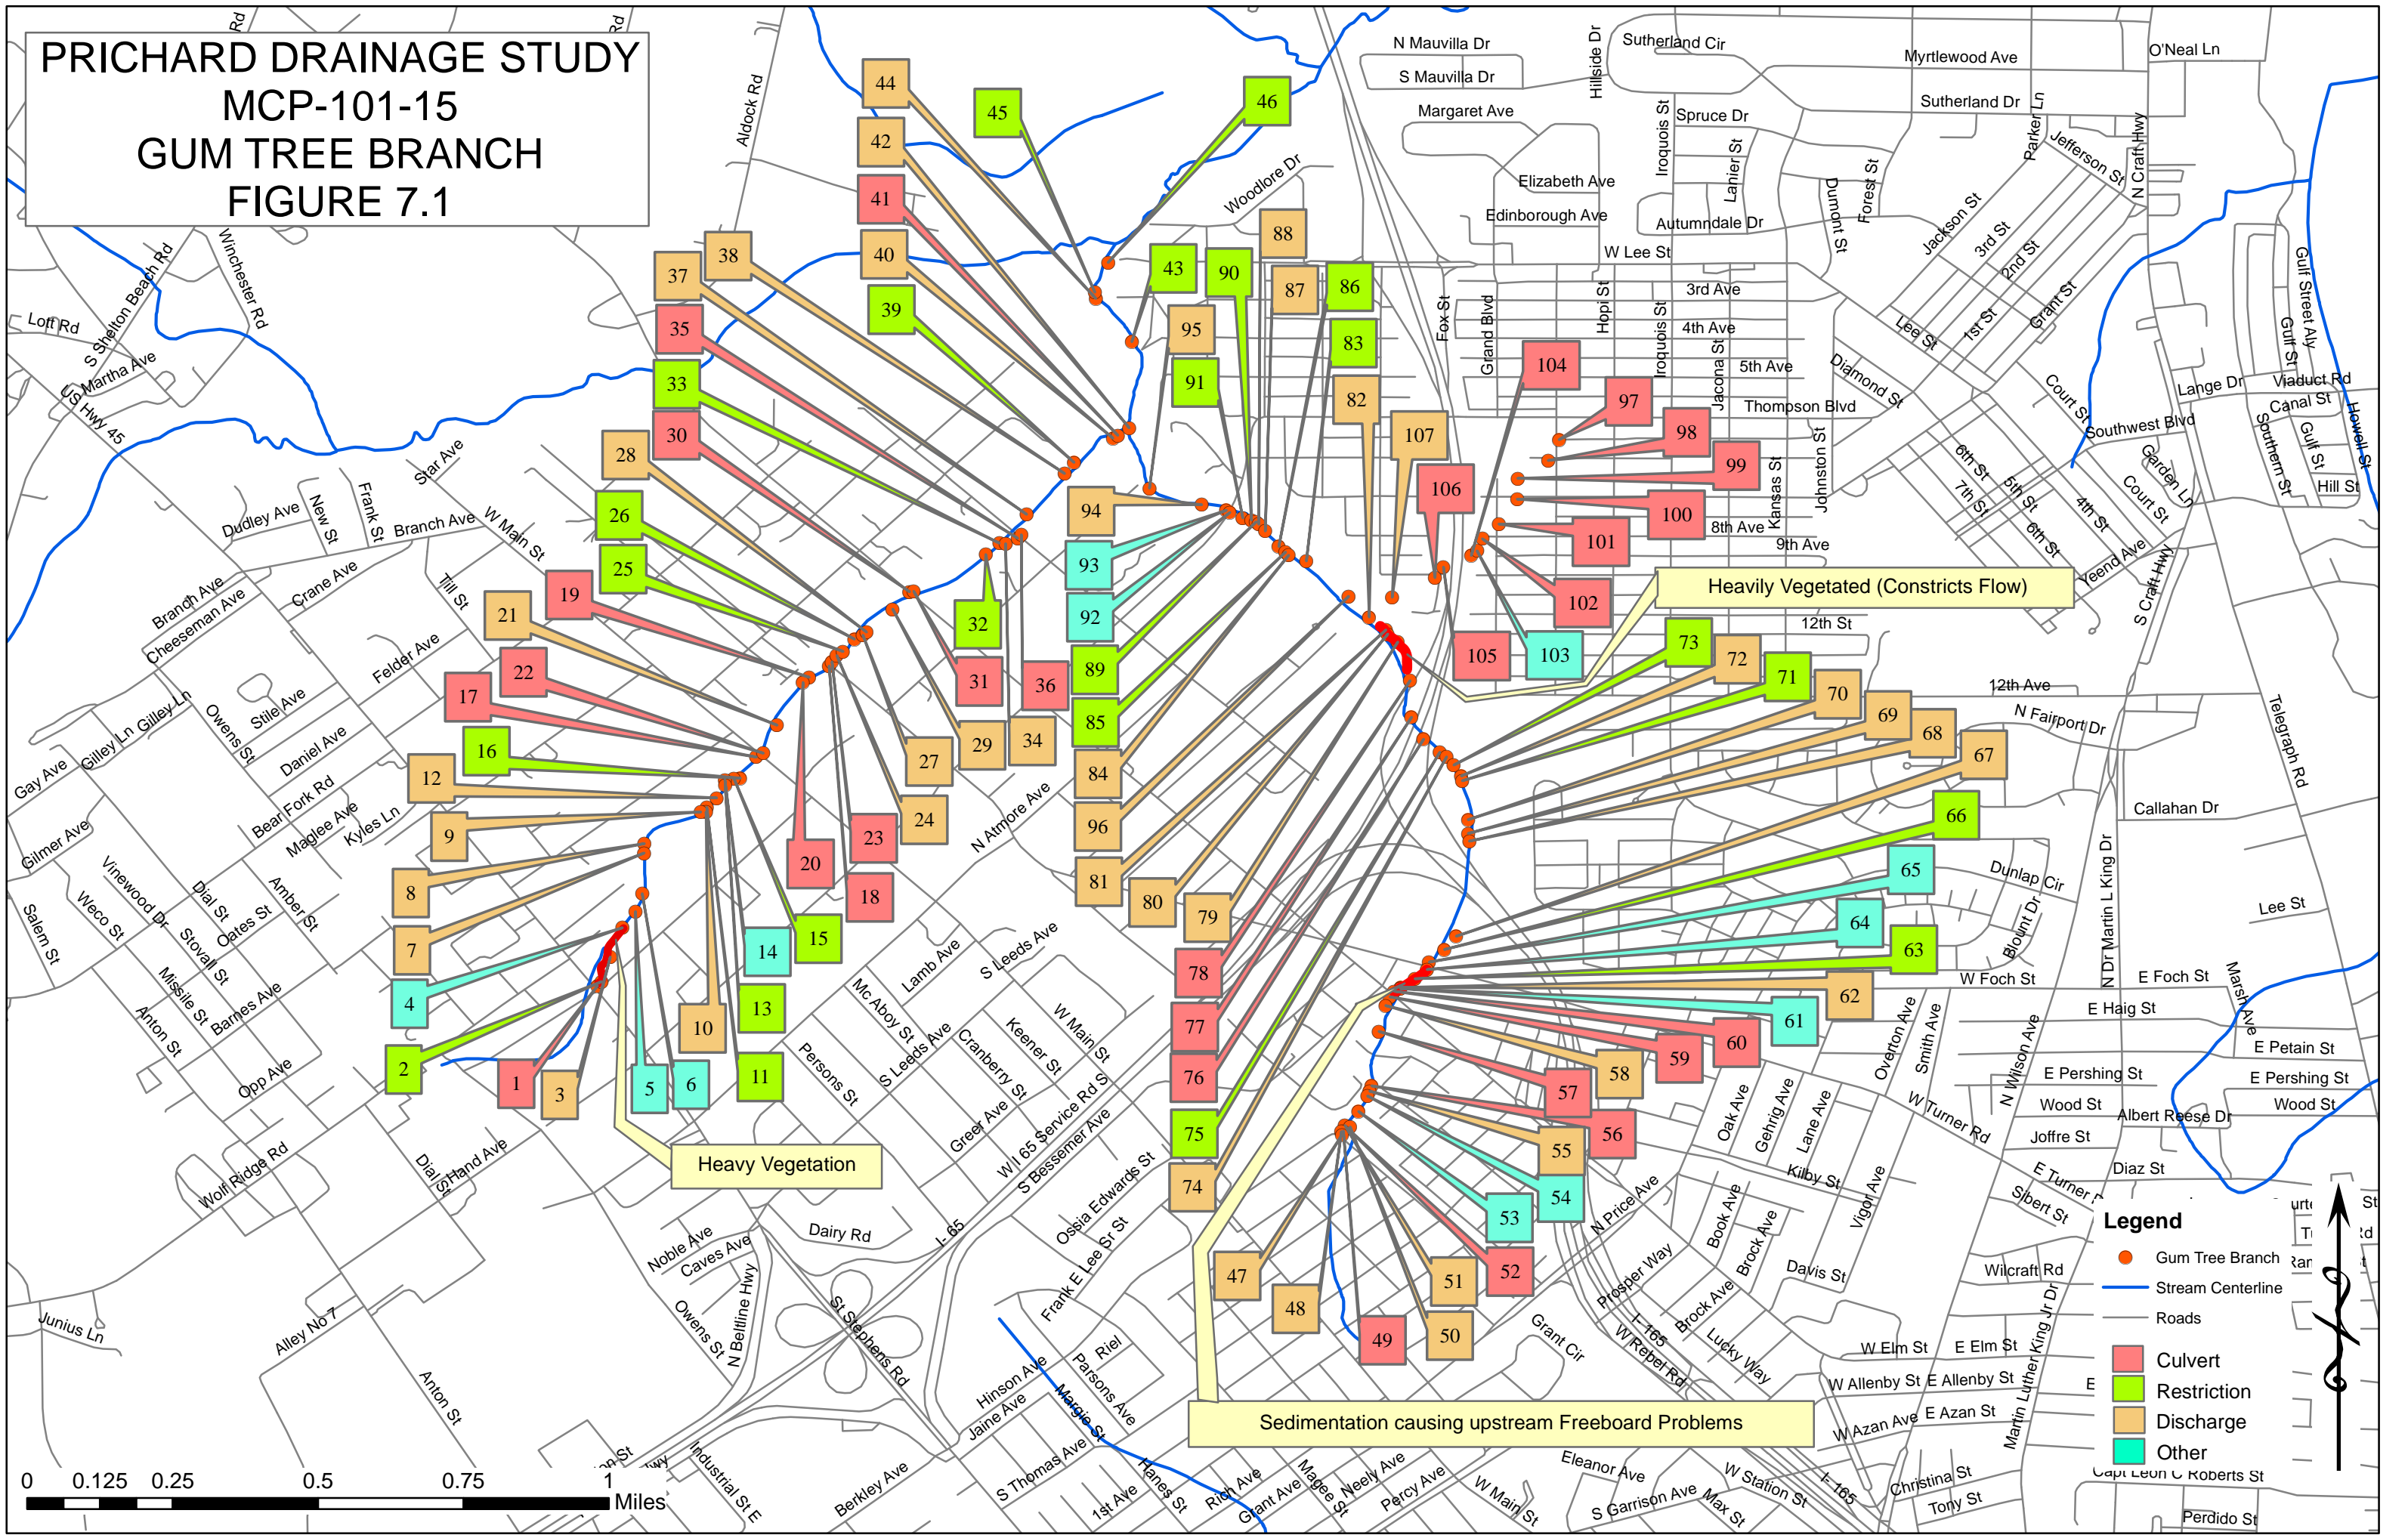
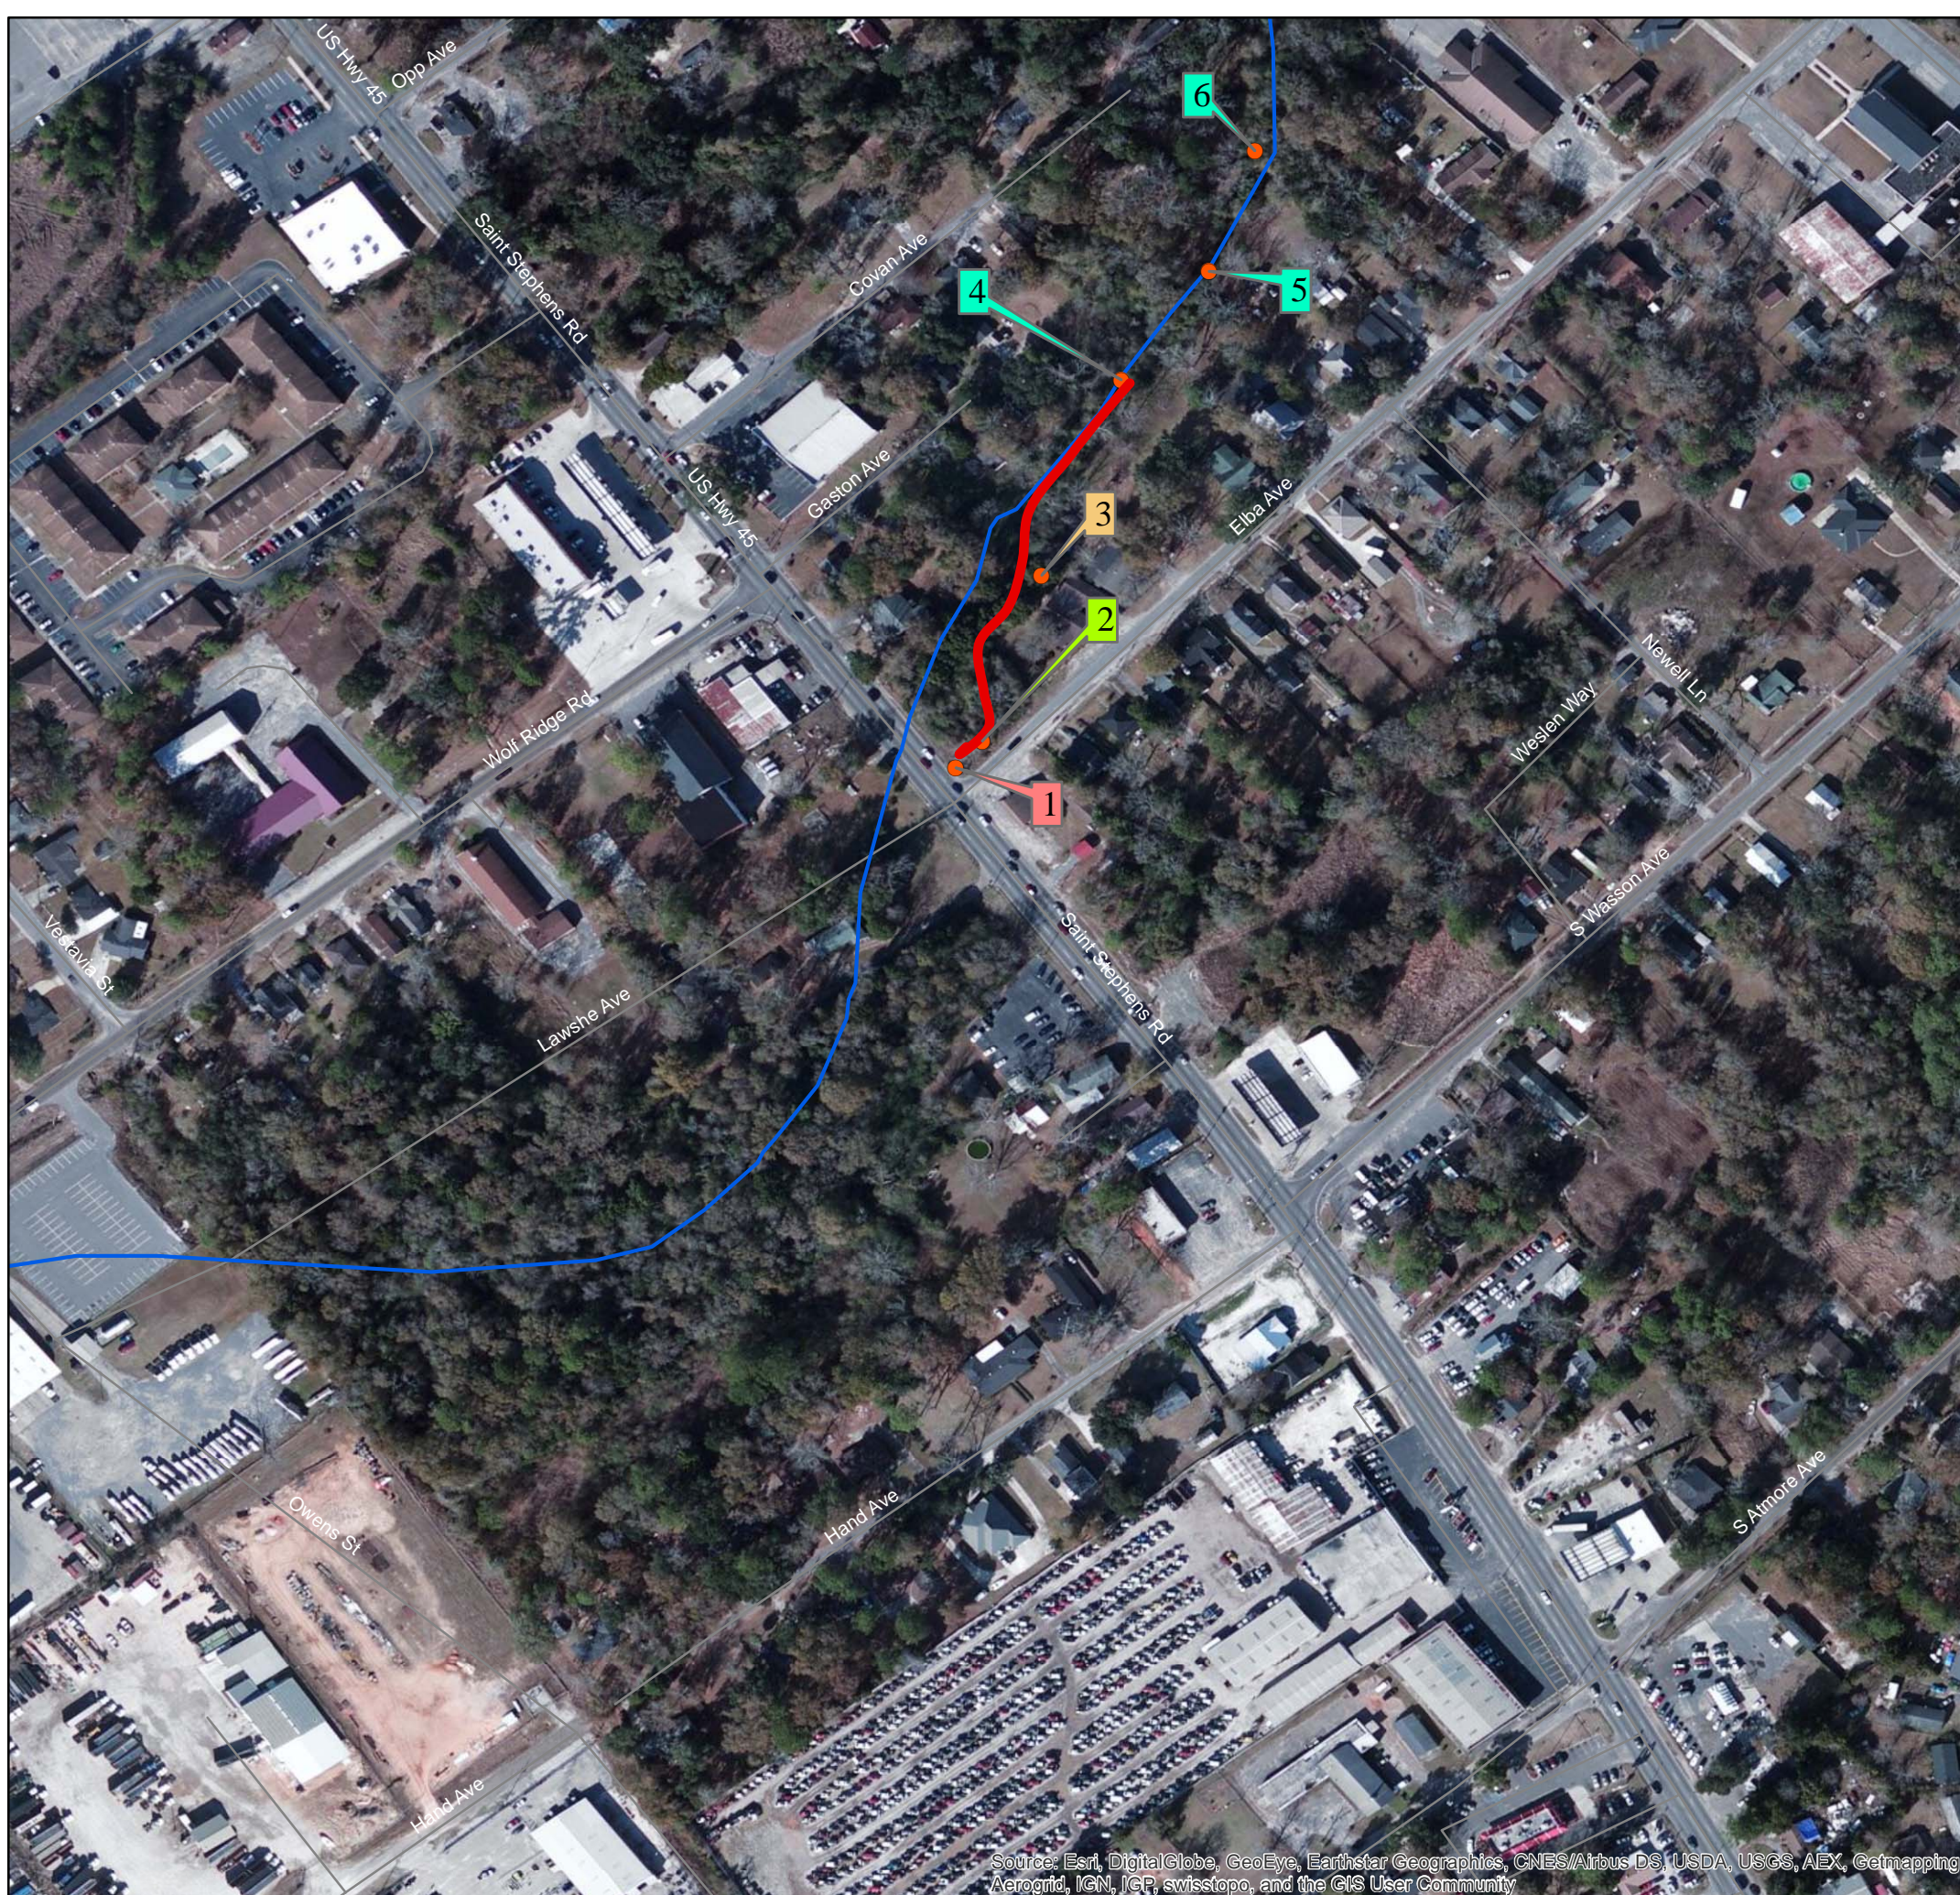
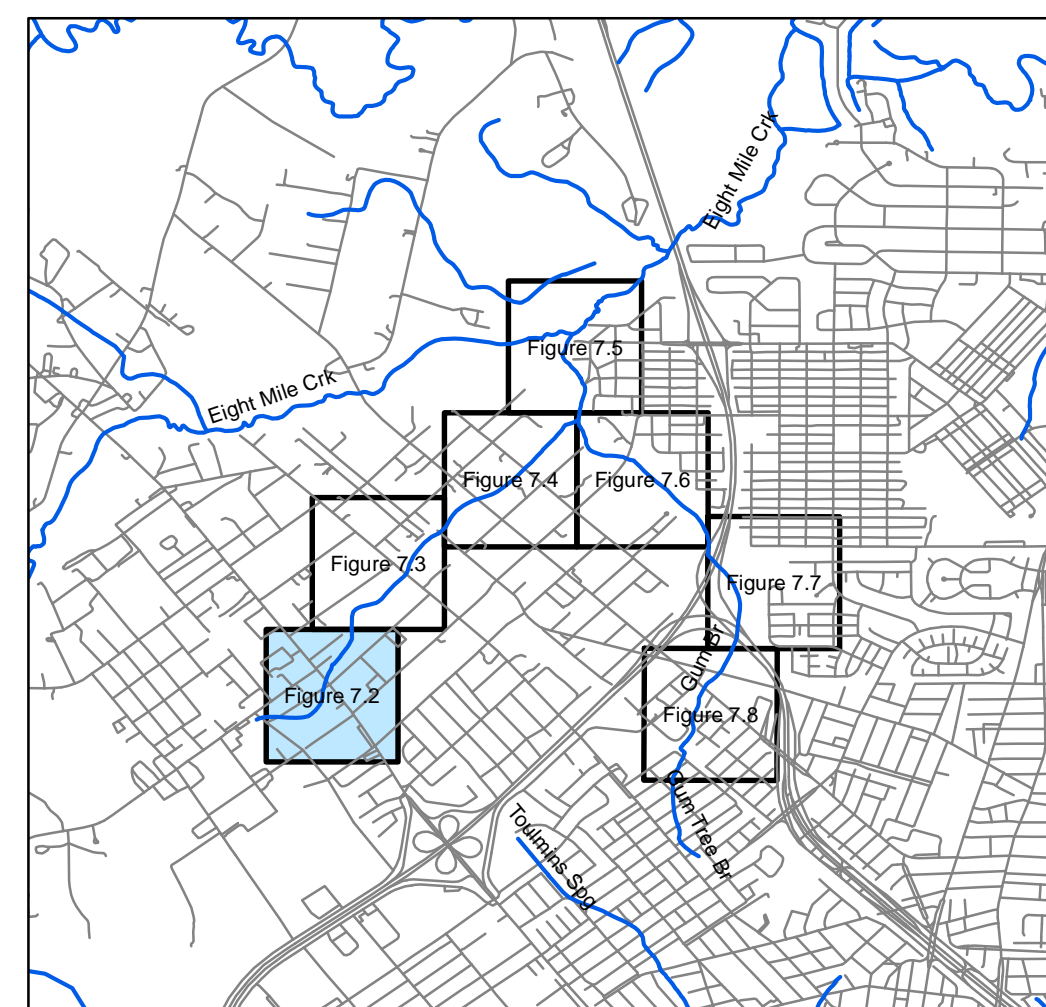
PRICHARD DRAINAGE STUDY
MCP-101-15
GUM TREE BRANCH
FIGURE 7.1

Gum Tree Branch is characterized by multiple areas of concern including erosion, vegetation, heavy sediment deposits, concrete damage, and debris accumulation.

Areas of concern are outlined in Tables B.1 through B.4, found in Appendix B. The features identified in Appendix B were used to create cost estimates for improvements along Gum Tree Branch. Sedimentation items are in place to remove excessive amounts of sediment deposited into the creek bottom, that in-turn increases upstream flooding. There are also several locations where concrete damage has occurred within the third section of the branch. Multiple debris restrictions throughout the branch were identified. To improve functionality of the waterway, debris should be removed. Locations of identified sedimentation, concrete damage, and debris accumulation are shown in Section 7 (Figures 7.1-7.8).
