Report of Findings

Prichard Drainage Study Toulmin Springs Branch and Gum Tree Branch

For
**Mobile Bay National Estuary Program
Mobile County Commission
Project No. MCP-101-15**

May 2016

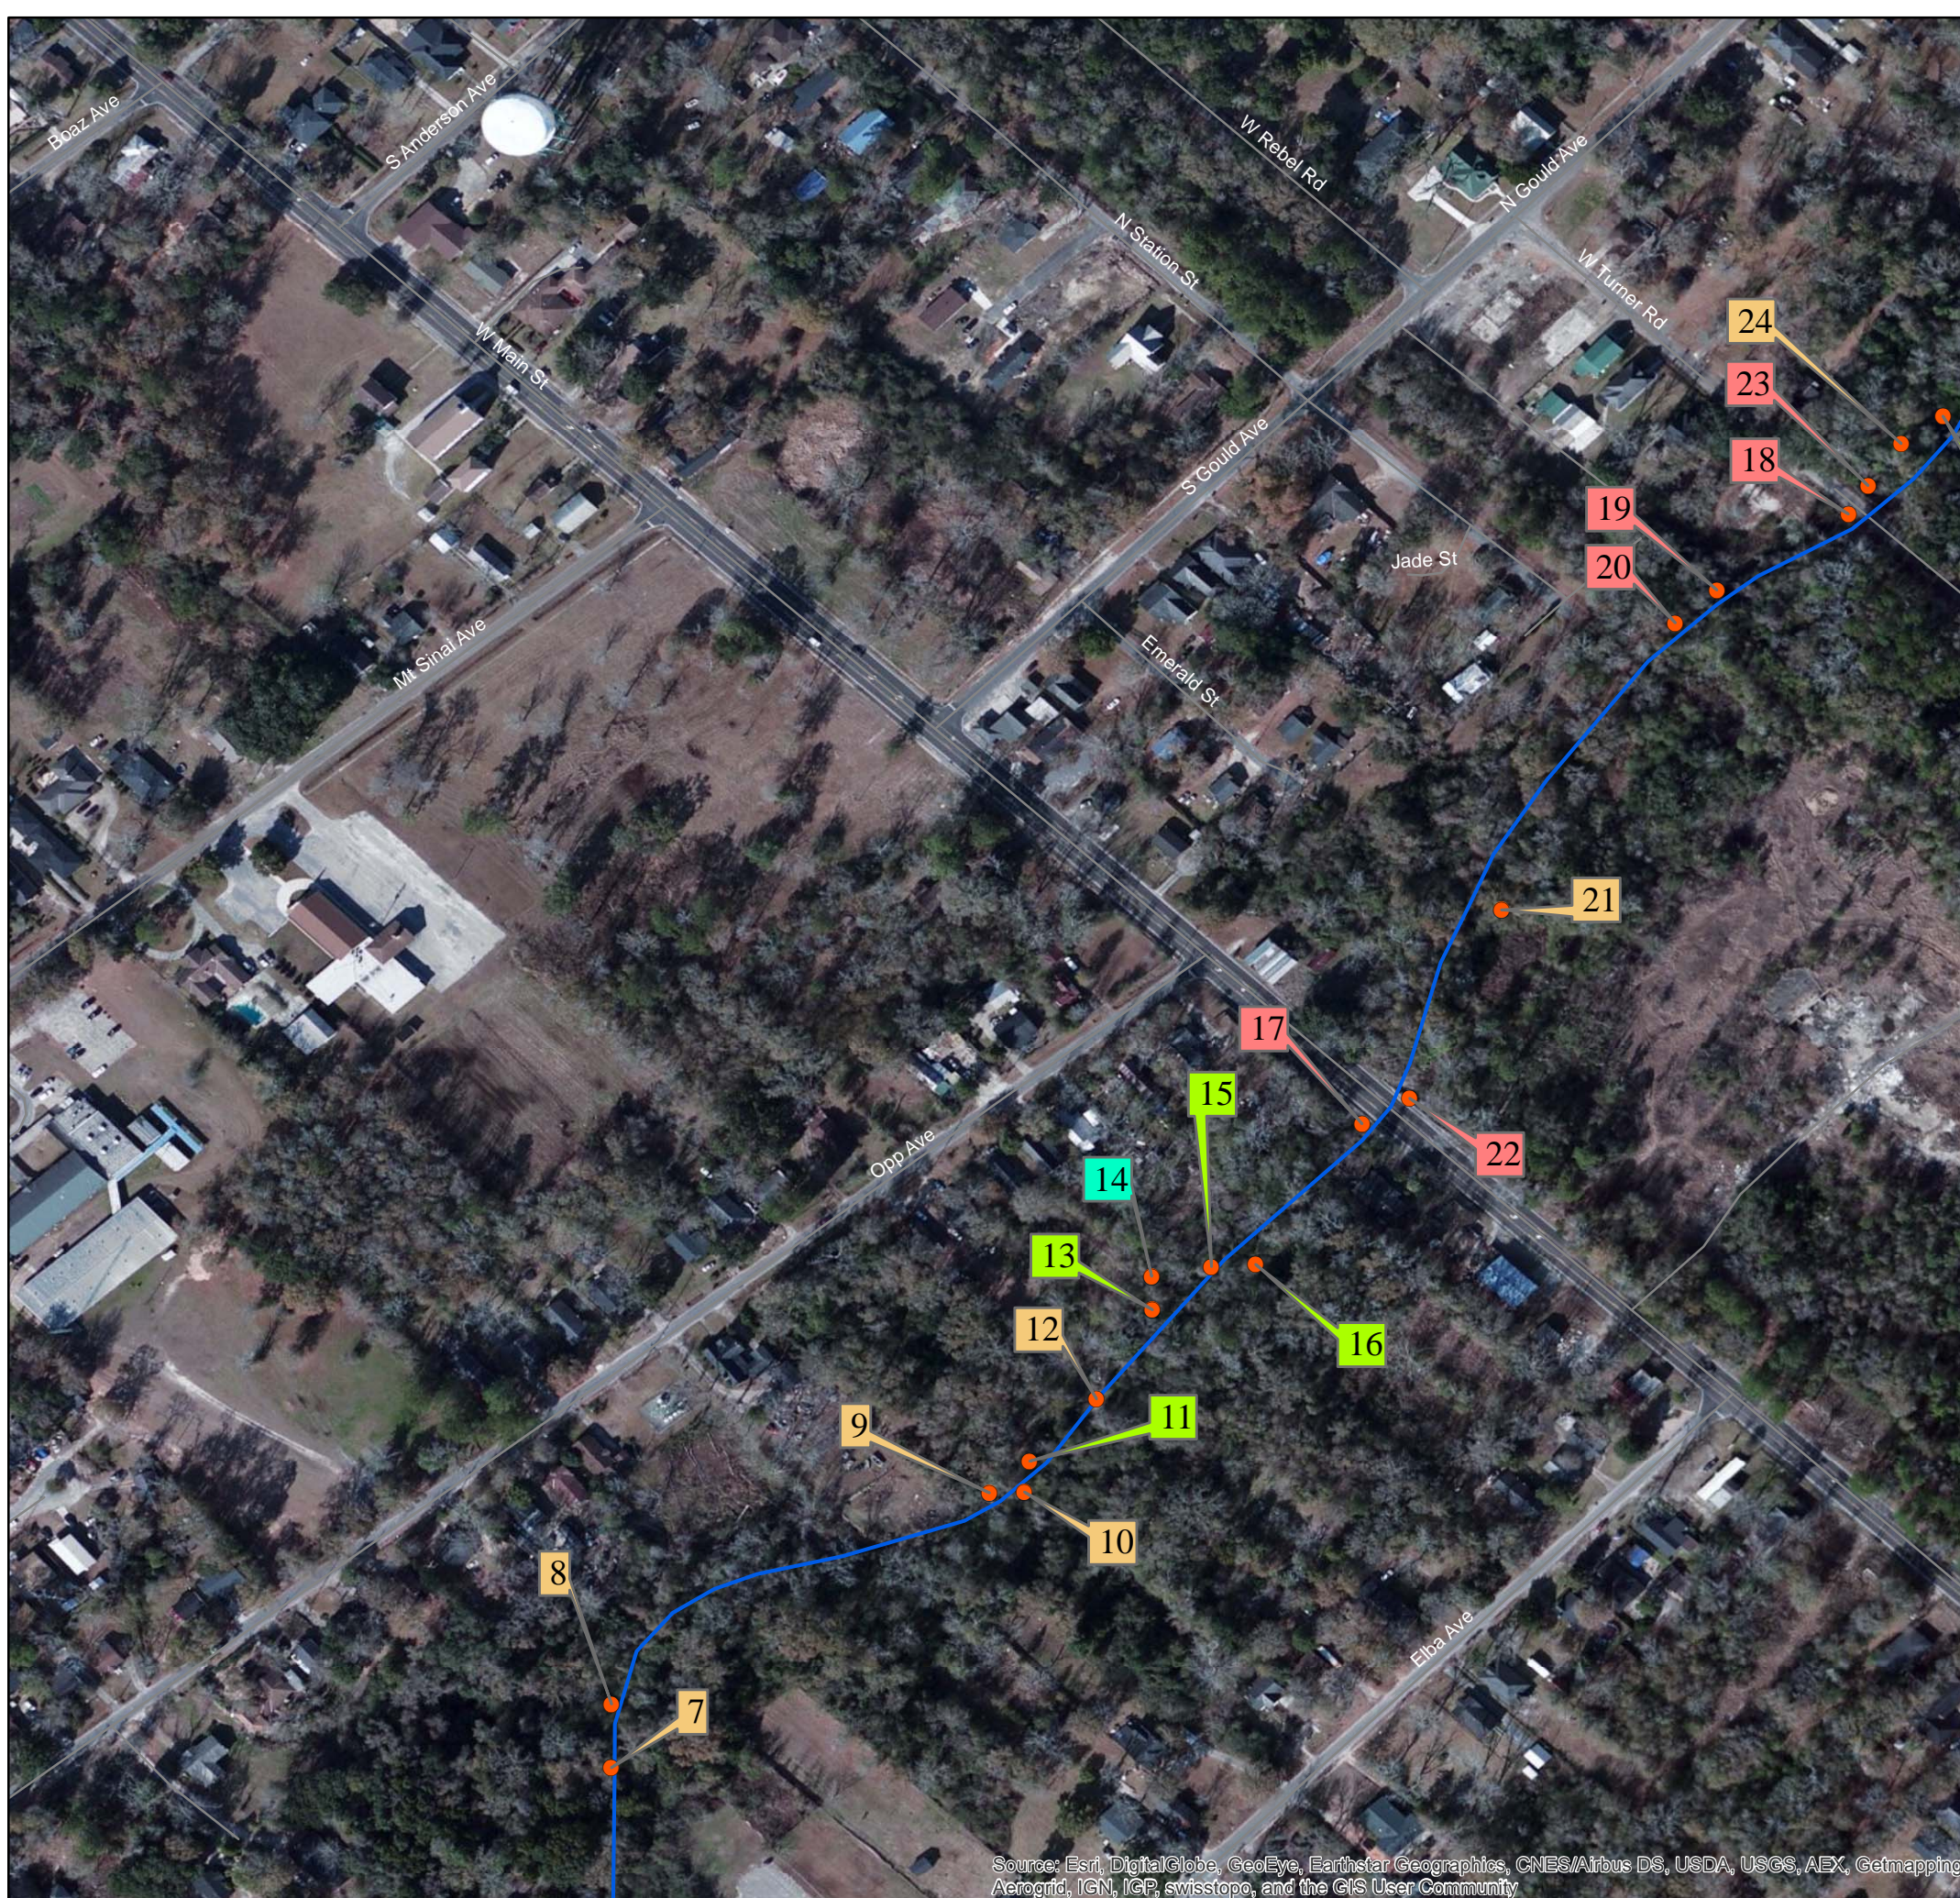
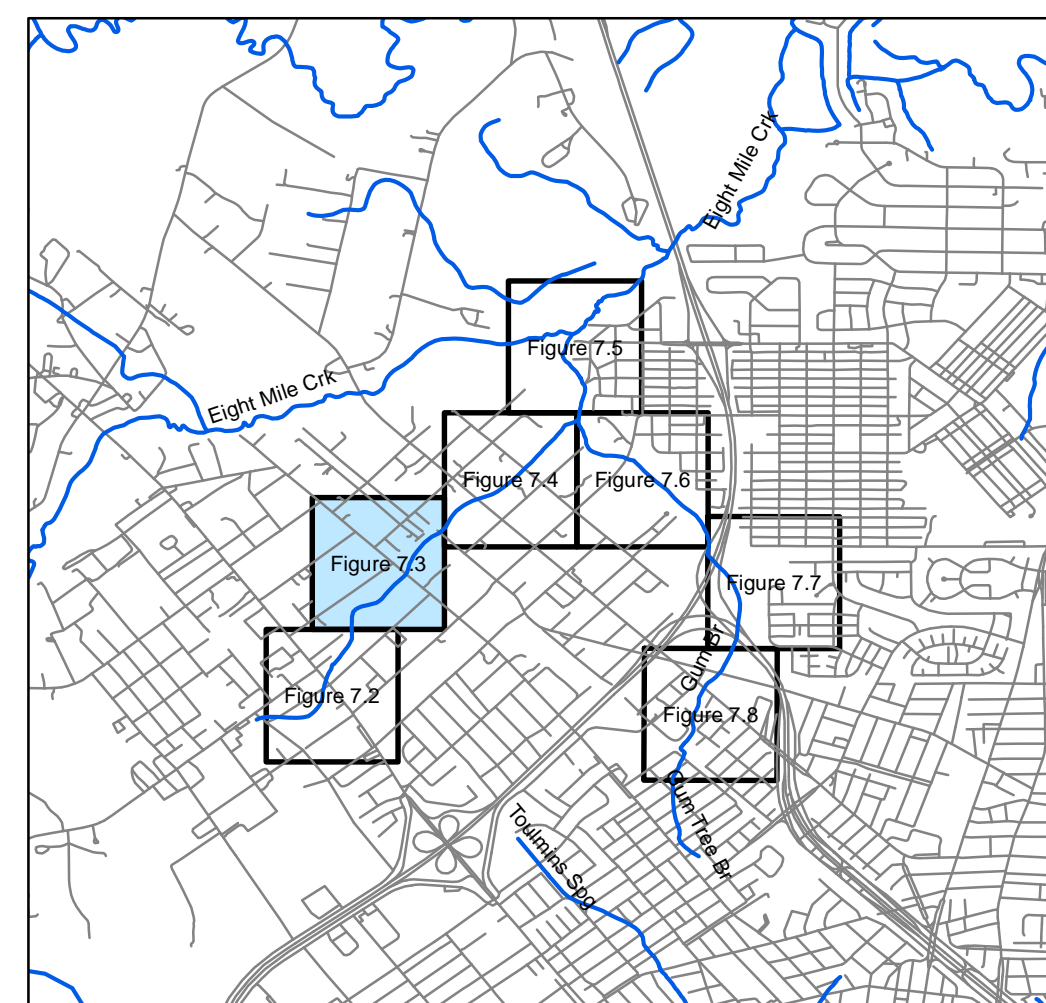
Figure 7.2

Areas of concern are outlined in Tables B.1 through B.4, found in Appendix B. The features identified in Appendix B were used to create cost estimates for improvements along Gum Tree Branch. Sedimentation items are in place to remove excessive amounts of sediment deposited into the creek bottom, that in-turn increases upstream flooding. There are also several locations where concrete damage has occurred within the third section of the branch. Multiple debris restrictions throughout the branch were identified. To improve functionality of the waterway, debris should be removed. Locations of identified sedimentation, concrete damage, and debris accumulation are shown in Section 7 (Figures 7.1-7.8).
