D'OLIVE WATERSHED MONITORING STUDY AND DEVELOPMENT OF A WATERSHED CONDITION FRAMEWORK

Prepared by

December 31, 2019

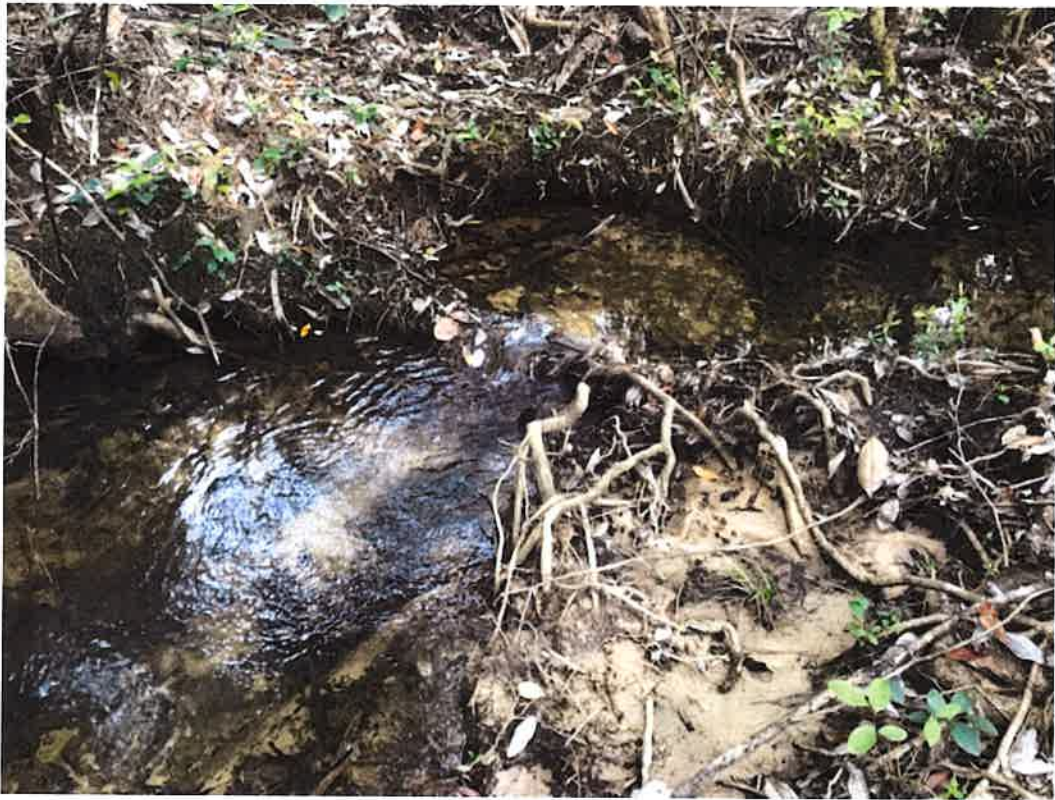
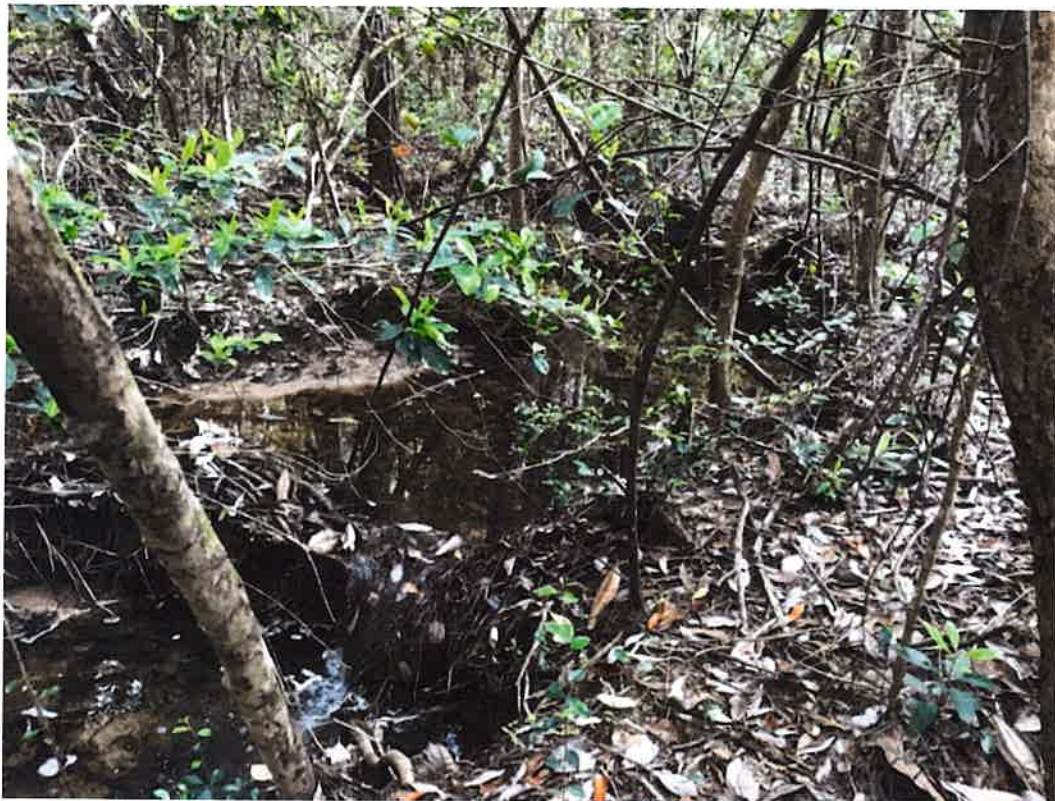
DA3-Upstream Sampling Site

In the D'Olive Creek DA Tributary Sub-watershed, highest quality streams are associated with Malbis Plantation (MP) property upstream from restoration site DA3 (Table 4-5 and Figure 4-5). The DA3 Upstream location scored "good" for riparian zone width, vegetative quality, canopy cover, channel alteration, and habitat smothering.

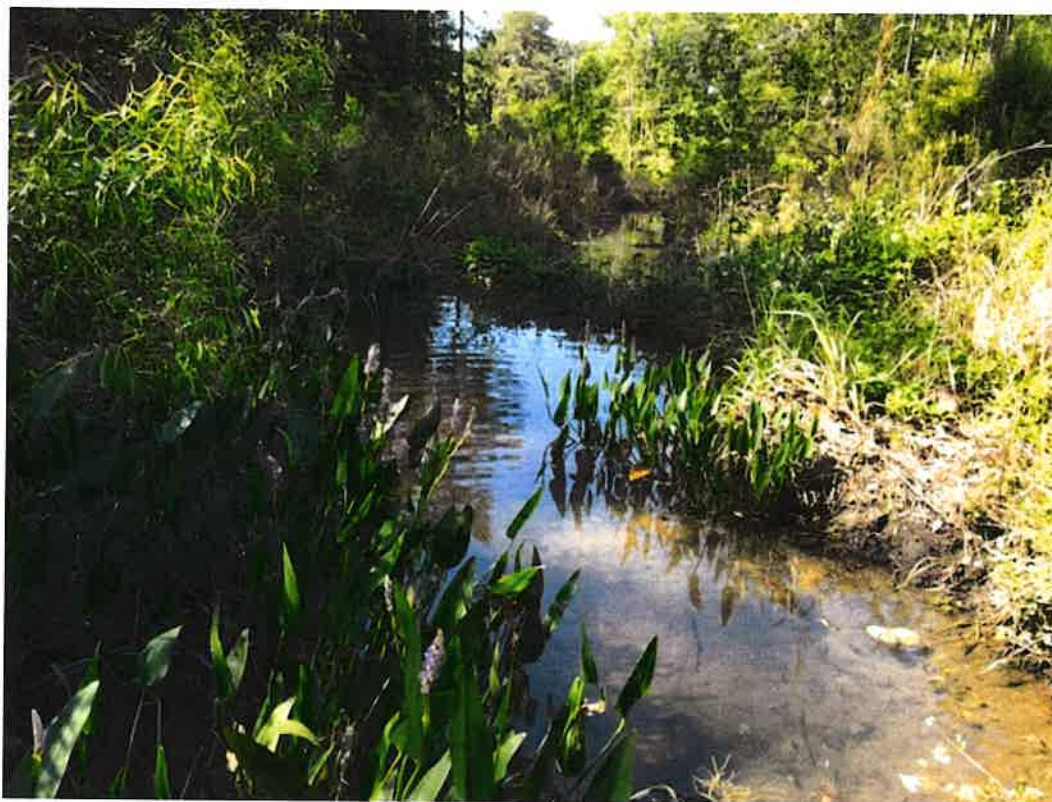
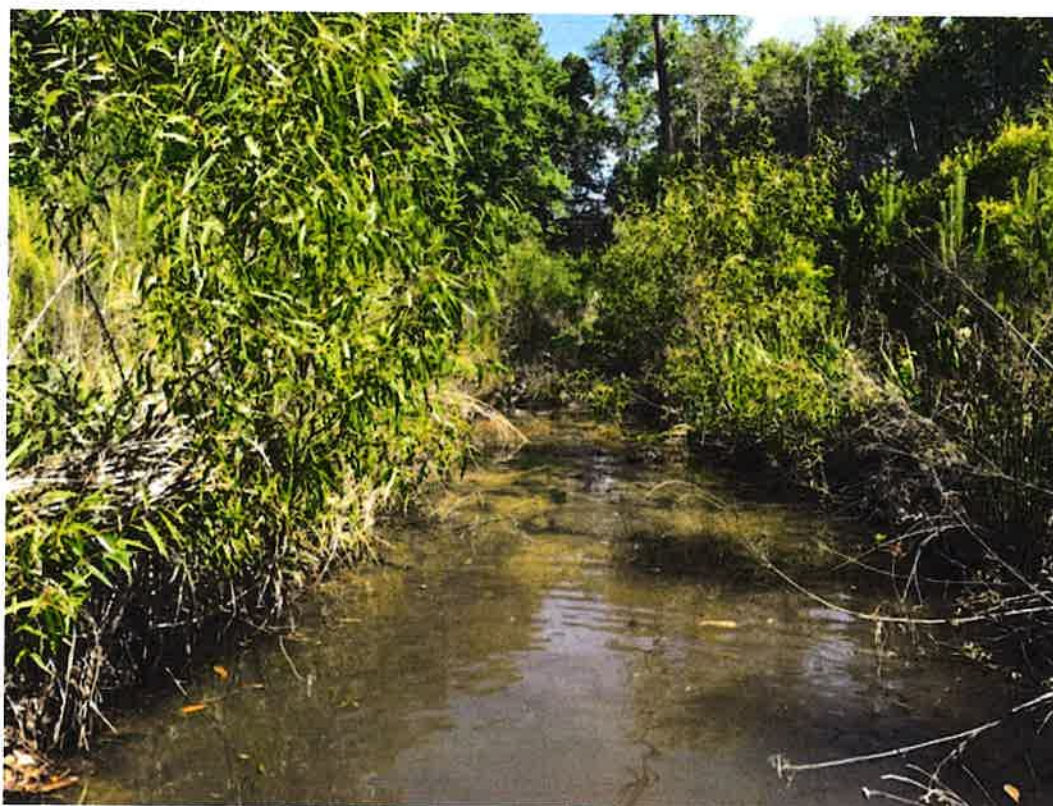
JB1-Restoration Sampling Site

The restoration sites in the Joe's Branch Sub-watershed had Poor stream conditions, including at JB1 (RSA=0.40), JB2 (0.36), and J4 (0.44). All three sites had "poor" scores for canopy cover and riparian zone width. The JB2 site had "poor" scores for channel alteration and sinuosity, whereas JB1 and JB4 had "moderate" scores for these two metrics. All three sites had "moderate" scores for sediment deposition and habitat smothering. The JA Downstream site is essentially a drainage ditch with good riparian buffer width and canopy cover, but received "poor" scores for channel sinuosity, habitat availability and smothering, and sediment deposition. Two upstream sites in Joe's Branch, at JB1 and J4, are in Fair condition, with RSA scores of 0.60 and 0.52, respectively.
