Watershed Management Plan

Volanta Gully Watershed

Fairhope, Alabama

April 9, 2012

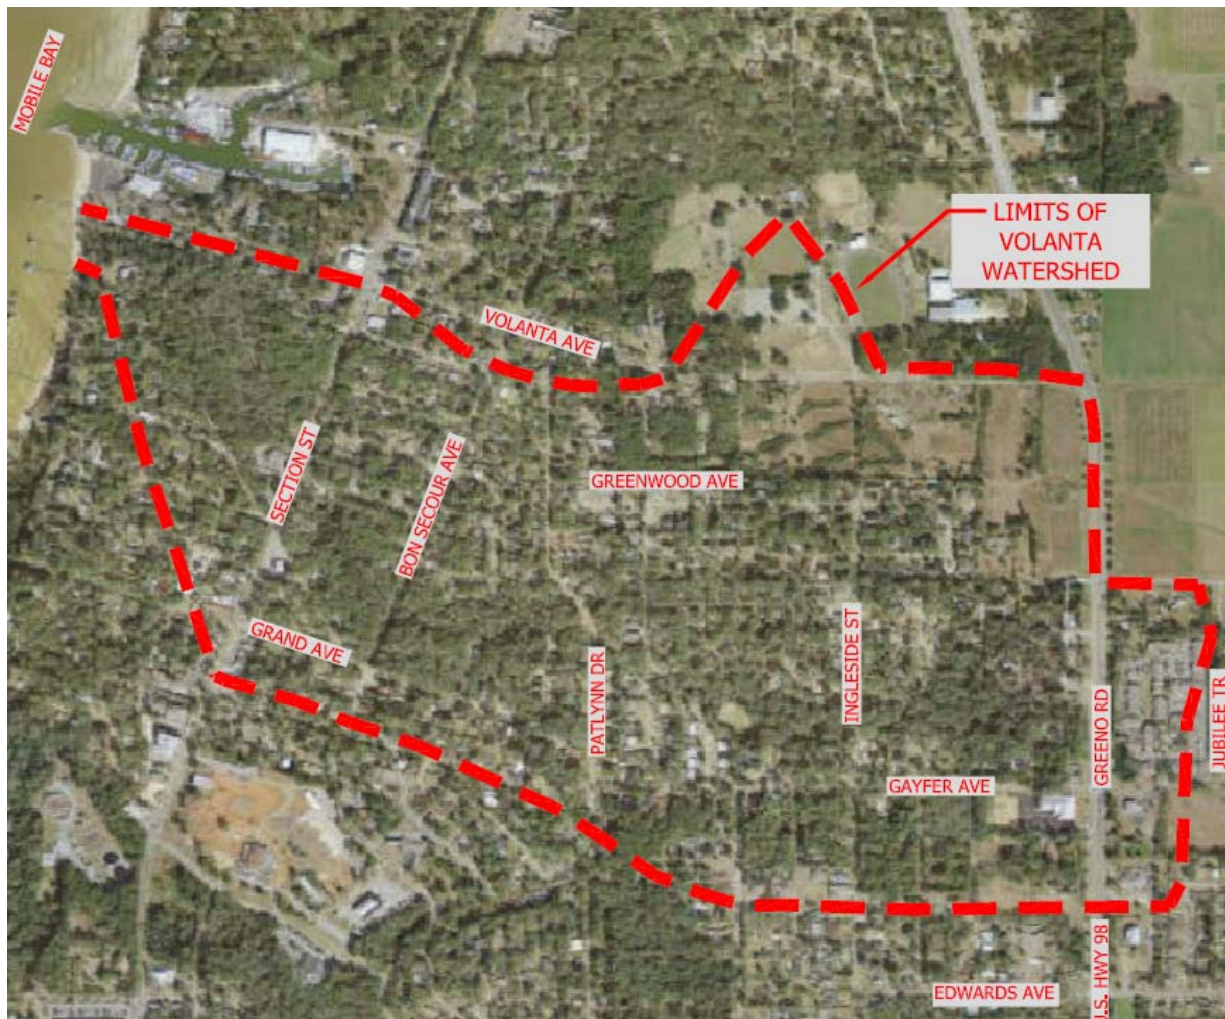
Figure 2-1
Aerial Photograph Identifying Watershed Limits

The Volanta Gully Watershed is located in the City of Fairhope (Baldwin County) Alabama. Figure 2-1 provides an aerial photograph identifying the watershed limits. The system is roughly bound by Volanta (north) and Gayfer (south) Avenues, U.S. Highway 98/Greeno Road (east) and Mobile Bay (west).

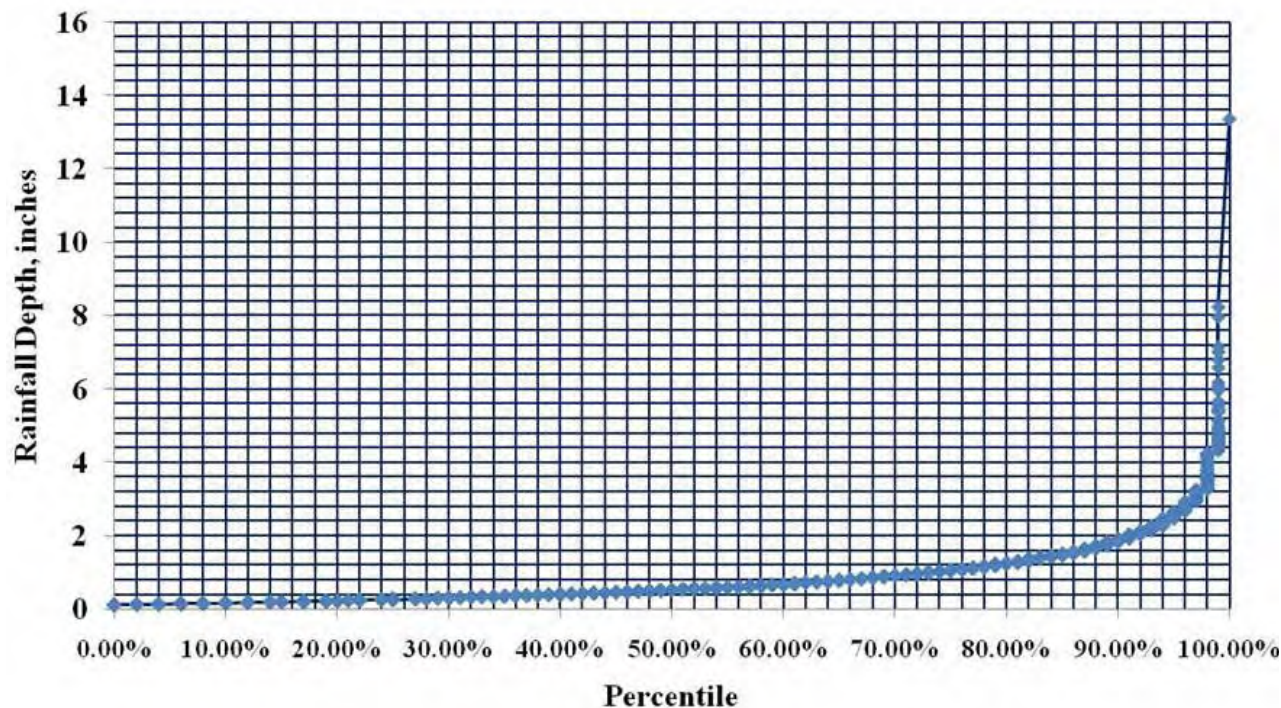
Figure 2-3 gives the rainfall percentages experienced at the Mobile Regional Airport for a period between 1900 and 1997 (ADEM, 2010). This chart indicates a 100-year storm for the Volanta Gully would anticipate 13.5 inches of rainfall within a 24 hour period.

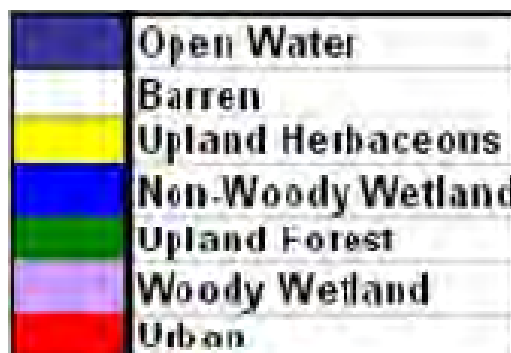
Figures 2-13
Volanta Gully Watershed Landsat Multispectral Scanner Imagery
Comparison of Land Use/Land Cover (Ellis et al, 2008)

Figures 2-13 indicate LMS data collected by NASA during three separate years. The images demonstrate the evolution of land cover/urbanization that has occurred in the Volanta Gully Watershed. The information helps illustrate a rapid growth period in the 1970s and 1980s. This growth is also supported by the recording of many subdivision plats during this same time frame.

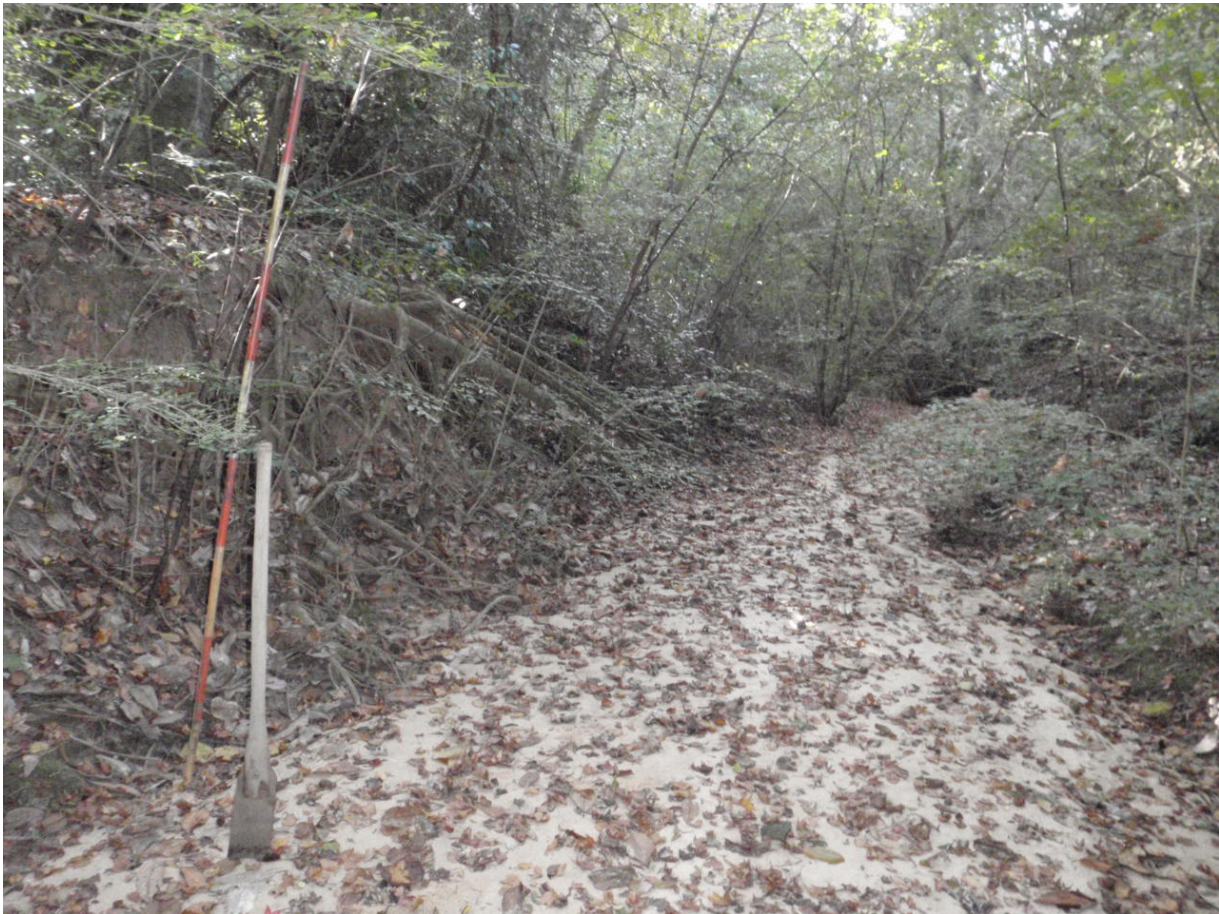
Figure 3-4
Stream Segment VI Just East of Mobile Bay (JADE, 11-08-11)

The streambeds just west of the head cuts and pipe outfalls contain heavy sediment accumulations. The sediment deposits are the result of both historic and ongoing erosion from upland and in-channel sources. Figures 3-4 and 3-5 provide representative views of the sediment laden reaches of the Volanta Gully Watershed.

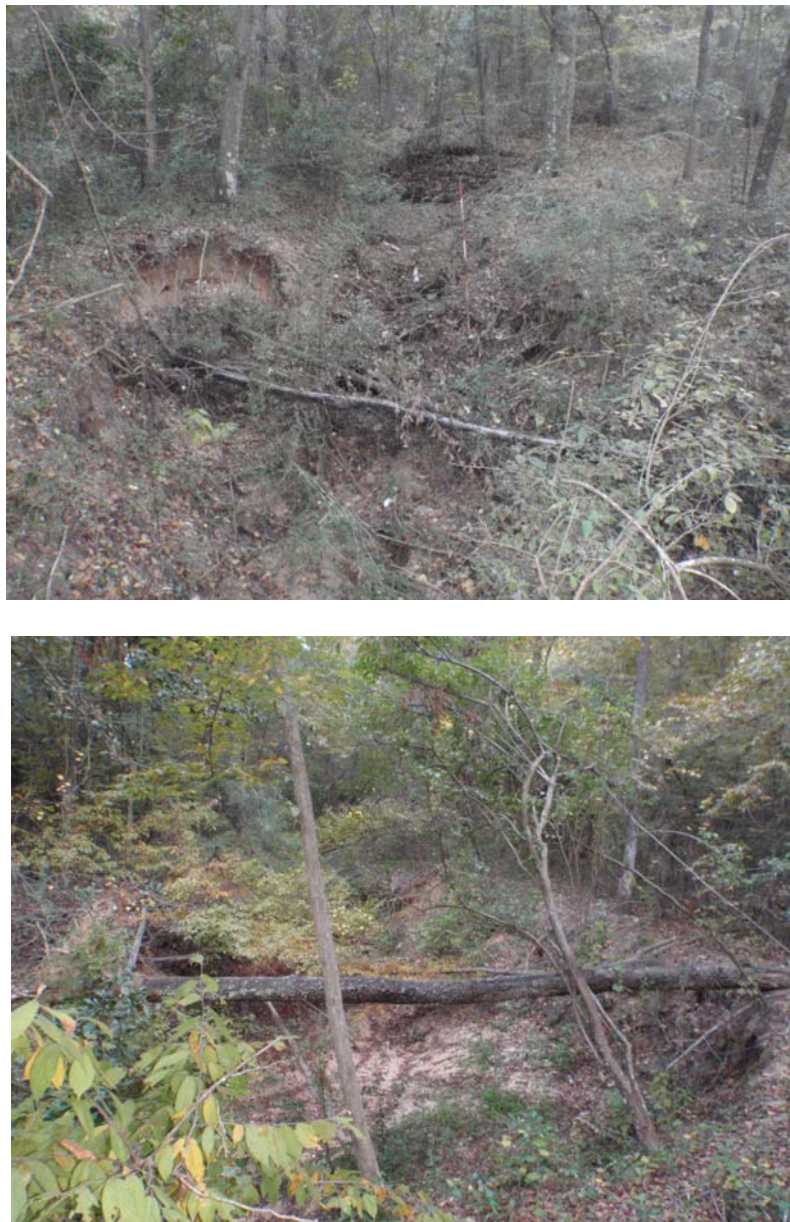
Figure 3-7 and 3-8
Stream Segment VI Just West of North Section Street (JADE, 11-08-11)

As mentioned in previous sections, the Volanta Gully Watershed channels are predominantly comprised of materials that are very susceptible to erosion. This can be found in several locations throughout the watershed, two examples of which are shown in Figures 3-7 and 3-8. The photos show mass bank failures and vegetation loss (i.e., uprooted trees). There are only a few areas that are moderately resistant due to the presence of cohesive clays, although this layer is significantly degraded and will ultimately succumb to erosion in the near future.

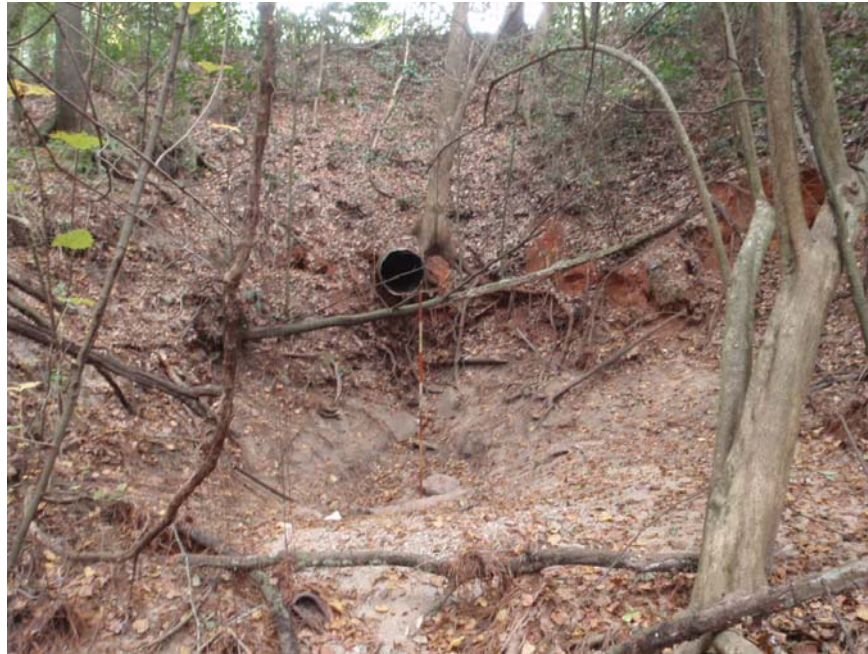
Figure 3-9
Stream Segment VI North of the Intersection at Grand Avenue and Bon Secour Avenue
(JADE, 11-09-11)

Figure 3-9 and 3-10 indicate another location head cuts are found, the outfalls of drainage pipe in the upper sections of slopes. Drainage piping has been installed to transfer flows under and around development and infrastructure. These culvert outfalls do not typically have any outfall reinforcement to prevent further incising and there are no measures to dissipate flow energy. The stormwater released from these areas is typically concentrated flow and has to travel down steep gradients, perfect conditions to form head cuts and massive gullies.

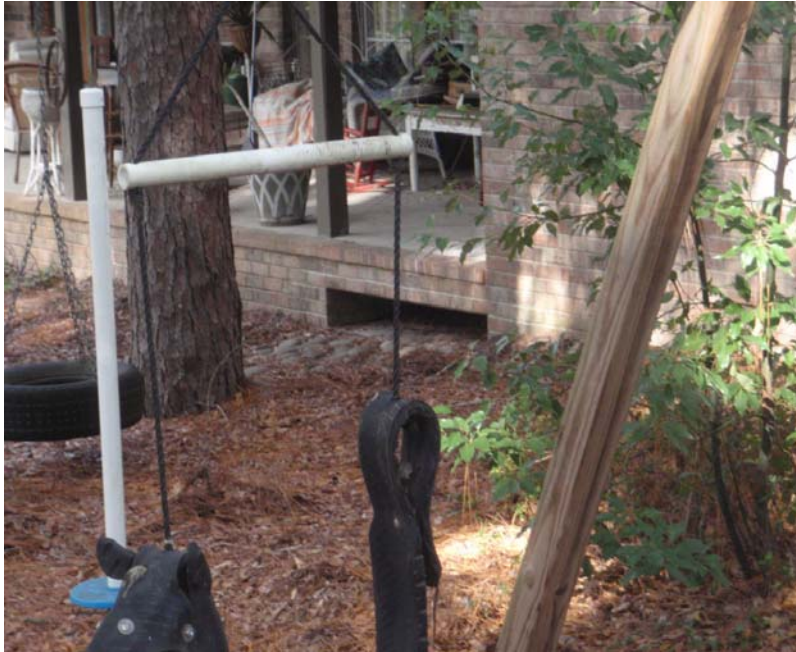
Figure 3-11
Segment V5 Just East of Mobile Bay (JADE, 11-30-11)

Areas of residential development within the watershed were constructed with long stretches of paved streets without sufficient inlets which, in turn discharge to an undersized underground conveyance system. Localized flooding can occur where runoff volumes exceed the curb inlet spacing within the streets. Once the inlet capacity has been exceeded, excess flow then migrates down a nautical overland swale. This statement is supported by Figure 3-11 which shows where a homeowner constructed a mini culvert under their porch to accommodate the overland flow.

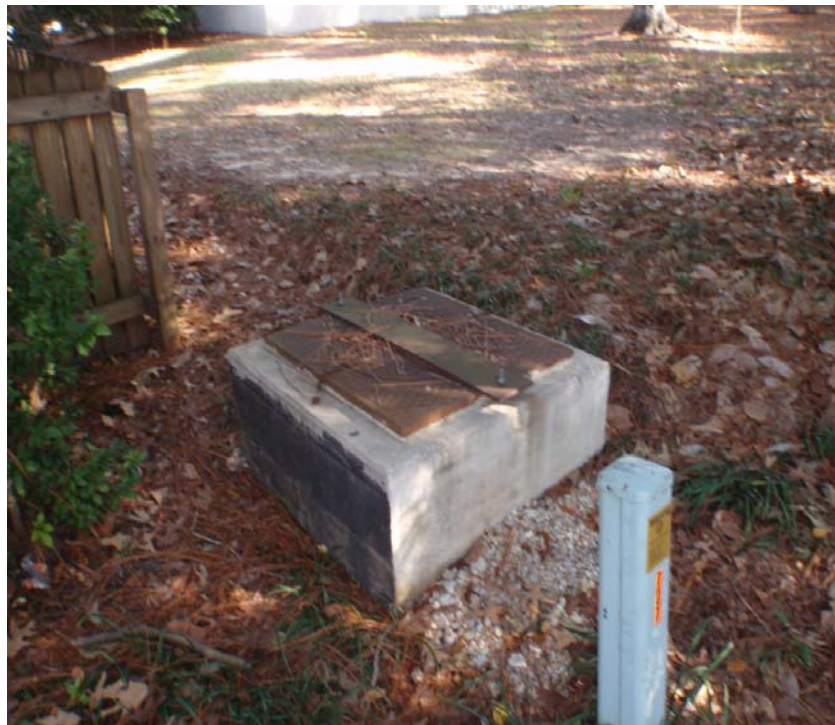
Figure 3-12
Segment V5 Just East of Mobile Bay (JADE, 11-30-11)

Figure 3-12 shows where an inlet has been sealed shut to prevent blowout of pressurized stormwater that is being carried in the underground system.

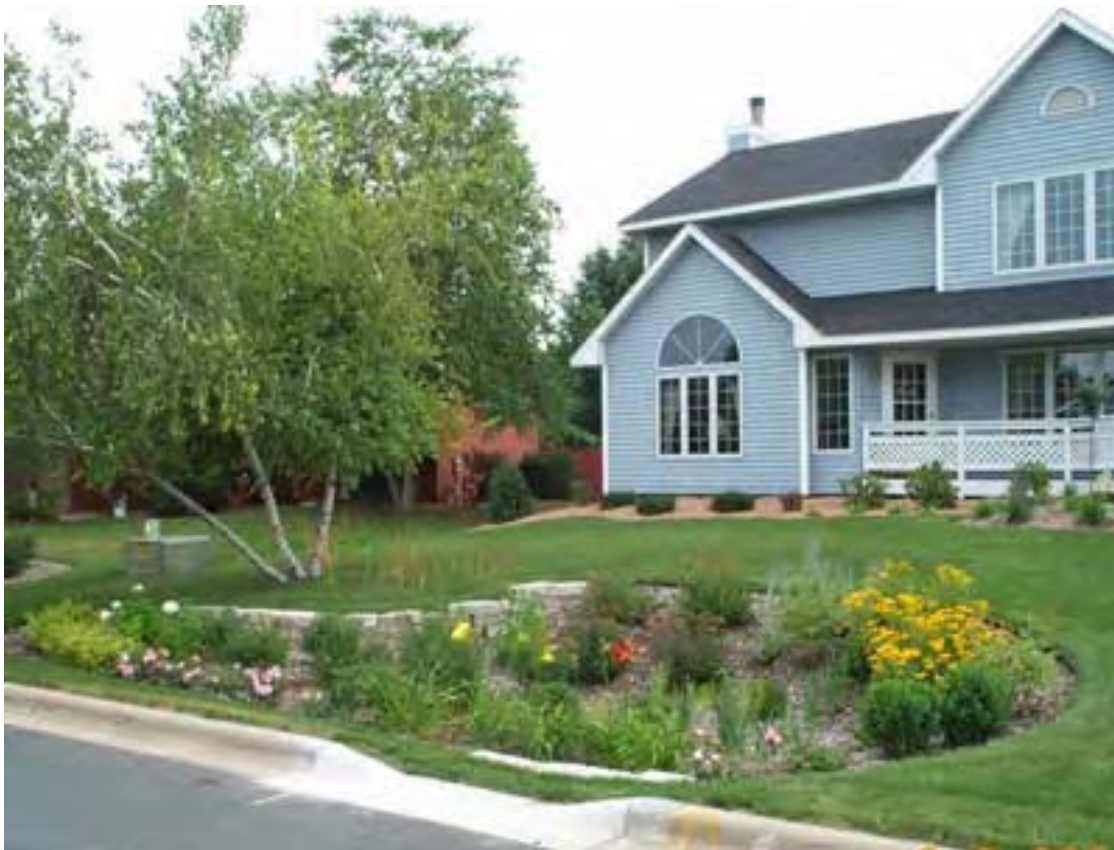
Figure 4-3
Rain Garden Example (CWP, 2007)

Individuals who love to garden and landscape around their homes are in fact creating and maintaining rudimentary rain gardens. Improvements can be incorporated into these spaces to enhance their capacity to retain rainfall runoff. Rain gardens can be placed adjacent to roads and between roofs and driveways to capture stormwater runoff and allow it to infiltrate into the soil, rather than continue down stream.

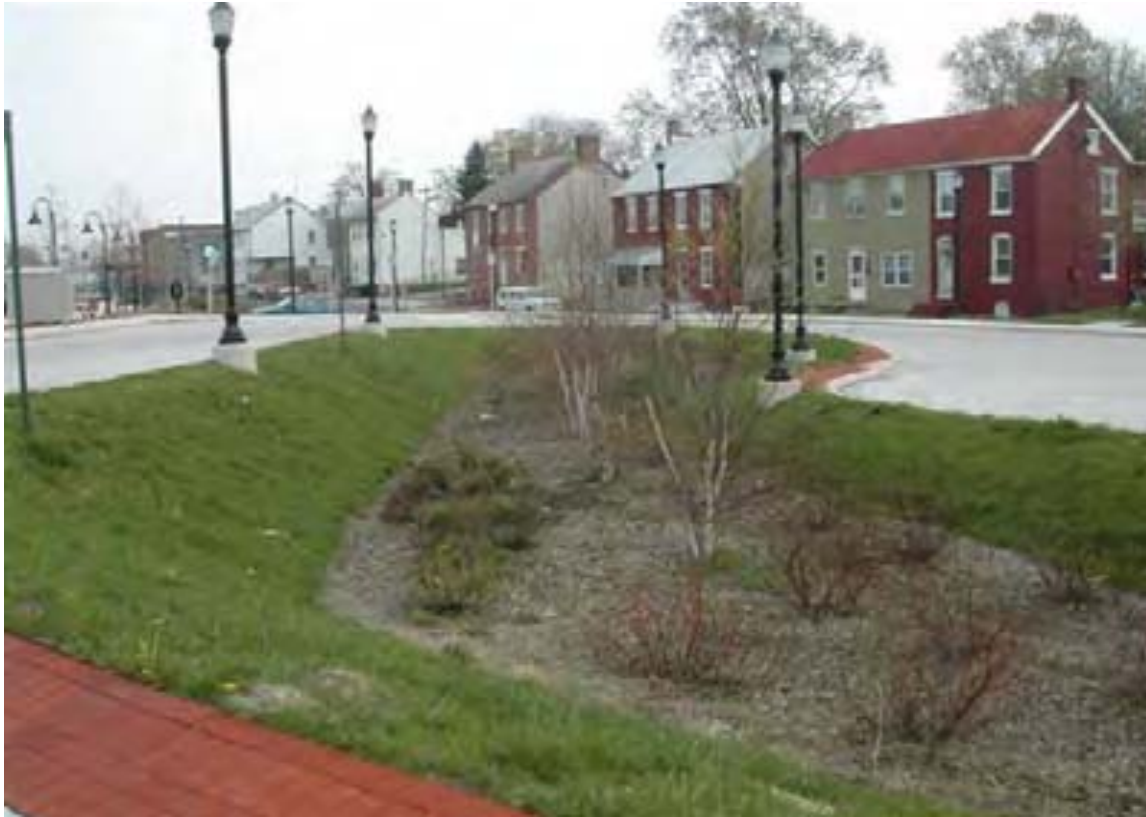
Figure 4-4
Example of Bioretention Pond (CWP, 2007)

A bioretention area captures runoff from an impervious surface and allows that water to infiltrate through the soil media. As the water infiltrates, pollutants are removed from the stormwater runoff through a variety of mechanisms including adsorption, microbial activity, plant uptake, sedimentation, and filtration. Some of the incoming runoff is temporarily held by the soil of the bioretention area and later "leaves" the system by way of evapotranspiration or infiltration into the ground. Besides retaining stormwater runoff, bioretention areas have been found to remove metals, nutrients, sediment, and fecal coliform, provided they are situated, designed, constructed, and maintained appropriately. Figure 4-4 and 4-5 illustrate examples of how bioretention facilities can be included in a redevelopment project.

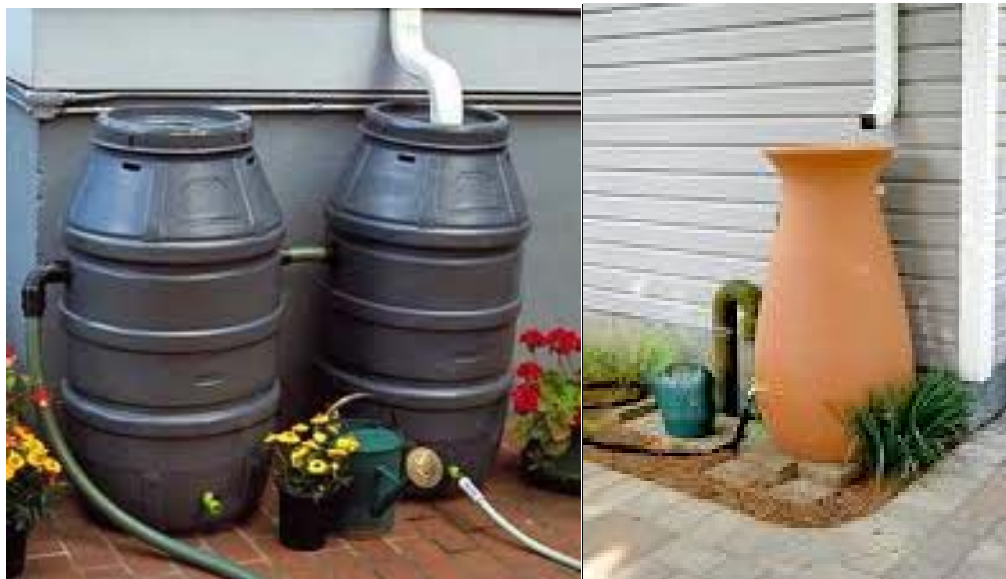
Figure 4-6
Typical Rain Barrel Use (non-copyrighted web photo)

Rainwater harvesting is a BMP that promotes the conservation of rainwater. Rainwater harvesting has many applications throughout the landscape. These applications include rain barrels for residential and institutional uses and large-scale cisterns in commercial and industrial areas. Rainwater harvesting when applied to lawns, gardens, and vegetated landscapes can reduce the amount of fertilizer application necessary, thus reducing the potential of nutrients entering into the watershed.

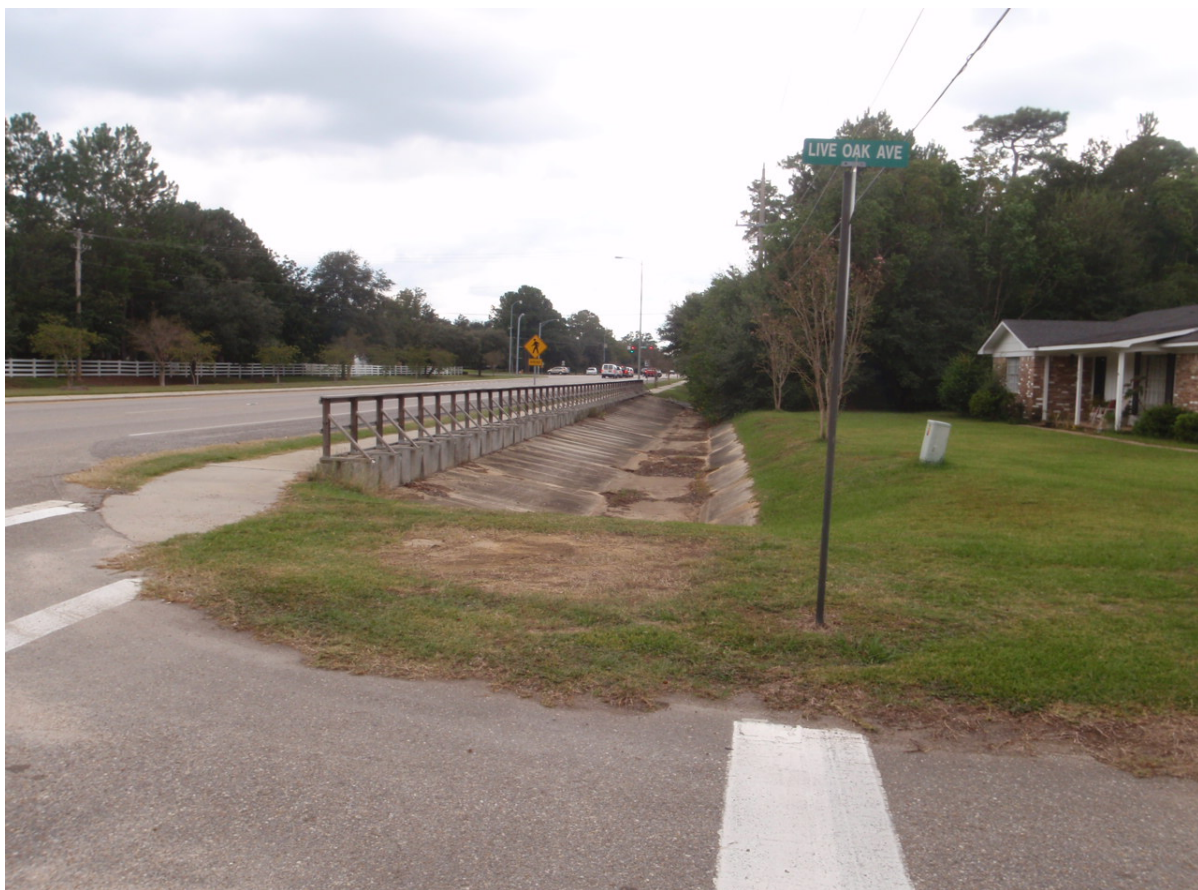
Figure 4-12
U.S. Highway 98/Greeno Road Ditches Lined with Concrete (JADE, 2011)

The below section of concrete ditch is found in the Volanta Gully Watershed, protected by an elevated sidewalk and retaining wall (Figure 4-2). It is extremely flat and located between two drainage structures. One retrofit option would involve removal and replacement of the concrete lining with a LID/GI surface that works well in flat areas. For example, the water surface of a constructed wetland could function as a contact connection between the inverts of the upstream and down stream pipes. A constructed wetland/bio-swale would allow for plant species to grow and create a type of filtering media that would help slow stormwater as it passed through this area creating additional storage as the headwater of the flow rises.

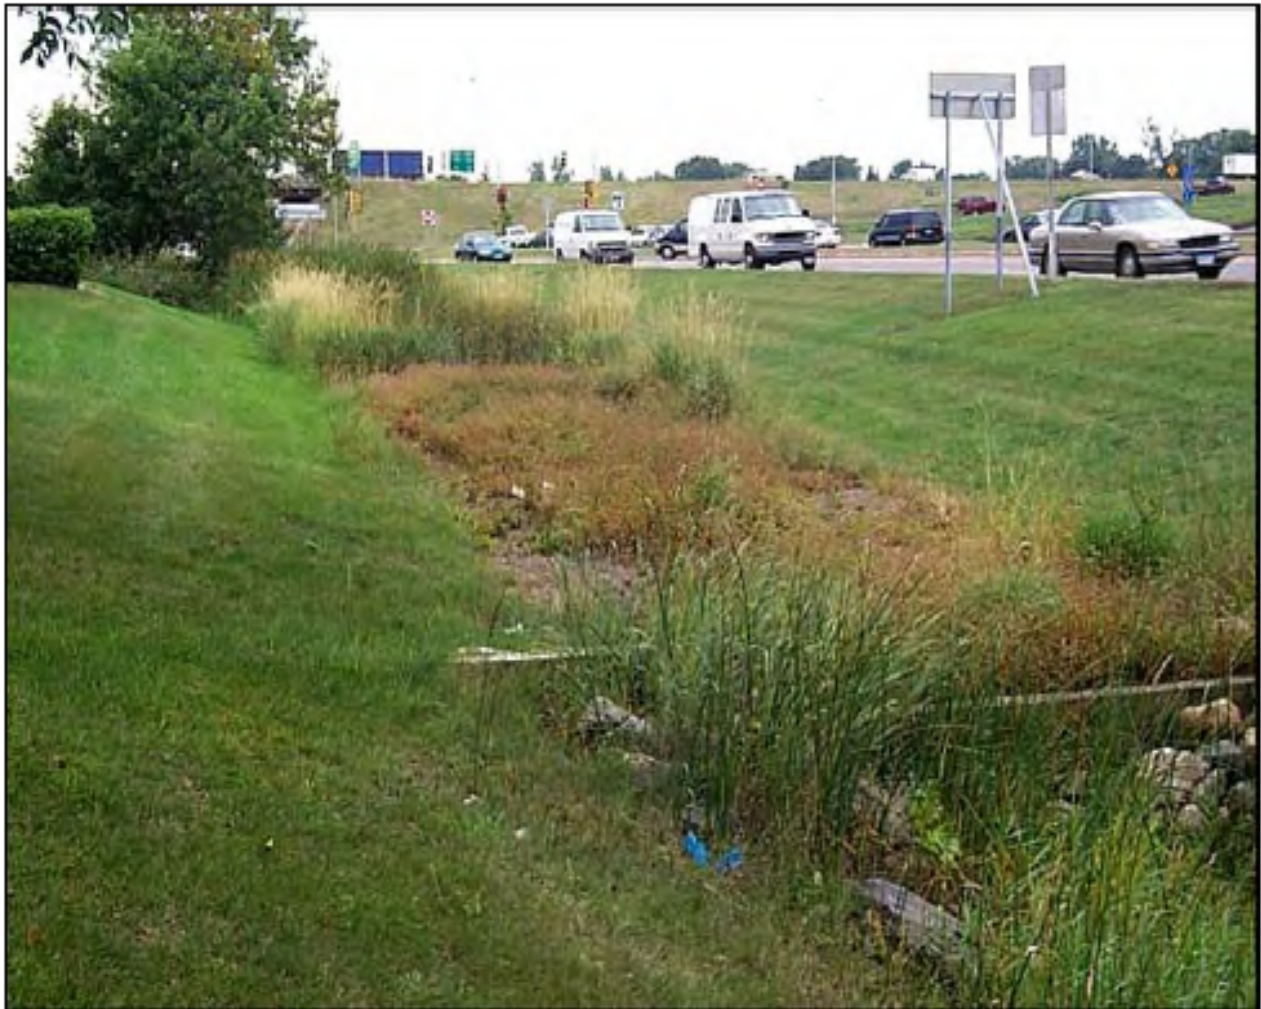
Figure 4-13
Potential Bioswale Retrofit for U.S. Highway 98/Greeno Road Ditches (CWP, 2007)

No reports have been found that document any localized flooding in this area from the many major storm events. It should be noted that the associated drainage double barrel culverts that channel stormwater under U.S. Highway 98/Greeno Road are also much larger than their immediate downstream infrastructure. The ability to temporarily hold staged stormwater in this area for an extended time would help dilute the concentrated flows that Volanta Gully has experienced since the roadway was constructed. Figure 4-13 gives a general explanation of this concept. Techniques such as these could be used as demonstration projects with the Alabama Department of Transportation.

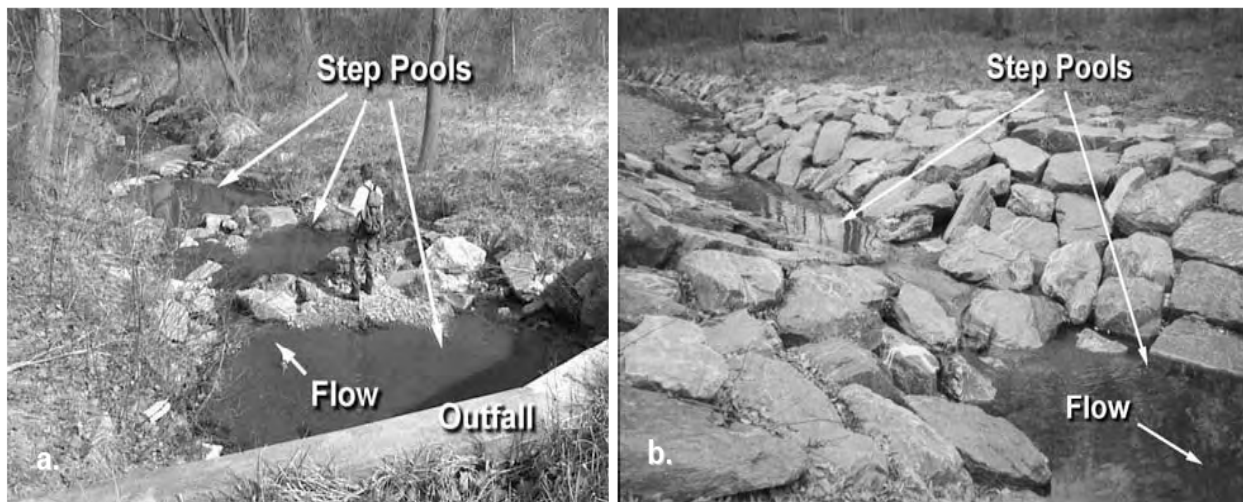
Figure 4-14
Step Pool Stream Restoration (CWP, 2004)

As previously described, the Volanta Gully has several locations where topography and heavy stormwater flows have created significant erosion and sediment problems. One type of restoration technique that is used for stabilizing areas with steep topography is called the Step Pool method. Step Pools are stream repair practices that consist of a series of low elevation weirs and pools that dissipate stream energy along degraded or incising stream reaches. They are often used where a large head cut has formed and is migrating upstream, or in channels that have incised below a culvert or stormwater outfall. They are generally made by using very large rocks, sheet piles, or poured concrete to create a series of weirs that alternate between short steep drops and longer low gradient pools. The number of steps and overall length of the pools are governed by the longitudinal elevation change that needs control (CWP, 2004). Figure 4-14 shows two examples of a Step Pool stream restoration.
