Dauphin Island

WATERSHED MANAGEMENT PLAN

FINAL

March 2023

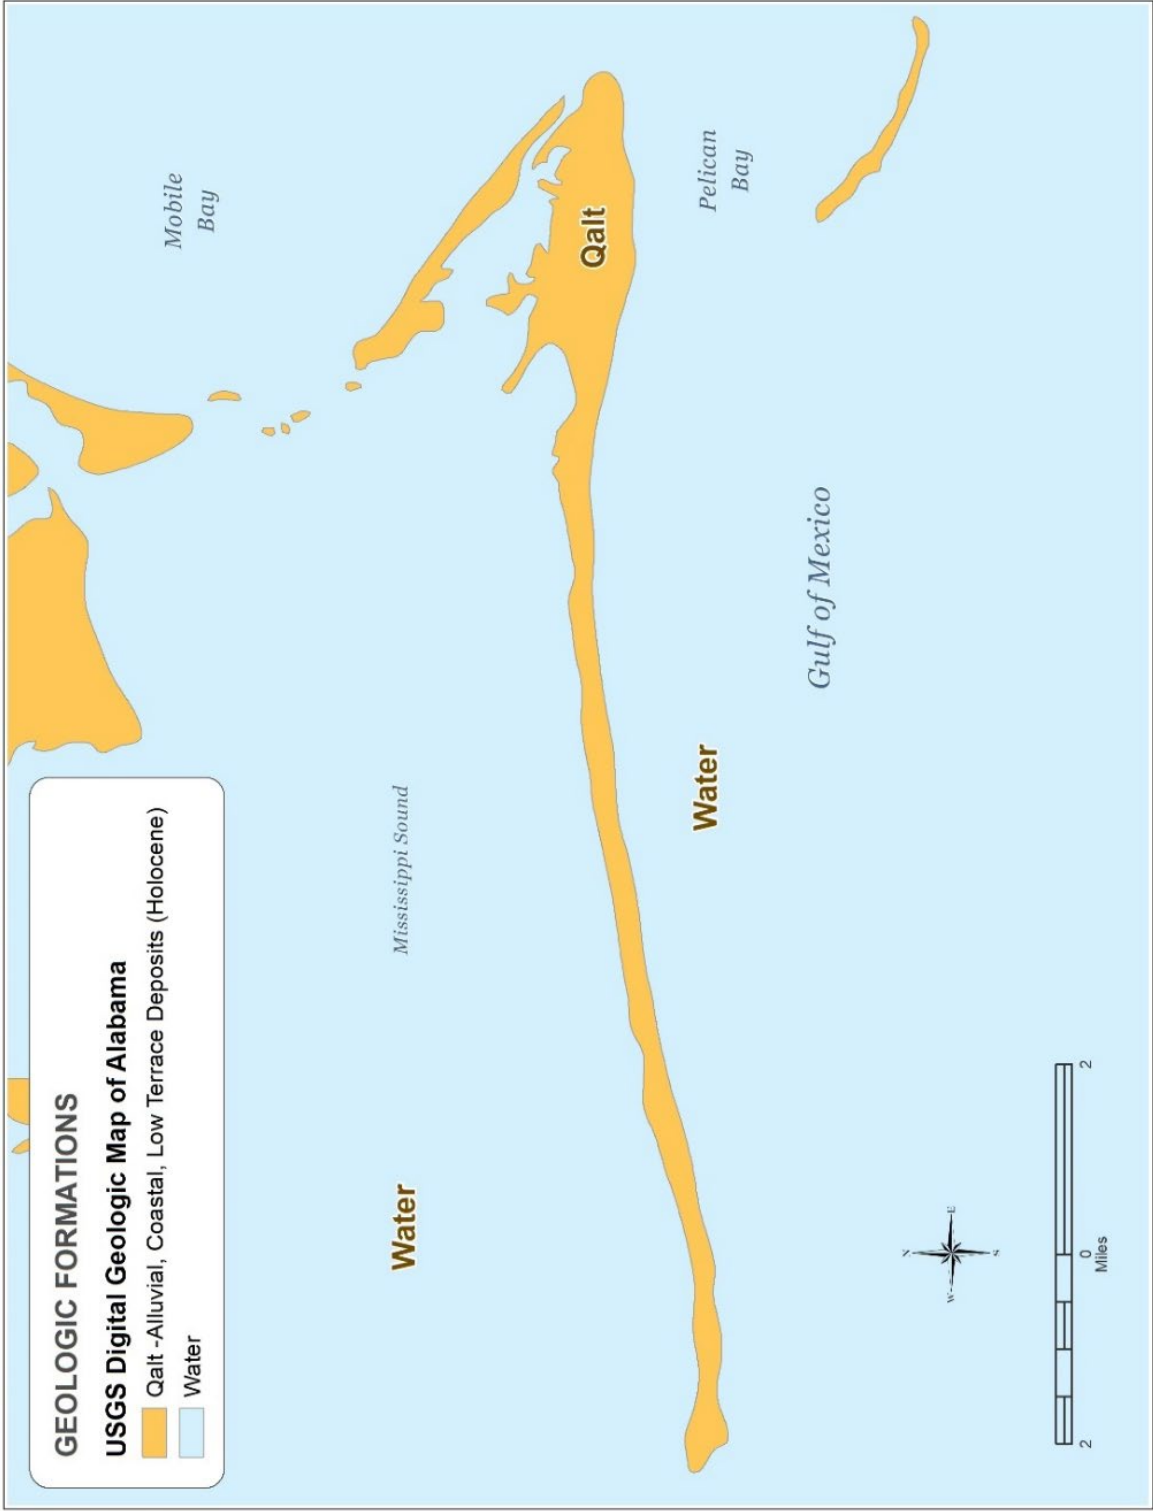
FIGURE 3-3 Geological Formations of Dauphin Island

All of Dauphin Island overlies one geological formation – the alluvial, coastal, and low-terrace deposits of the Pleistocene to Holocene age (**Figure 3-3**). The Alluvial low terrace and coastal deposits represent complex beach, dune, lagoonal, estuarine, and deltaic depositional environments, which generally consist of white, gray, orange, and red, very fine to coarse quartz sand containing gray and orange clay lenses and gravel in places (Szabo and Copeland 1988). The gravel is composed of quartz and chert pebbles.

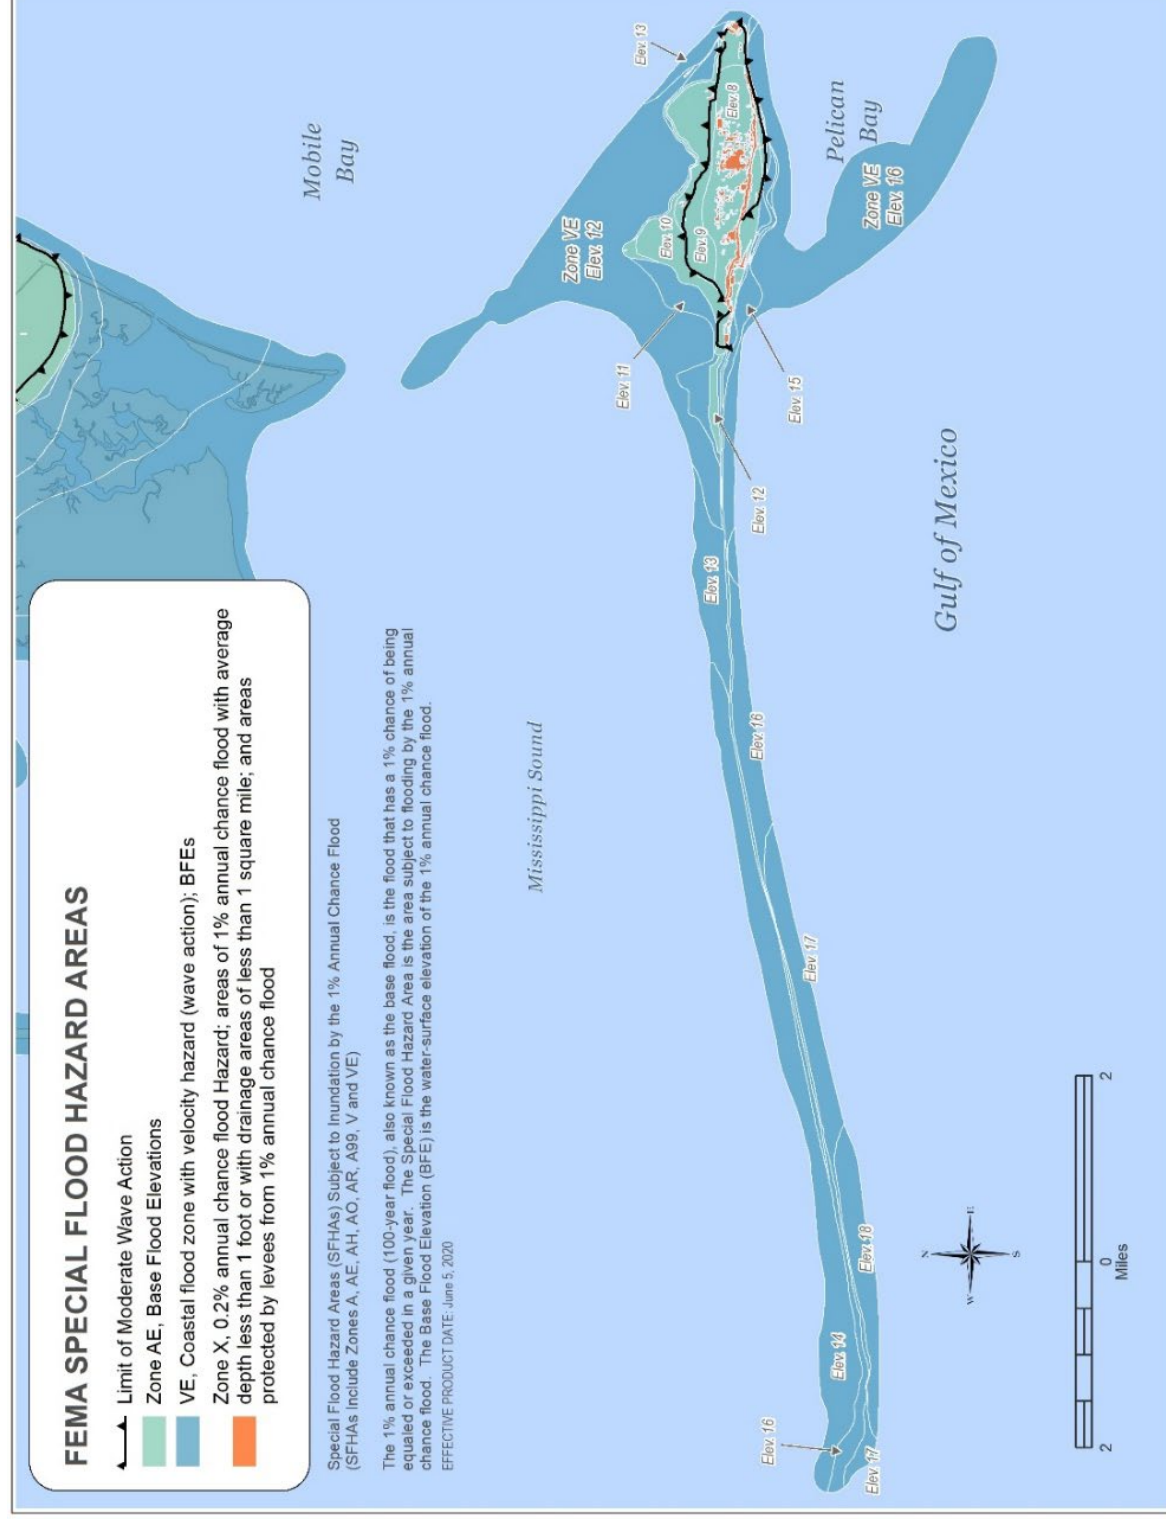
FIGURE 3-14A Federal Emergency Management Agency Flood Zones within Dauphin Island Watershed

Dauphin Island's floodplains and their flood hazard area designations are depicted in **Figure 3-14A–C**. These include Zone AE (subject to inundation by the 1% annual-chance flood event with base flood elevation determined), Zone VE (subject to inundation by the 1% annual-chance flood event with additional hazards due to storm waves with base flood elevation determined) and Zone X (area between the limits of the base flood and the 0.2% annual-chance [or 500-year] flood). Base Flood Elevation is the elevation of surface water resulting from a flood that has a 1% chance of equaling or exceeding that level in any given year.

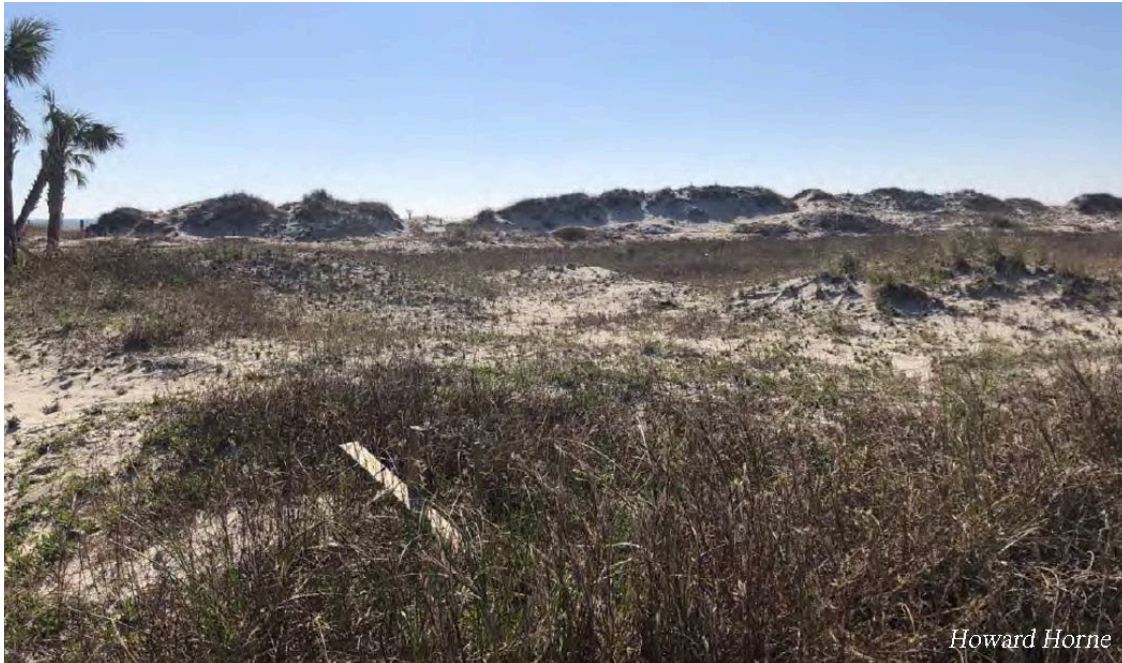
FIGURE 3-18 Natural Dunes and Adjacent Coastal Grassland Community

The Gulf-fronting dune system includes primary and secondary dunes (**Figure 3-18**). The primary dune system is a ridge or series of ridges or mounds of unconsolidated and usually mobile sands lying immediately landward of the upper limit of the Gulf beach and contiguous to mean high water. Secondary dunes include the dune field landward of the primary dunes. Primary dunes are low-elevation, typically less than about 10 feet relative to mean sea level (USGS 2017). Recent Mobile County elevation data (2015) show primary dune crests on the Island's East End ranging from 4 to 10 feet above sea level.

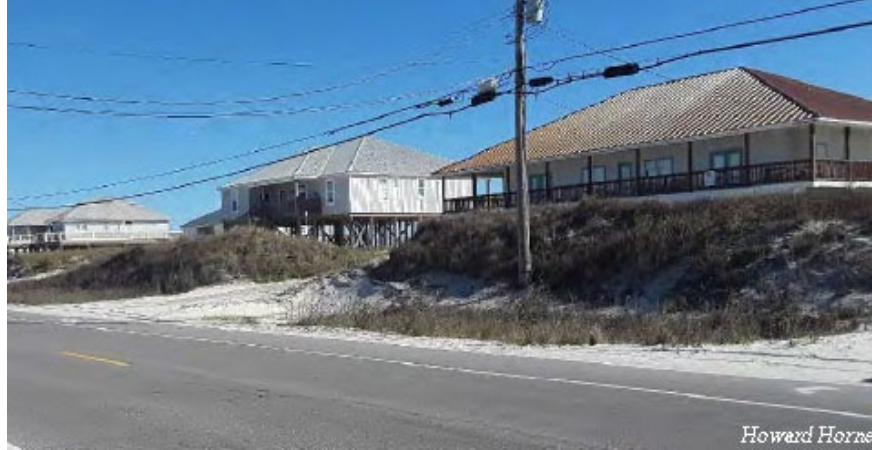
FIGURE 3-19 Densely Vegetated Berm on South Side of Bienville Boulevard

On the West End, roadside rights-of-way berms comprise relocated sand deposits, with many of these having fairly dense plant cover (**Figure 3-19**). The most abundant species on these “artificial dunes” are sea oats (*Uniola paniculata*) and Gulf bluestem (*Schizachyrium maritium*). Other common species include shell mound prickly pear cactus (*Optunia stricta*), camphor weed (*Heterotheca subaxillaris*), large-leaf pennywort (*Hydrocotyle bonariensis*), common reed (*Phragmites mauritianus*), and bladderpod (*Sesbania vesicaria*). Torpedo grass (*Panicum repens*), a highly invasive species, also occurs on the berms.

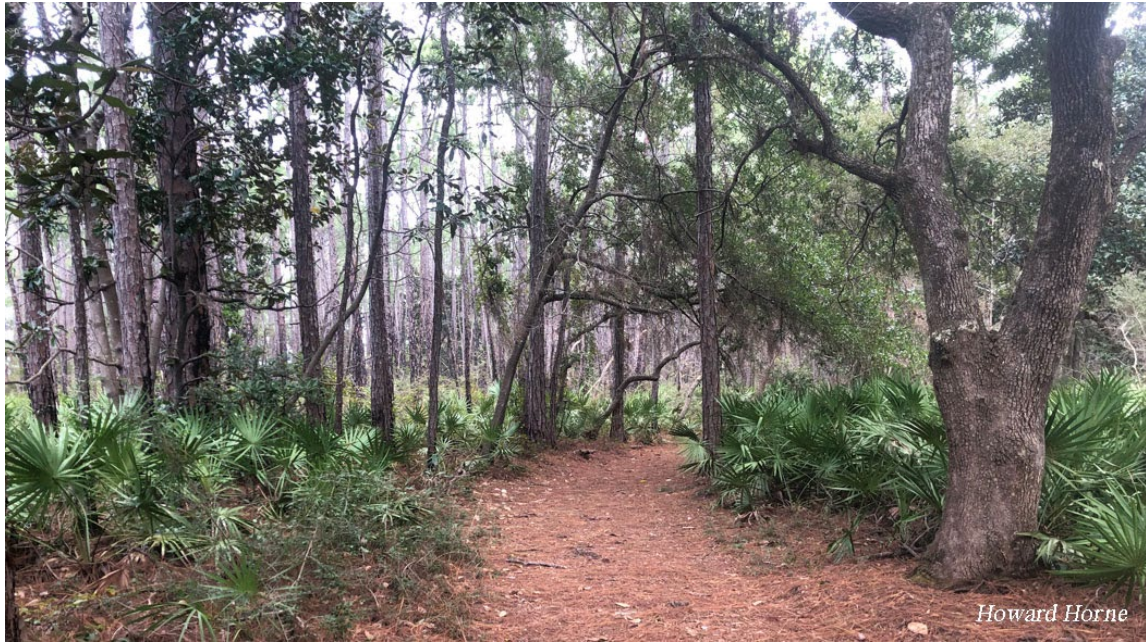
FIGURE 3-20 Dauphin Island Maritime Forest

Maritime forests are dominated by broadleaved evergreen trees and shrubs (**Figure 3-20**). Some of the common tree and shrub species in the maritime forest of Dauphin Island are presented in **Table 3-3**. Southern magnolia (*Magnolia grandiflora*) and live oak (*Quercus virginiana*) are characteristic species, along with wild olive (*Cartrema Americanum*). Dwarf live oak (*Quercus minima*) is a rare maritime forest species tracked by the ALNHP.

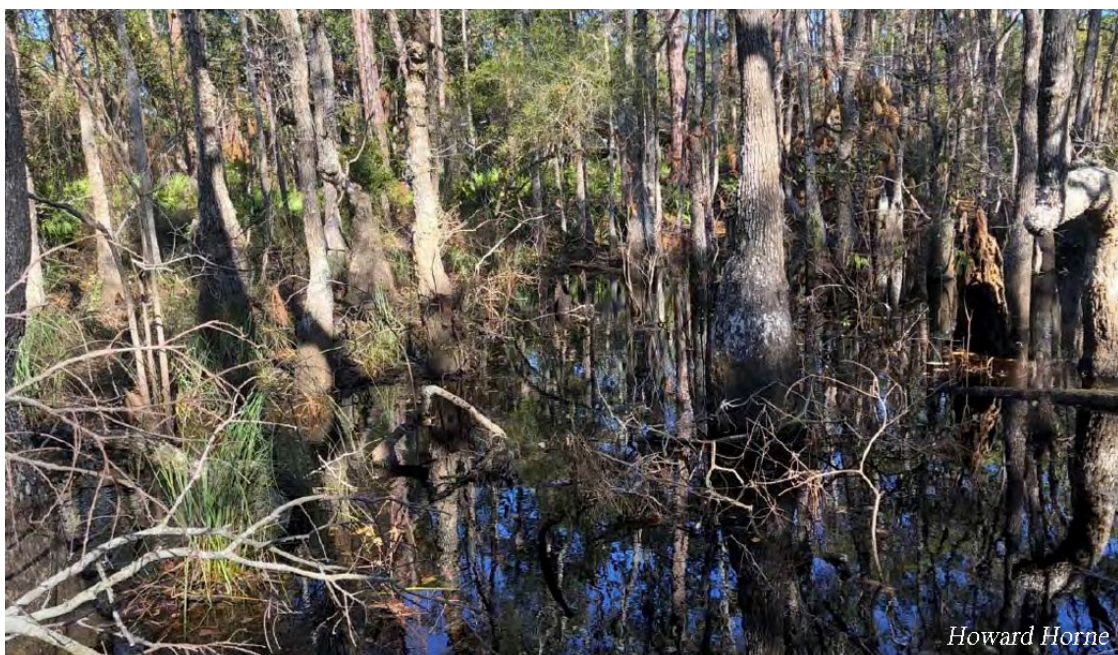
FIGURE 3-21 Forested Gum Swamp on Dauphin Island

Forested depressions are topographically isolated and seasonally inundated by rainwater, primarily during late winter and early spring and again in the fall. When flooded, they are pond-like with standing water reaching two feet in depth (or more) that can persist for several weeks (**Figure 3-21**). Swamp tupelo (*Nyssa biflora*) typically dominates the upper canopy of these gum swamps. Woody shrub diversity is low in gum swamp habitats, particularly within the deeper water areas where buttonbush (*Cephalanthus occidentalis*) and myrtle-leaf holly (*Ilex myrtifolia*) are the only species present. Outside of the wetter center, slash pine (*Pinus elliottii*), red maple (*Acer rubrum*), sweet bay magnolia (*Magnolia virginiana*), sweetgum (*Liquidambar styraciflua*), water oak (*Quercus nigra*), live oak (*Q. virginiana*), and southern magnolia (*Magnolia grandiflora*) are frequently encountered.

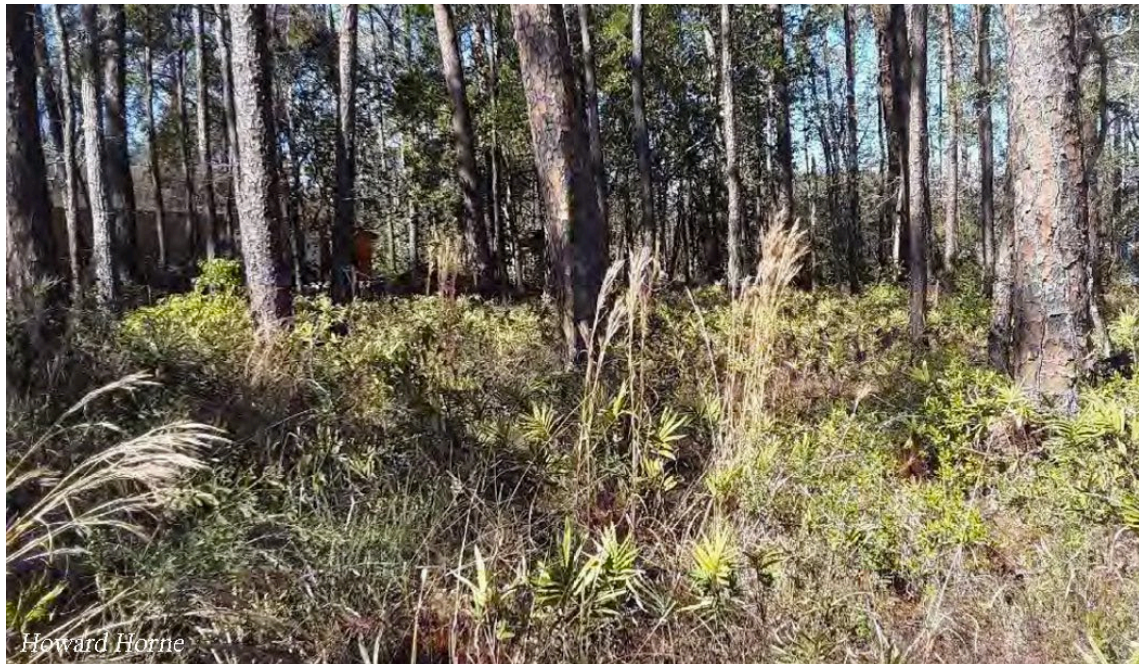
FIGURE 3-22 Wet Pine Forest on Dauphin Island

Wet pine forests on the Island naturally have a sparse or absent midstory and a dense groundcover of hydrophytic grasses, herbs, and low shrubs (**Figure 3-22**). The understory of moist pinelands may be very dense, especially if fire has been prevented, and consists largely of gallberry (*Ilex glabra*), wax myrtle, and saw palmetto. Herbs include grass-like plants, mostly of the sedge family (Cyperaceae), but also with true grasses (Poaceae), such as switch cane (*Arundinaria tecta*), rushes (Juncaceae), and yellow-eyed grasses (*Xyris* spp.).

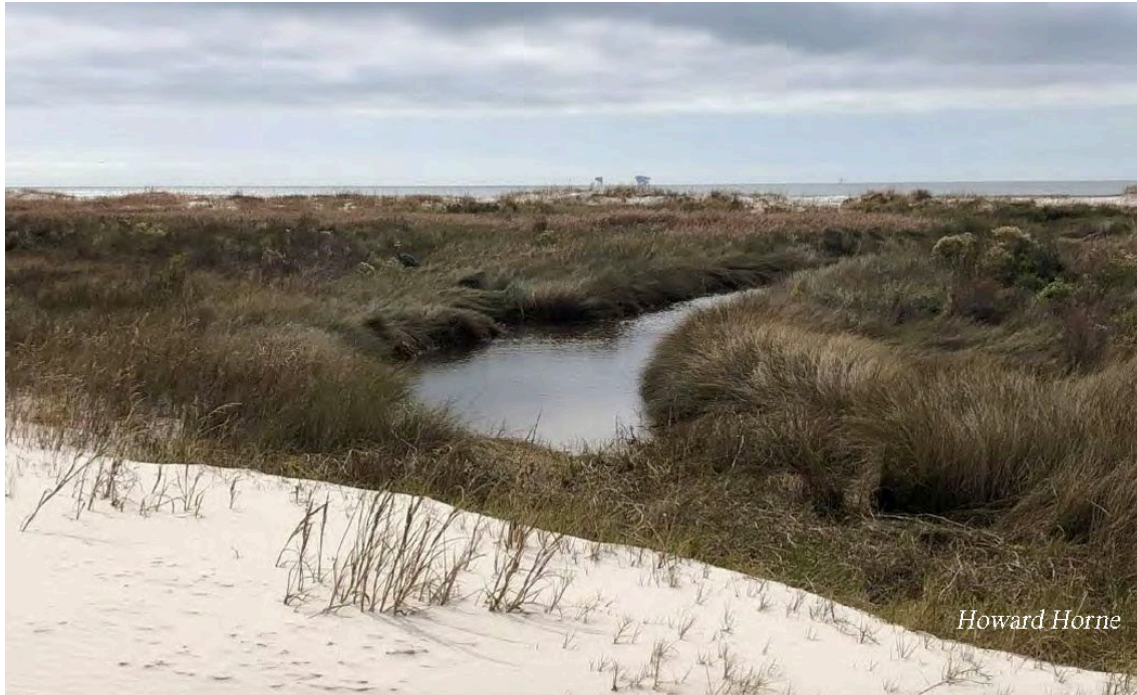
FIGURE 3-23 Tidal Marsh on Pelican Island

Tidal marshes are primarily distributed along the northern shoreline of Dauphin Island and on the west side of Little Dauphin Island (see **Figure 3-16** and **Figure 3-17**). These areas are inundated mainly by daily tides with high marsh inundated mainly by wind-driven high tides. Tidal marshes provide important nursery habitat for shrimps, crabs, and fishes; baffle wave energy; prevent shoreline erosion; sequester nutrients; improve water quality; and provide habitat for a diverse wildlife community (**Figure 3-23**).

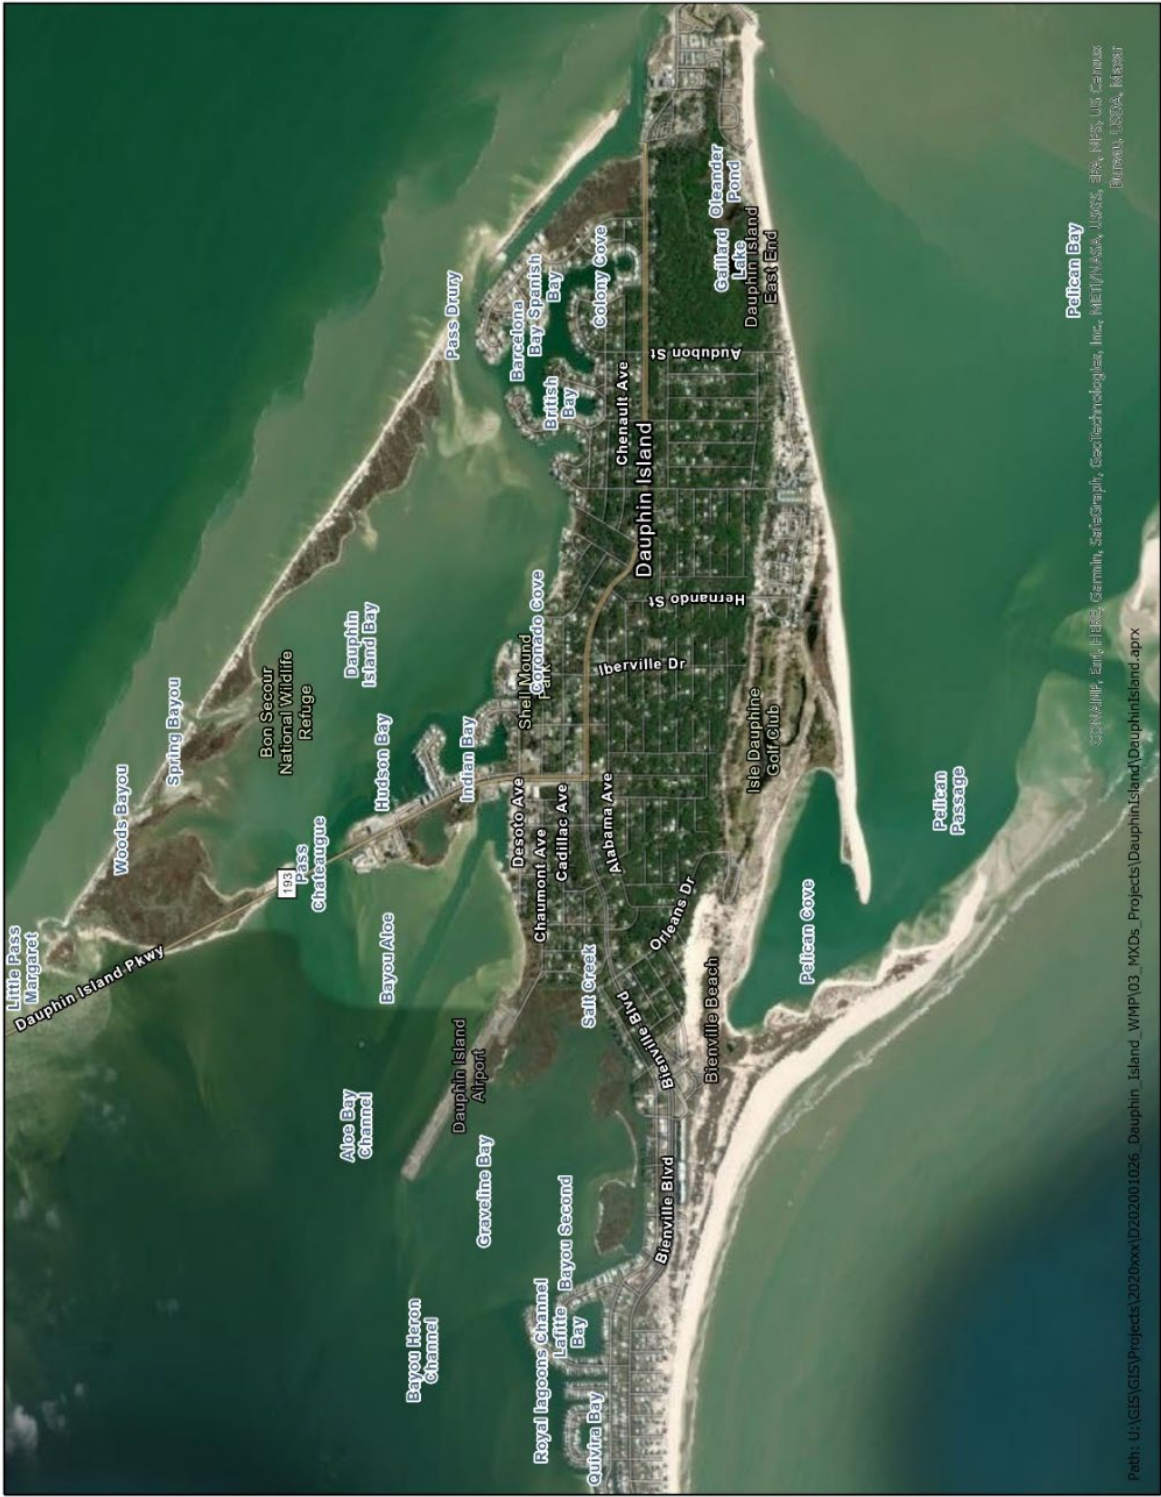
This section presents a narrative summary of existing conditions in the Dauphin Island Watershed from the review of available data. While Dauphin Island does not have any main tributaries, like more traditional watersheds, it does contain several unnamed tidal creeks and small water bodies including Salt Creek, Spring Bayou, Woods Bayou, Dauphin Island Bay, Colony Cove, Spanish Bay, Barcelona Bay, British Bay, Coronado Cove, Hudson Bay, Indian Bay, Aloe Bay, Graveline Bay, Lafitte Bay, Bayou Second, Quivera Bay, Pelican Cove, Pelican Bay, Gaillard Lake, and Oleander Pond (**Figure 4-1**).

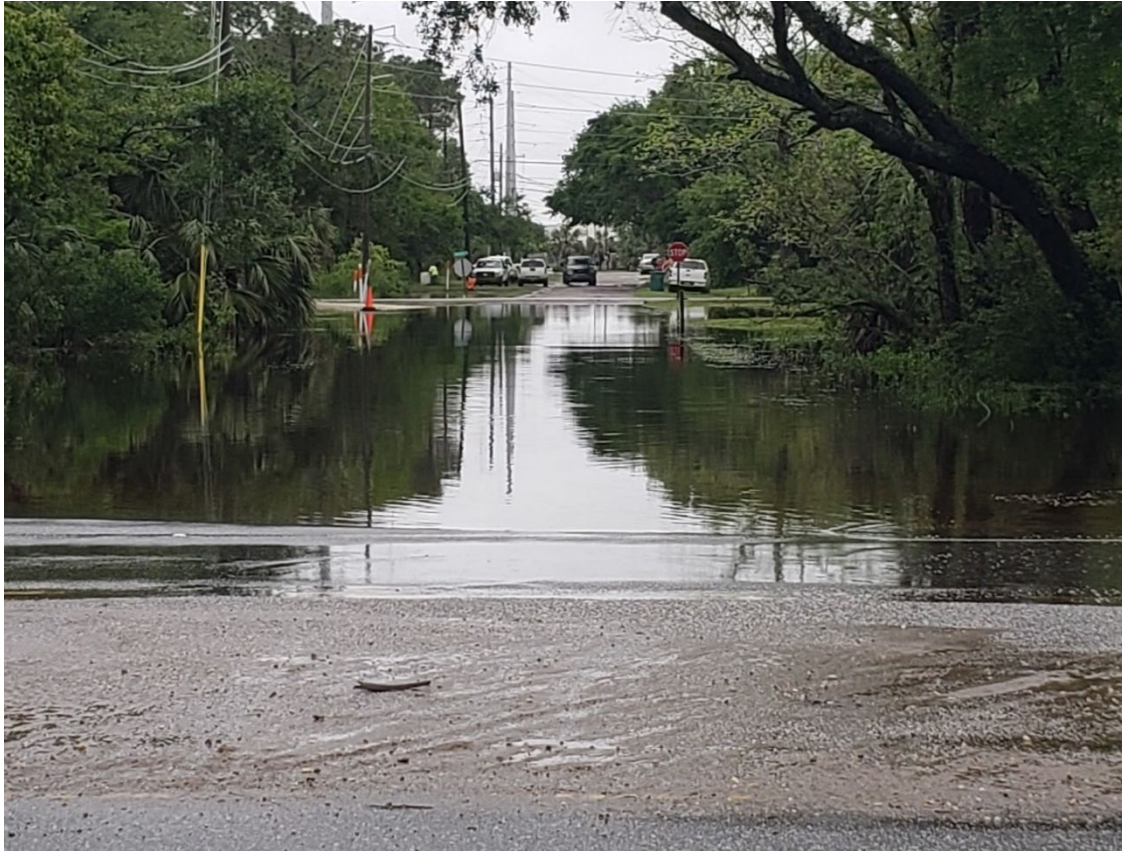
Due to its small size and population, Dauphin Island does not have a MS4 system. Like many small communities in coastal Alabama, a comprehensive stormwater management system was not created when the Town was platted and developed. The Town's drainage system is primarily made up of small open ditches and culverts that do not have the capacity to handle large rainfall events on the Island, which results in frequent flooding (**Figure 4-2**).

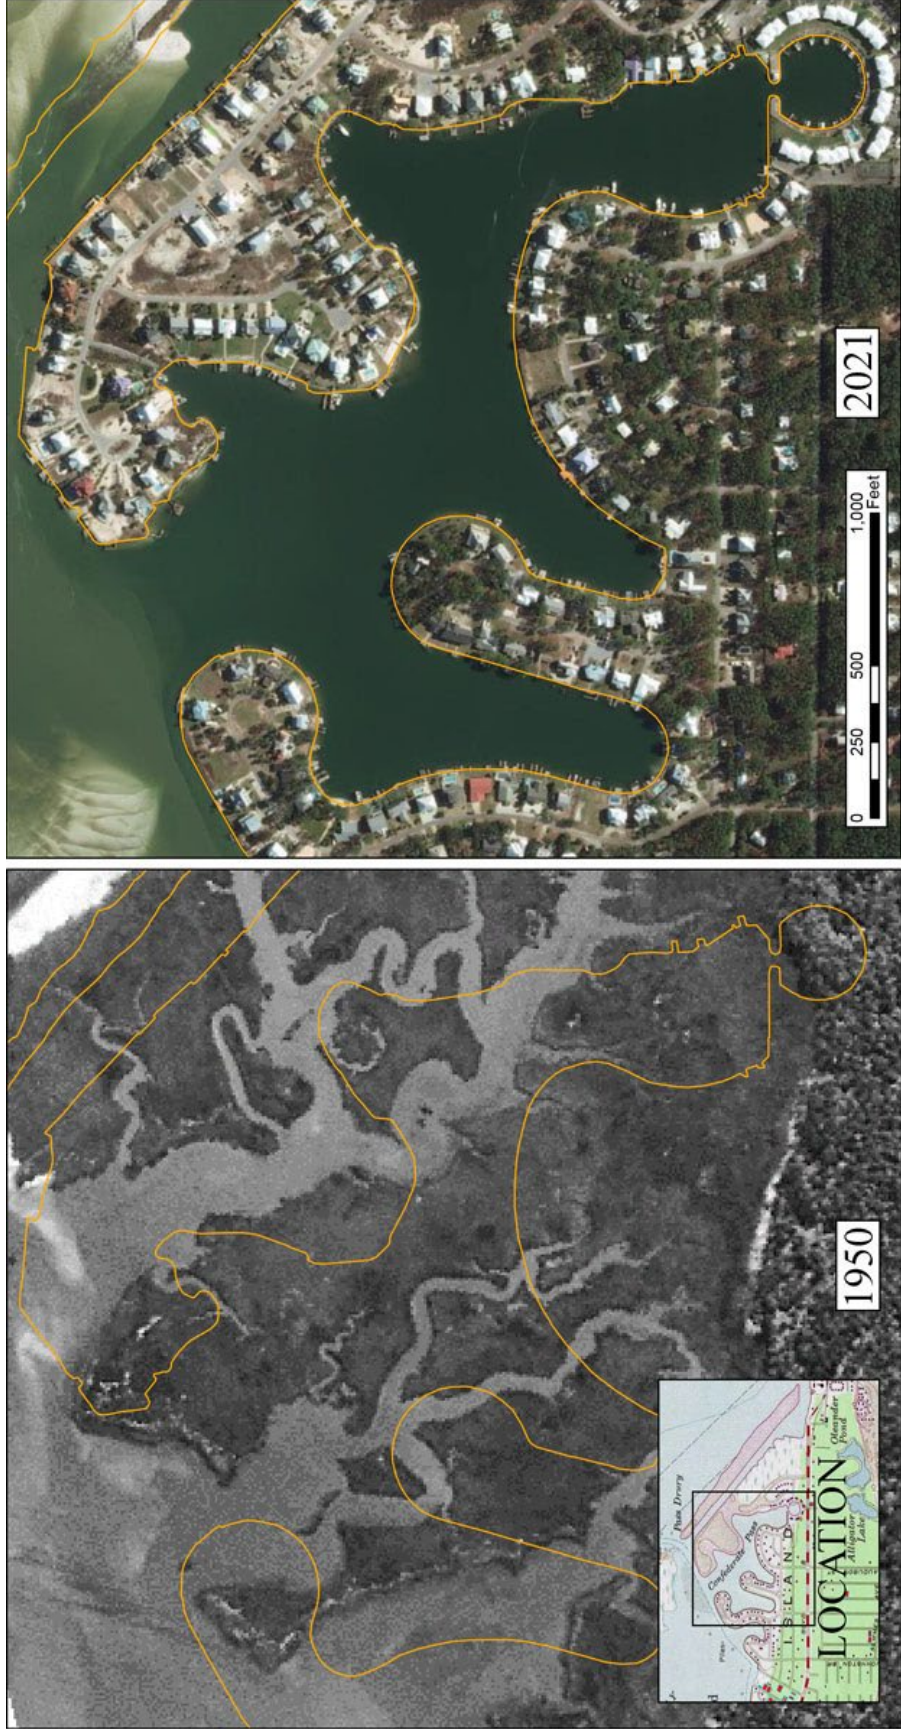
FIGURE 4-5 Aerial Imagery Comparing the Pre-Development Condition of a Tidal Marsh Complex (1950) with the Present Day Developed Shoreline (2021) at Confederate Pass

Tidal marshes are generally classified as high-quality wetlands throughout the Alabama coastal zone. From a regulatory standpoint, the Town classifies all Island wetlands as high quality. In terms of the important ecosystem services provided by the Island's non-tidal wetlands, forested depressions such as gum ponds and swamps are critical locations for stormwater attenuation and groundwater recharge, and are a high priority for preservation. The Town is in the process of updating its 2004 Wetland Ordinance to address ongoing loss of wetlands through filling for development.

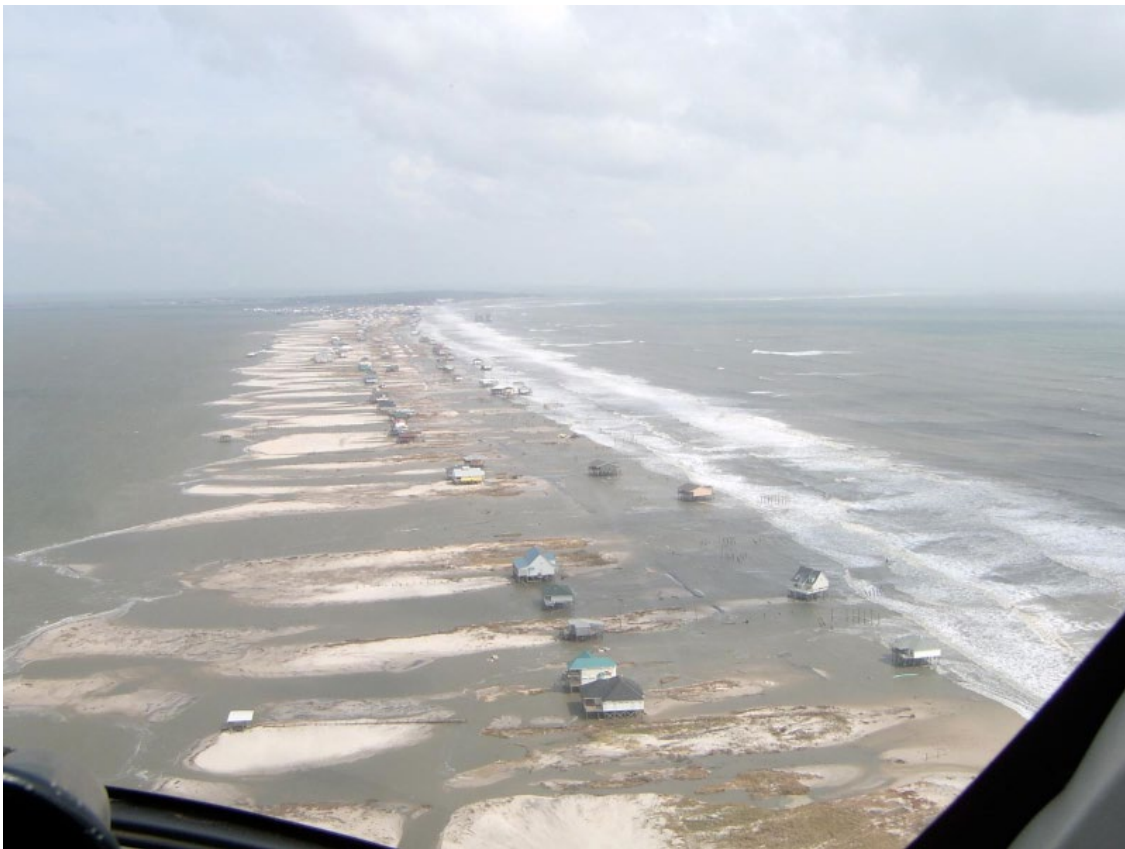
FIGURE 4-24 Overwash of the West End during Hurricane Katrina

The western four-fifths of the Island are considered a simple barrier island, indicating a low and narrow sandy landform dominated by overwash and longshore transport. This part of the Island is highly susceptible to storm impacts due to its low elevation (around five feet above sea level), narrow width, lack of substantial dune features, and no shielding from Pelican Island or existence of maritime forest found naturally on the East End. For example, when Hurricane Katrina made landfall in August 2005, 450 of the 500 homes on the West End were damaged when this part of the Island was completely covered with water (**Figure 4-24**; Gaul 2019).

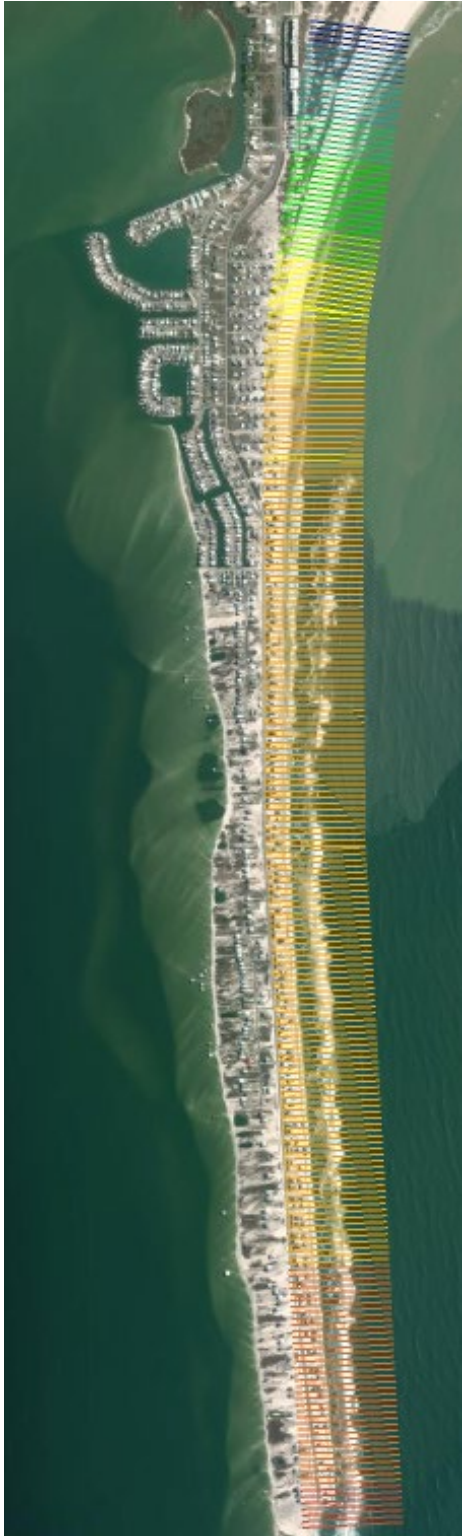
FIGURE 4-25 Long-Term Erosion Rates (LRR in meters/year) Along the Western Gulf Shore

Based on the USGS's review of historic shoreline locations discussed earlier in **Section 4.6.2**, **Figure 4-25** shows cross-shore transects color-coded based on the calculated long-term erosion rates between 1975 and 2019 (Smith et al. 2018). Almost the entire West End has experienced erosion greater than 3 feet/year (1 meter/year) since 1975.

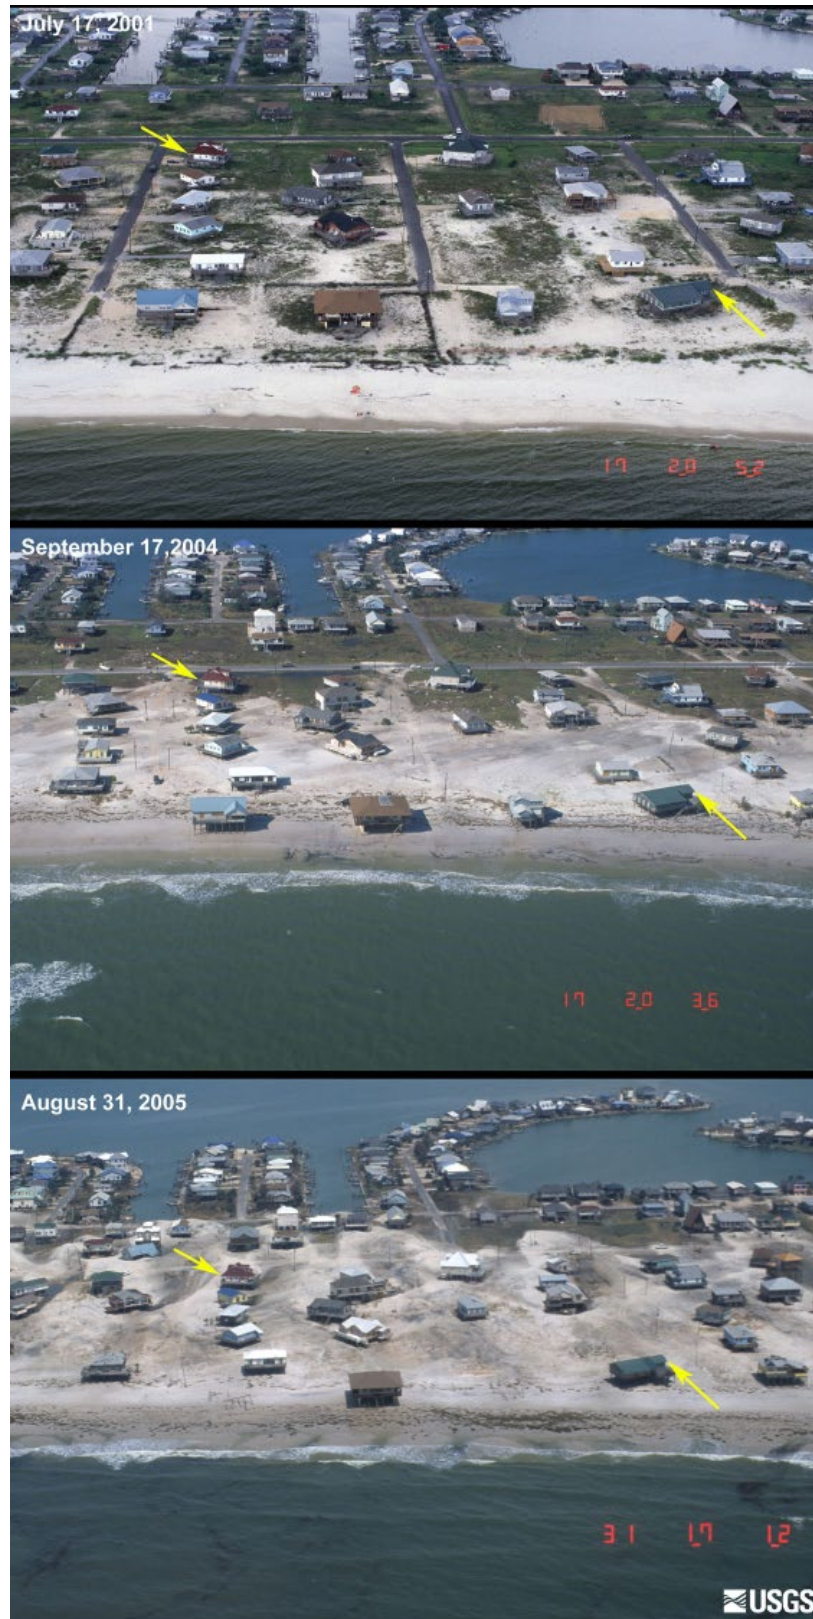
FIGURE 4-26 Photos Showing the Overwash of Sand from Hurricanes Ivan and Katrina

During extreme storm events, overwash transports sediment from the Gulf side of the Island to the back-barrier shorelines, which is an important process for sustaining barrier island width (Smith et al. 2018). This is called barrier island rollover and allows the Island to be maintained, but at a more landward location after major storm events. **Figure 4-26** shows how the overwash from Hurricanes Ivan (September 2004) and Katrina (August 2005) covered much of the West End in sand. However, human activities, such as the residential construction on the West End, have attempted to “pin” the Island in place. **Figure 4-27** shows the West End shoreline in 1992 and in 2022 and the bulkheaded western-most house, which is “attempting” to hold the shoreline in place. This pinning of the shoreline has resulted in loss of structures during extreme events as the Island tries to “adjust” out from under the development.

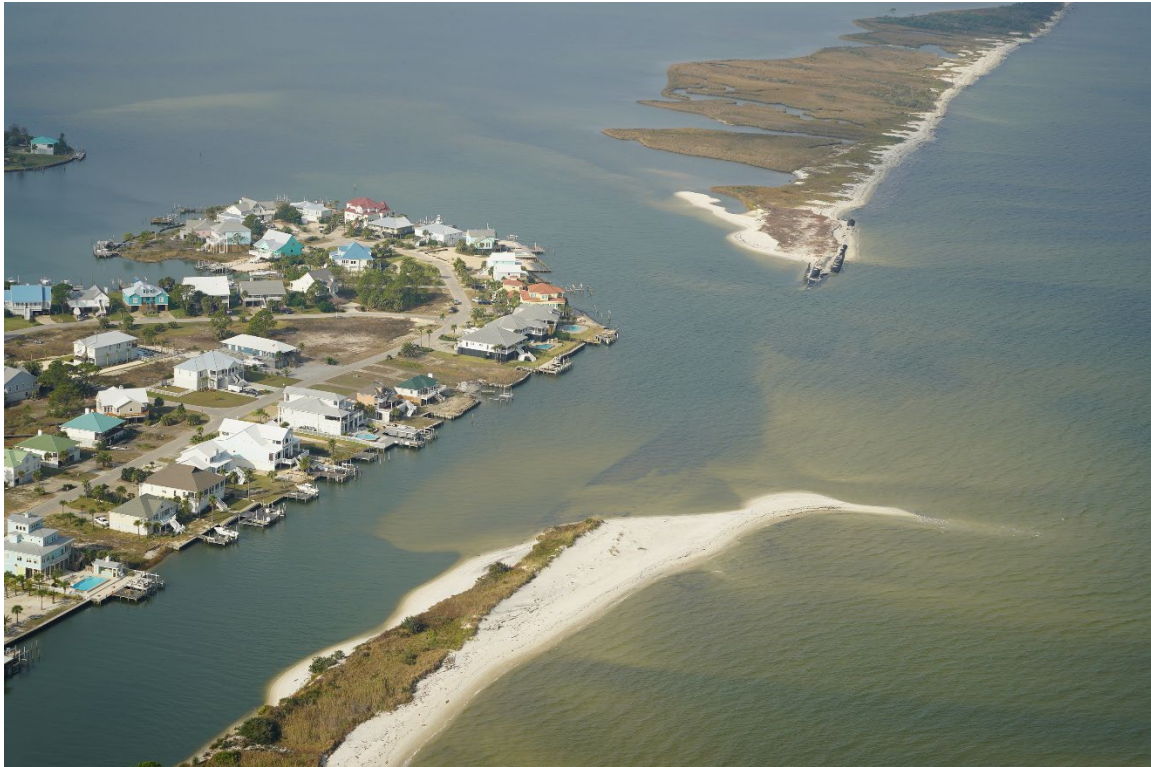
FIGURE 4-29 Photo of Pass Drury Adjacent to Homes

Just north of Barcelona Dr. on Dauphin Island is the historic Pass Drury. In the late 1950s, the Pass was closed off with dredge material, but it reopened during Hurricane Frederic in 1979 and was again closed with dredge material soon after (Douglass 1994). More recently, Little Dauphin Island was breached at the historic location of Pass Drury, and the Pass has remained open since. However, since the 1950s, development just inside the Pass has been extensive (**Figure 4-29**). At the time of this writing, the USACE is conducting the National Fish and Wildlife Foundation–funded Little Dauphin Island Restoration Assessment project, which is investigating restoration alternatives for Little Dauphin Island.

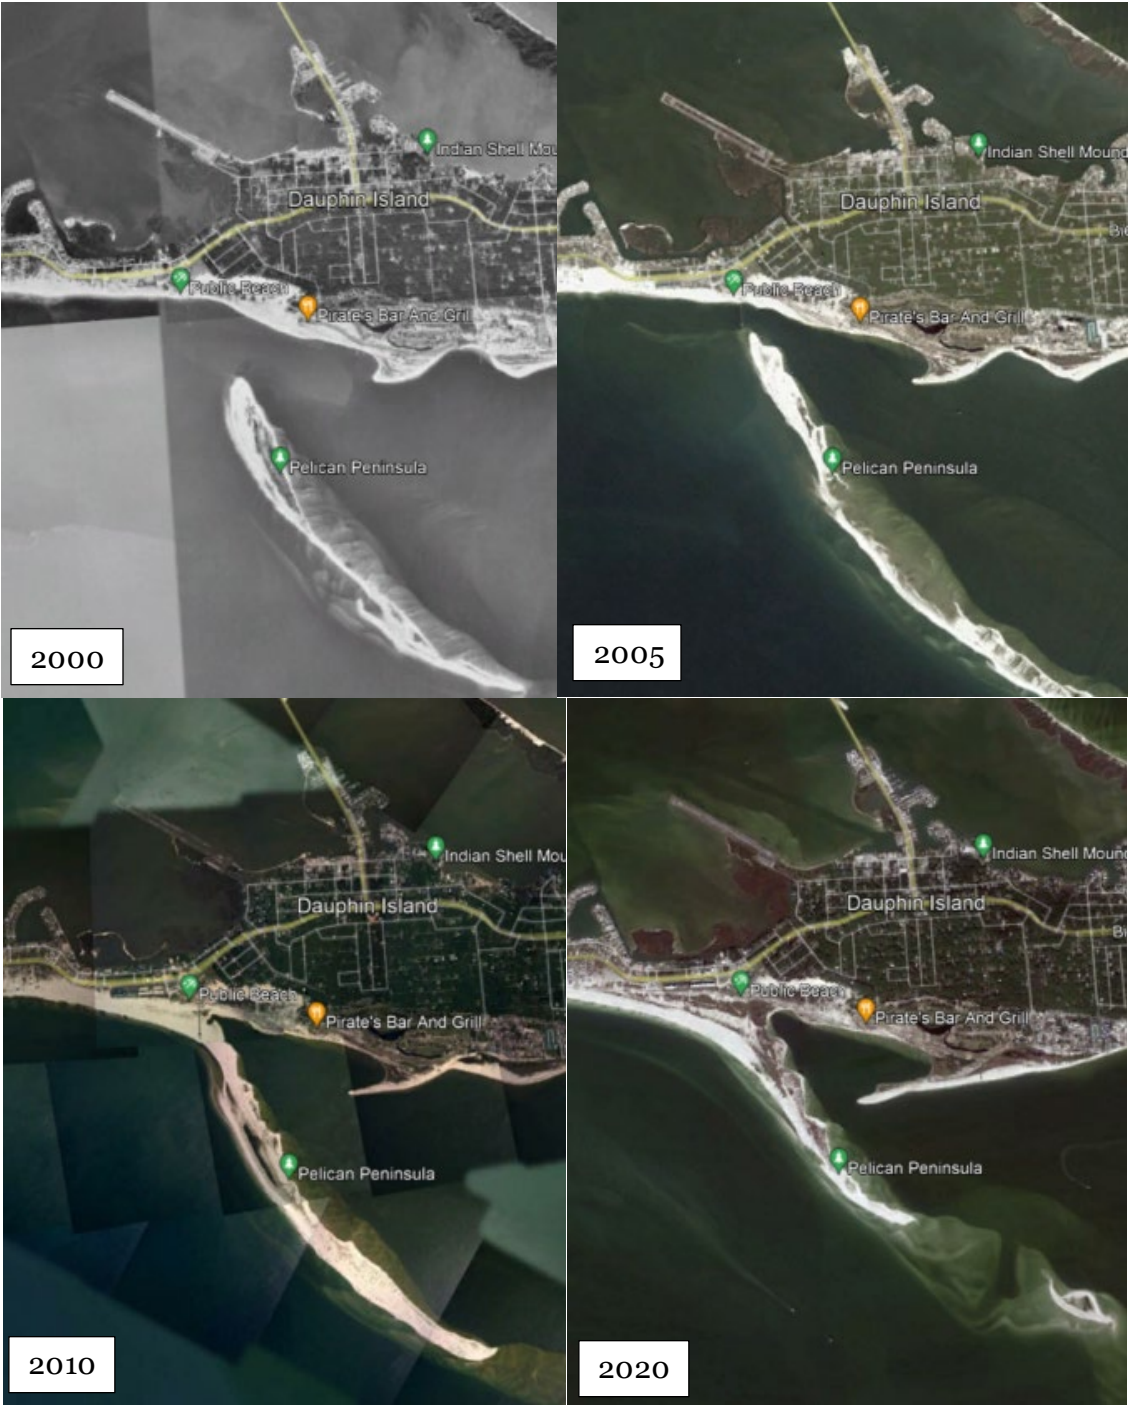
FIGURE 4-30 Pelican Island Morphology Over Time

Pelican Island or Peninsula, south of Dauphin Island, is very dynamic and has formed, merged, grown, and disappeared over the last century. In 2008, Pelican Island merged with Dauphin Island where the eastern and western shorelines meet, as shown in **Figure 4-30**. This connection of Pelican Island to Dauphin Island is the attachment of the ebb shoal fillet to the beach face. This is an indication that the ebb shoal complex is a very mature one, or that the ebb shoal is accreting volume. The ebb shoal complex will continue to accrete and erode sand seasonally, but this is a natural occurrence and provides an important buffer to the eastern portion of the Island. While there may be consideration to mine Pelican Island for sand to benefit other portions of Dauphin Island further west, due to its close proximity, it is important that the Island is not altered by anthropogenic means, as that could cause detrimental downdrift effects.

SOURCE: Jones and Tidwell 2012
NOTE: The figure presented is prior to Pelican Island merging into the public beach shoreline. Figure 4-30 presents those changes over time.

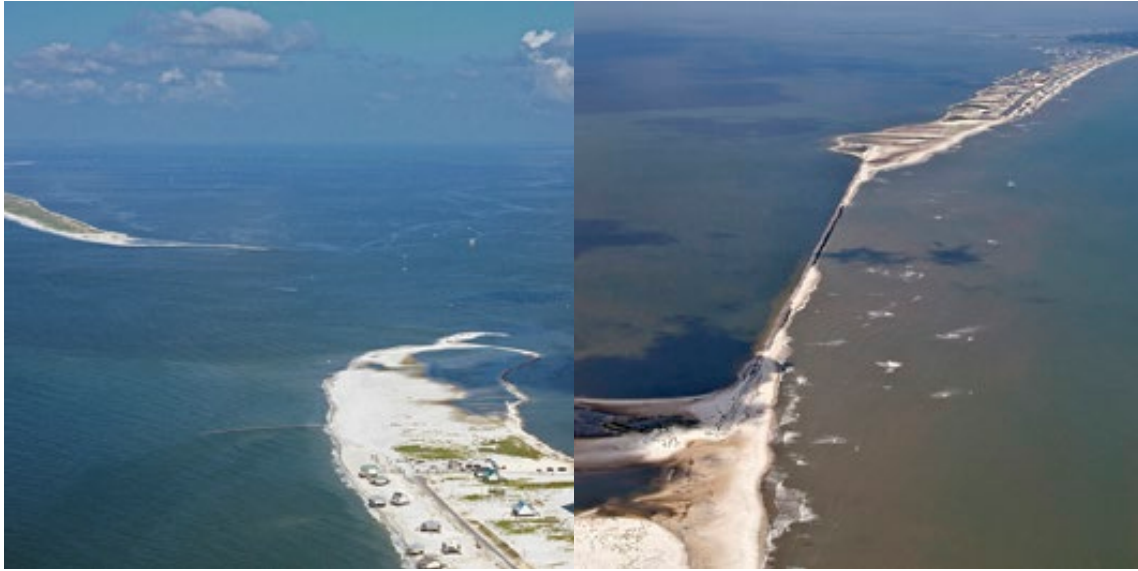
FIGURE 4-33 Katrina Cut Before and After Construction of the Rubble Mound

While the inlet resulted in back-barrier shoaling, which contributed to the Island width, the USACE issued an emergency permit to close the Katrina Cut with a rubble mound structure in April 2011 to protect against oil from the *Deepwater Horizon* oil spill getting into the Mississippi Sound (**Figure 4-33**). Additionally, the Cut led to concerns about additional saltwater entering the Sound and impacting oyster reefs (Enwright et al. 2020). In 2020, as part of the Barrier Island Study, the USACE developed a three-dimensional hydrodynamic and water quality model to evaluate the impacts of additional breaches on the Island (Bunch et al. 2020). Model results showed that breaches in Dauphin Island contribute to the exchange of water between the Gulf and the Sound, while breaches in Little Dauphin Island and Pelican Island only resulted in localized impacts. The USGS found that restoration to reduce breaches would affect oysters in Mississippi Sound positively (Enwright et al. 2020).
