Dauphin Island

WATERSHED MANAGEMENT PLAN

FINAL

March 2023

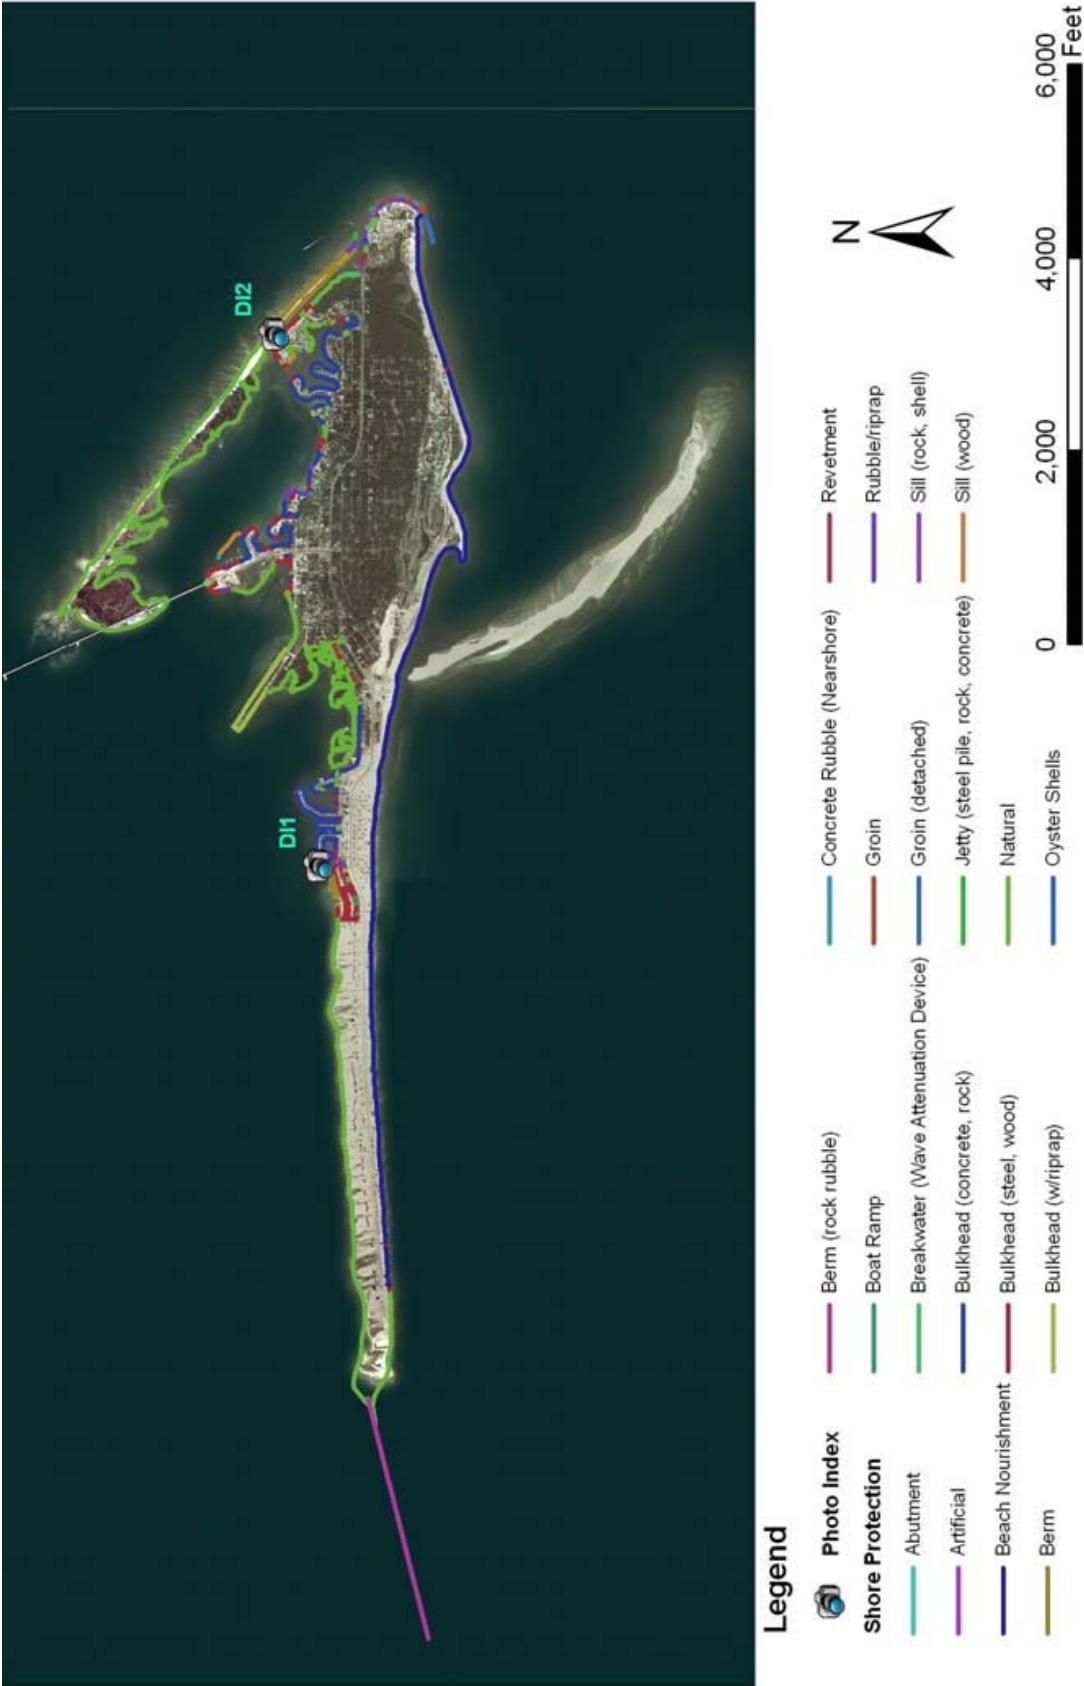
FIGURE 4-35 Shore Protection Along Dauphin Island

Bulkhead shore protection encompasses 12 miles of the Island, with beach nourishment encompassing 7.3 miles, berm shore protection 3.6 miles, and the remaining two miles armored through various methods. No apparent hard shoreline modification was found in 18.6 miles of the Island (Jones and Tidwell 2012; Alabama Department of Conservation & Natural Resources 2017). **Figure 4-34** illustrates the proportional breakdown of each shoreline protection type as a percentage of the entire shoreline. **Figure 4-35** depicts the geographic distribution of shore protection types, followed by **Figures 4-36, 4-37, 4-38, and 4-39**, which depict the shore protection types in greater detail. Due to geomorphological changes, the mapping shows some inconsistencies between the shore protection type data and the aerial imagery.

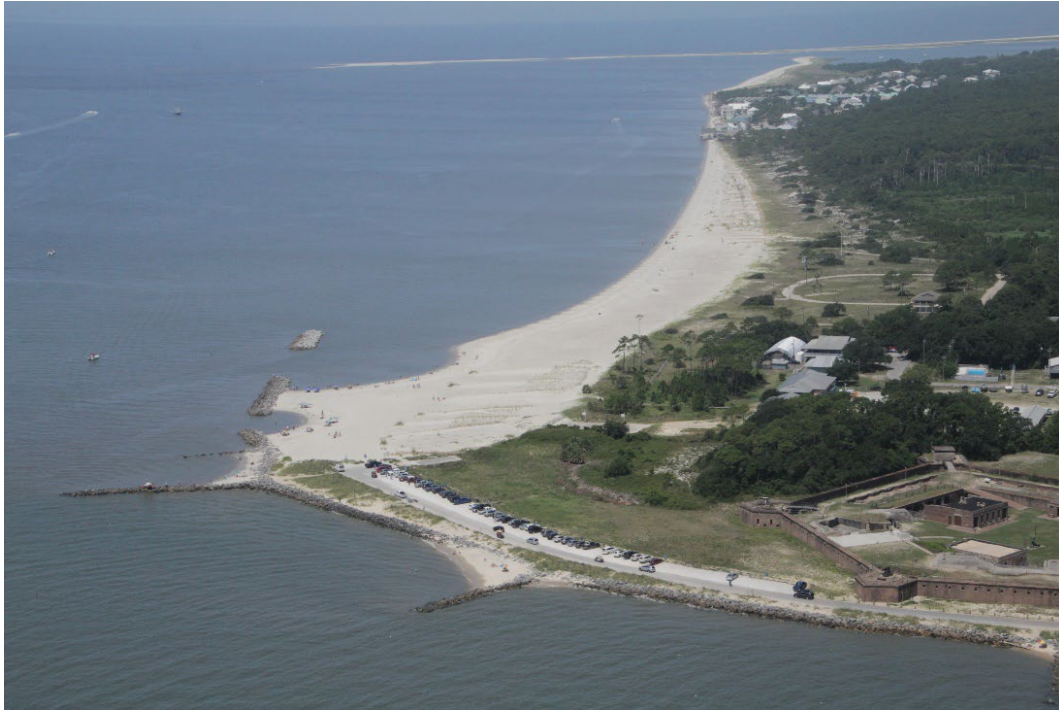
FIGURE 4-40 Shoreline Stabilization at East End

The eastern portion of the Island includes a groin field first built in 1894 to protect Fort Gaines. In 1897, a seawall was incorporated, and in 1909 additional groins were added along the shoreline southwest of the seawall. To mitigate for extensive erosion, eight of the western-most detached groins were reoriented in 2015 and 2016 into segmented breakwaters as a part of the Coastal Impact Assistance Program East End Shoreline Restoration Project (**Figure 4-40**).

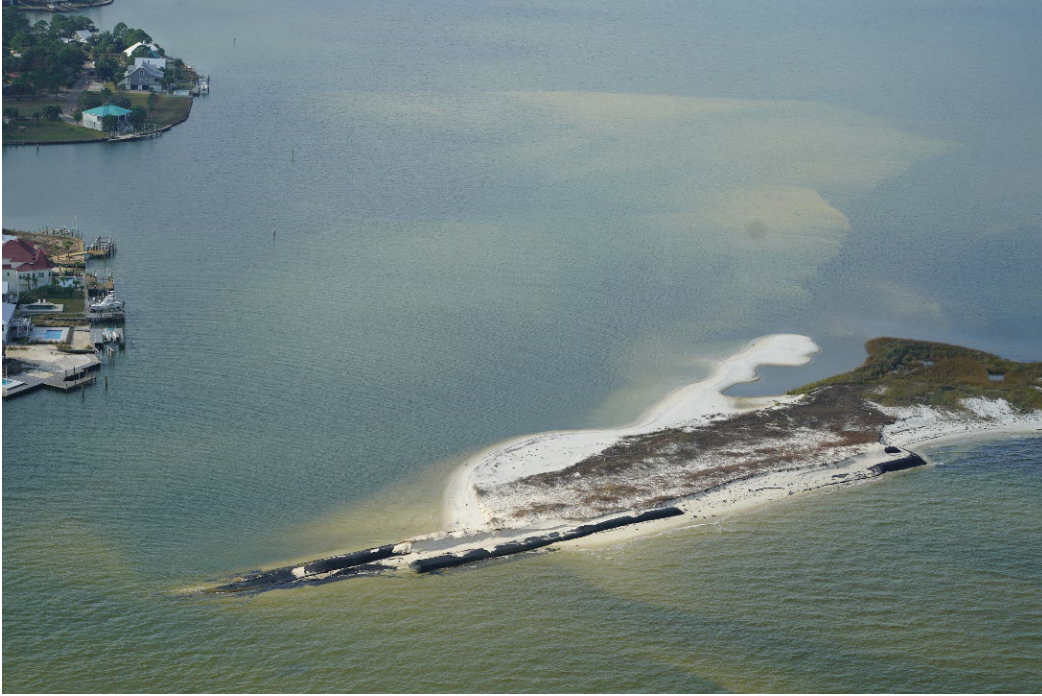
FIGURE 4-41 Shoreline Stabilization at Little Dauphin Island

Pelican Island is not currently protected by anthropogenic measures. Geotubes have been used on Little Dauphin Island during previous stabilization attempts (**Figure 4-41**). Sand Island is constantly shifting; however, the lighthouse is stabilized by a concrete base and rocks (**Figure 4-42**).

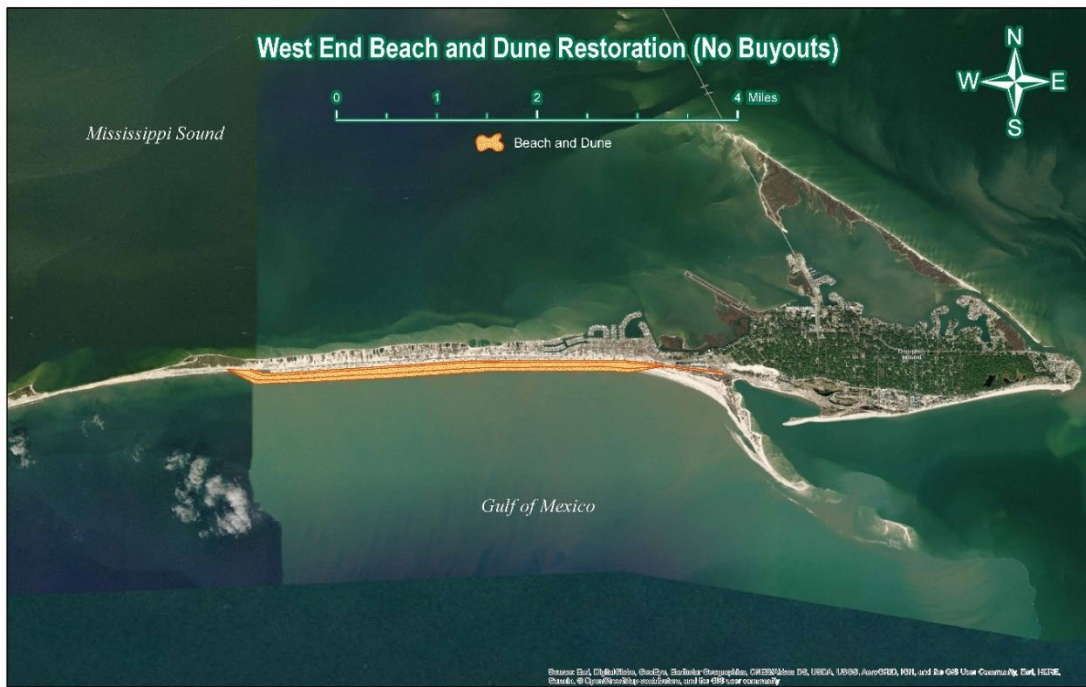
FIGURE 4-44 West End Beach and Dune Restoration Project

The Town has also received grant funds from National Fish and Wildlife Foundation to complete engineering and 30% design of a beach nourishment project on the West End. The project will focus on the Gulf shore from approximately Mid-Island west to Katrina Cut (**Figure 4-44**).

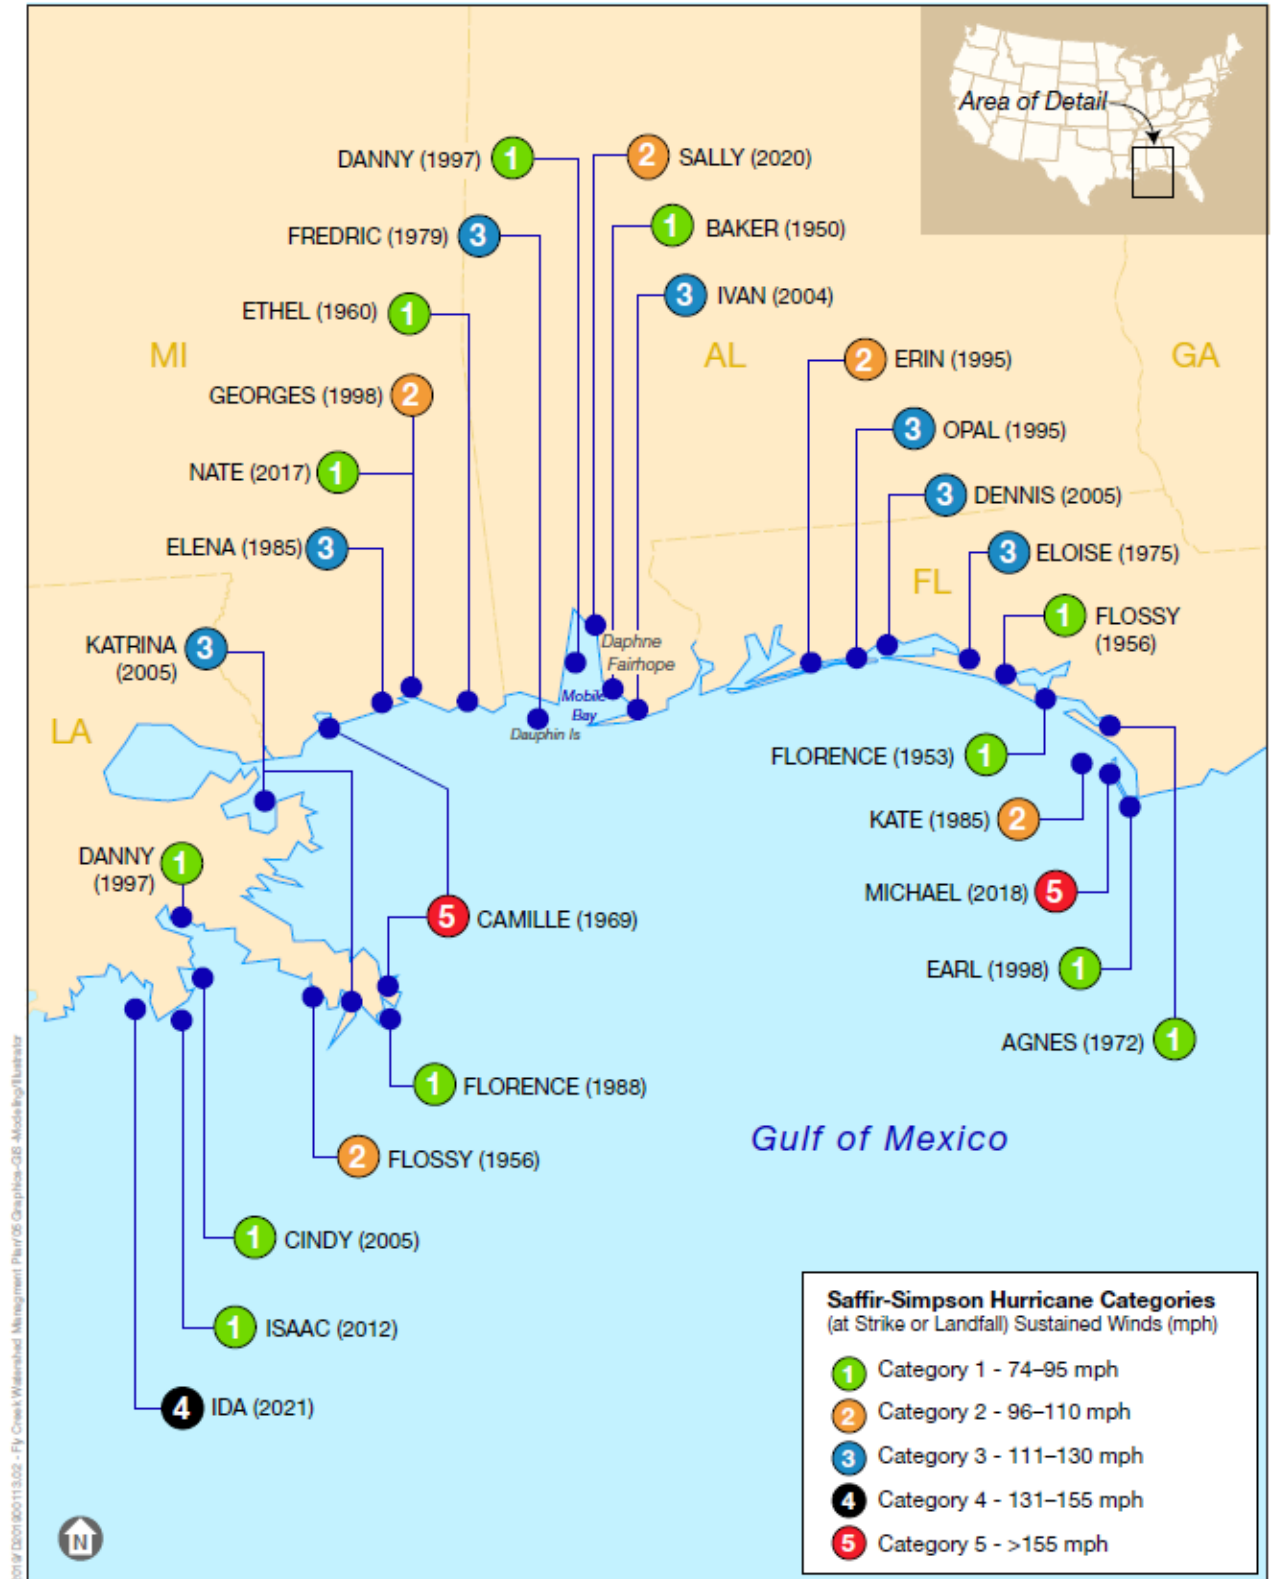
FIGURE 5-6 Gulf Coast Hurricane Strikes Between 1950 and 2021

As discussed in **Sections 3.3.1** and **4.6**, Dauphin Island residents have endured many severe storms throughout history (see **Figure 5-6**) and the 2020 hurricane season impacted local community with Hurricane Sally making landfall nearby in Gulf Shores. This storm made landfall in the same place and on the same day (September 16) as Hurricane Ivan did 16 years earlier in 2004. Some of Sally's impacts can be attributed to its slow speed—sometimes only moving 2 to 3 miles per hour, which brought sustained winds and dumped extensive amounts of rain across Dauphin Island. Many lost power for an extended time and homes on the sound side of the Island took the brunt of the damage with the sustained winds causing significant roof and siding damage.

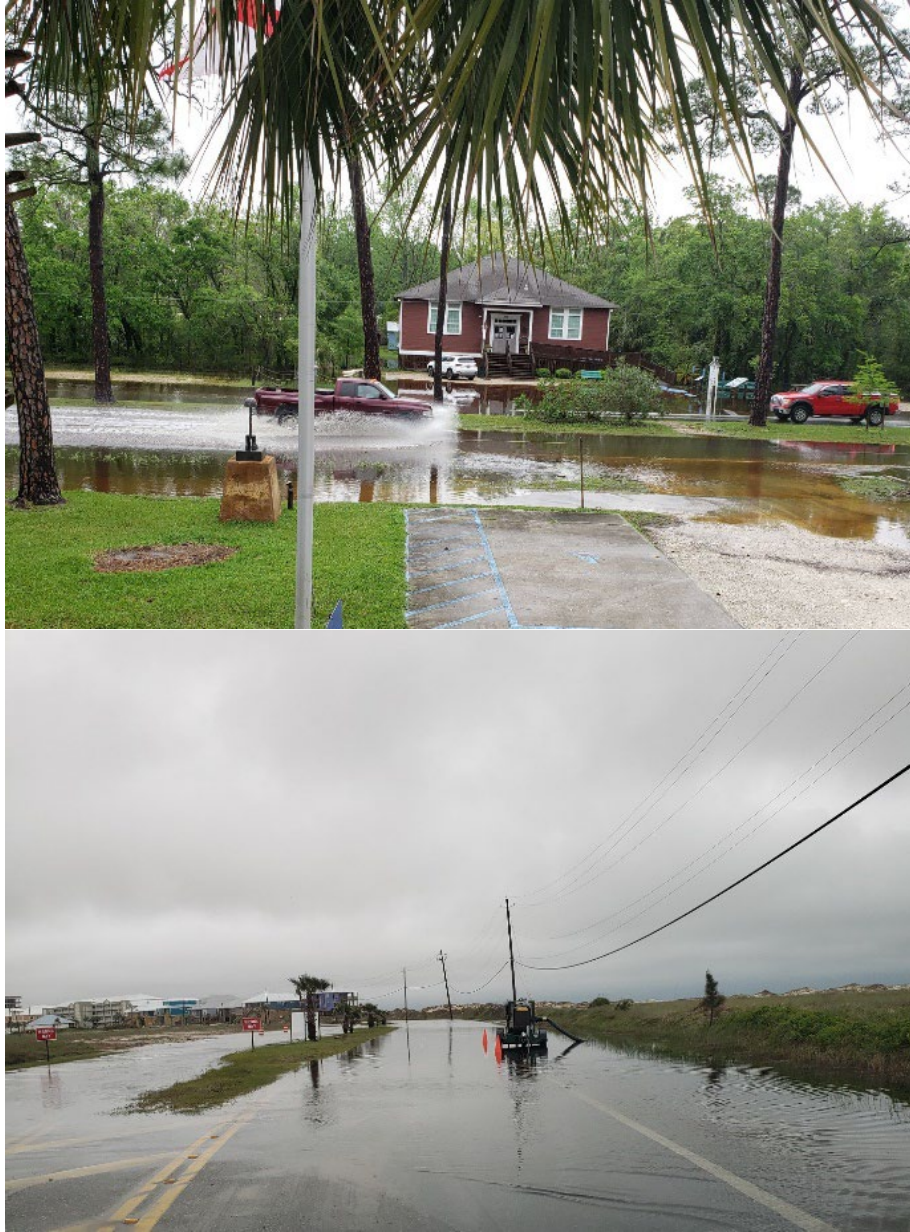
FIGURE 5-8 Photos Showing Flooding on the Island after Heavy Rains in April 2021 (Top: East End; Bottom: West End)

Dauphin Island already experiences extreme precipitation, as the Alabama Gulf Coast is one of the wettest areas in the United States. As discussed in **Section 3.3.1**, Dauphin Island already experiences very intense rainfall based on NRCS rainfall distribution pattern categories. An increase in the number of flood events can impact homes and businesses in low-lying areas resulting in property damage, injuries, and displacement. Additionally, with higher sea levels, drainage to the ocean will be impeded, which will extend the duration for flood events. Vulnerable populations such as low-income households, senior citizens, or people living in ground level housing will face greater impacts of flooding as they have a reduced ability to respond to damage from flood events. Dauphin Island’s Comprehensive Plan (2013) noted that the population of Dauphin Island is aging, with 23% of the population 65 years and older—this is significantly higher than the percentages for Mobile County or Alabama. The Plan discusses that 34% of households have persons over the age of 65, and almost 10% of households have someone 65 years and older living alone. Additionally, many households will face difficulties in the event of evacuations due to street flooding and other access issues. Flooding may also impact emergency response facilities and other critical infrastructure that is below grade and can temporarily interrupt key access roads for emergency responders or evacuation routes.

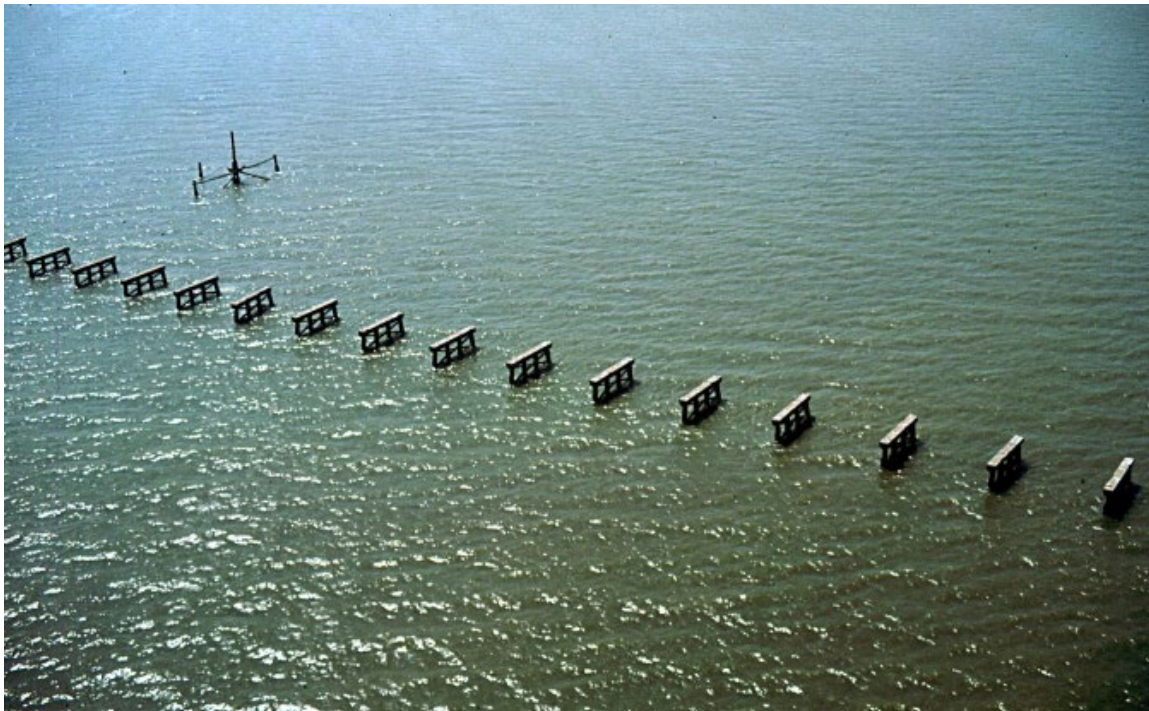
FIGURE 5-9 Photo of the Remains of the Dauphin Island Bridge after Hurricane Frederic

In September 1979, Category 4 Hurricane Frederic passed over Dauphin Island with winds gusting from 100 to 145 miles per hour and 12- to 15-foot storm surge (NOAA NWS 2021). As shown in **Figure 5-9**, the storm toppled the only bridge to the Island and destroyed 140 houses (Gaul 2019). For the 34 months after the hurricane, those traveling to and from the Island had to use the ferry until the new bridge was opened.

The South Alabama Regional Planning Commission (2020) assessed the vulnerability of transportation in the Mobile area and determined a vulnerability score of 2.92 for the Dauphin Island Bridge and causeway, where 1 to 1.9 indicates low vulnerability, 2 to 2.9 indicates medium vulnerability, and 3 to 4 indicates high vulnerability.

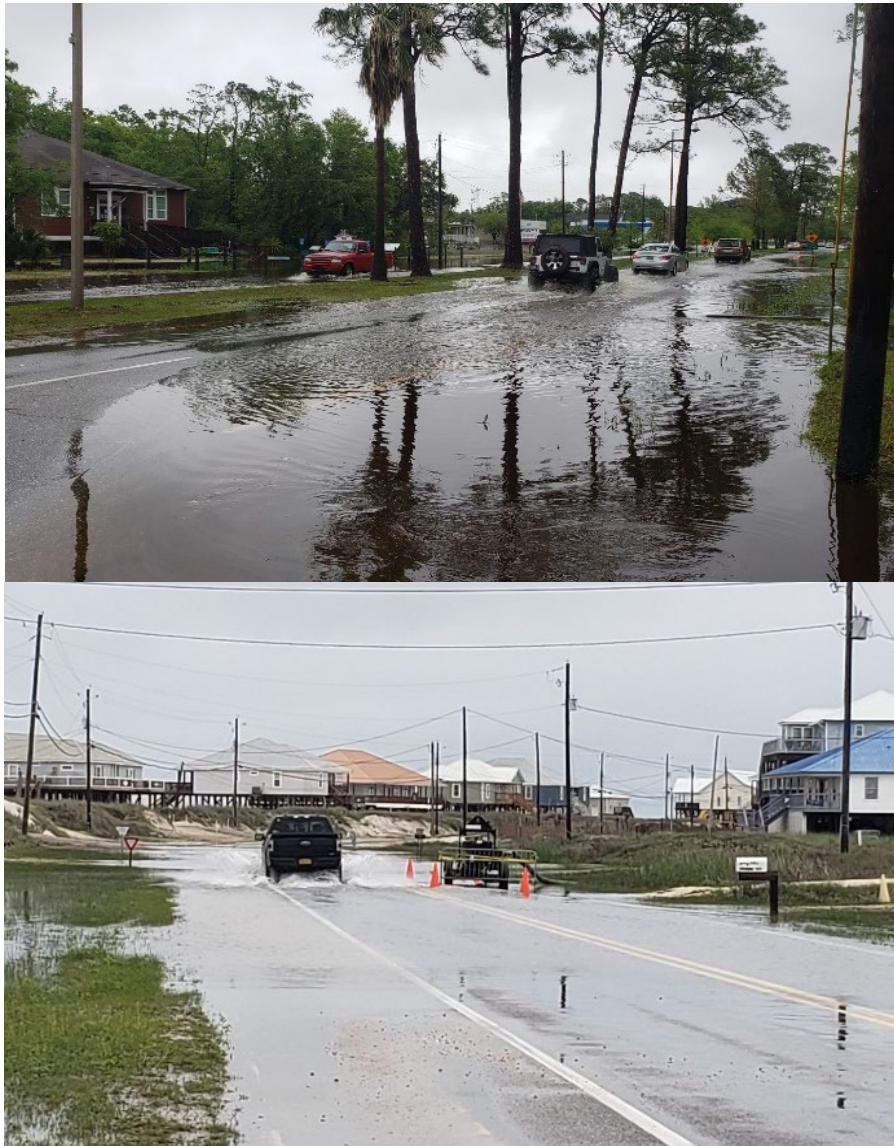
FIGURE 5-10 Photos of Flooding on Bienville Boulevard after Heavy Rains in April 2021 (Top: East End; Bottom: West End)

Sea level rise and flooding are likely to continue impacting transportation systems to and around Dauphin Island (**Figure 5-10**). Evacuation and re-entry during storms are particularly challenging since the causeway to the Island can become impassable (Janasie 2014). Additionally, storms often wash sand over Bienville Boulevard, temporarily blocking access to the homes on the West End (**Figure 5-11**). Sea level rise may also cause impacts to docks and shoreline protections (e.g., sea walls), reducing access to the shorelines, which could affect water-based transportation to and from the Island (e.g., ferrying). Impacts to transportation have the additional impact of delaying utility and emergency workers, reducing the ability of the Island to adapt to hazards, individual and community emergencies, and other challenges.

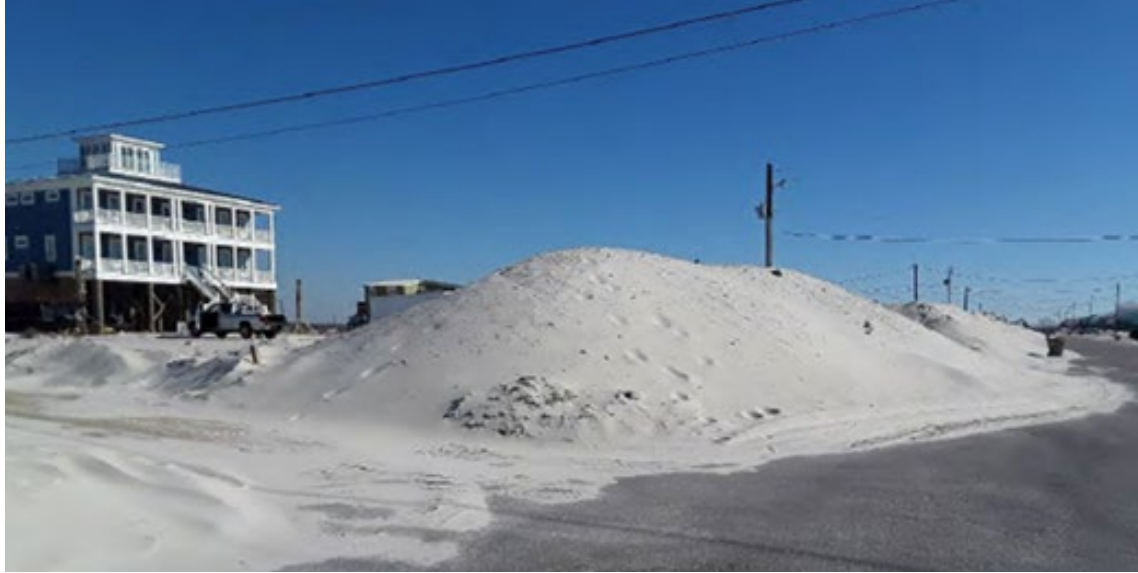
FIGURE 5-11 Photo of Sand Berm along Bienville Boulevard on the West End of the Island

As discussed in **Chapter 4**, Dauphin Island is already experiencing erosion from long-term processes and extreme weather events and has lost 16% of its area between 1958 and 2007 (Morton 2008). Recent tropical storms have eroded and flattened the roadside berms and low dunes south of Bienville Boulevard. Subsequent sand removal operations have reestablished most of the roadside berms, but these areas lack vegetative cover and are susceptible to future erosion (**Figure 5-11**).

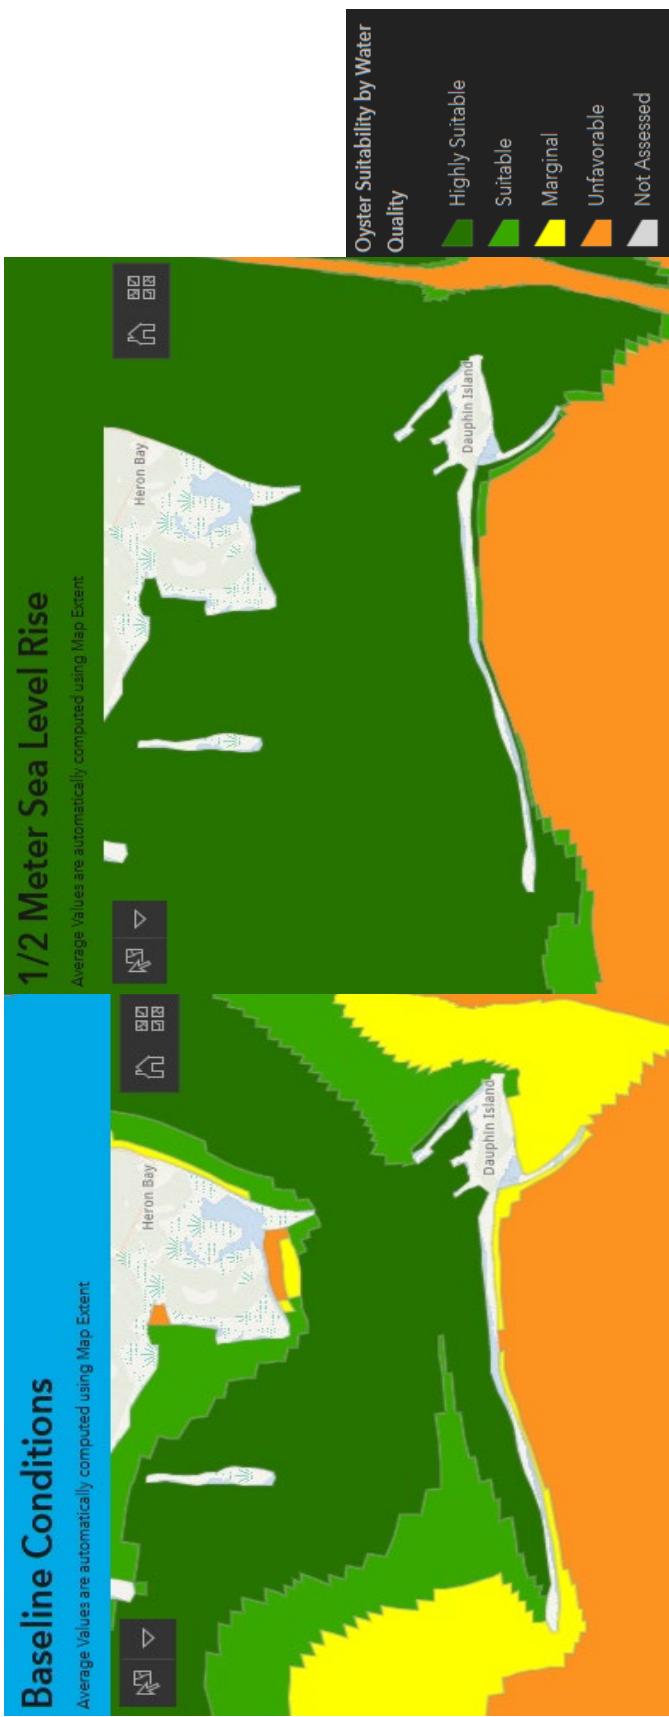
FIGURE 5-15 Oyster Habitat Suitability by Water Quality in Eastern Shore Watershed Study Area

Presently, the Gulf side of Dauphin Island is considered to be unfavorable for oyster recruitment, while the Sound side is considered highly suitable, and some oyster aquaculture is currently occurring. Under 1.6 feet of sea level rise, the suitability of the region improves and is predicted to be more hospitable for oyster growth (**Figure 5-15**).

Oyster habitat suitability under existing and future conditions (1.6 feet or 0.5 meters of sea level rise) were evaluated and mapped for the eastern Mississippi Sound and Mobile Bay by the U.S. Geological Survey National Fish and Wildlife Foundation Alabama Barrier Island Restoration Assessment Study (Enwright et al. 2019). Key water quality parameters for oyster growth and survival, such as salinity, temperature, dissolved oxygen (DO), local water depth, and total suspended solids (TSS), from existing hydrodynamic and water quality modeling efforts were assessed in the region and used to create rankings of habitat quality from Highly Suitable to Unfavorable.

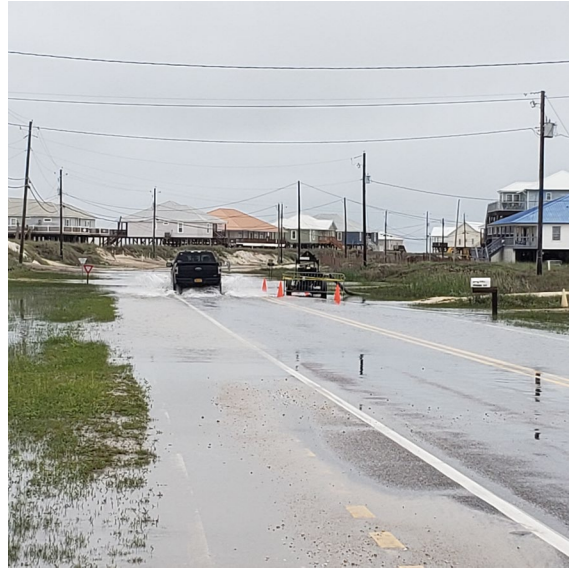
West End flooding

The entirety of Dauphin Island is susceptible to flooding due to its low elevation, limited stormwater storage capacity, and drainage system. The West End of the Island is a vulnerable area that regularly experiences flooding during storm events that produce heavy rainfall, including but not limited to tropical systems. In addition, flooding pressures exerted by rainfall are worsened by storm surge impacts to varying degrees during tropical events. The East End of the Island also experiences flooding due to both rainfall and groundwater inundation.

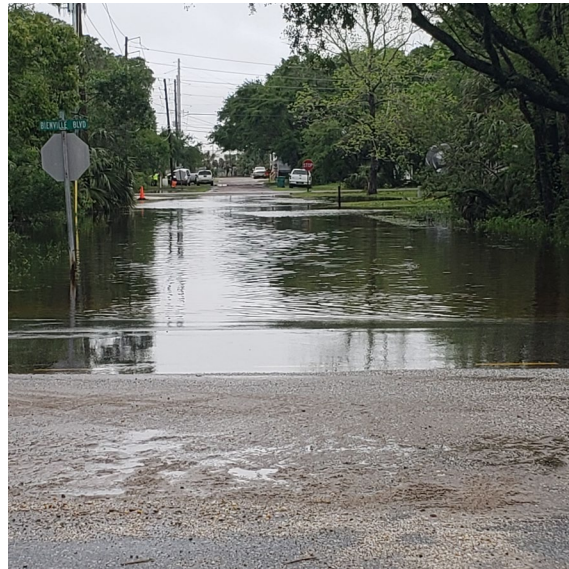
East End flooding

The Water Table Aquifer located beneath Dauphin Island contributes to Island flooding. The top of the aquifer is visible at ground level and is recharged directly by precipitation falling on the Island. Under normal conditions, as rain enters the aquifer, it discharges to area water bodies such as Mississippi Sound to the north and the Gulf of Mexico to the south. However, when the precipitation rate exceeds the discharge rate, the aquifer's potentiometric surface (water table) rises above ground level in low-lying areas giving the appearance of flooding. This phenomenon is known as groundwater flooding. Groundwater flooding takes longer to dissipate than surface water flooding because groundwater moves much more slowly than surface water and will take time to flow away underground. As the aquifer slowly discharges to the surrounding water bodies, the water table drops and the

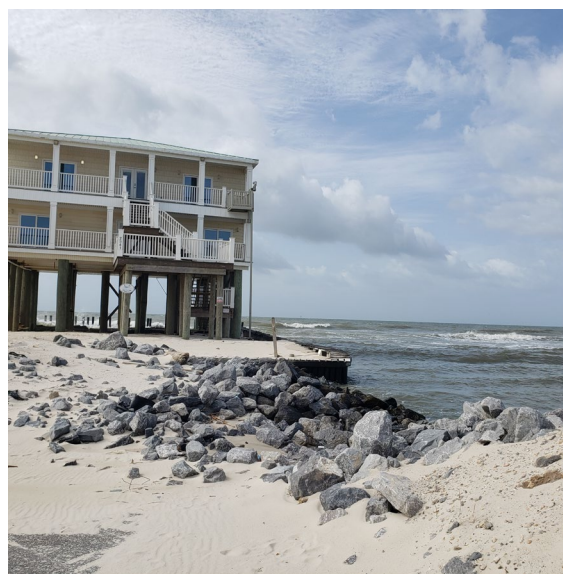
Source: Photo by Environmental Science Associates
West End bulkhead

Development in vulnerable locations has contributed to the risks people on the Island face. Residential construction on the West End has attempted to “pin” the Island in place, leading to loss of structures during extreme events as overwash transports sediment from the Gulf side of the Island to the back-barrier and the shorelines “adjust” out from under the development.

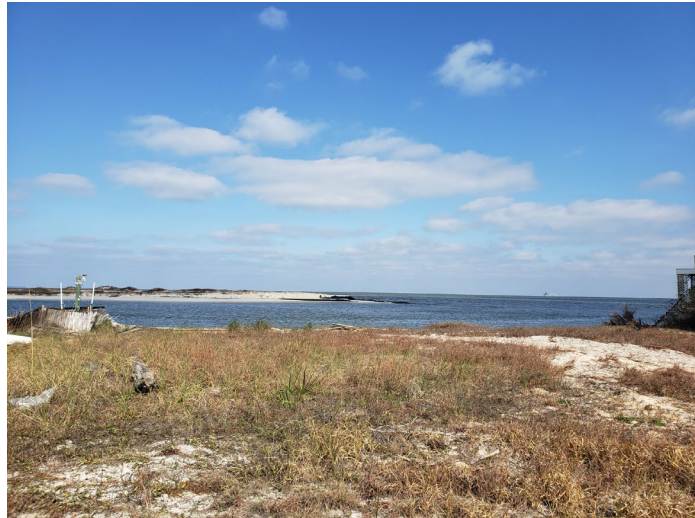
Source: Photo by Environmental Science Associates
Pass Drury

While Pass Drury is an historic breach of Little Dauphin Island, the development that has occurred just inside the Pass, which was protected from waves when the pass was closed, is now at risk from waves and erosion during large storm events.

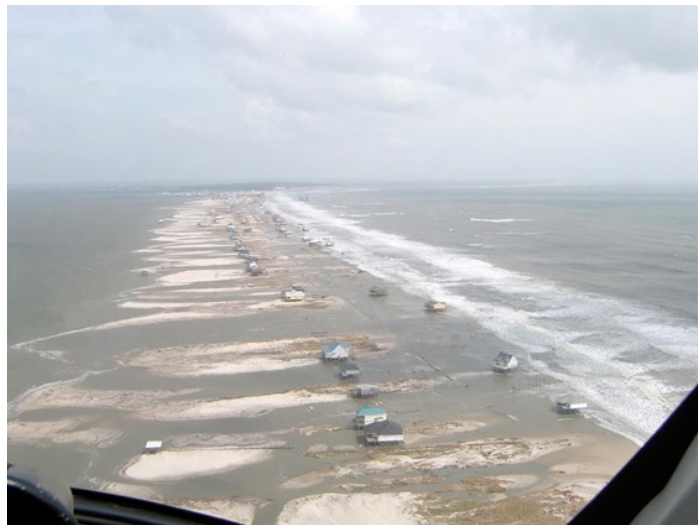
Source: NOAA NWS 2021b
Hurricane Katrina overwash

Dauphin Island has been breached by hurricanes and storm waters several times in recorded history. In September 2004, Hurricane Ivan breached the West End of the Island and in 2005 Hurricane Katrina widened the breach, which then became known as Katrina Cut. After the *Deepwater Horizon* oil spill, the U.S. Army Corps of Engineers issued an emergency permit to close the Katrina Cut with a rubble mound structure to protect against oil getting into the Mississippi Sound. The Island is susceptible to additional breaches during extreme storm events and the risk of breaching is expected to increase with sea level rise.

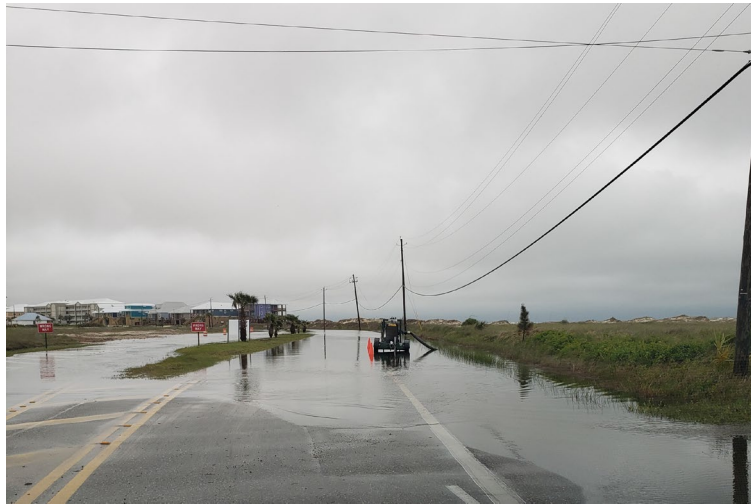
West End flooding

washing sand over Bienville Boulevard, temporarily blocking access to homes on the West End. As sea levels rise and increased storm intensity impacts the Island, water and sewage maintenance, 60% of which is already due to the West End (**Appendix A**), is likely to increase. Based on U.S. Army Corps of Engineers modeling, 1.0 meters of sea level rise combined with the 100-year storm surge is predicted to result in damage to 1,814 structures.

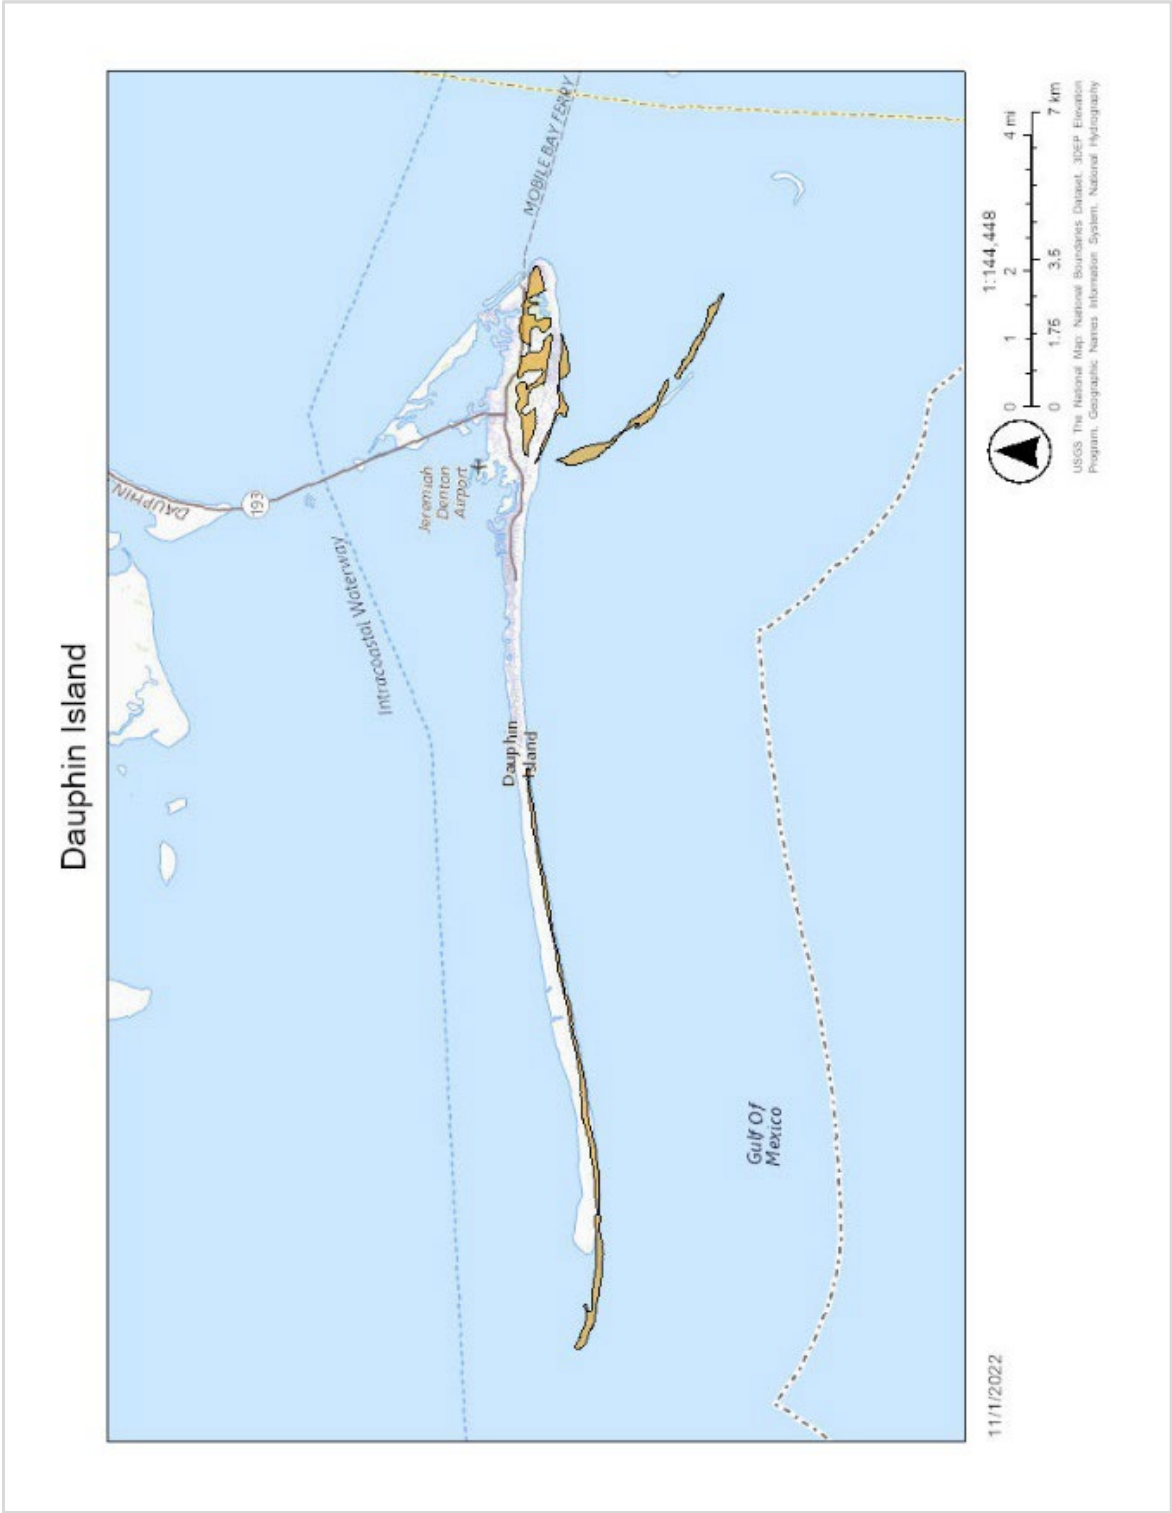
FIGURE 7-2 Fair Infiltration Soil Types (BcC and PcA) on Dauphin Island

Two soil types have been classified as fair soils. They have a good water table suitability and have a water table depth range of 25 to 50 inches. These soil types, BcC and PcA, are moderately well drained soils and have a moderately high to very high capacity to transmit water making them rarely flooded. These soils comprise 493.85 acres of the Island, which is approximately 1% of the soils present (**Figure 7-2**).

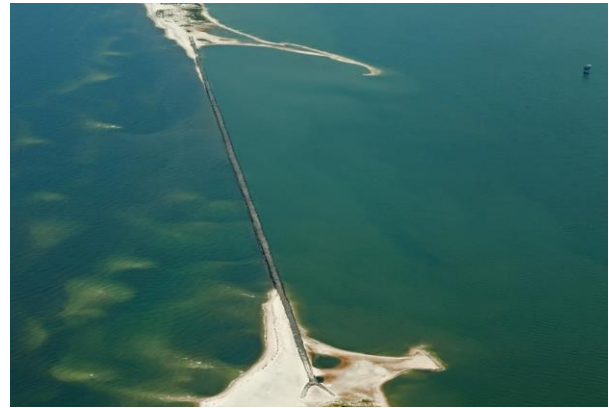
Source: Thompson Engineering
Katrina Cut repair, June 2011

Katrina Cut started as a 300-foot breach in the barrier island caused by Hurricane Ivan in 2004. This breach was widened by Hurricane Katrina in 2005 to over 6,500 feet and then to approximately 8,000 feet by Hurricane Gustav in 2010. In response to concerns of oil from the Deepwater Horizon oil spill reaching the marshes of Mississippi

Sound and Portersville Bay, ADEM executed a contract to design, permit and construct a coastal structure to close Katrina Cut as an “emergency repair.” The gap was closed in October of 2010 and the structure completed in April 2011.

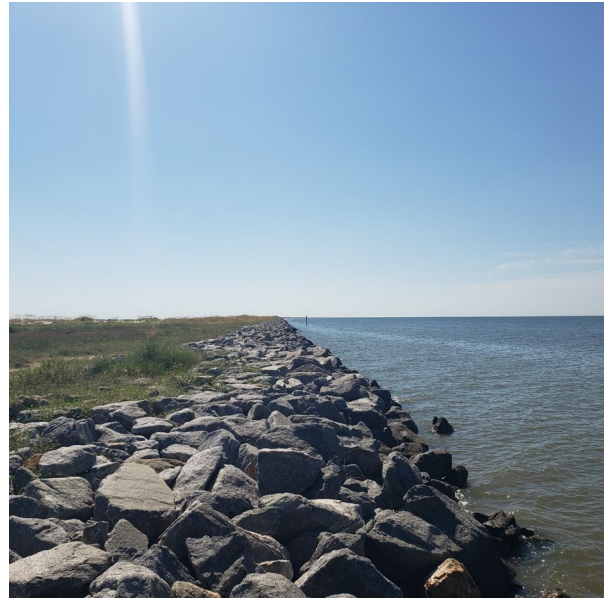
Katrina Cut structure

The structure has breached on the East End and West End flanks after Hurricane Isaac in 2012, but those breaches healed naturally. Katrina Cut continues to be susceptible to breaches on the east and west flank, but modeling studies have shown that the breaches may occur whether the structure was left intact, modified, or removed (Thompson Engineering 2013).

In April 2020, USACE Mobile District published a paper titled the Alabama Barrier Island Restoration Assessment Life-Cycle Structure Response Modeling (Gonzalez et.al. 2000). A Monte Carlo life cycle structure response assessment of the Katrina Cut rubble mound structure was performed as part of this study by the USACE Engineer Research and Development Center, Coast and Hydraulics Laboratory. Damage, wave transmission, and reliability were computed within the context of the decadal barrier evolution analysis performed by the USGS for various storm events and relative sea level change scenarios. The presence of a beach in front of the structure plays an important role in its protection. Since construction, morphological changes near the structure have been characterized by the steady accumulation of sand and the formation of a broad beach on the seaside of the rubble mound structure.

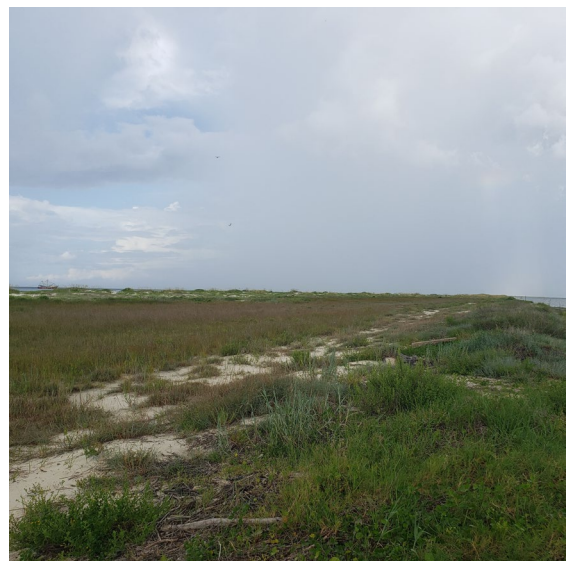
Katrina Cut dune area

The 2020 Alabama Barrier Island Restorations Assessment Report (USACE/USGS) identified three potential projects at Katrina Cut. The first project proposed a beach berm and dune nourishment on the Gulf side of the structure. The 2020 cost for the beach and dune nourishment in the area adjacent to Katrina Cut was approximately \$60 million, with another \$25 million in 20 years as O&M. The utility score for this project was highest at 231.1.

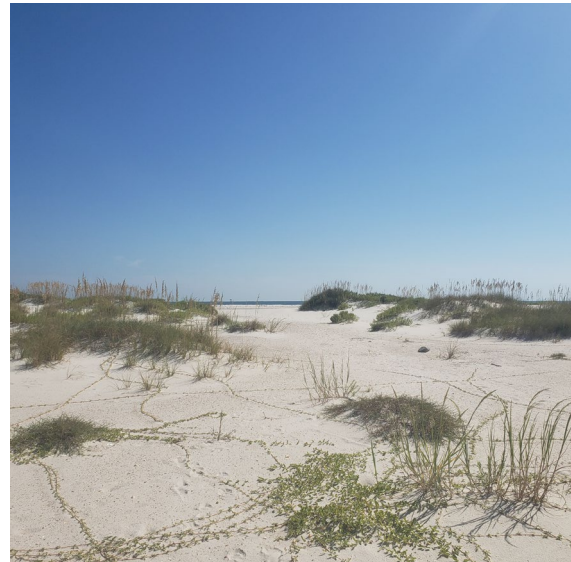
Far West End potential overwash area

The WMP Team recommends the marsh restoration of the back-bay platform, but without removal of the Katrina Cut structure and beach nourishment. Sand has already naturally migrated and formed dunes on the Gulf-side of the Katrina Cut structure; and longshore transport will continue to bring sand from the West End and from sandbars immediately offshore. Adding more sand to the gulf side beaches and dunes would be beneficial. The beach plays an important protective role by dissipating wave energy through wave breaking due to depth limitation. An initial assessment of the effect of the beach on the reliability of the structure showed that the absence of the beach can reduce its reliability more than 50%. Purposefully establishing and maintaining a beach long-term on the Gulf side of the rubble mound appears to be a viable option to extend the life and resilience of what was initially installed as a temporary structure. However, this can be costly to construct and maintain in the long-term. There is the potential for a lower cost, dune only project that would help to connect some of the existing dunes and eliminate lower elevation sections that are more prone to overwash or breach.

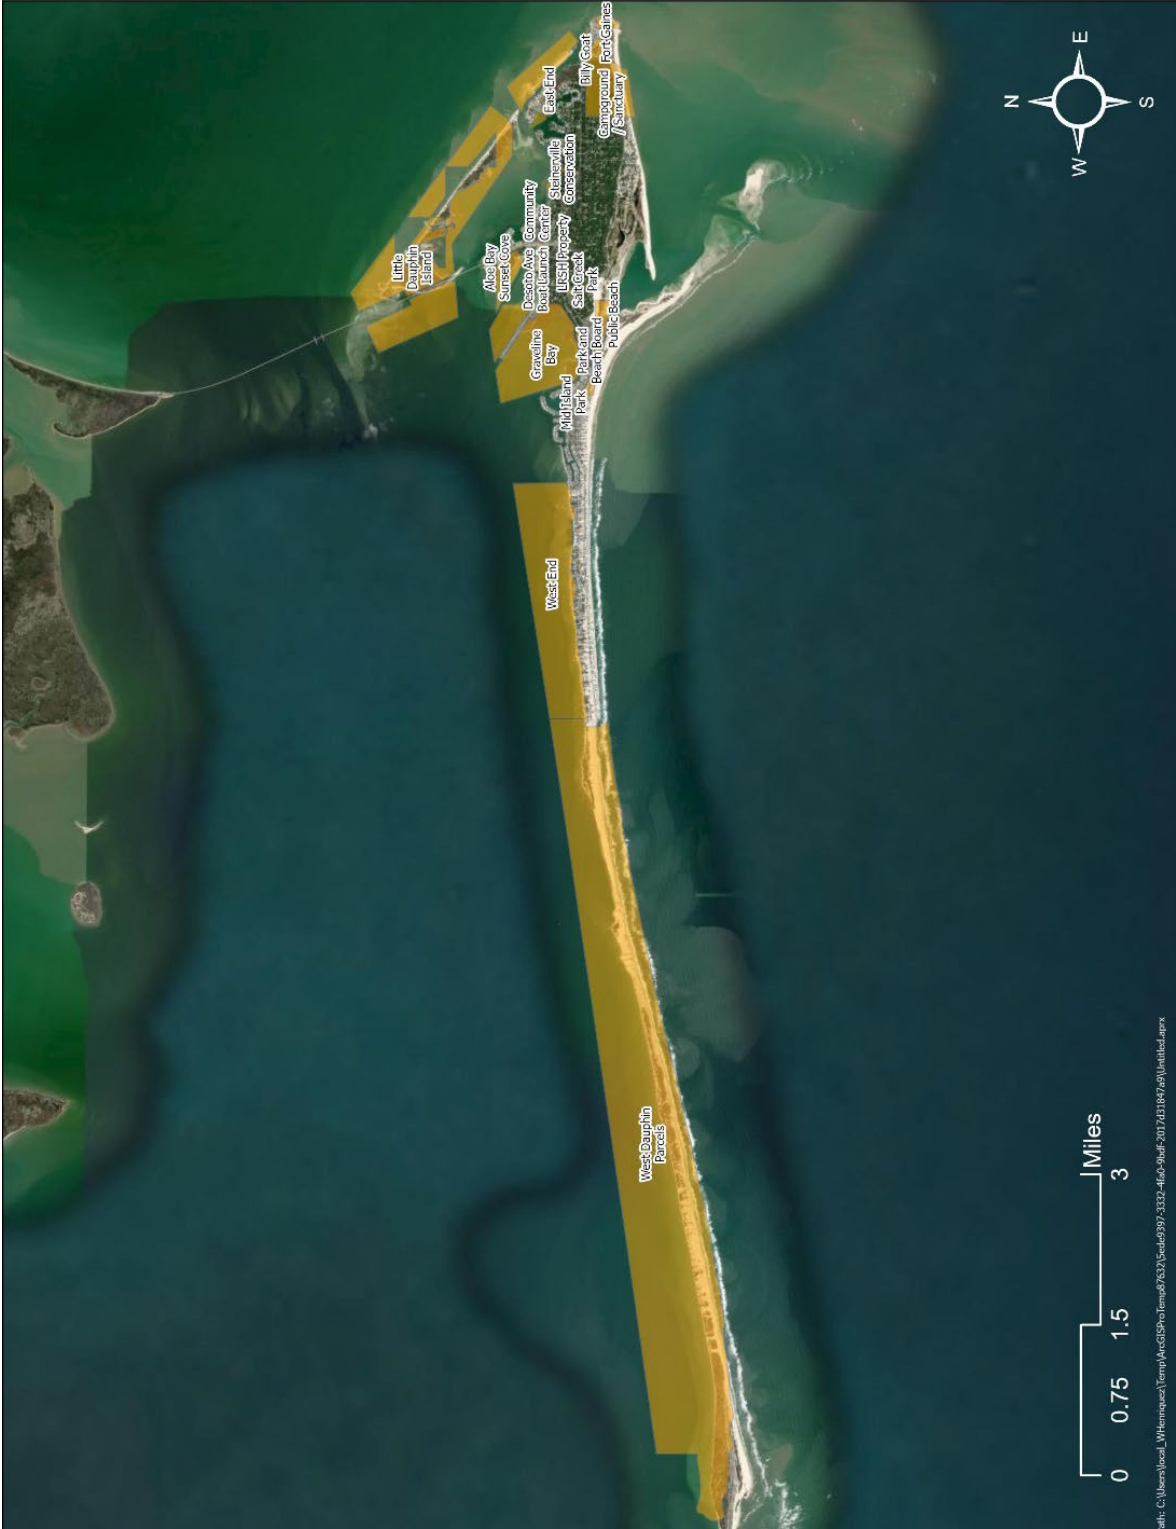
FIGURE 7-5 Land Acquisitions – Overview

The Town of Dauphin Island, Mobile County, federal agencies, and other stakeholders have made great strides in acquiring lands throughout the Watershed. **Figures 7-5 through 7-7** show land acquisitions in the Dauphin Island Watershed. Note that due to geomorphological changes in the Island and geographic inconsistencies between data sets, there may be some inconsistencies in exact parcel locations.
