Dauphin Island

WATERSHED MANAGEMENT PLAN

FINAL

March 2023

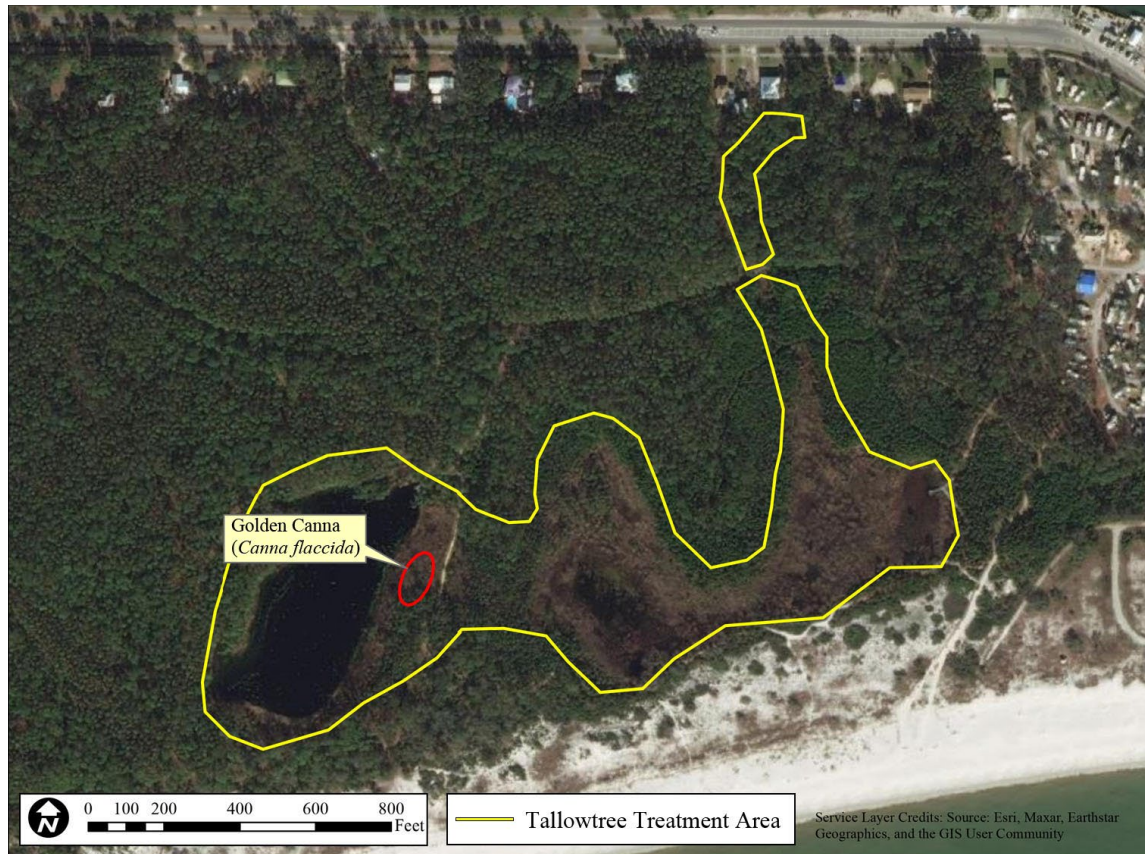
FIGURE 7-8 Priority Area for Chinese Tallow Tree Invasive Plant Management

Chinese tallow tree infestations are widespread in wetlands and uplands within the East End of the Island's interior freshwater marshes and swamps. Invasive plant management is recommended for an approximate 23-acre area in the in the Audubon Bird Sanctuary, shown in **Figure 7-8**.

A small population of golden canna (*Canna flaccida*) occurs along the east margin of Alligator Lake in the Audubon Bird Sanctuary (**Figure 7-8**). Golden canna is a Priority 1 (S1) species considered critically imperiled in Alabama because of extreme rarity. The species should be flagged and avoided when spraying herbicide or implementing other methods to control the tallow tree infestation.

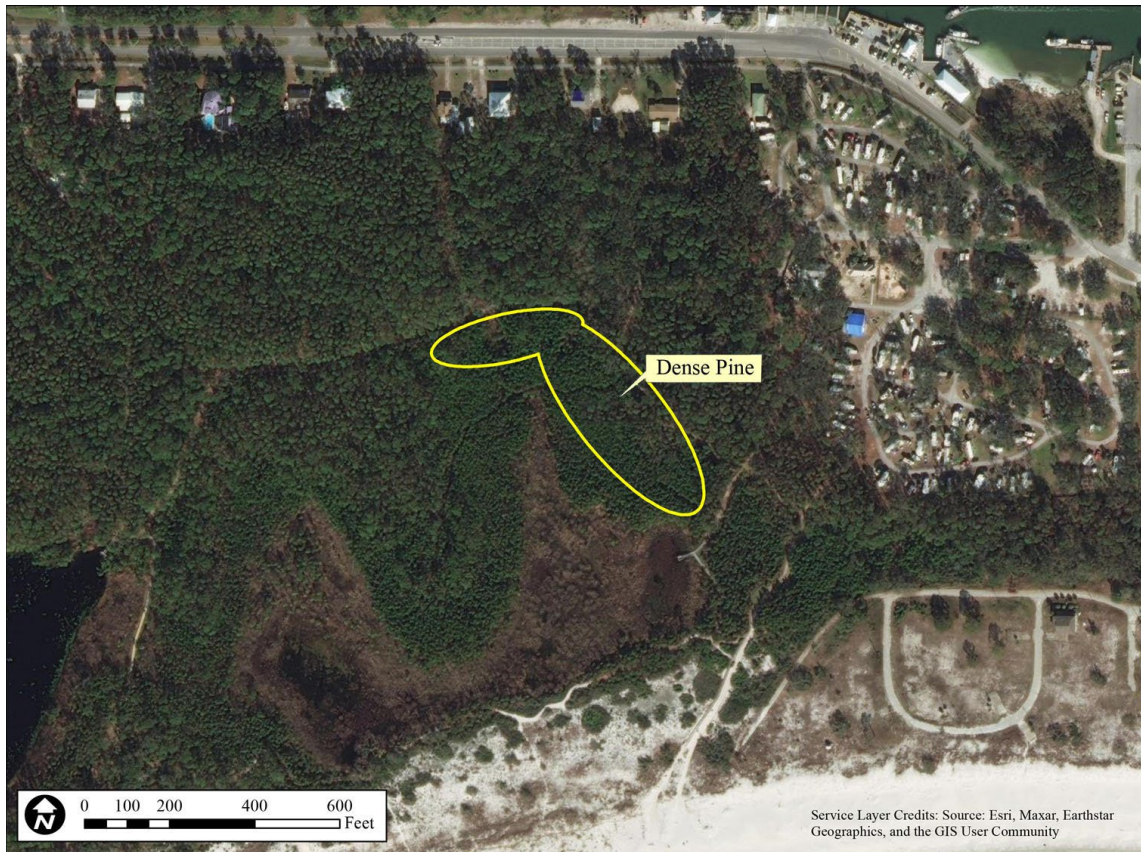
FIGURE 7-9 Management Area for Dense Pine Management and Forest Restoration

Fire suppression and livestock exclusion over many decades in the Audubon Bird Sanctuary property has allowed the conversion in some areas of formerly sparse and open understory of the native maritime forest, to shrubs and other woody species (Bailey 2013). This degraded habitat can potentially be restored using either controlled burning or mechanical removal. The recommended area for management is approximately 2.5-acres in size, as shown in **Figure 7-9**.

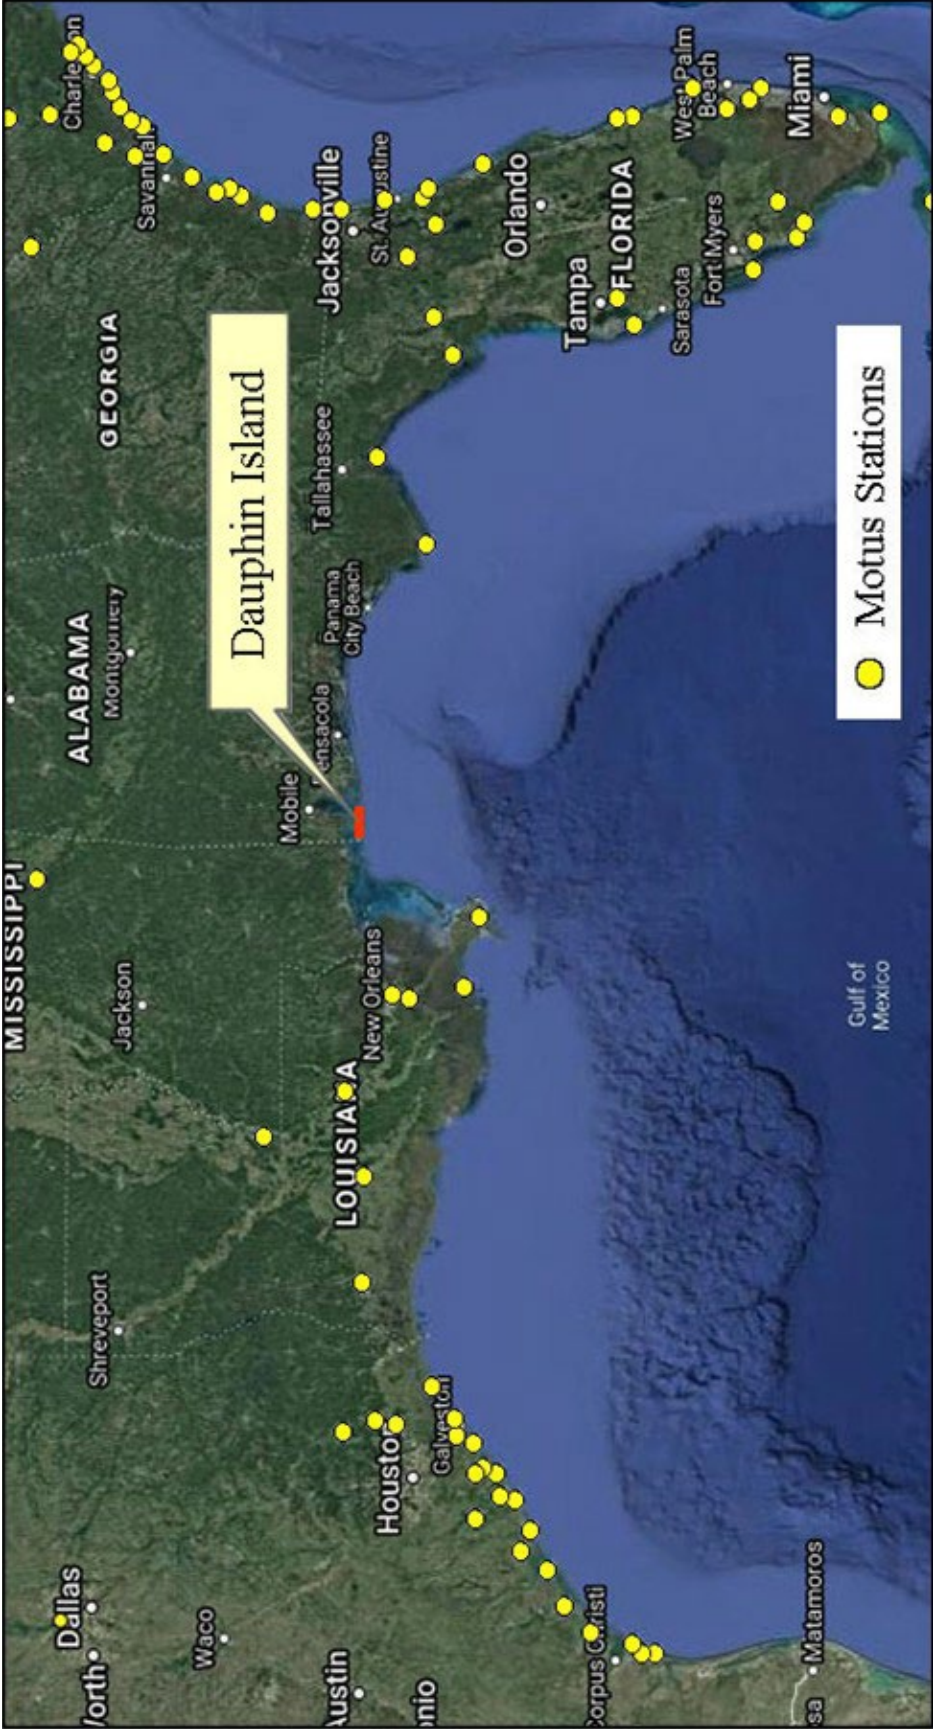
FIGURE 7-11 Motus Radio Telemetry Stations Along the Northern Gulf Coast

Despite its location within a major migratory flyway, the Alabama coast represents a significant gap within the existing Motus array (**Figure 7-11**). The Motus system harnesses the collective resources of many independent researchers into a larger collaborative effort. Data from across the network is provided to researchers. A condensed version is publicly available. A local Motus station will help document and improvement understanding of migratory patterns and the extent of use of Island habitats during both fall and spring migration, to identify needed conservation actions and make informed decisions regarding protection of neotropical migrant songbirds and their habitats.

This recommended management measure is the installation and maintenance of a Motus Wildlife Tracking System station in the Watershed at a secure location with an available power source and internet access, such as the Dauphin Island Sea Lab. Automated radio telemetry is used in a wide variety of ecological applications particularly for tracking migration of small animals or determining fine scale temporal information about movement or behavior. The Motus system uses a coordinated array of automated radio telemetry stations that are all monitoring the same frequency to detect tagged animals over broader spatial scales. The Motus system collects data from more than 750 receiving stations as well as metadata from stations (location, deployment dates, height, antenna bearing) and tags (species, location, date deployed). Researchers have access to detection data from all receivers within the Motus network regardless of who maintains those stations. Tagged animals are detected on their local array, as well as any other station in the network.
